REPORT ON
Slope Stability Assessment
150 Steeles Avenue East
Milton, Ontario

PREPARED FOR:
NEATT Communities

Project No. 21-122-103
January 17, 2023

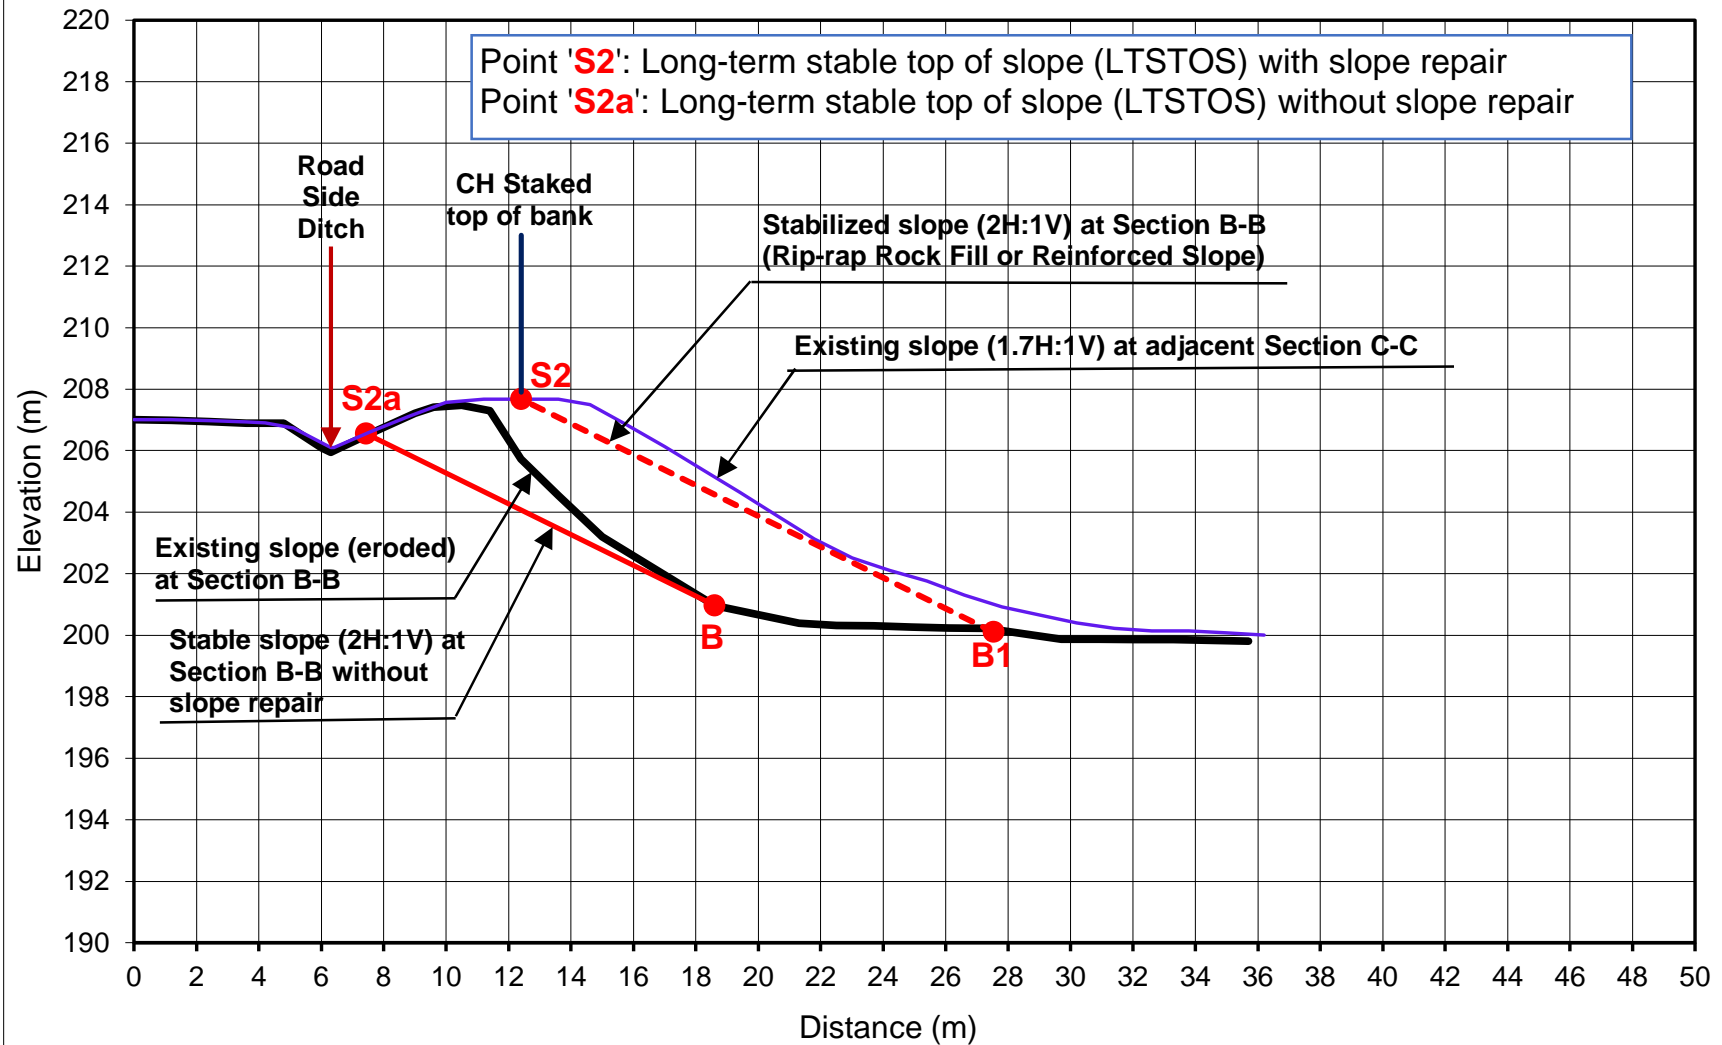
Project: 21-122-103 - **Drawing 6**
Slope Profile at **Cross-Section B-B** (See Drawing 1 for Location Plan)

Without stabilization (repair) of the eroded slope, the stable top of slope at Cross-Section B-B is at Point "S2a" as shown in **Drawing 6**, assuming there would be no further erosion in the area (i.e. no more discharge from the broken sewer pipe, or the sewer pipe will be repaired and extended to beyond the slope toe area).

It is recommended that the eroded/failed slope in the area of Cross-Section B-B be stabilized/repared. Based on the site conditions, **rip-rap rock fill or reinforced slope** can be adopted to stabilize the slope in the area of Cross-Section B-B.

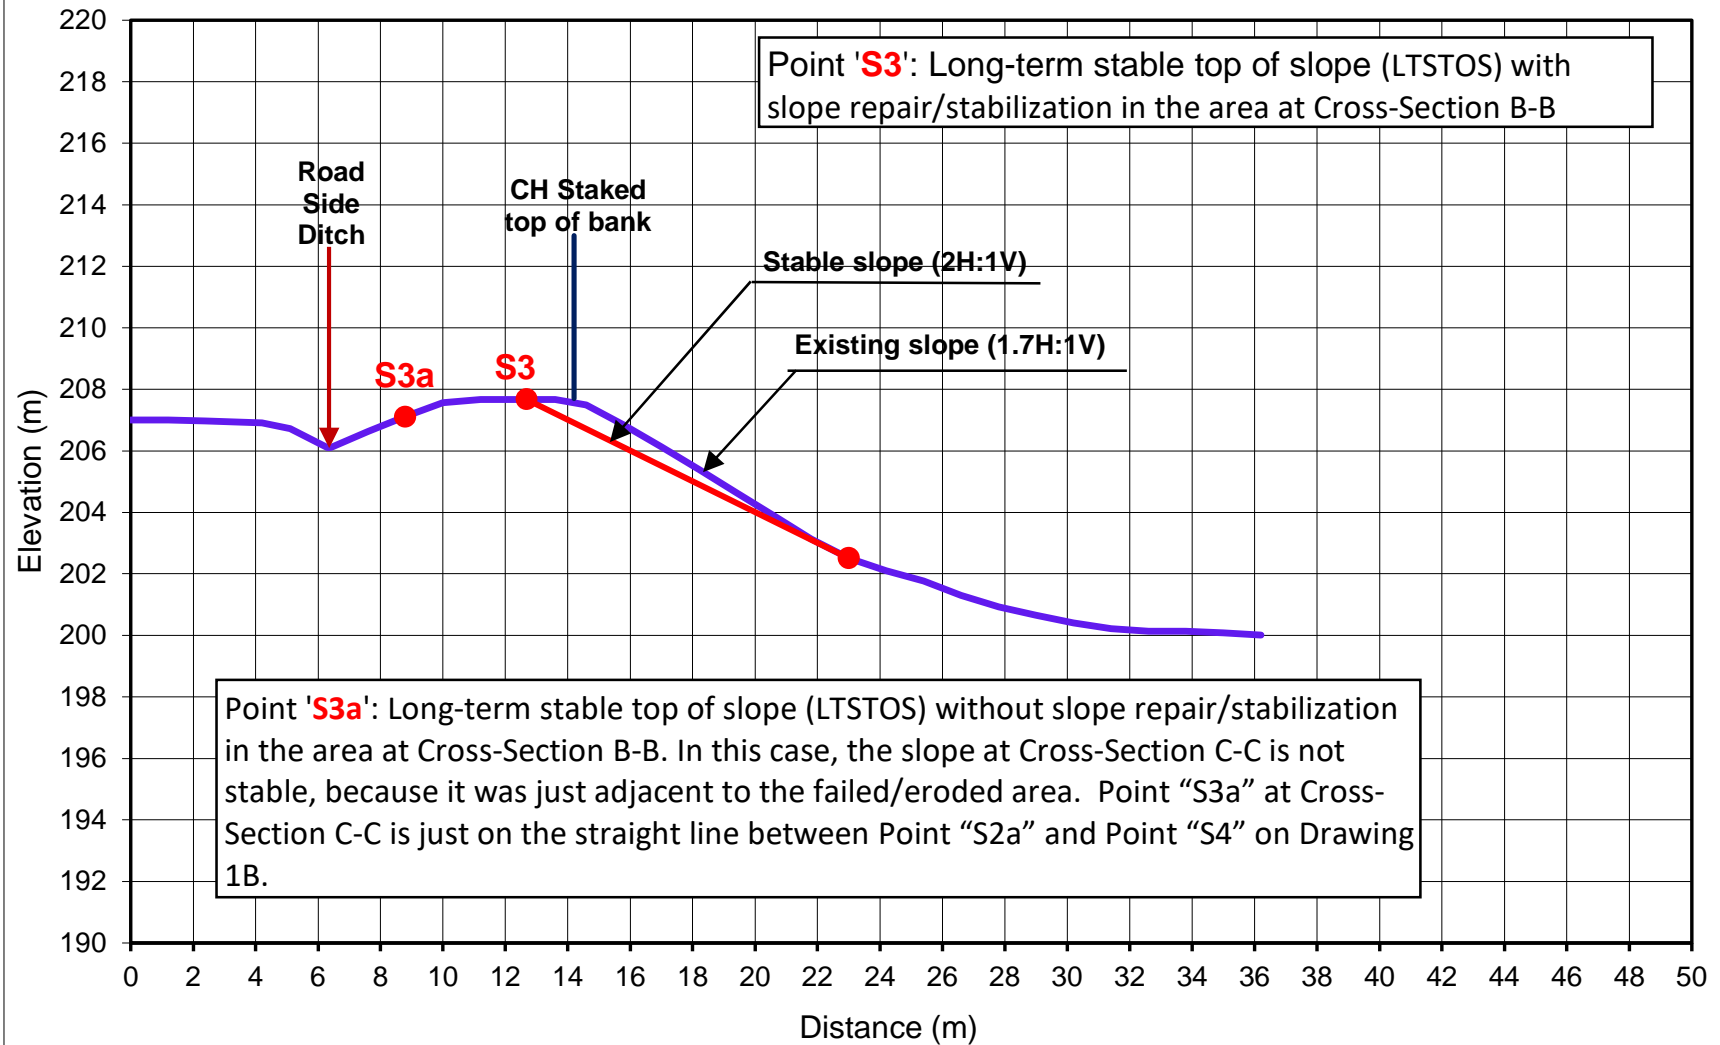
Project: 21-122-103 - **Drawing 7**
Slope Profile at **Cross-Section C-C** (See Drawing 1 for Location Plan)

Without stabilization (repair) of the eroded slope at Cross-Section B-B, the stability of the adjacent slope, such as at Cross-Section C-C, will also be affected in future.

If the eroded/failed slope in Cross-section B-B area is not to be stabilized/repared, the slope at Cross-Section C-C is not stable, because it was just adjacent to the failed/eroded area. Point “S3a” at Cross-Section C-C is just on the straight line between Point “S2a” and Point “S4” as shown on Drawing 1B.

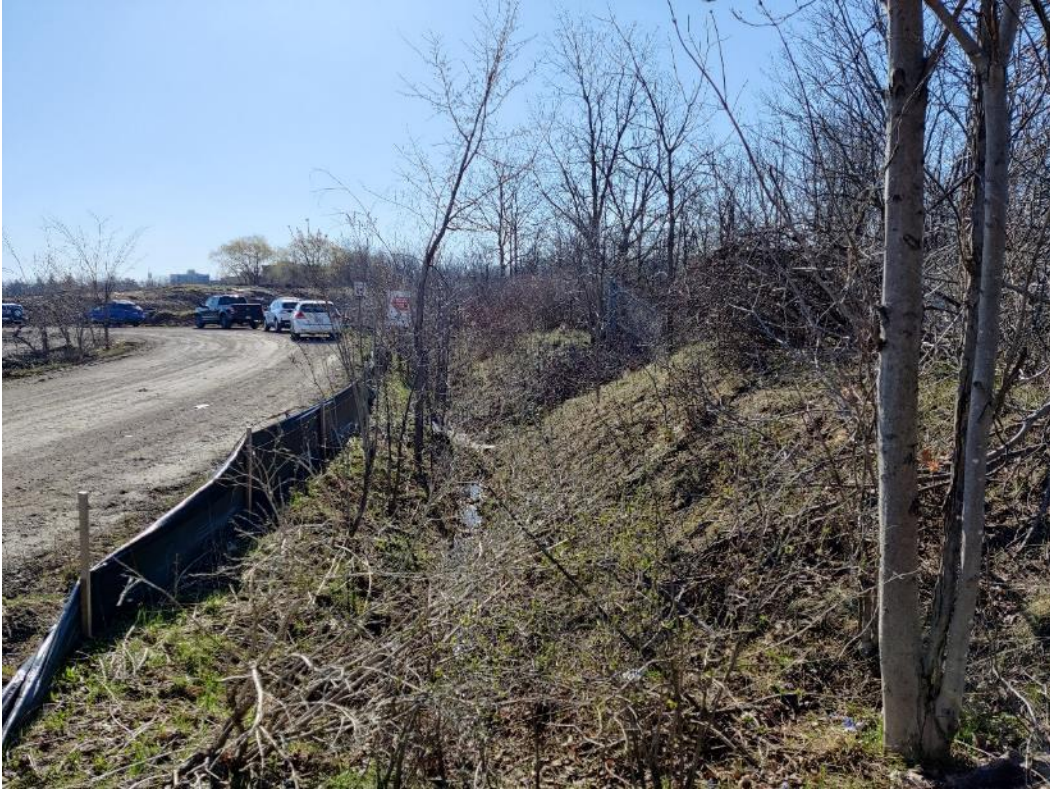
Photo 1: Top of Slope Area in Cross-Section B-B and C-C (looking east)

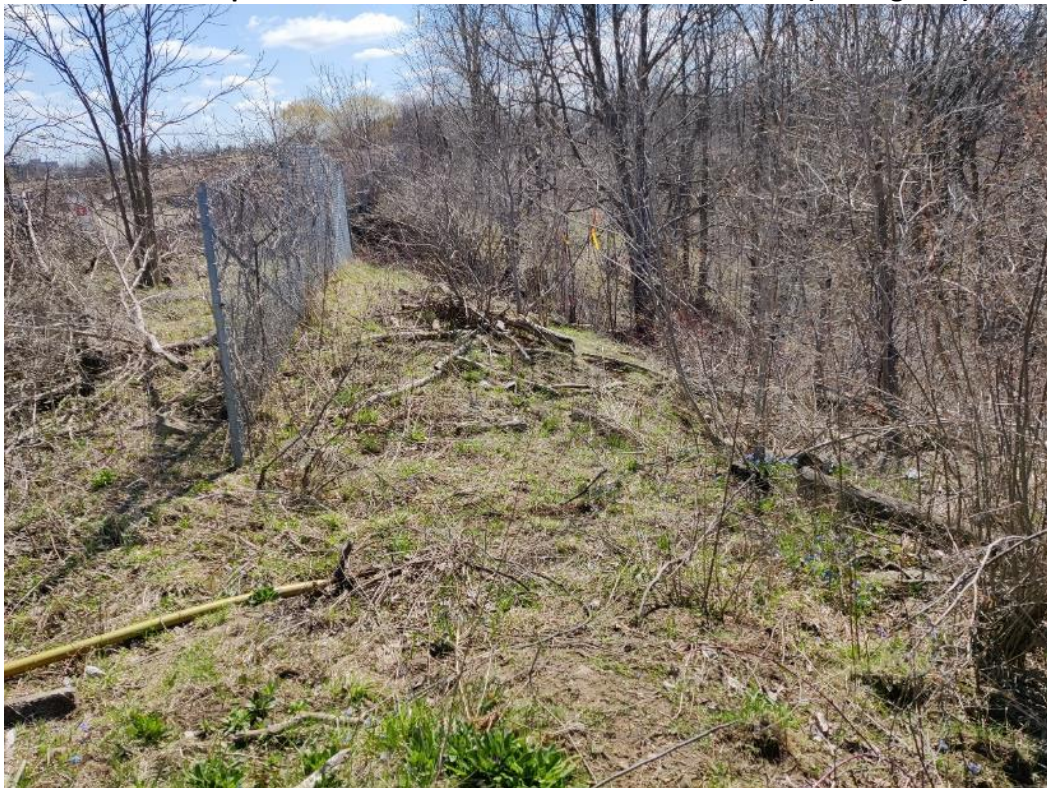
Photo 2: Slope Condition in Cross-Section B-B and C-C Area (looking east)

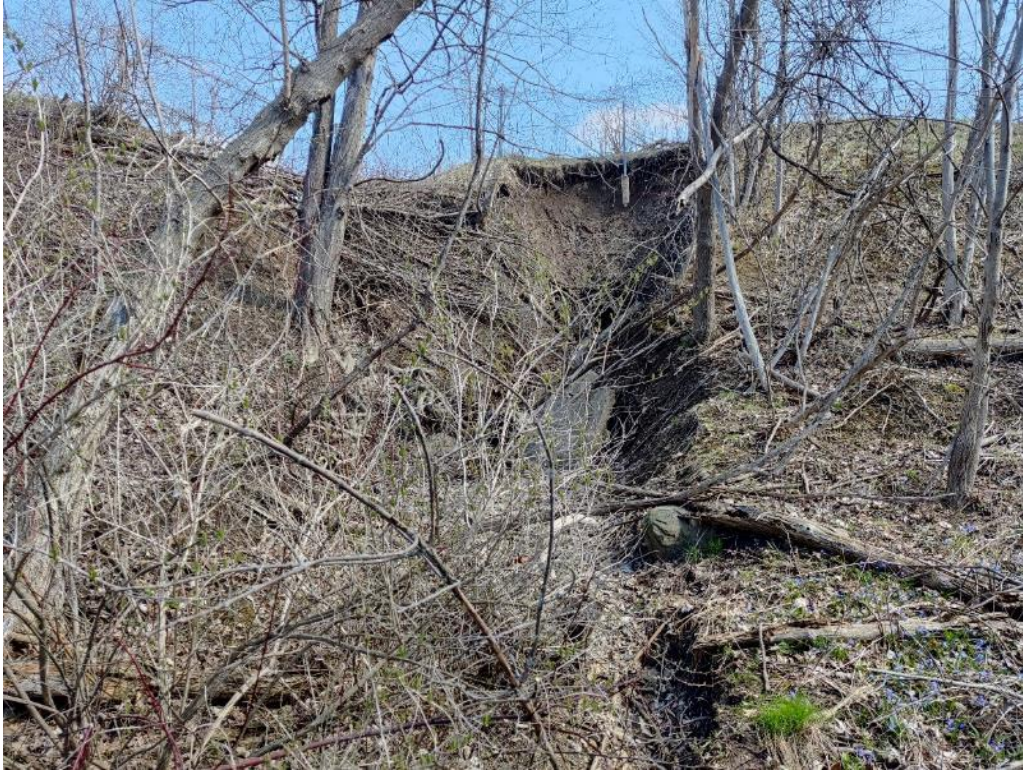
The erosion (failure of slope) was about 6 to 10 m wide and was about 4 m deep below the original slope surface (as compared to the adjacent slope that was not eroded). The erosion of the slope extended into the top of slope area and the founding pier of the existing fence was exposed due to erosions.

**Photo 5: Slope conditions and erosion/failure in Cross-Section B-B area
(looking north from toe of slope)**

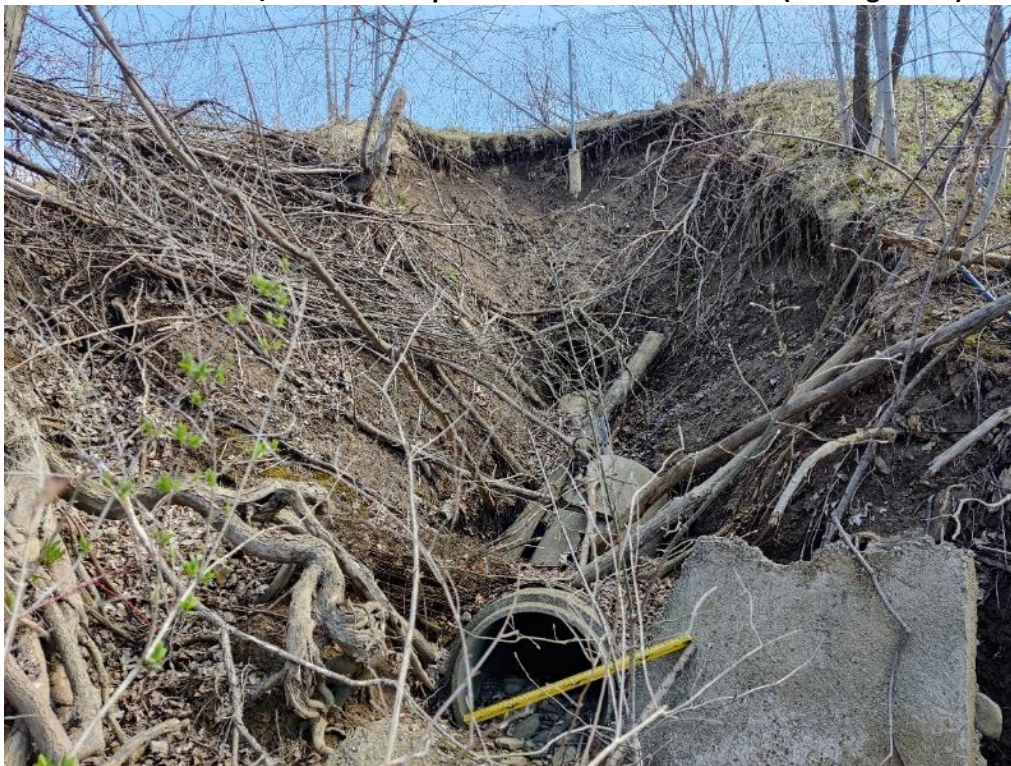
As discussed in **Section 4.1** of this report, severe erosions of the slope in the area of Cross-Section B-B (see **Drawing 1B** for location) had occurred. The erosions of the slope appeared to be caused by the flow from the broken concrete sewer pipe. However, no water flow was observed from the sewer pipe during our site visits.

Photo 6: Erosion/Failure of Slope in Cross-Section B-B Area (looking north)

Prior to the placement of rip-rap rock fill, all disturbed/loose materials in the eroded area must be removed. A geotextile (such as Terrafix 420R) should be placed at the excavation base and the sides of the eroded ditch, and rip-rap rock fill can then be placed above the geotextile.
