**Project: 21-122-100-R****June 6, 2023****Neatt Communities****via email: [Colin.Rauscher@neattcommunities.com](mailto:Colin.Rauscher@neattcommunities.com)****Re: Additional Comments Regarding Impact Slope Stabilization Methodology  
150 Steeles Avenue East, Milton**

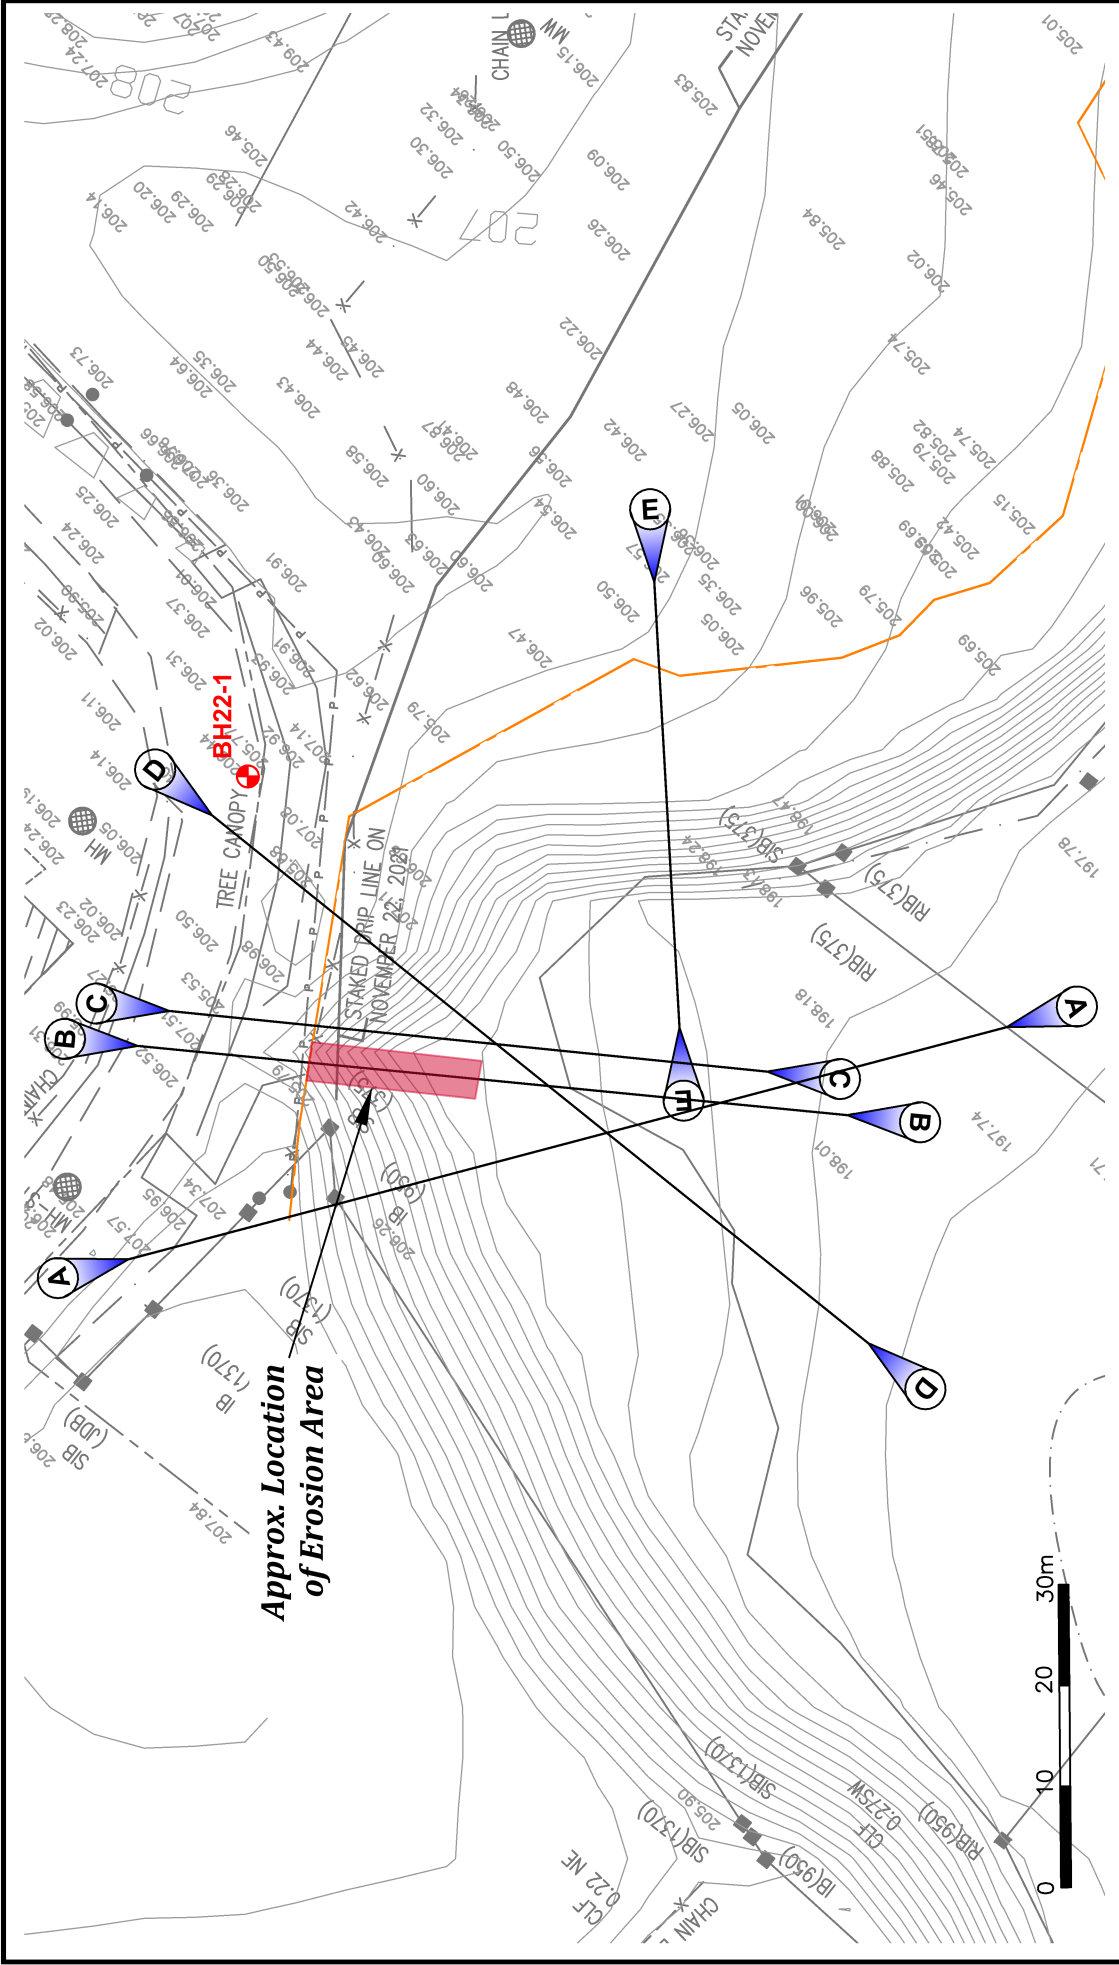
Further to the recent comments from Conservation Halton (CH) and Halton Region (the Region) we extend the following comments in regards to the methodology/approach for stabilization of the eroded slope (Section B-B on attached Drawing 1) at subject site noted above.

Field measurements of the failed (eroded) slope area (must be confirmed by proper survey conducted by a licensed surveyor) were obtained by DS and are presented in plan and profile on attached Drawings 1, 2 and 3. The affected area measures approximately 17 m in length, 7.3 m in width and on a depth of about 5.0 m at its deepest point.
