**Geotechnical Investigation-Top of Bank Stability  
For the property at Part Lot 48  
(6451 Sixth Line, Milton, ON) – Rev01  
Project No. 30291.233**

Neamsby Investment Inc.  
7501 Keele Street, Suite 100,  
Vaughan, ON L4K 1Y2

**AME** Materials Engineering  
10 Perdue Court, Units 2 & 3  
Caledon, ON L7C 3M6

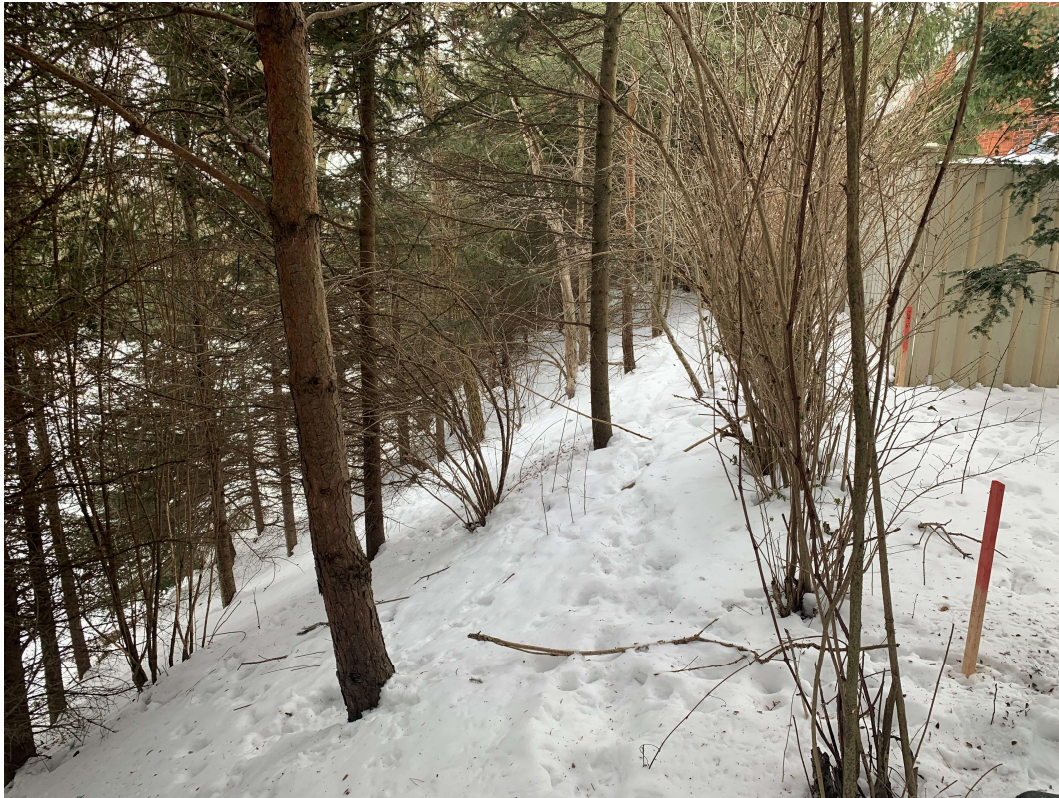
**Figure E1: Top of Bank at the location of Heritage building**

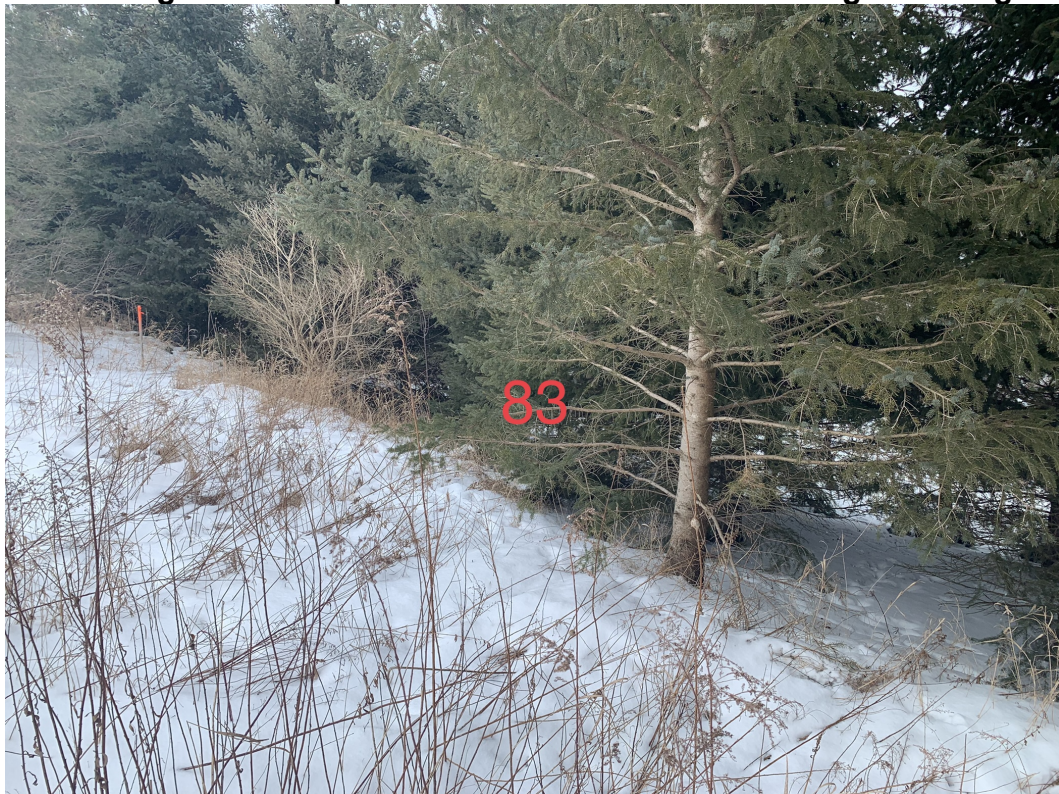
**Figure E2: Top of the Bank at the location of BH22-03**

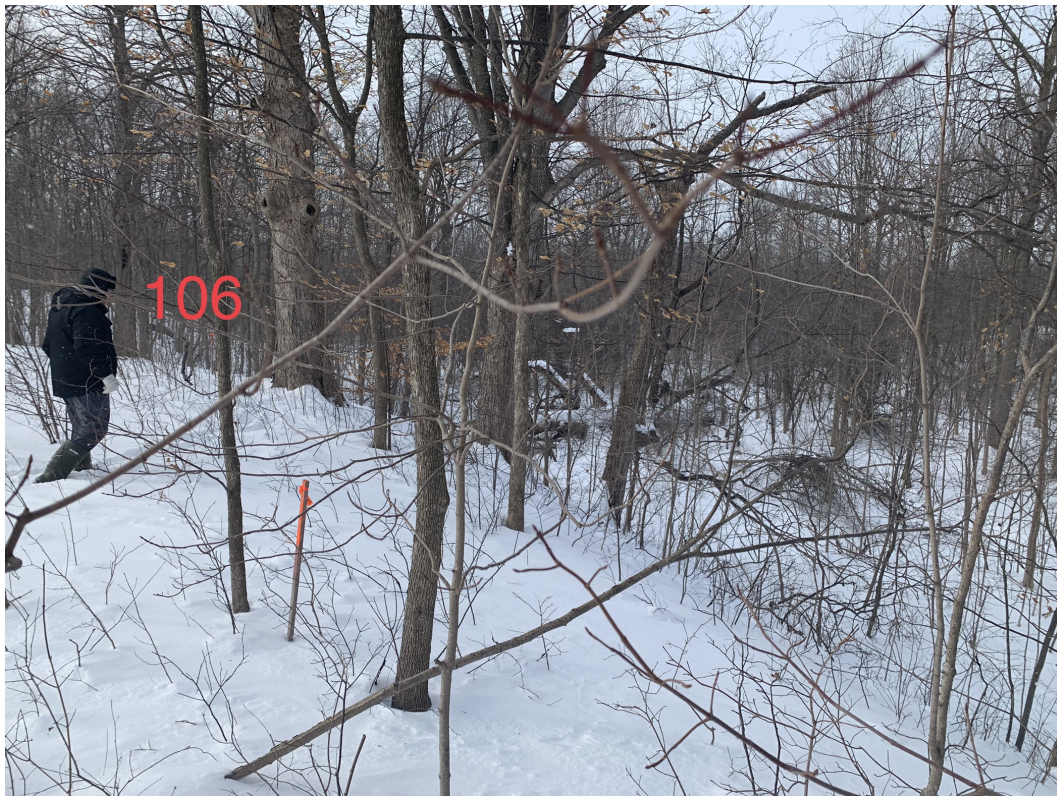
**Figure E3: Top of Bank at the location of BH22-13**

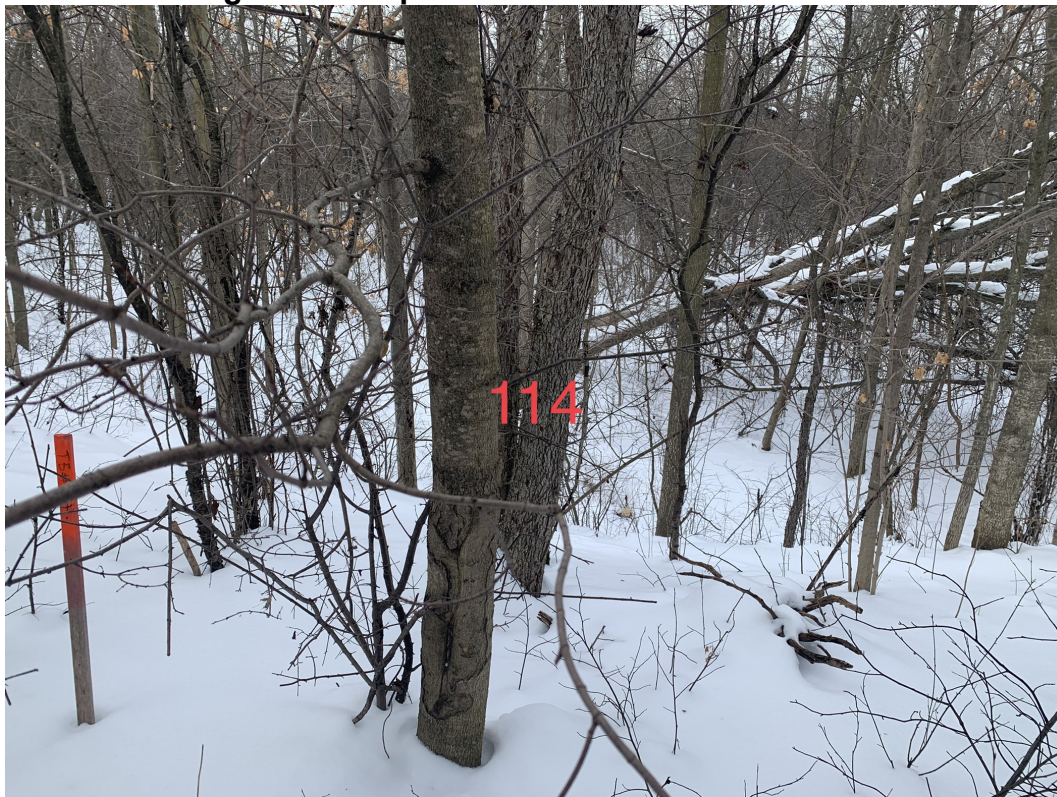
- The steepness of the slope generally ranged from 5.0H to 1.0 V to 2.0H:1.0V
- The slope was generally covered with mature trees and other vegetation as shown in the photographs in Appendix E. During the site visit, few bending / tilted trees were noted on the slope; however, majority of trees were generally standing straight.
- No slope slumping or tension cracks were observed on the slope surface.
- No water seepage was observed on the slope surface or at the toe of slope area.

**Figure E4: Evidence of falling trees on the slope**
