### A REPORT TO 833697 ONTARIO LIMITED Frontenac Forest Estates Inc PHASE I ENVIRONMENTAL SITE ASSESSMENT

PROPOSED MIXED-USE DEVELOPMENT

6692 EIGHTH LINE " ove property" TOWN OF MILTON

Reference No. 1011-S049E

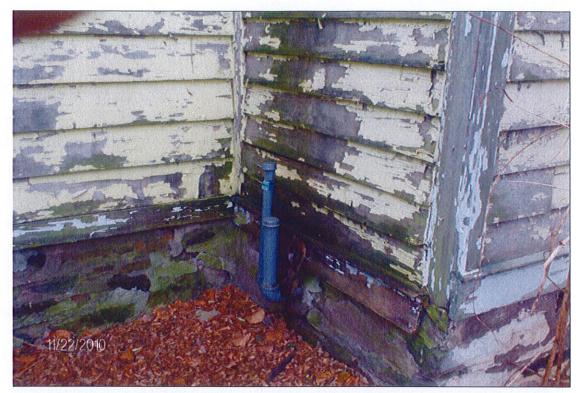
Our representative observed several above-ground storage tanks (ASTs) on the subject property. Vent and filler pipes were observed on the east wall of the home, indicating a heating oil tank in the basement. The metal heating oil tank was in good condition. The concrete floor immediately beneath the tank appeared in good condition, with no cracks or stains.

View of vent and fill pipes located on the eastern wall of the home

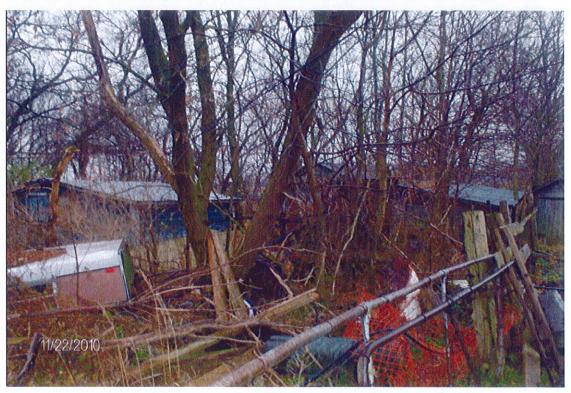
At the time of inspection, the site consisted mainly of agricultural grazing fields with a residence and several barns and farm equipment along the northeastern portion of the subject site. The site is fenced, and ditches extend along Derry Road and Eighth Line. A stockpile of manure was seen in the east-central portion of the site and several piles of soil were located near the barns in the east portion. Debris, including old farm equipment and used tires, was noticed on the site.

View of debris and sheds located on the subject site

As no materials of concern were noted during our walk-through, the debris items are considered more of a nuisance than a hazard. It is recommended that during construction, any deleterious debris found on the surface or buried on site must be removed and disposed of properly.

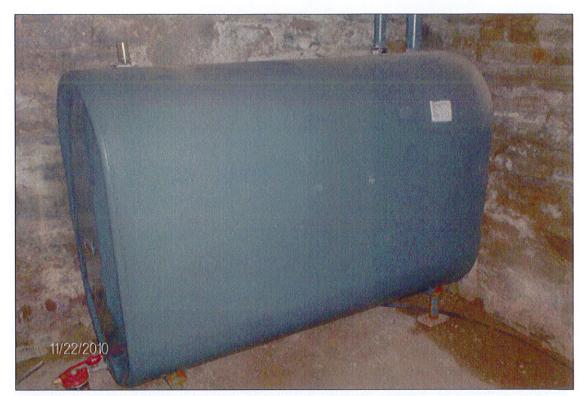
View of AST located in the basement of the home on the subject site

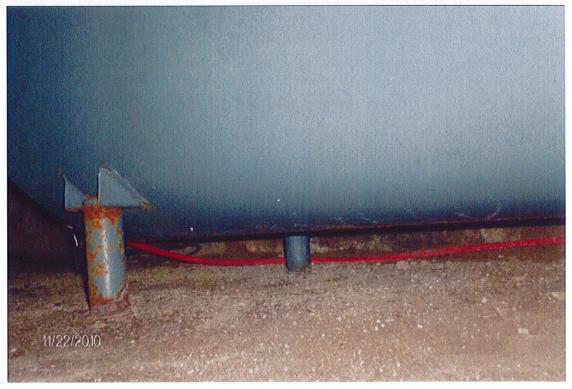
View beneath the AST located in the basement

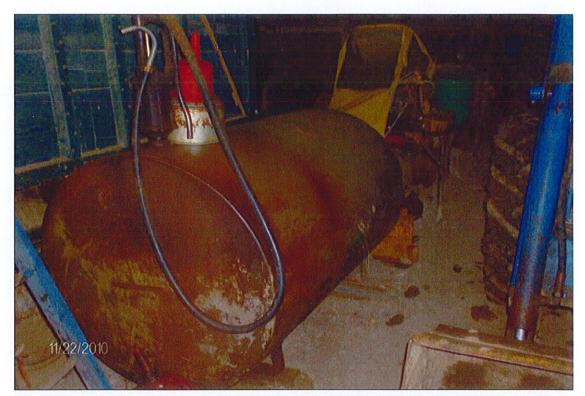
An AST containing diesel fuel was found in the barn situated behind the residence. The AST appeared in good condition, with no leaks or cracks noticed in the tank. No stained ground or nuisance odours were noticed around or beneath the tank.

View of diesel-containing AST located in a barn on the subject site

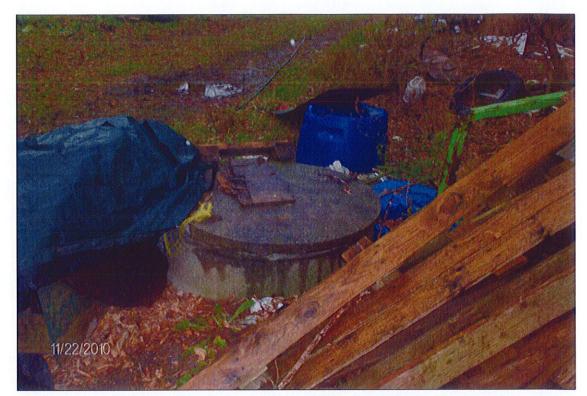
A review of the Registered Well Record database revealed that there is one well located on the subject site. The well was installed in 1977 to a depth of 40 ft. It is registered for domestic use and has UTM coordinates of 597415E, 4823883N.

View of water well in use at the subject site

Domestic wells and sewage disposal systems (such as septic tanks) that are found and not in use must be properly decommissioned.

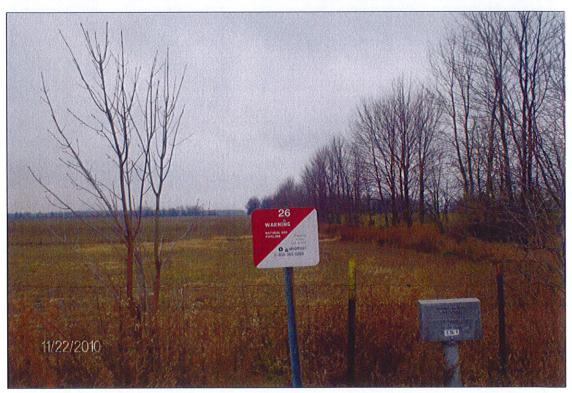
Mr. Paul Sherriff, Superintendent, of Transmission Pipelines East informed us that there are a total of 3 pipelines located south of the subject property. They were installed at various dates and are of steel construction, 26, 34 and 48 inches in size, and operate at 550 to 890 psi. He also informed us that there has never been any leaks associated with the pipelines.

Natural gas pipelines transport natural gas at high pressure. It is possible that the pipeline may have leaked or had a spill during its use. However, based on a review of the topographic map as confirmed by our visual/walkthrough of the site, the pipeline is at a lower elevation that the subject site, and therefore there is a low potential for environmental concern associated with the pipeline. In addition, these pipelines and their associated equipment are generally maintained by government-regulated utility companies, agencies of licensed government contractors that specialize in their upkeep.

View of natural gas pipeline easement located south of the subject site

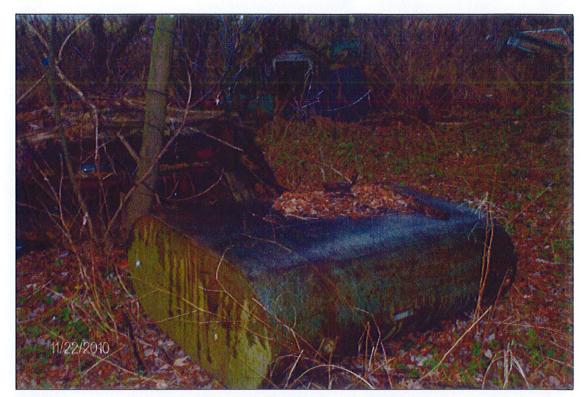
Several ASTs were noticed outside the home. The tanks were not connected and were empty of fluid. No stained soils or nuisance odours were noticed beneath or around the ASTs that were not connected.

View of unused AST on the subject site

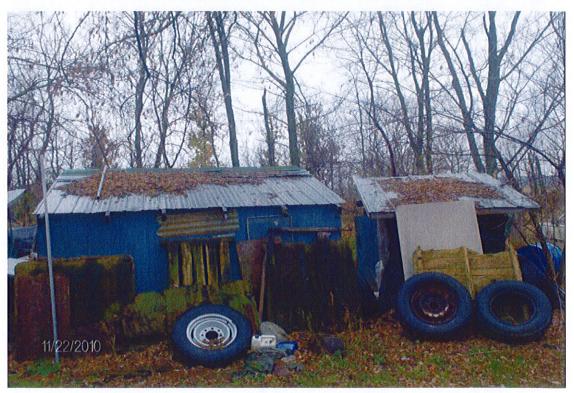
View of sheds and debris located on the subject site
