September 15, 2025

## ARBORIST REPORT

Derry Road and Bronte Street, Milton, Ontario

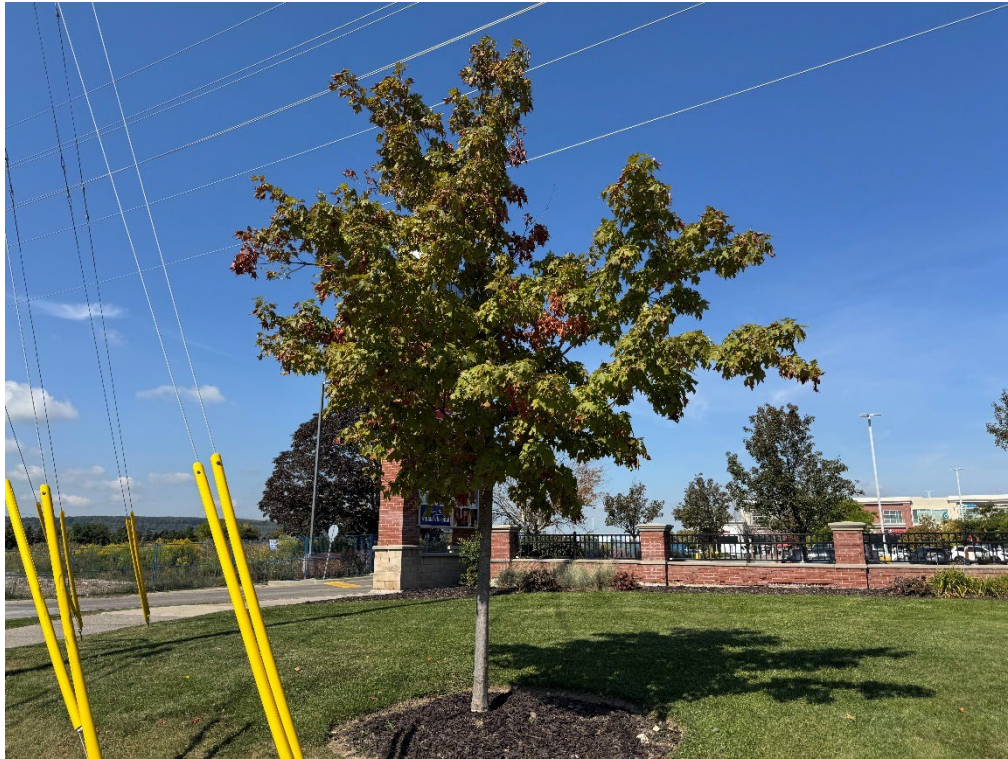
Tree 349

| Tree # | Common Name | Botanical Name | DBH (CM) | Condition | Comments | Recommendation |
|---|---|---|---|---|---|---|
| 349 | Red Maple | Acer rubrum | 10 | F | | Retain |

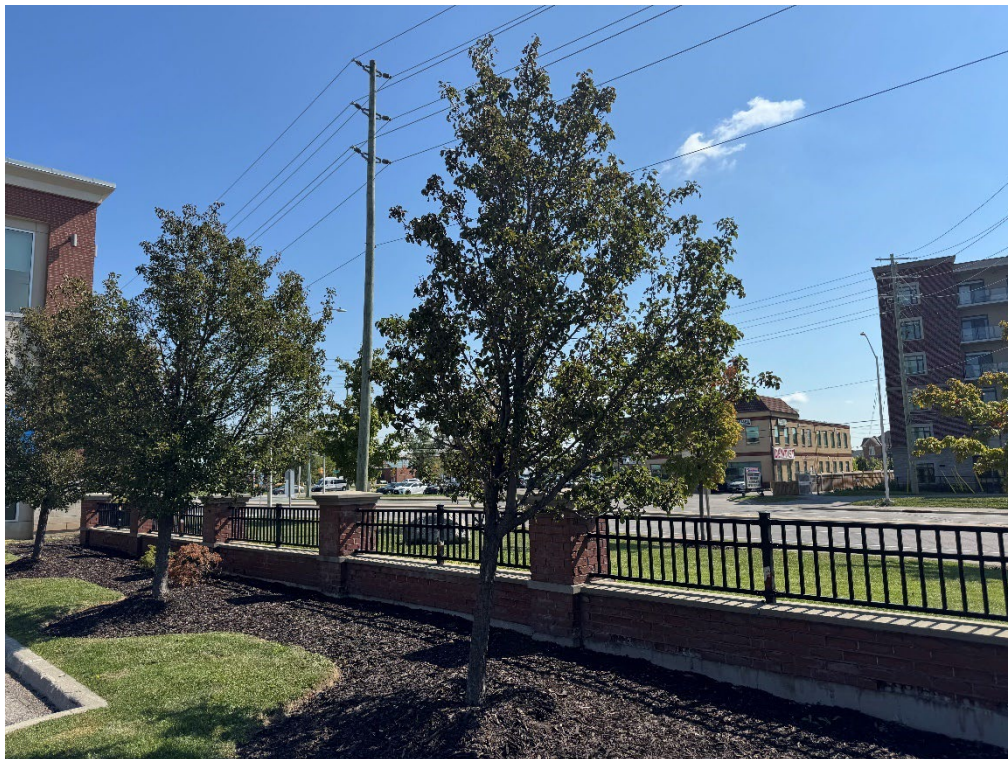
Tree 350

| Tree # | Common Name | Botanical Name | DBH (CM) | Condition | Comments | Recommendation |
|---|---|---|---|---|---|---|
| 350 | Ornamental Pear | Pyrus calleryana | 7 | F | | Retain |

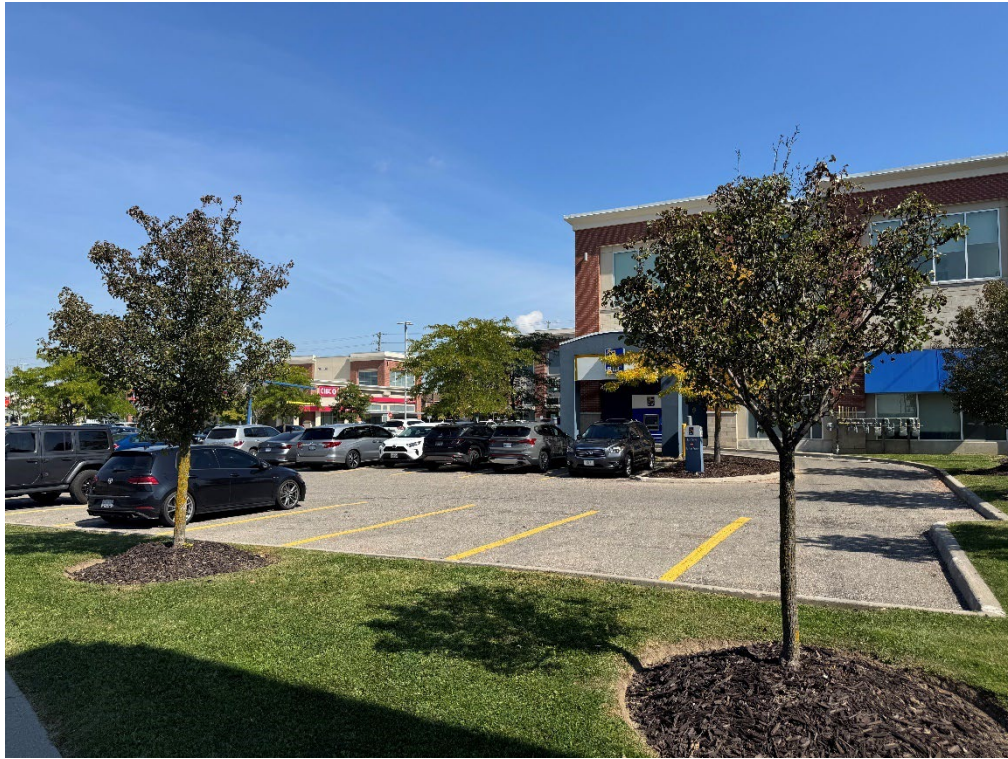
Trees 351, 352

| Tree # | Common Name | Botanical Name | DBH (CM) | Condition | Comments | Recommendation |
|---|---|---|---|---|---|---|
| 351 | Ornamental Pear | Pyrus calleryana | 9 | F/P | Minor to moderate deadwood throughout | Retain |
| 352 | Ornamental Pear | Pyrus calleryana | 11 | F | | Retain |

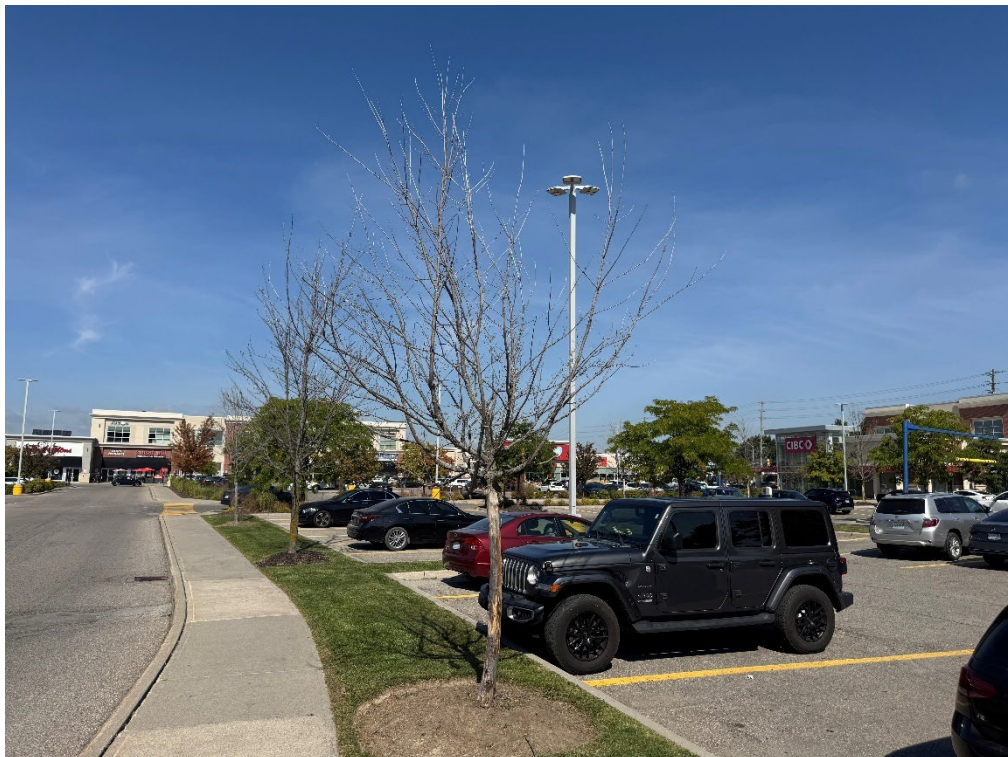
Tree 353

| Tree # | Common Name | Botanical Name | DBH (CM) | Condition | Comments | Recommendation |
|---|---|---|---|---|---|---|
| 353 | Red Maple | Acer rubrum | 10 | D | Tree is 100% dead | Remove due to condition |

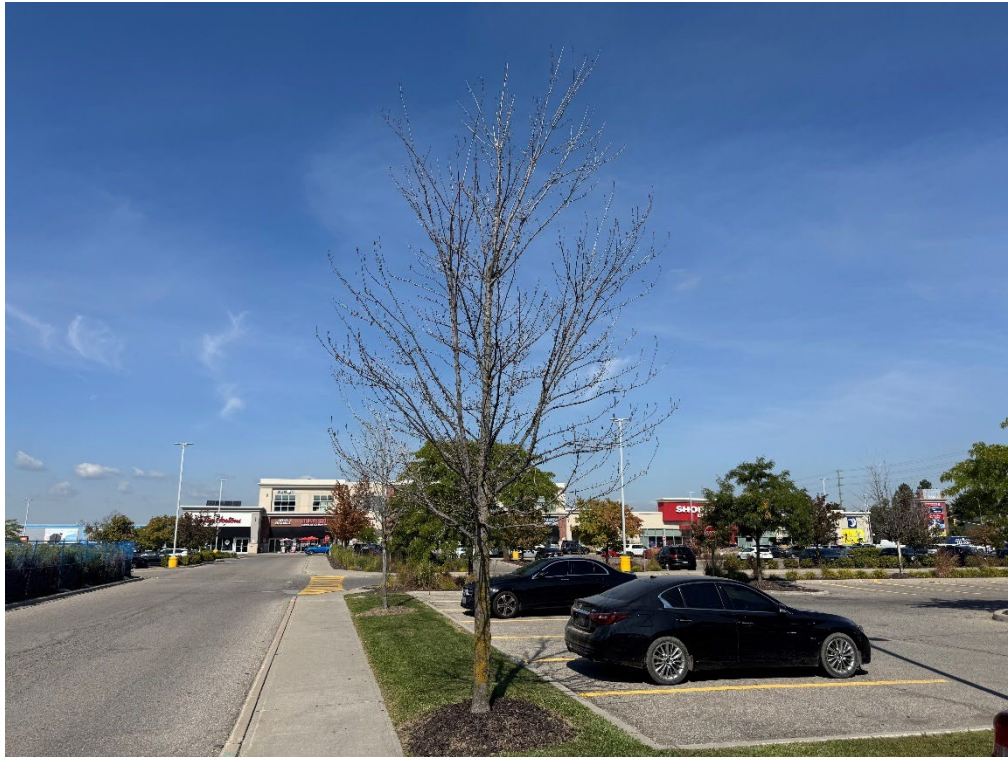
Tree 354

| Tree # | Common Name | Botanical Name | DBH (CM) | Condition | Comments | Recommendation |
|---|---|---|---|---|---|---|
| 354 | Red Maple | Acer rubrum | 15 | P/D | Moderate to significant deadwood throughout, tree is in decline, tree is 70% dead | Remove due to condition |

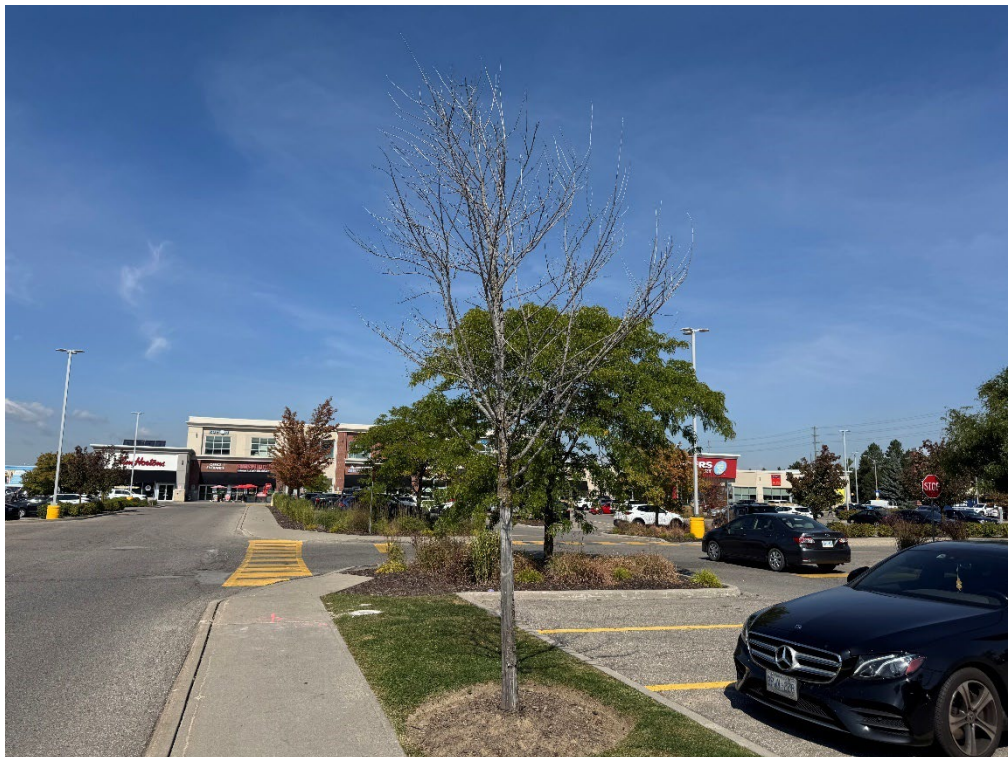
Tree 355

| Tree # | Common Name | Botanical Name | DBH (CM) | Condition | Comments | Recommendation |
|---|---|---|---|---|---|---|
| 355 | Red Maple | Acer rubrum | 10 | D | Tree is 100% dead | Remove due to condition |

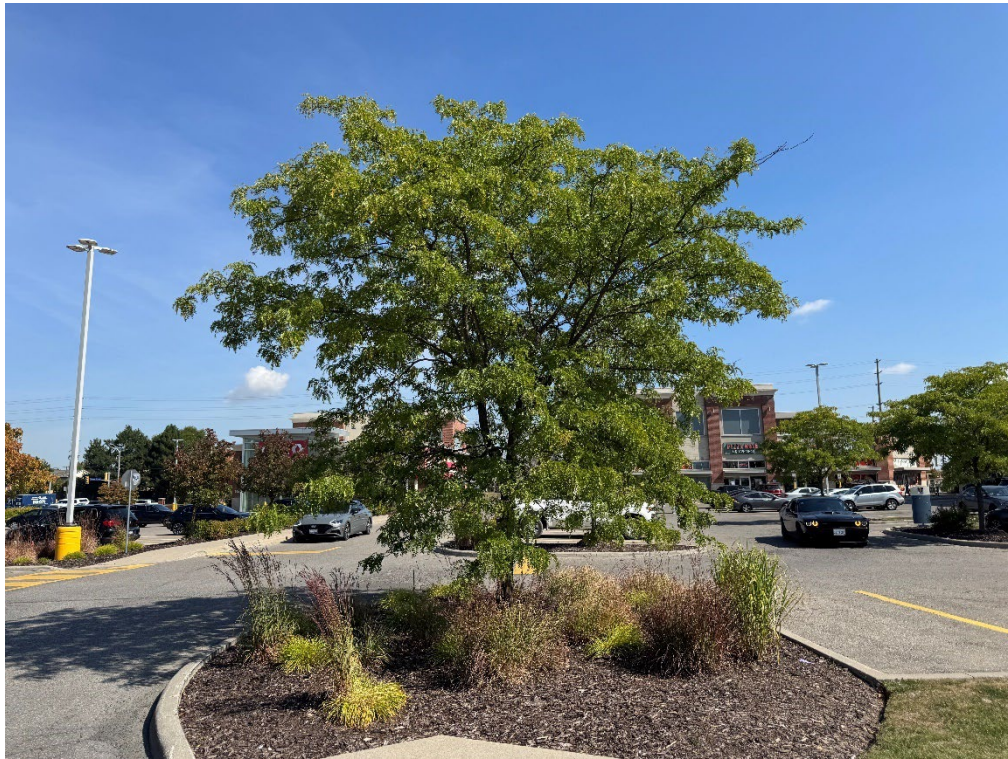
Tree 356

| Tree # | Common Name | Botanical Name | DBH (CM) | Condition | Comments | Recommendation |
|---|---|---|---|---|---|---|
| 356 | Honey Locust | Gleditsia triacanthos | 18 | F | | Retain |

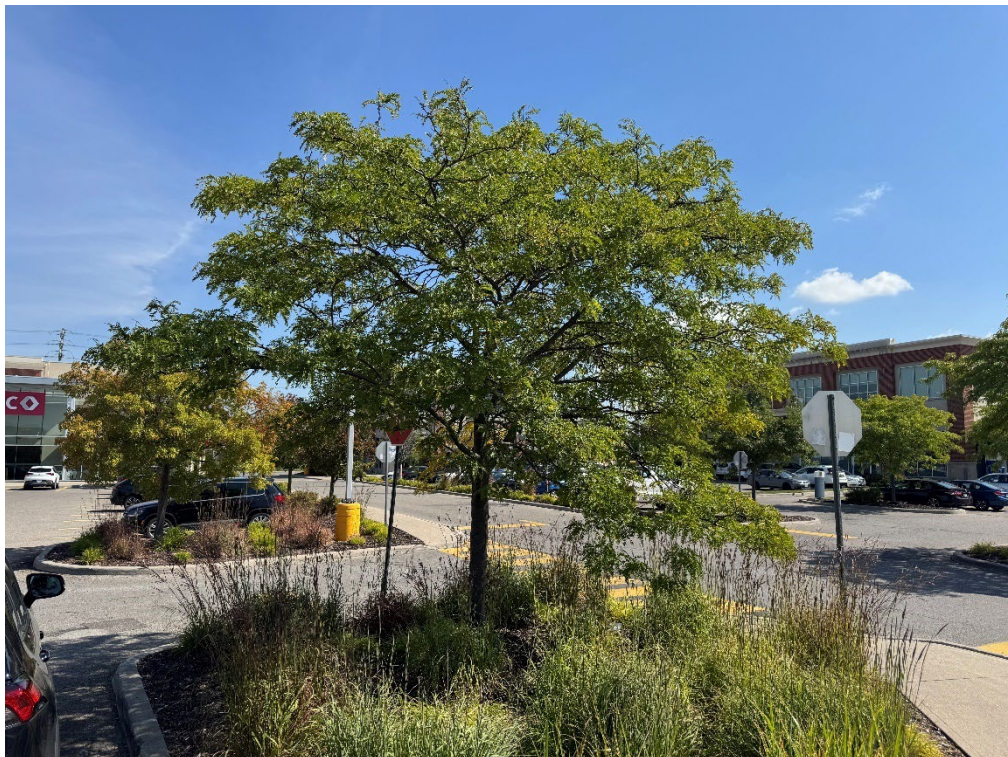
Tree 357

| Tree # | Common Name | Botanical Name | DBH (CM) | Condition | Comments | Recommendation |
|---|---|---|---|---|---|---|
| 357 | Honey Locust | Gleditsia triacanthos | 18 | F | | Retain |

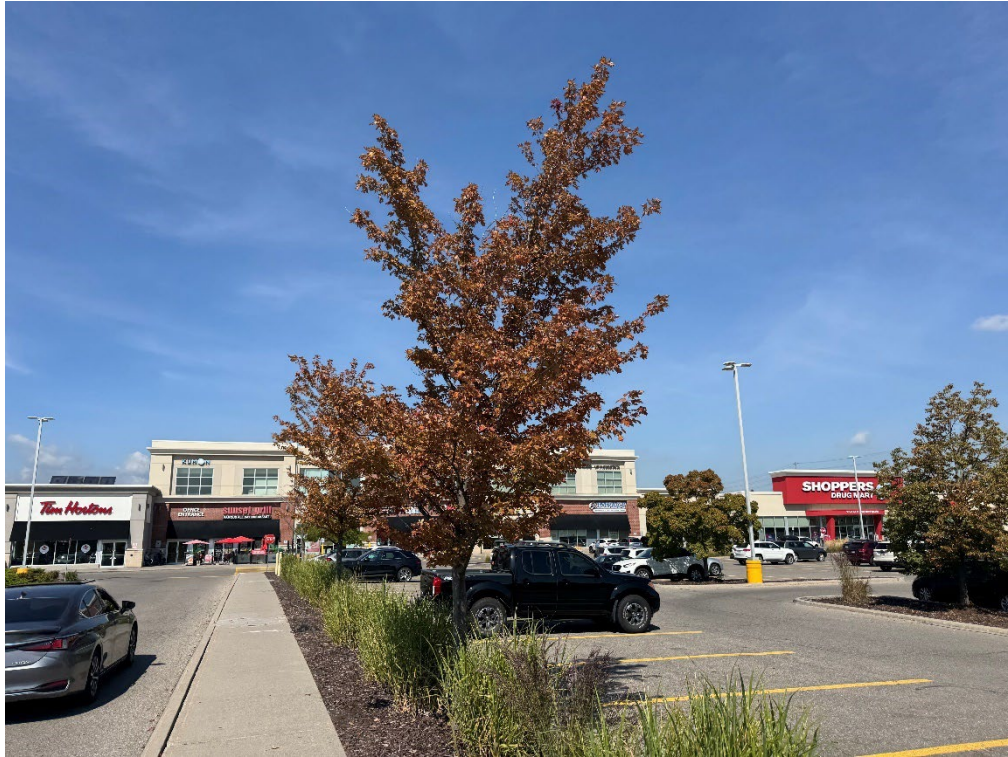
Tree 358

| Tree # | Common Name | Botanical Name | DBH (CM) | Condition | Comments | Recommendation |
|---|---|---|---|---|---|---|
| 358 | Red Maple | Acer rubrum | 13 | F | Minor deadwood throughout | Retain |

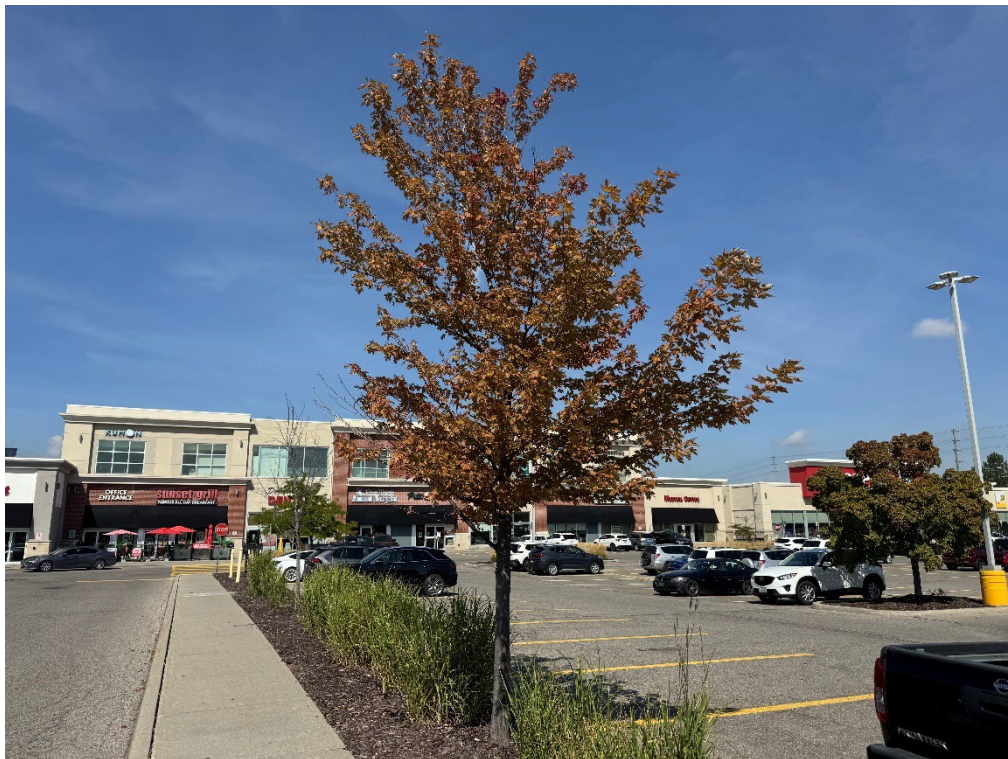
Tree 359

| Tree # | Common Name | Botanical Name | DBH (CM) | Condition | Comments | Recommendation |
|---|---|---|---|---|---|---|
| 359 | Red Maple | Acer rubrum | 12 | F | Minor deadwood throughout | Retain |

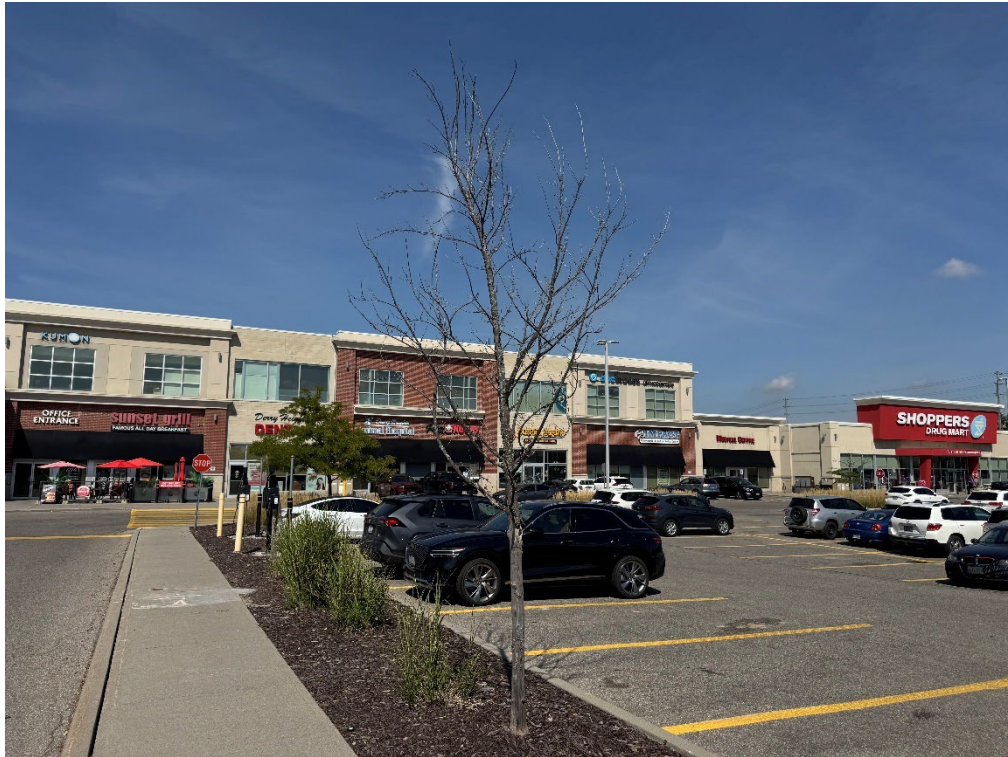
Tree 360

| Tree # | Common Name | Botanical Name | DBH (CM) | Condition | Comments | Recommendation |
|---|---|---|---|---|---|---|
| 360 | Red Maple | Acer rubrum | 9 | D | Tree is 100% dead | Remove due to condition |

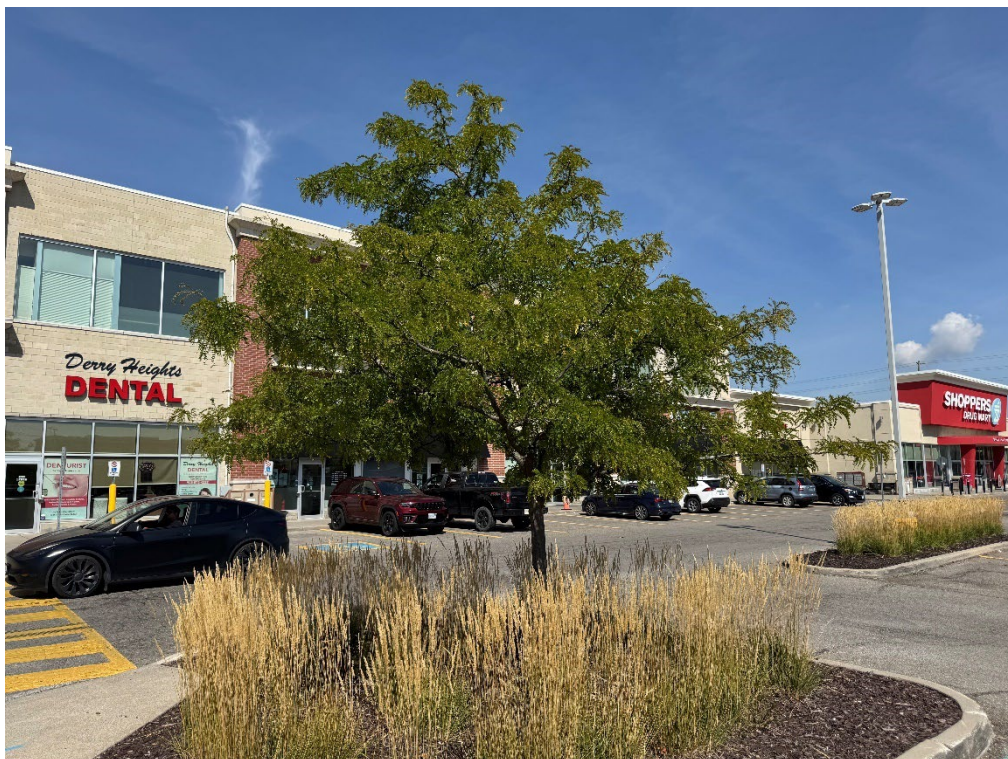
Tree 361

| Tree # | Common Name | Botanical Name | DBH (CM) | Condition | Comments | Recommendation |
|---|---|---|---|---|---|---|
| 361 | Honey Locust | Gleditsia triacanthos | 13 | F/G | | Retain |

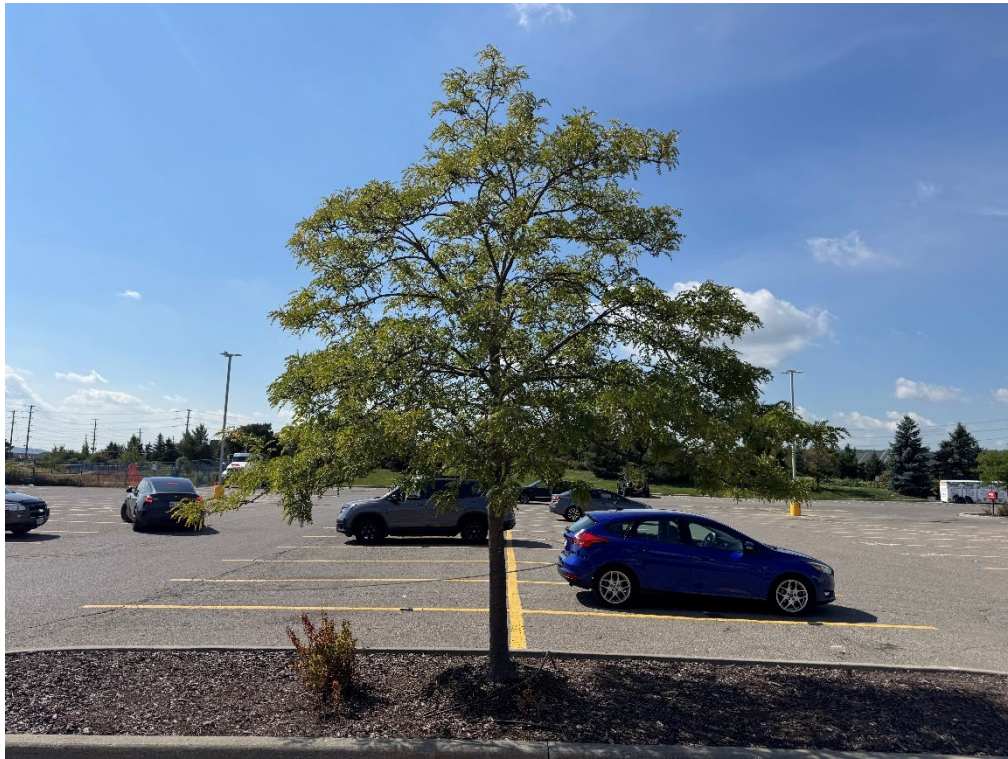
Tree 362

| Tree # | Common Name | Botanical Name | DBH (CM) | Condition | Comments | Recommendation |
|---|---|---|---|---|---|---|
| 362 | Honey Locust | Gleditsia triacanthos | 14 | F | Minor deadwood throughout | Remove due to construction |

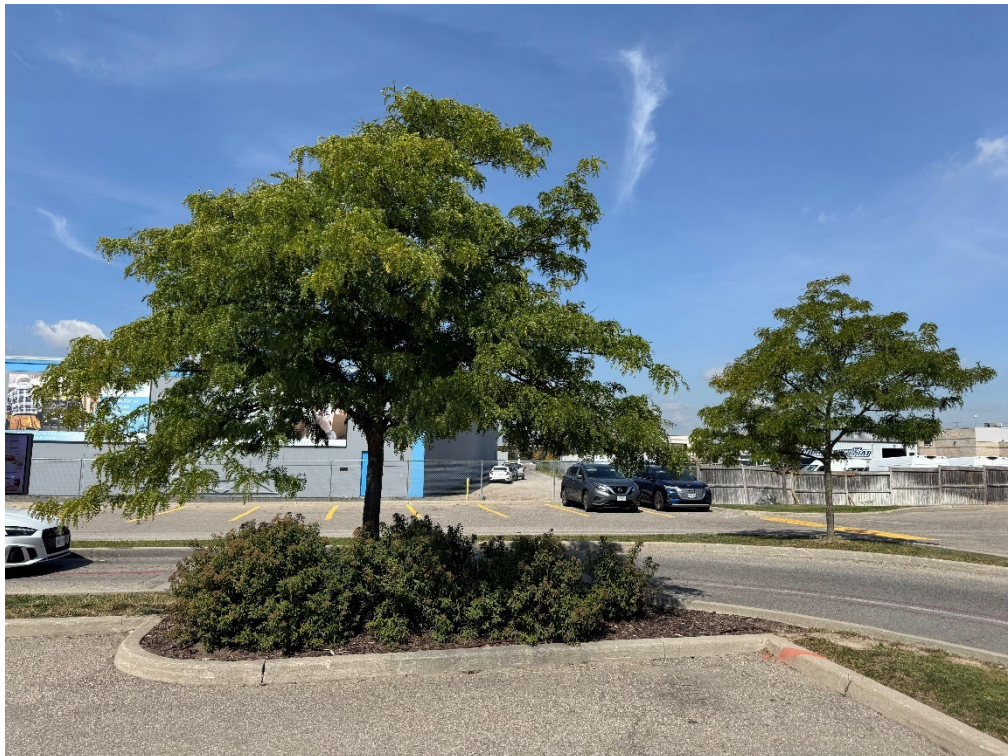
Trees 363, 364

| Tree # | Common Name | Botanical Name | DBH (CM) | Condition | Comments | Recommendation |
|---|---|---|---|---|---|---|
| 363 | Honey Locust | Gleditsia triacanthos | 17 | F/G | | Remove due to construction |
| 364 | Honey Locust | Gleditsia triacanthos | 13 | F | Multiple wounds on north side of tree | Remove due to construction |

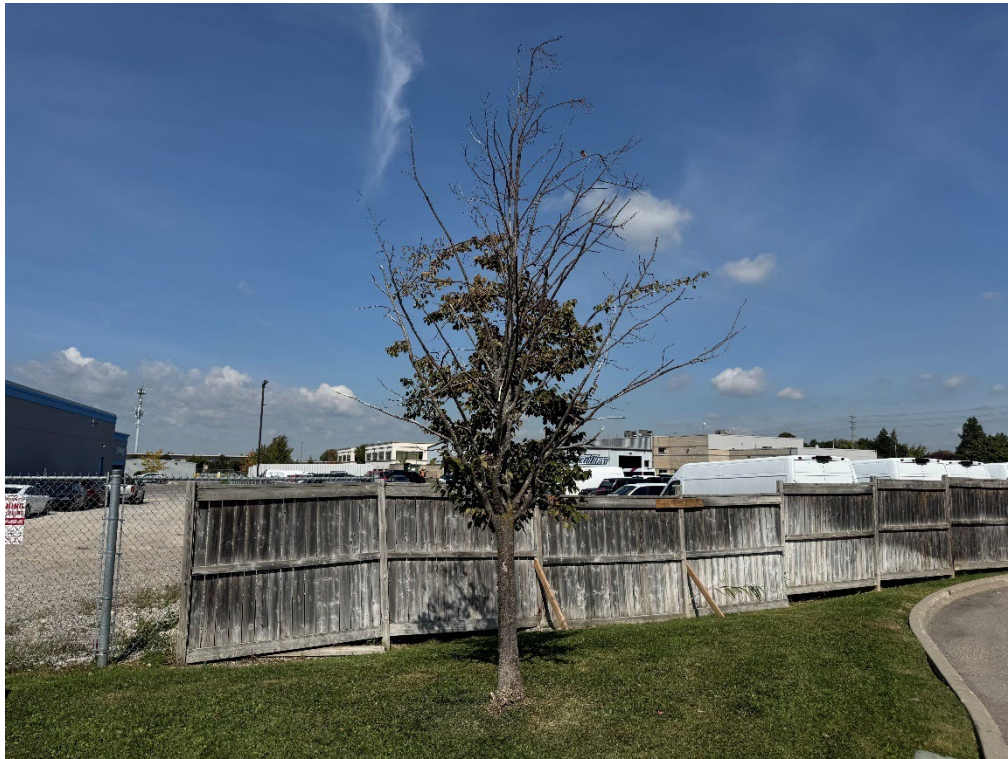
Tree 365

| Tree # | Common Name | Botanical Name | DBH (CM) | Condition | Comments | Recommendation |
|---|---|---|---|---|---|---|
| 365 | Linden Sp. | Tilia Sp. | 13 | P/D | Significant deadwood throughout, split trunk, tree is 90% dead | Remove due to condition |

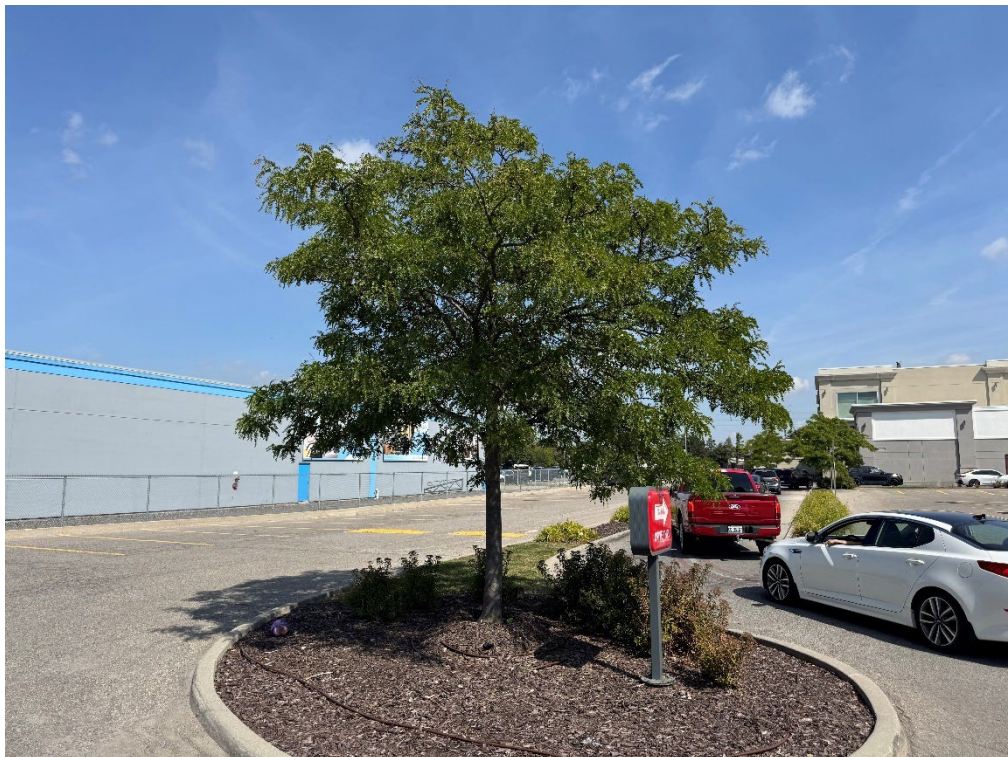
Tree 366

| Tree # | Common Name | Botanical Name | DBH (CM) | Condition | Comments | Recommendation |
|---|---|---|---|---|---|---|
| 366 | Honey Locust | Gleditsia triacanthos | 16 | F | | Remove due to construction |

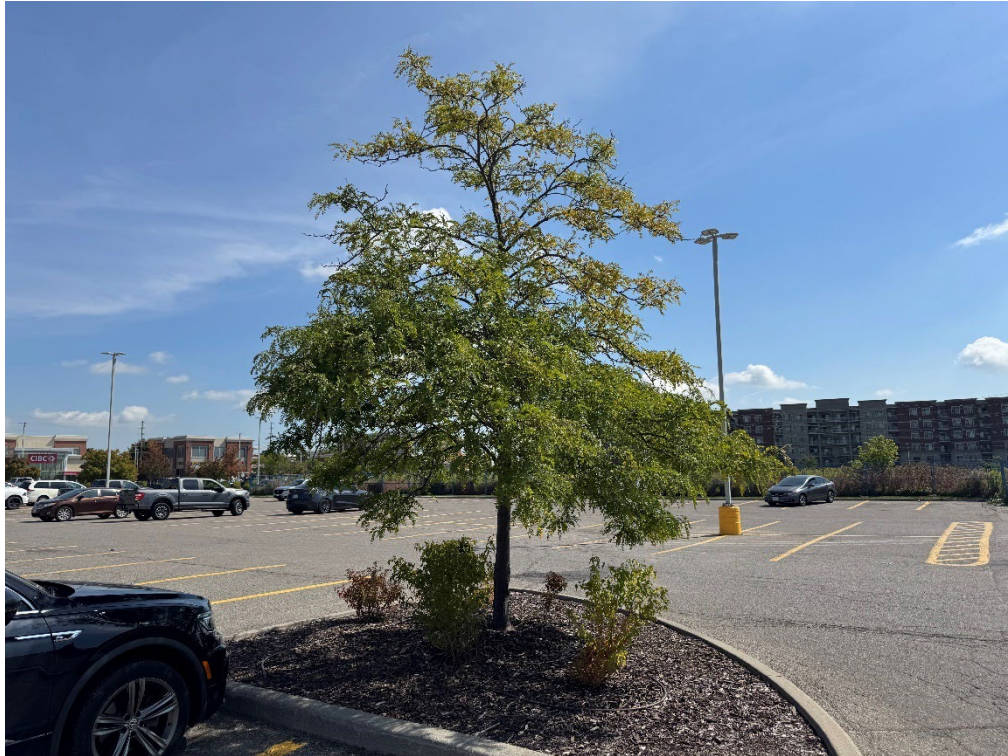
Tree 367

| 367 | Honey Locust | Gleditsia triacanthos | 13 | F | | Remove due to construction |

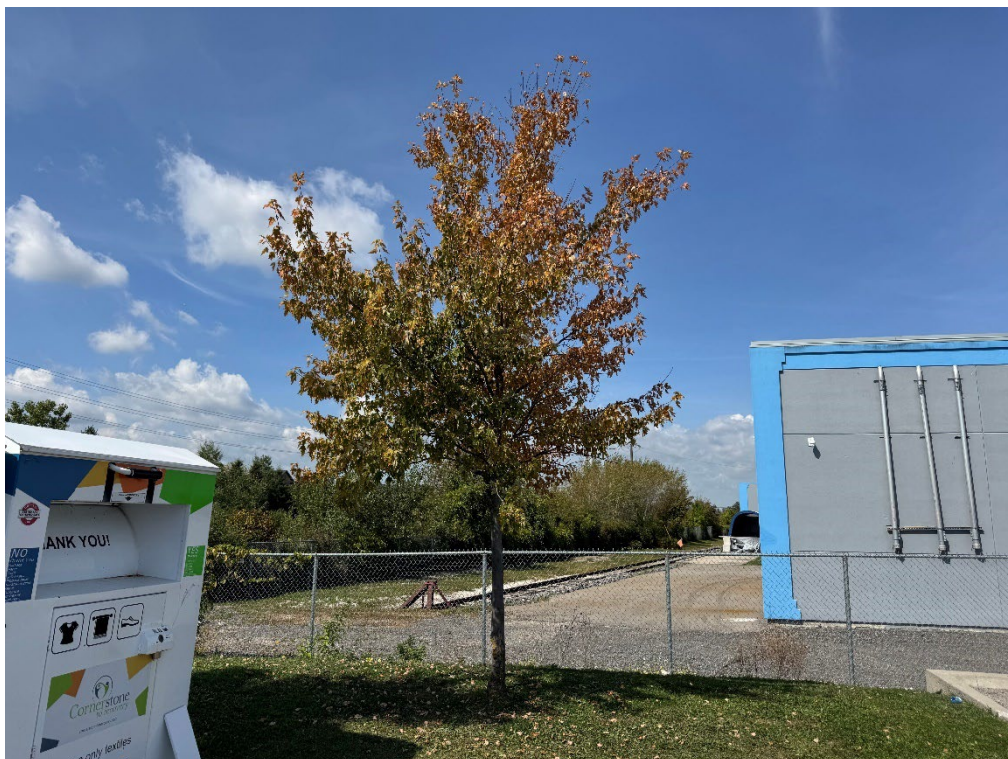
Tree 368

| 368 | Red Maple | Acer rubrum | 10 | F | Wound at base on west side of tree | Remove due to construction |

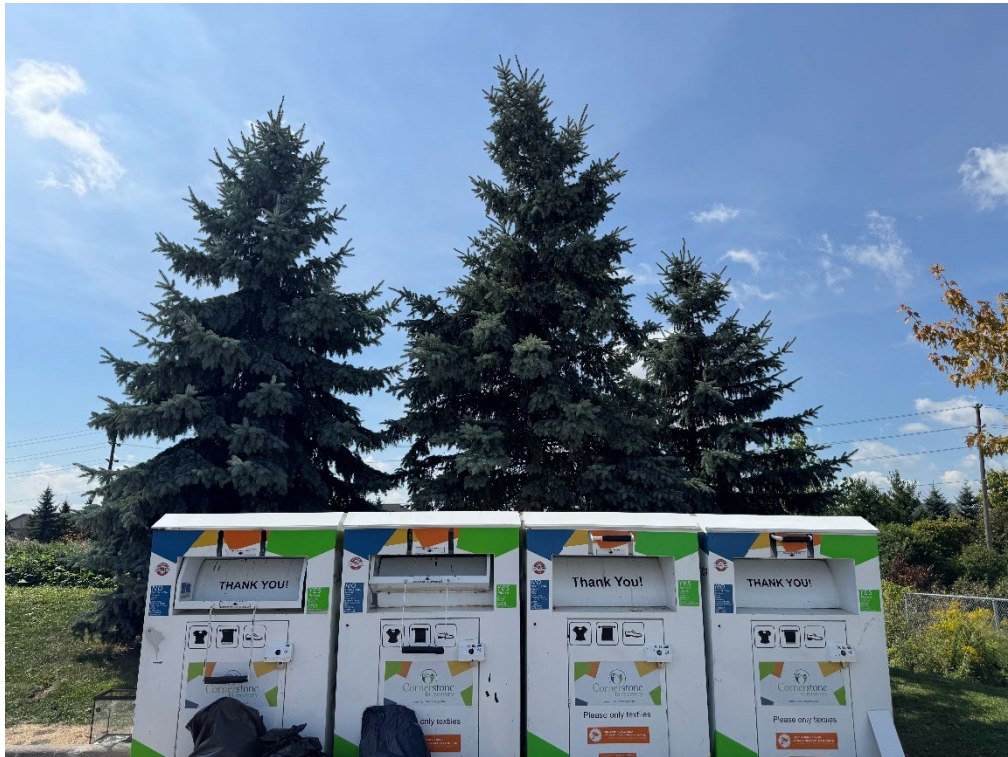
Trees 369 – 371

| 369 | Colorado Blue Spruce | Picea pungens var. glauca | 18 | F | | Remove due to construction |
| 370 | Colorado Blue Spruce | Picea pungens var. glauca | 22 | F | Minor deadwood throughout | Remove due to construction |
| 371 | Colorado Blue Spruce | Picea pungens var. glauca | 24 | F | | Remove due to construction |

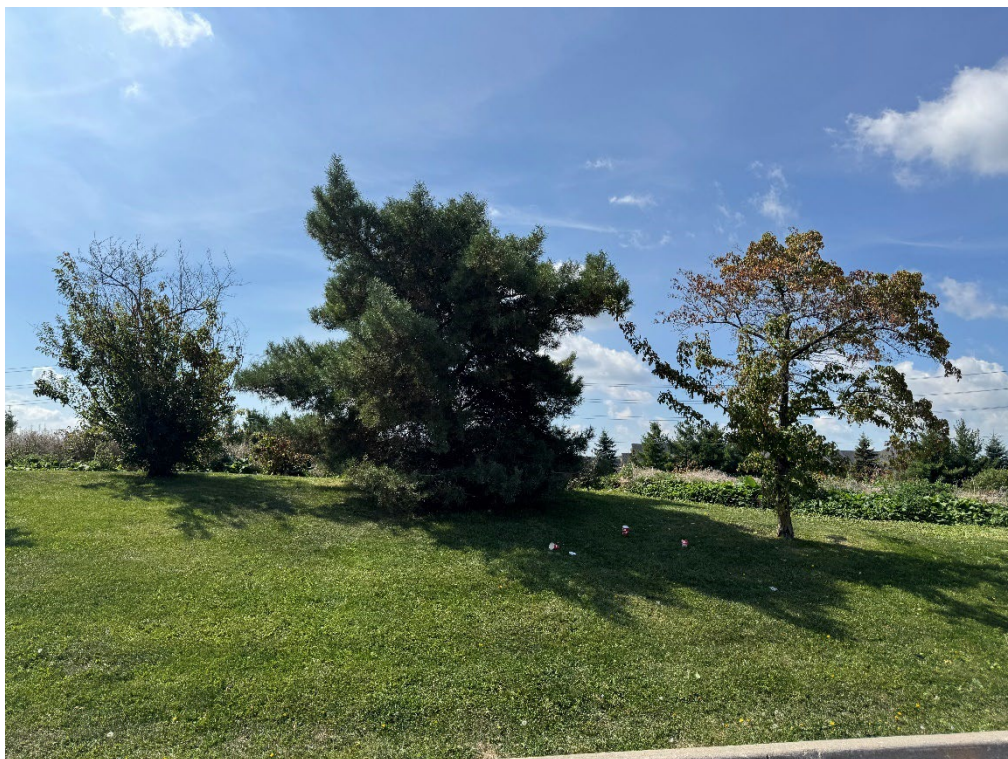
Trees 372 – 374

| 372 | Amur Maple | Acer ginnala | 13 | F/P | Moderate deadwood throughout | Remove due to construction |
| 373 | Scots Pine | Pinus sylvestris | 20 | F | Minor deadwood throughout | Remove due to construction |
| 374 | Amur Maple | Acer ginnala | 9 | D | Tree is 100% dead, suckers at base | Remove due to construction |

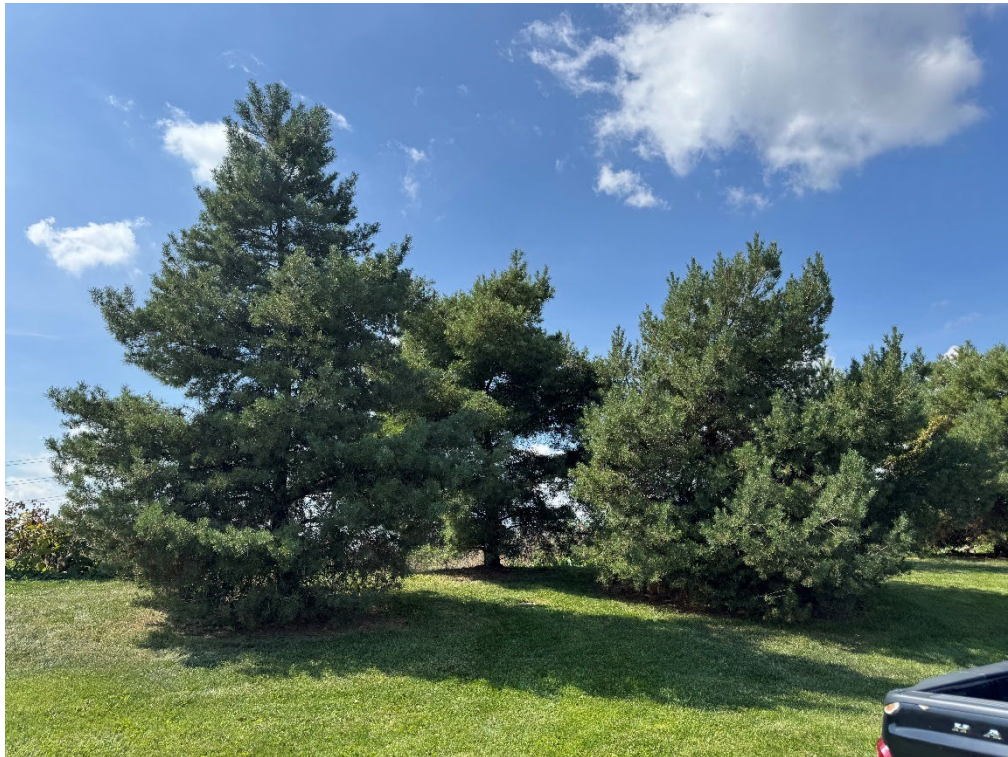
Trees 375 – 377

| 375 | Scots Pine | Pinus sylvestris | 18 | F | | Remove due to construction |
| 376 | Scots Pine | Pinus sylvestris | 22 | F | | Remove due to construction |
| 377 | Scots Pine | Pinus sylvestris | 13 | F | | Remove due to construction |

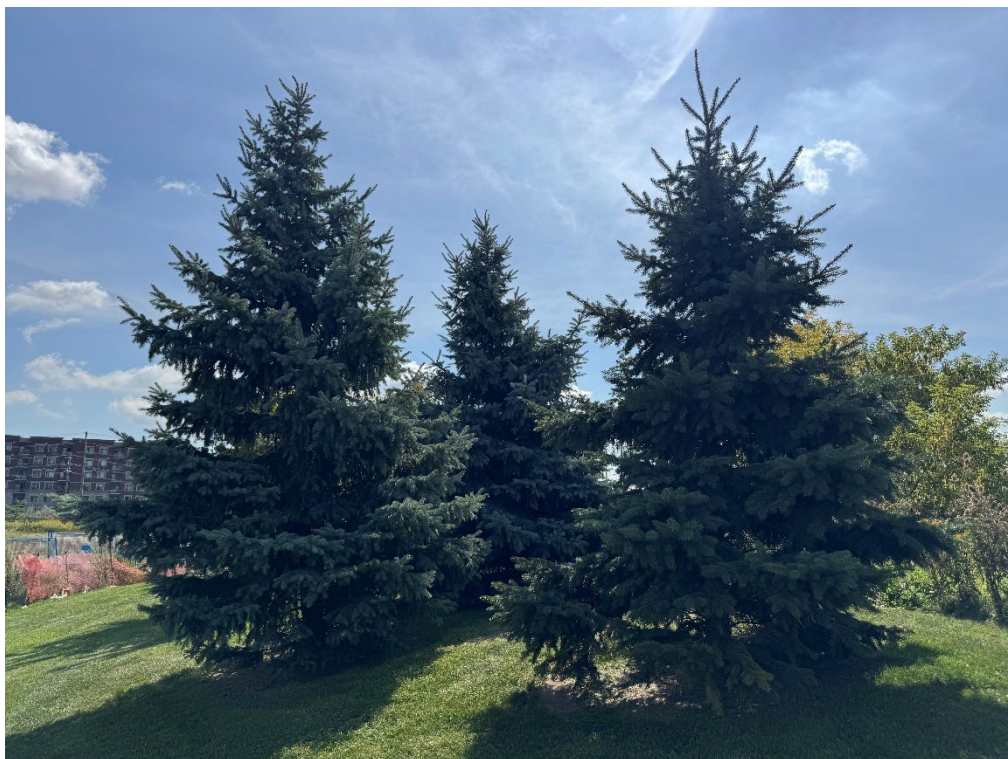
Trees 378 – 380

| 378 | Colorado Blue Spruce | Picea pungens var. glauca | 11 | F | | Remove due to construction |
| 379 | Colorado Blue Spruce | Picea pungens var. glauca | 15 | F | | Remove due to construction |
| 380 | Colorado Blue Spruce | Picea pungens var. glauca | 17 | F/G | | Remove due to construction |

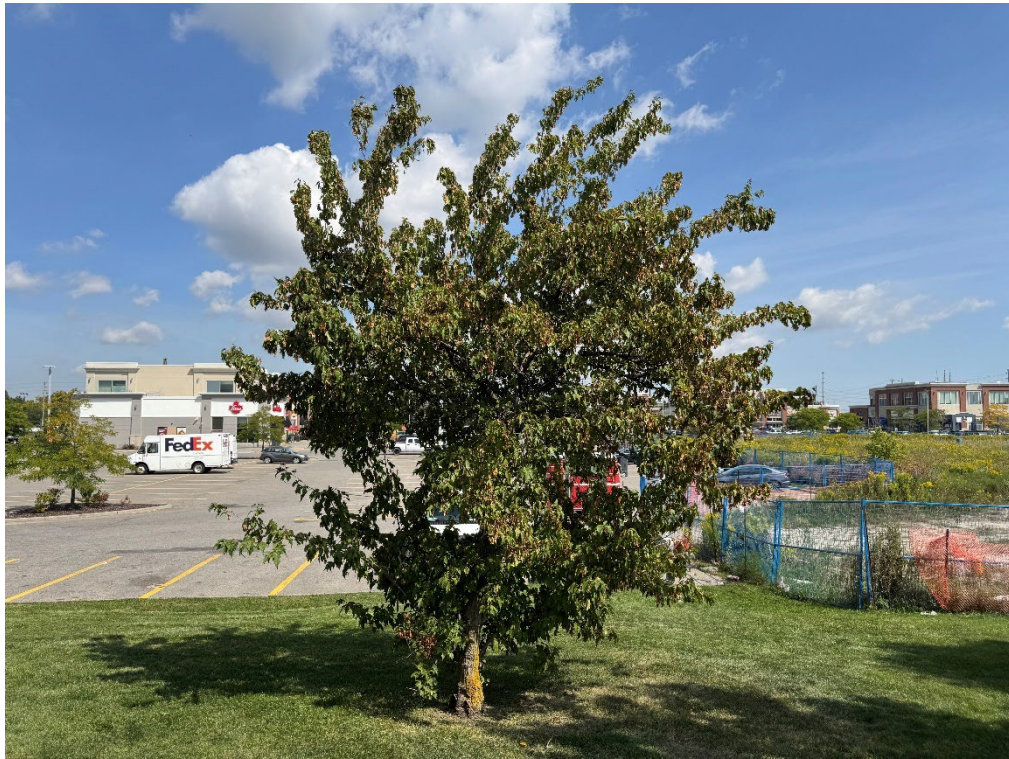
Tree 381

| 381 | Amur Maple | Acer ginnala | 11 | F | | Remove due to construction |

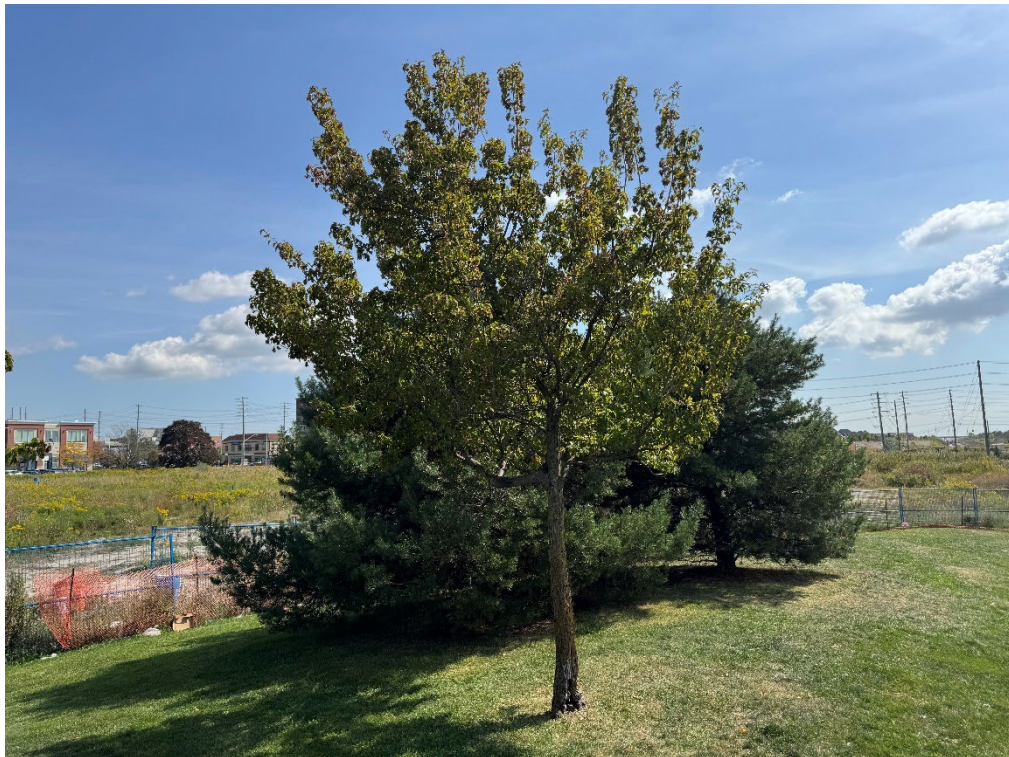
Tree 382

| 382 | Amur Maple | Acer ginnala | 12 | F | Minor deadwood throughout, cavity at base on west side of tree | Remove due to construction |

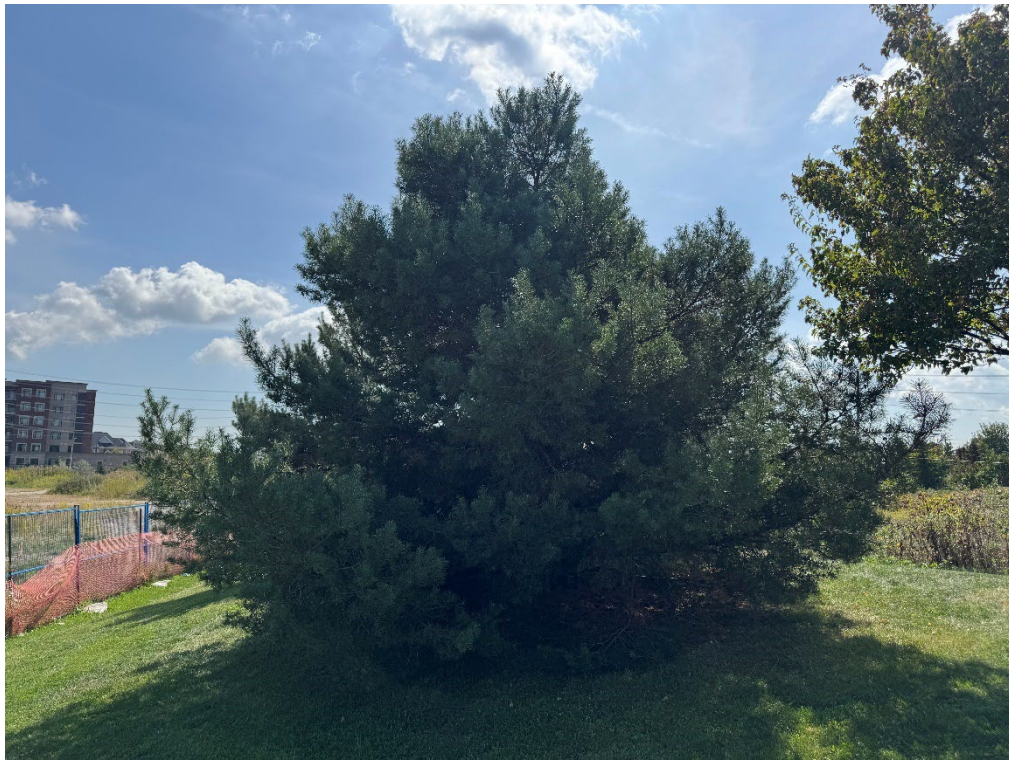
Tree 384

| 384 | Scots Pine | Pinus sylvestris | 22 | F | | Remove due to construction |

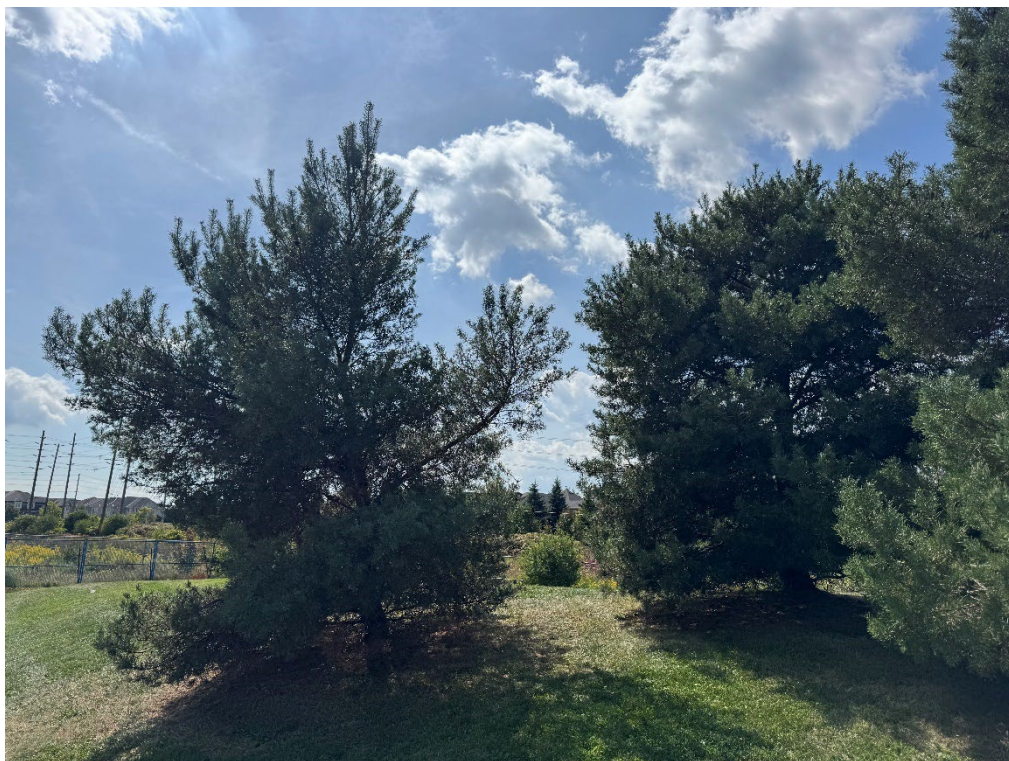
Trees 385, 386

| 385 | Scots Pine | Pinus sylvestris | 16 | F | | Remove due to construction |
| 386 | Scots Pine | Pinus sylvestris | 11 | F | | Remove due to construction |

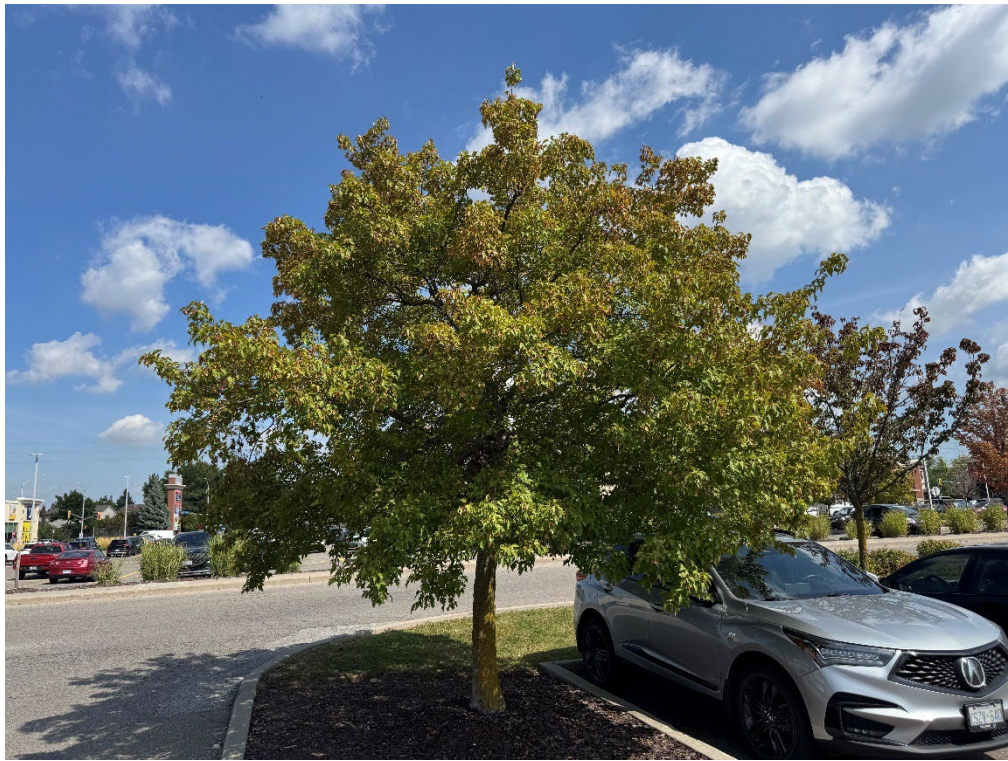
Tree 387

| 387 | Amur Maple | Acer ginnala | 16 | F | | Remove due to construction |

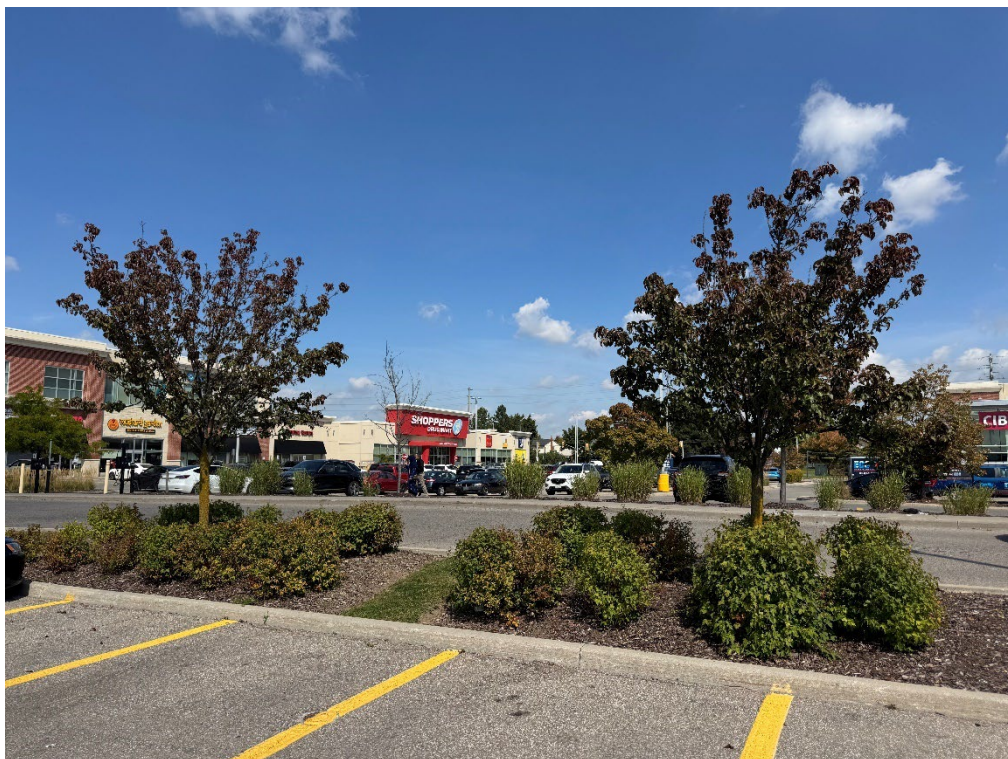
Trees 388, 389

| 388 | Ornamental Pear | Pyrus calleryana | 13 | F/P | | Remove due to construction |

| 389 | Ornamental Pear | Pyrus calleryana | 12 | F | | Remove due to construction |
