September 15, 2025

## ARBORIST REPORT

Derry Road and Bronte Street, Milton, Ontario

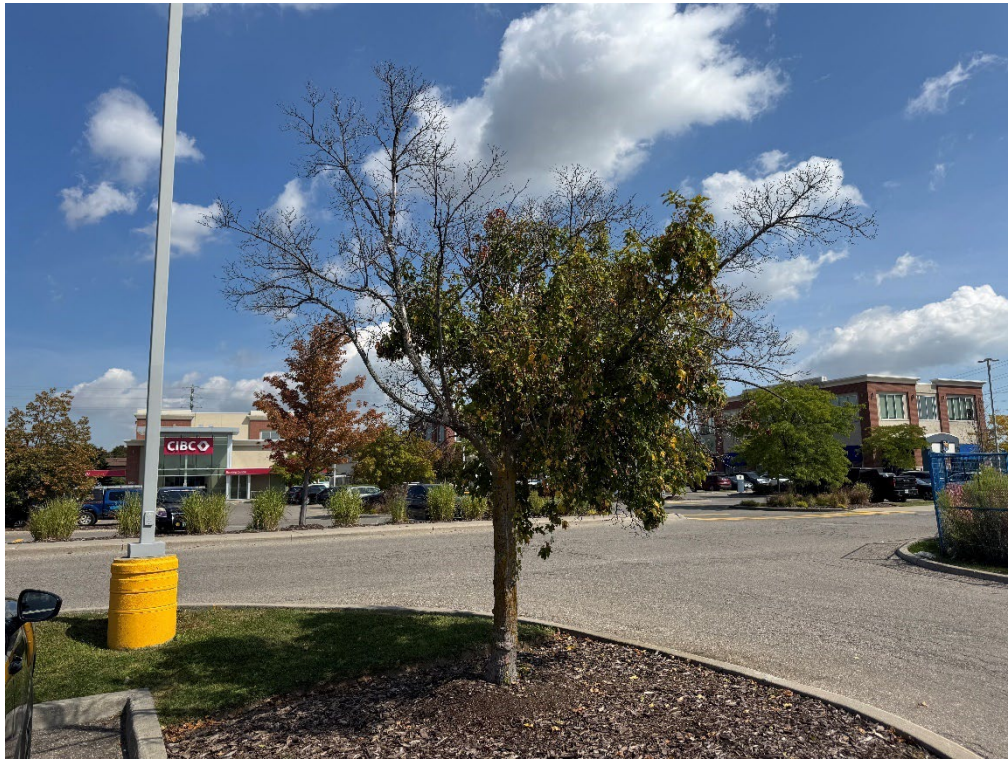
Tree 390

| 390 | Amur Maple | Acer ginnala | 15 | P/D | Moderate to significant deadwood throughout, water shoots throughout, tree is 70% dead | Remove due to construction |

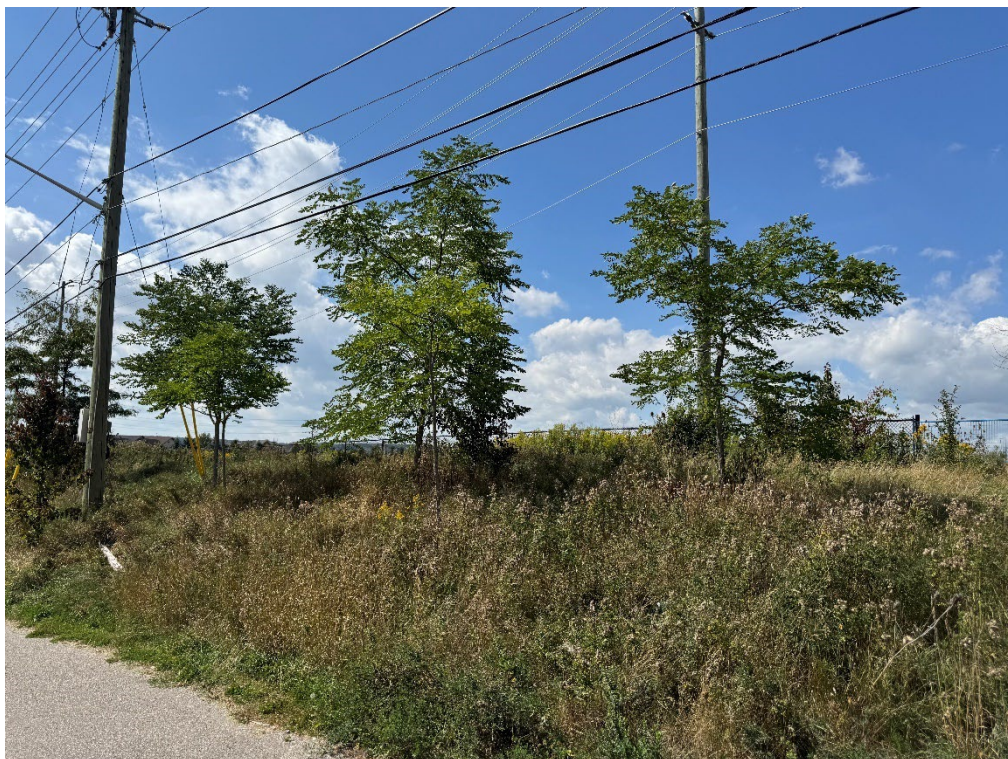
Trees 391 – 395

| 391 | Kentucky Coffee Tree | Gymnocladus dioicus | 8 | F | | Retain |
| 392 | Kentucky Coffee Tree | Gymnocladus dioicus | 5 | F | | Retain |
| 393 | Kentucky Coffee Tree | Gymnocladus dioicus | 11 | F | | Retain |
| 394 | Kentucky Coffee Tree | Gymnocladus dioicus | 5 | F | | Retain |
| 395 | Kentucky Coffee Tree | Gymnocladus dioicus | 9 | F | | Retain |

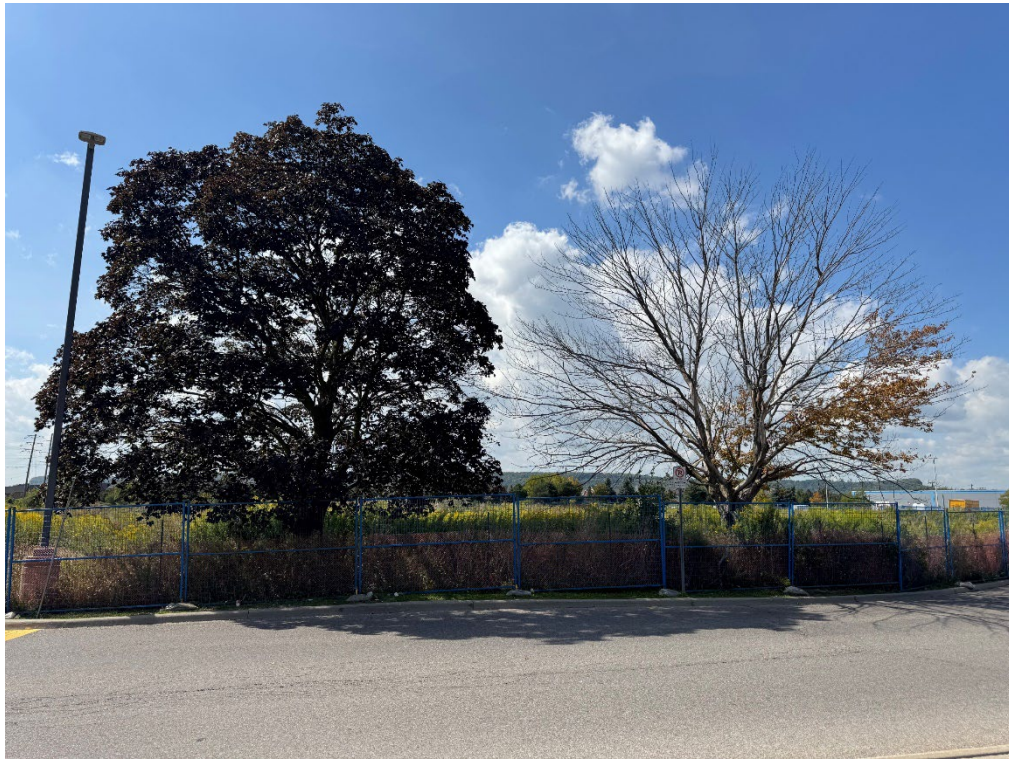
Trees 396, 397

| 396 | Schwedler Norway Maple | Acer platanoides 'Schwedleri | 59 | F | Moderate tip die-back throughout canopy | Remove due to construction |
| 397 | Sugar Maple | Acer saccharum | 46 | P/D | Tree is 90% dead with only one live limb | Remove due to condition |
