# **Phase One Environmental Site Assessment (Final)**

8995 Boston Church Road  
Ontario L9T 9C7

BC5L Inc.

**25-1242-01**

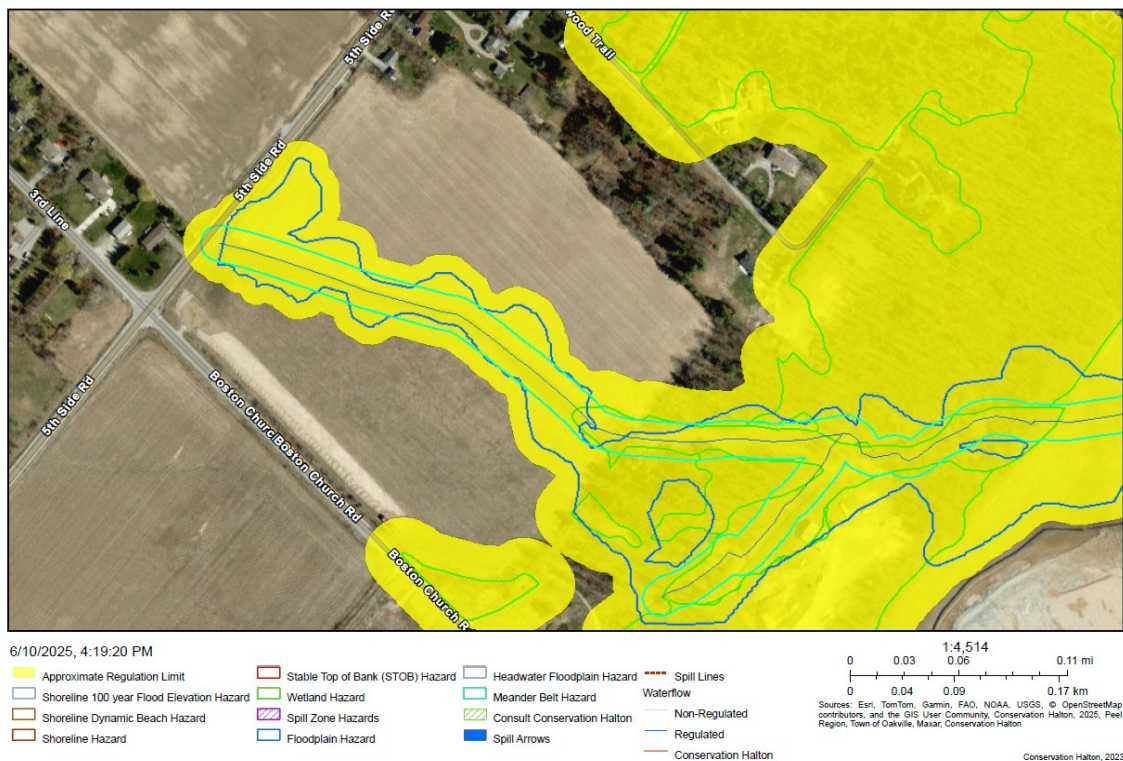
Image 1. Conservation Halton Regulation Mapping

Based on the Conservation Halton Regulation Mapping, the drainage trench and area around it in the Phase One Property lies in regulated areas. The image below represents the regulated area.

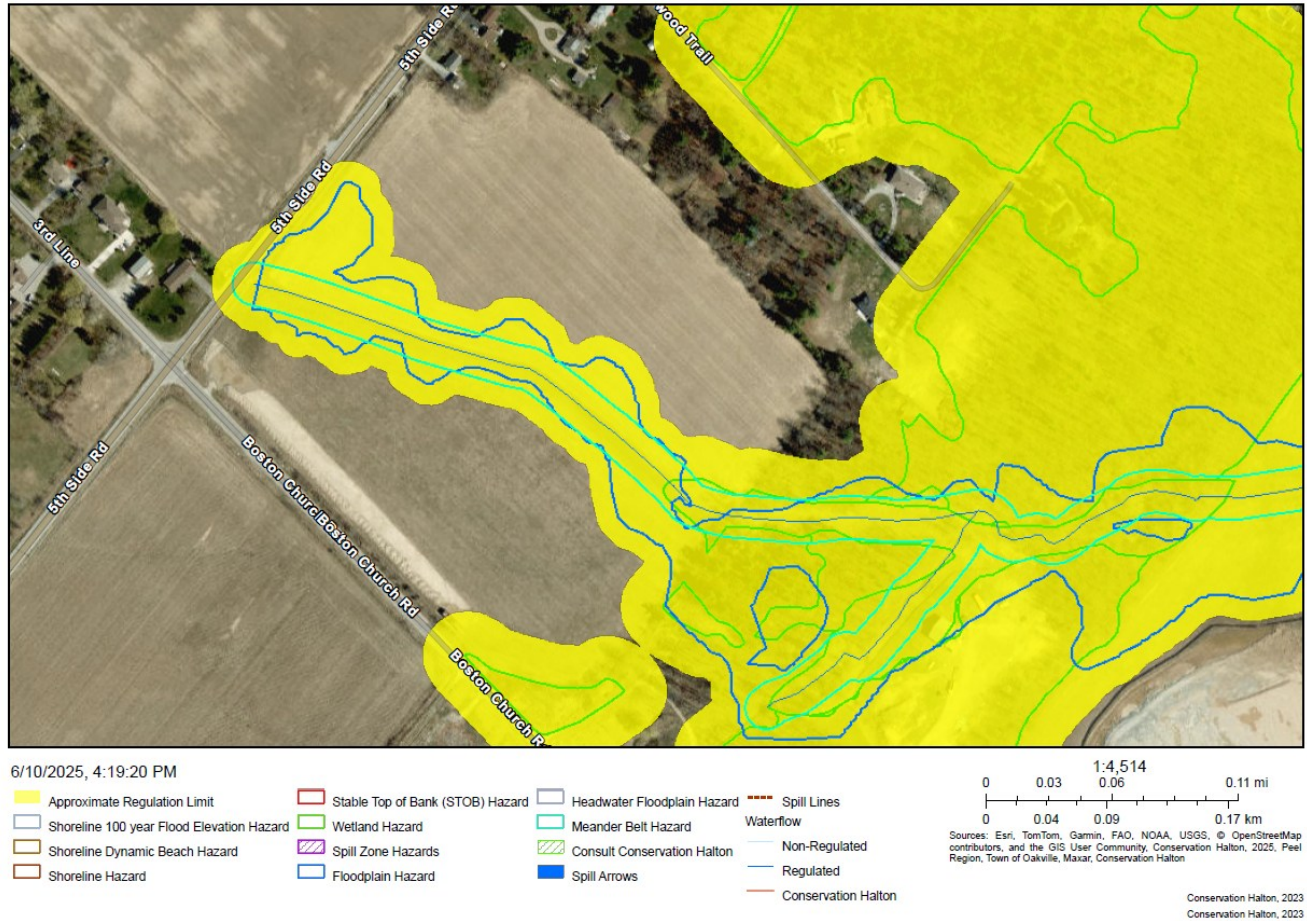
Image 1. Conservation Halton Regulation Mapping

Based on the Conservation Halton Regulation Mapping, a considerable portion of The Phase One Property lies in the regulated areas. Representation of the regulated areas is in the image below.
