Long Term Stable Top of Slope Assessment

REPORT ON
Slope Stability Assessment
150 Steeles Avenue East
Milton, Ontario

PREPARED FOR:
NEATT Communities

Project No. 21-122-103
January 17, 2023

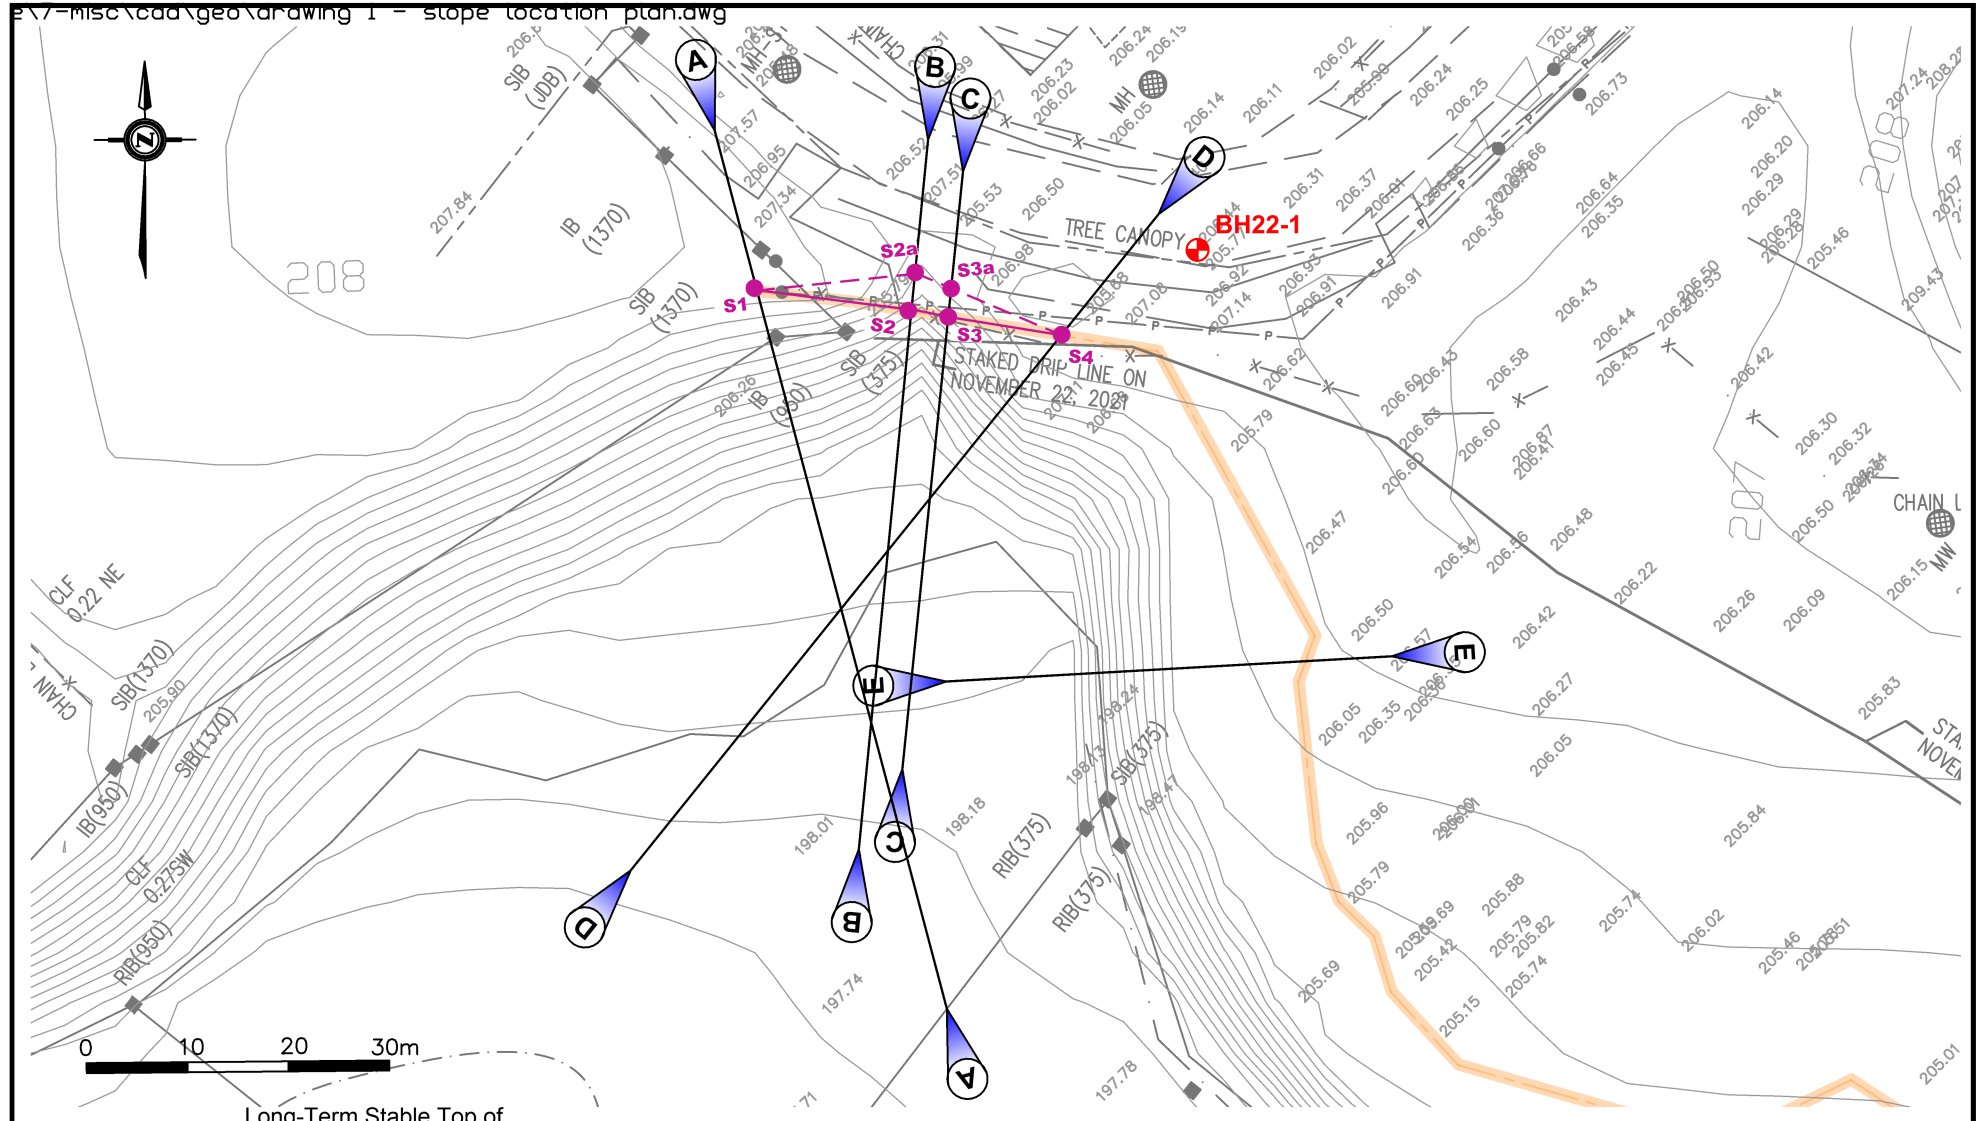
If the eroded/failed slope in the area of Cross-Section B-B **is to be** stabilized/repared as recommended in Section 4.5 of this report, the LTSTOS at the west part of the site is Line S1-S2-S3-S4, as shown on **Drawing 1B**.

If the eroded/failed slope in the area of Cross-Section B-B **is not to be** stabilized/repared, the LTSTOS at the west part of the site is Line S1-S2a-S3a-S4, as shown on **Drawing 1B**.

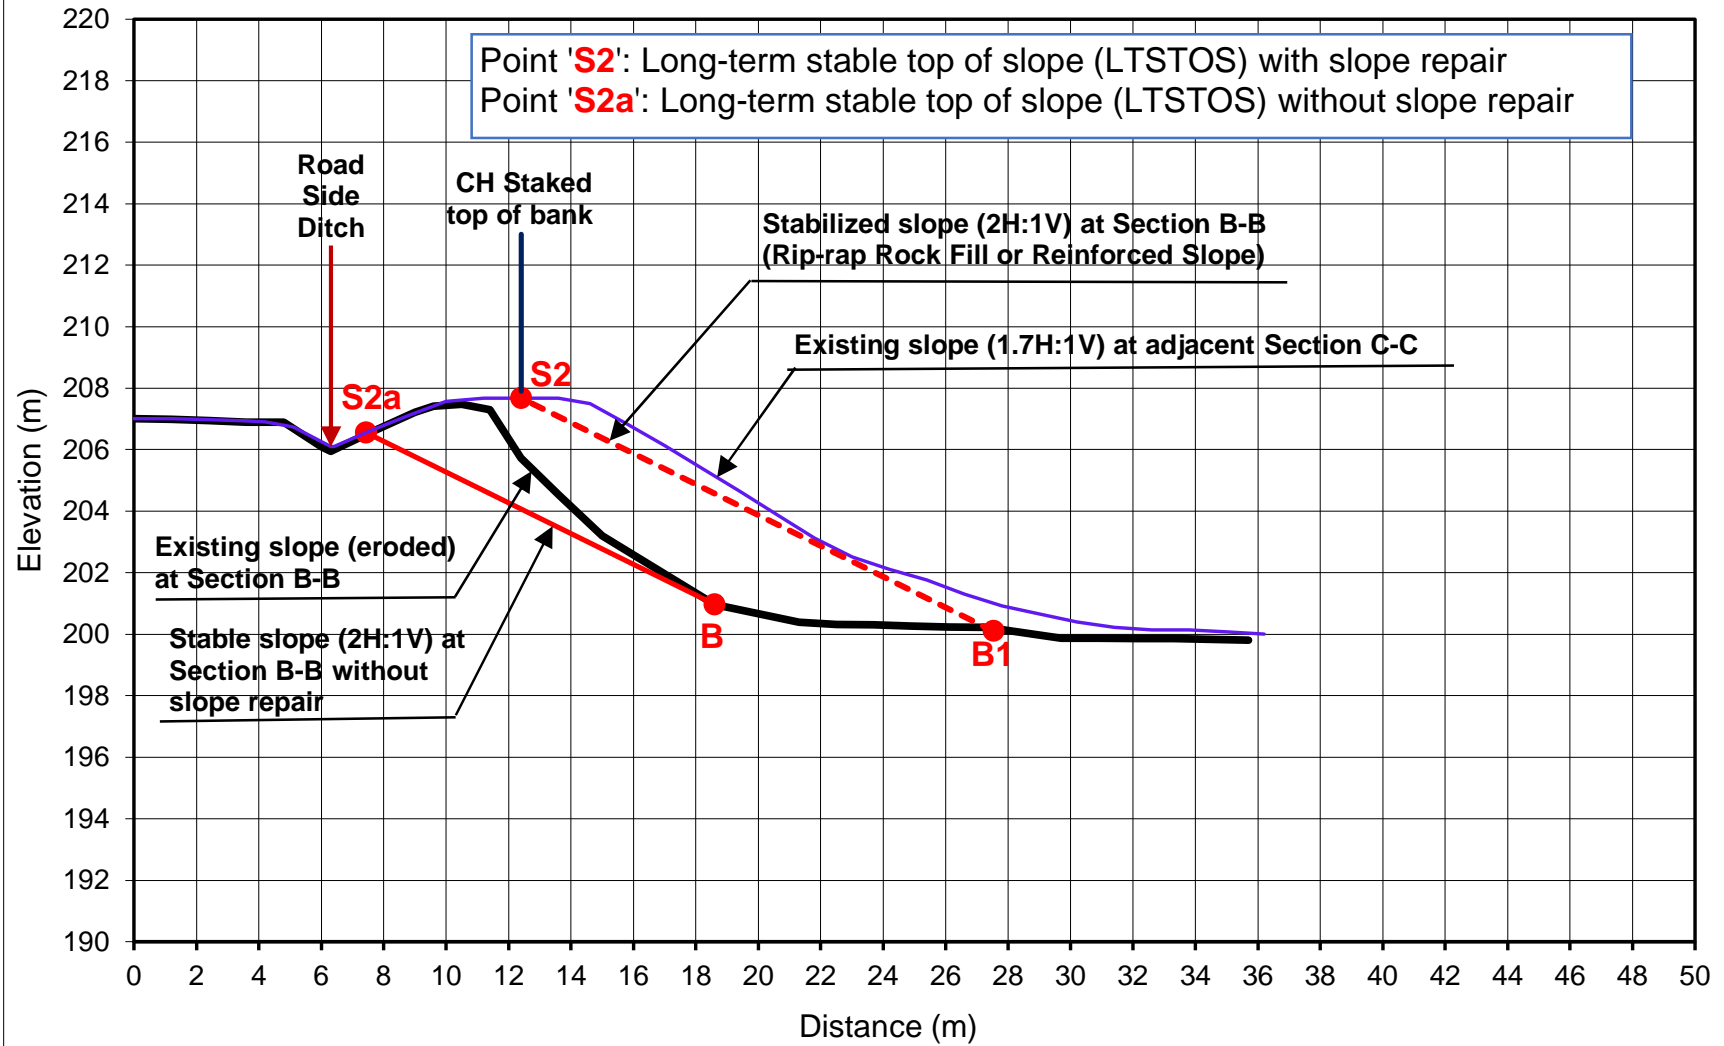
Project: 21-122-103 - **Drawing 6**
Slope Profile at **Cross-Section B-B** (See Drawing 1 for Location Plan)

Without stabilization (repair) of the eroded slope, the stable top of slope at Cross-Section B-B is at Point "S2a" as shown in **Drawing 6**, assuming there would be no further erosion in the area (i.e. no more discharge from the broken sewer pipe, or the sewer pipe will be repaired and extended to beyond the slope toe area).

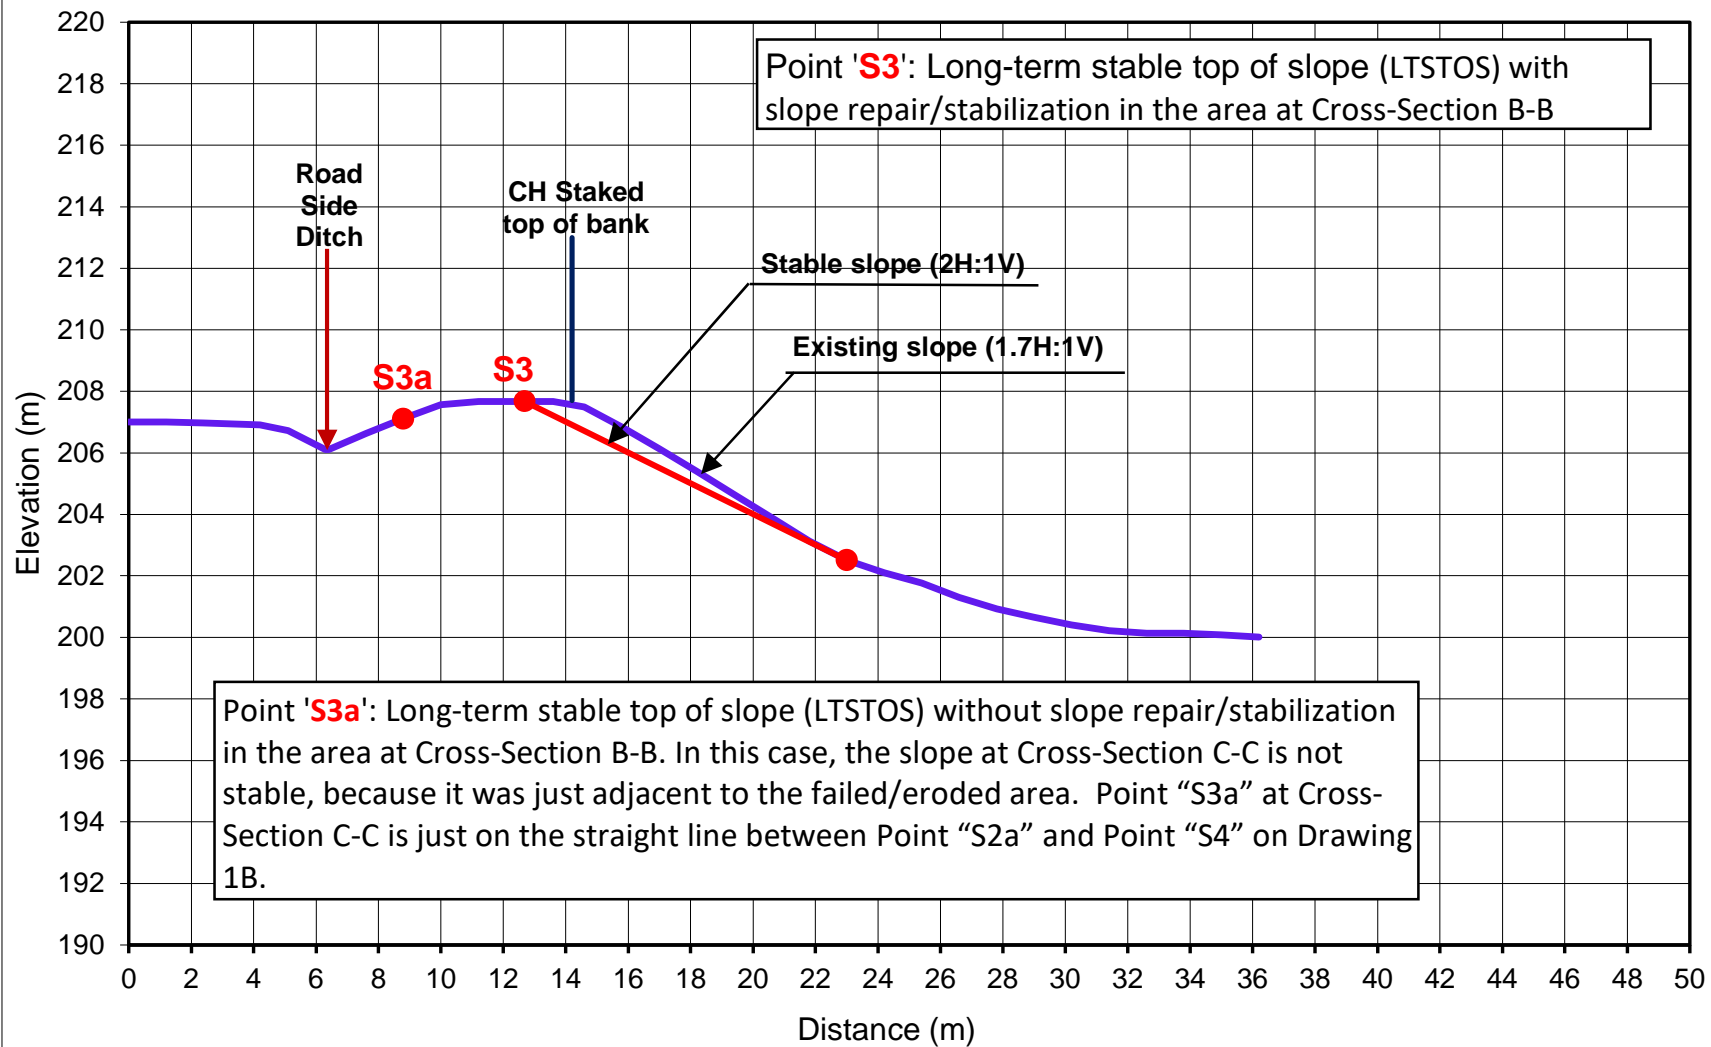
Project: 21-122-103 - **Drawing 7**
Slope Profile at **Cross-Section C-C** (See Drawing 1 for Location Plan)

Without stabilization (repair) of the eroded slope at Cross-Section B-B, the stability of the adjacent slope, such as at Cross-Section C-C, will also be affected in future.

If the eroded/failed slope in Cross-section B-B area is not to be stabilized/repared, the slope at Cross-Section C-C is not stable, because it was just adjacent to the failed/eroded area. Point “S3a” at Cross-Section C-C is just on the straight line between Point “S2a” and Point “S4” as shown on Drawing 1B.

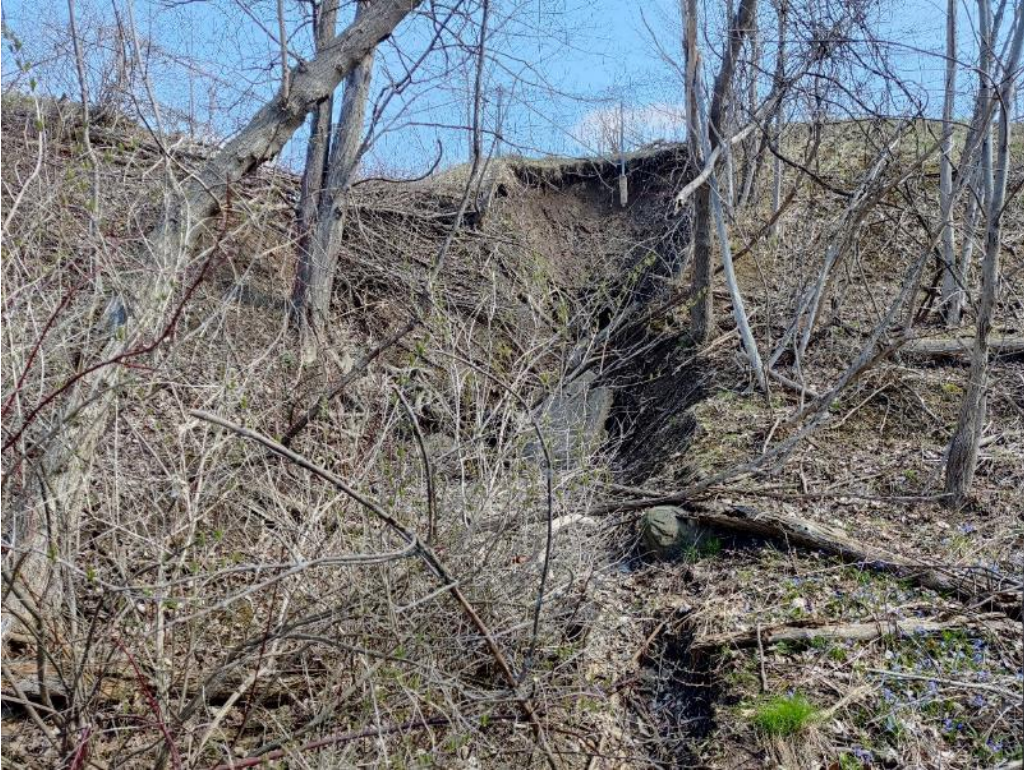
The erosion (failure of slope) was about 6 to 10 m wide and was about 4 m deep below the original slope surface (as compared to the adjacent slope that was not eroded). The erosion of the slope extended into the top of slope area and the founding pier of the existing fence was exposed due to erosions.

As discussed in **Section 4.1** of this report, severe erosions of the slope in the area of Cross-Section B-B (see **Drawing 1B** for location) had occurred. The erosions of the slope appeared to be caused by the flow from the broken concrete sewer pipe. However, no water flow was observed from the sewer pipe during our site visits.

Photo 5: Slope conditions and erosion/failure in Cross-Section B-B area (looking north from toe of slope)

It is recommended that the eroded/failed slope in the area of Cross-Section B-B be stabilized/repared. Based on the site conditions, **rip-rap rock fill or reinforced slope** can be adopted to stabilize the slope in the area of Cross-Section B-B.

Prior to the placement of rip-rap rock fill, all disturbed/loose materials in the eroded area must be removed. A geotextile (such as Terrafix 420R) should be placed at the excavation base and the sides of the eroded ditch, and rip-rap rock fill can then be placed above the geotextile.

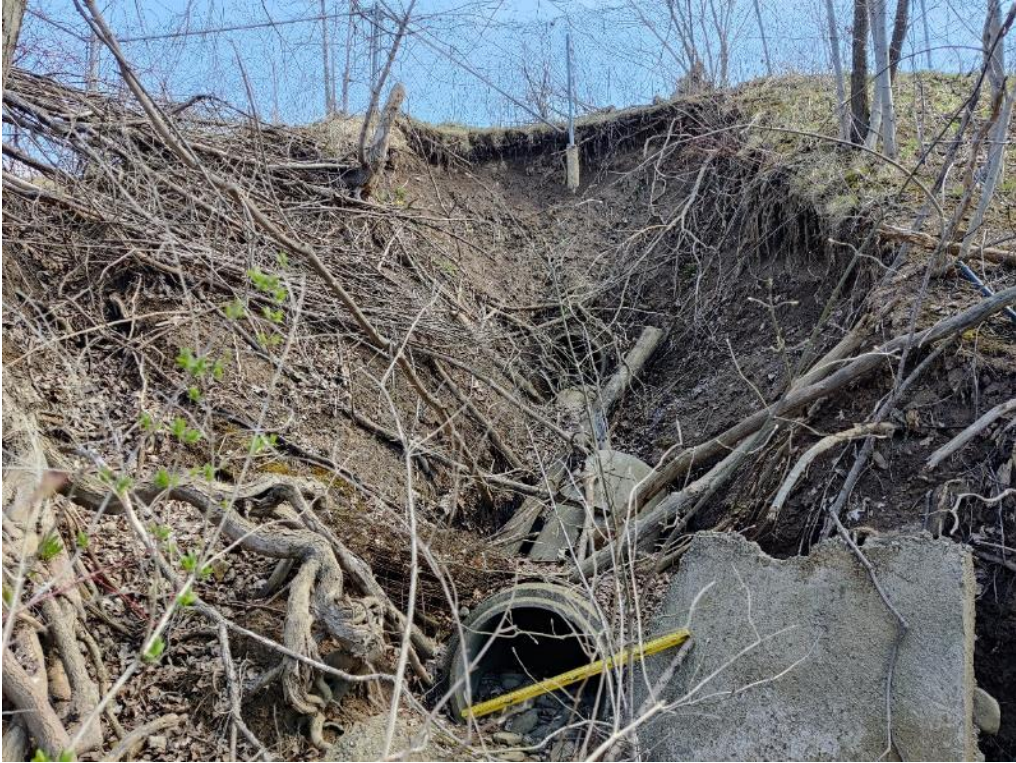
Photo 6: Erosion/Failure of Slope in Cross-Section B-B Area (looking north)

With the stabilization of the eroded slope using rip-rap rock fill or reinforced slope in the area of Cross-Section B-B, no more discharge from the broken sewer pipe should be allowed, or the sewer pipe must be repaired and extended to beyond the toe of the stabilized slope. The existing pipe can be abandoned and left in place, provided it is well capped.

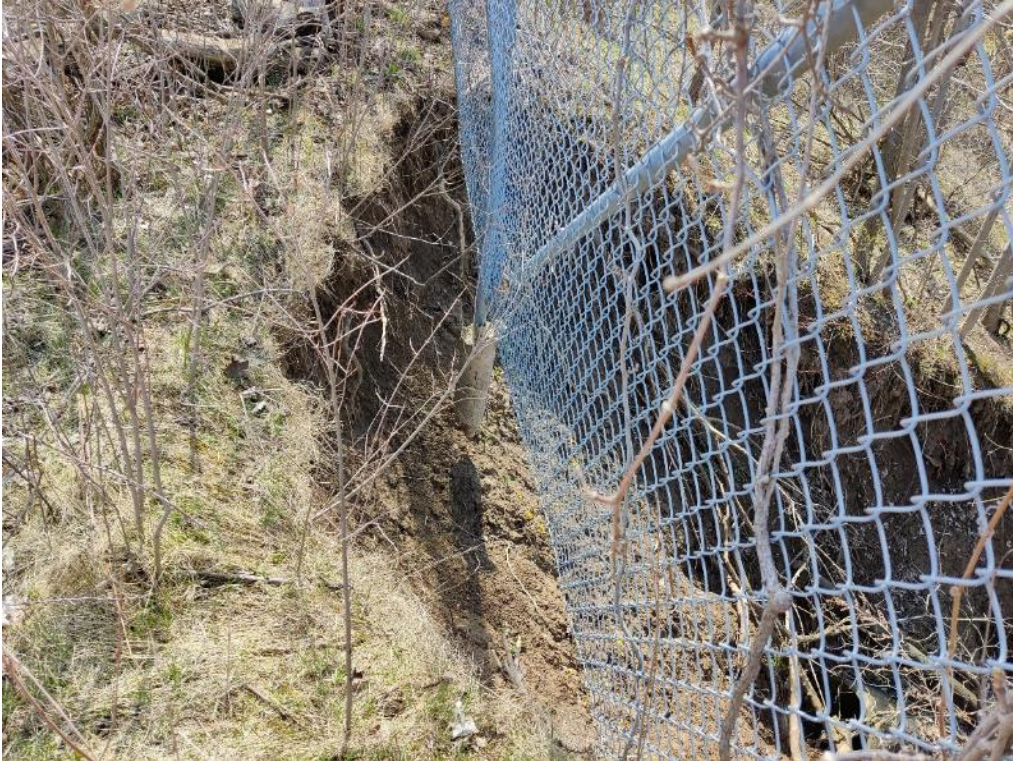
Photo 7: Slope failure at Cross-Section B-B (looking east at top of slope)

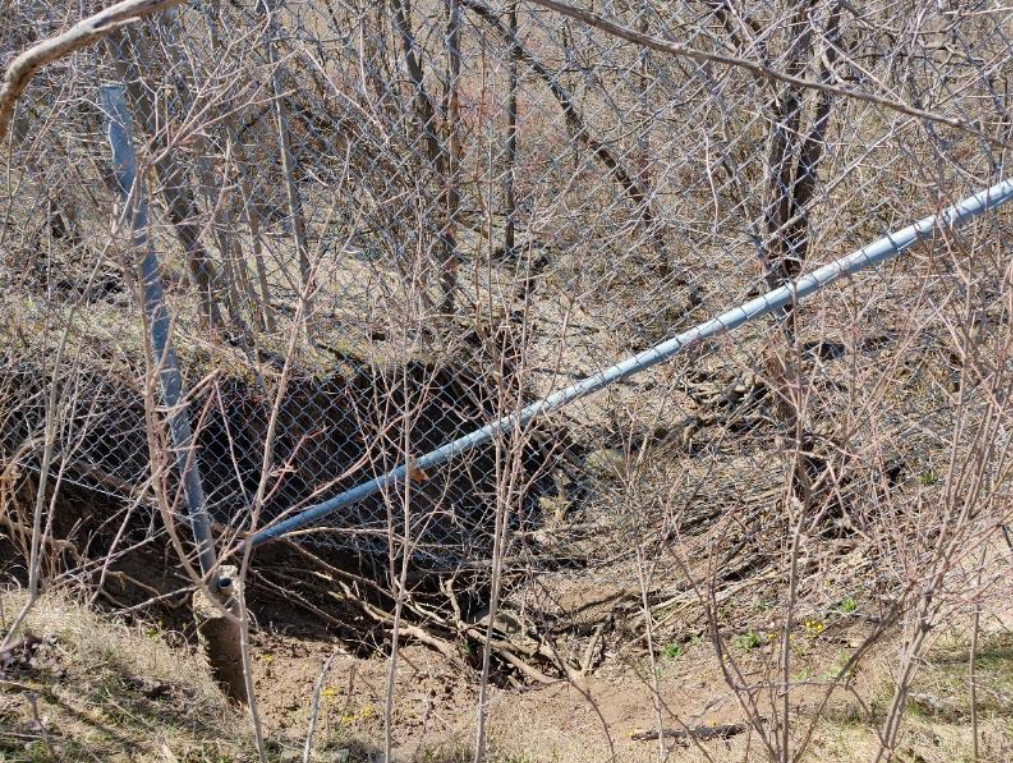
Photo 8: Slope failure in Cross-Section B-B area (looking southeast from top of slope)
