# ARBORIST REPORT AND TREE PROTECTION PLAN

7072 Sixth Line, Milton, Ontario

Project #: 24-0774

Date: July 29, 2025

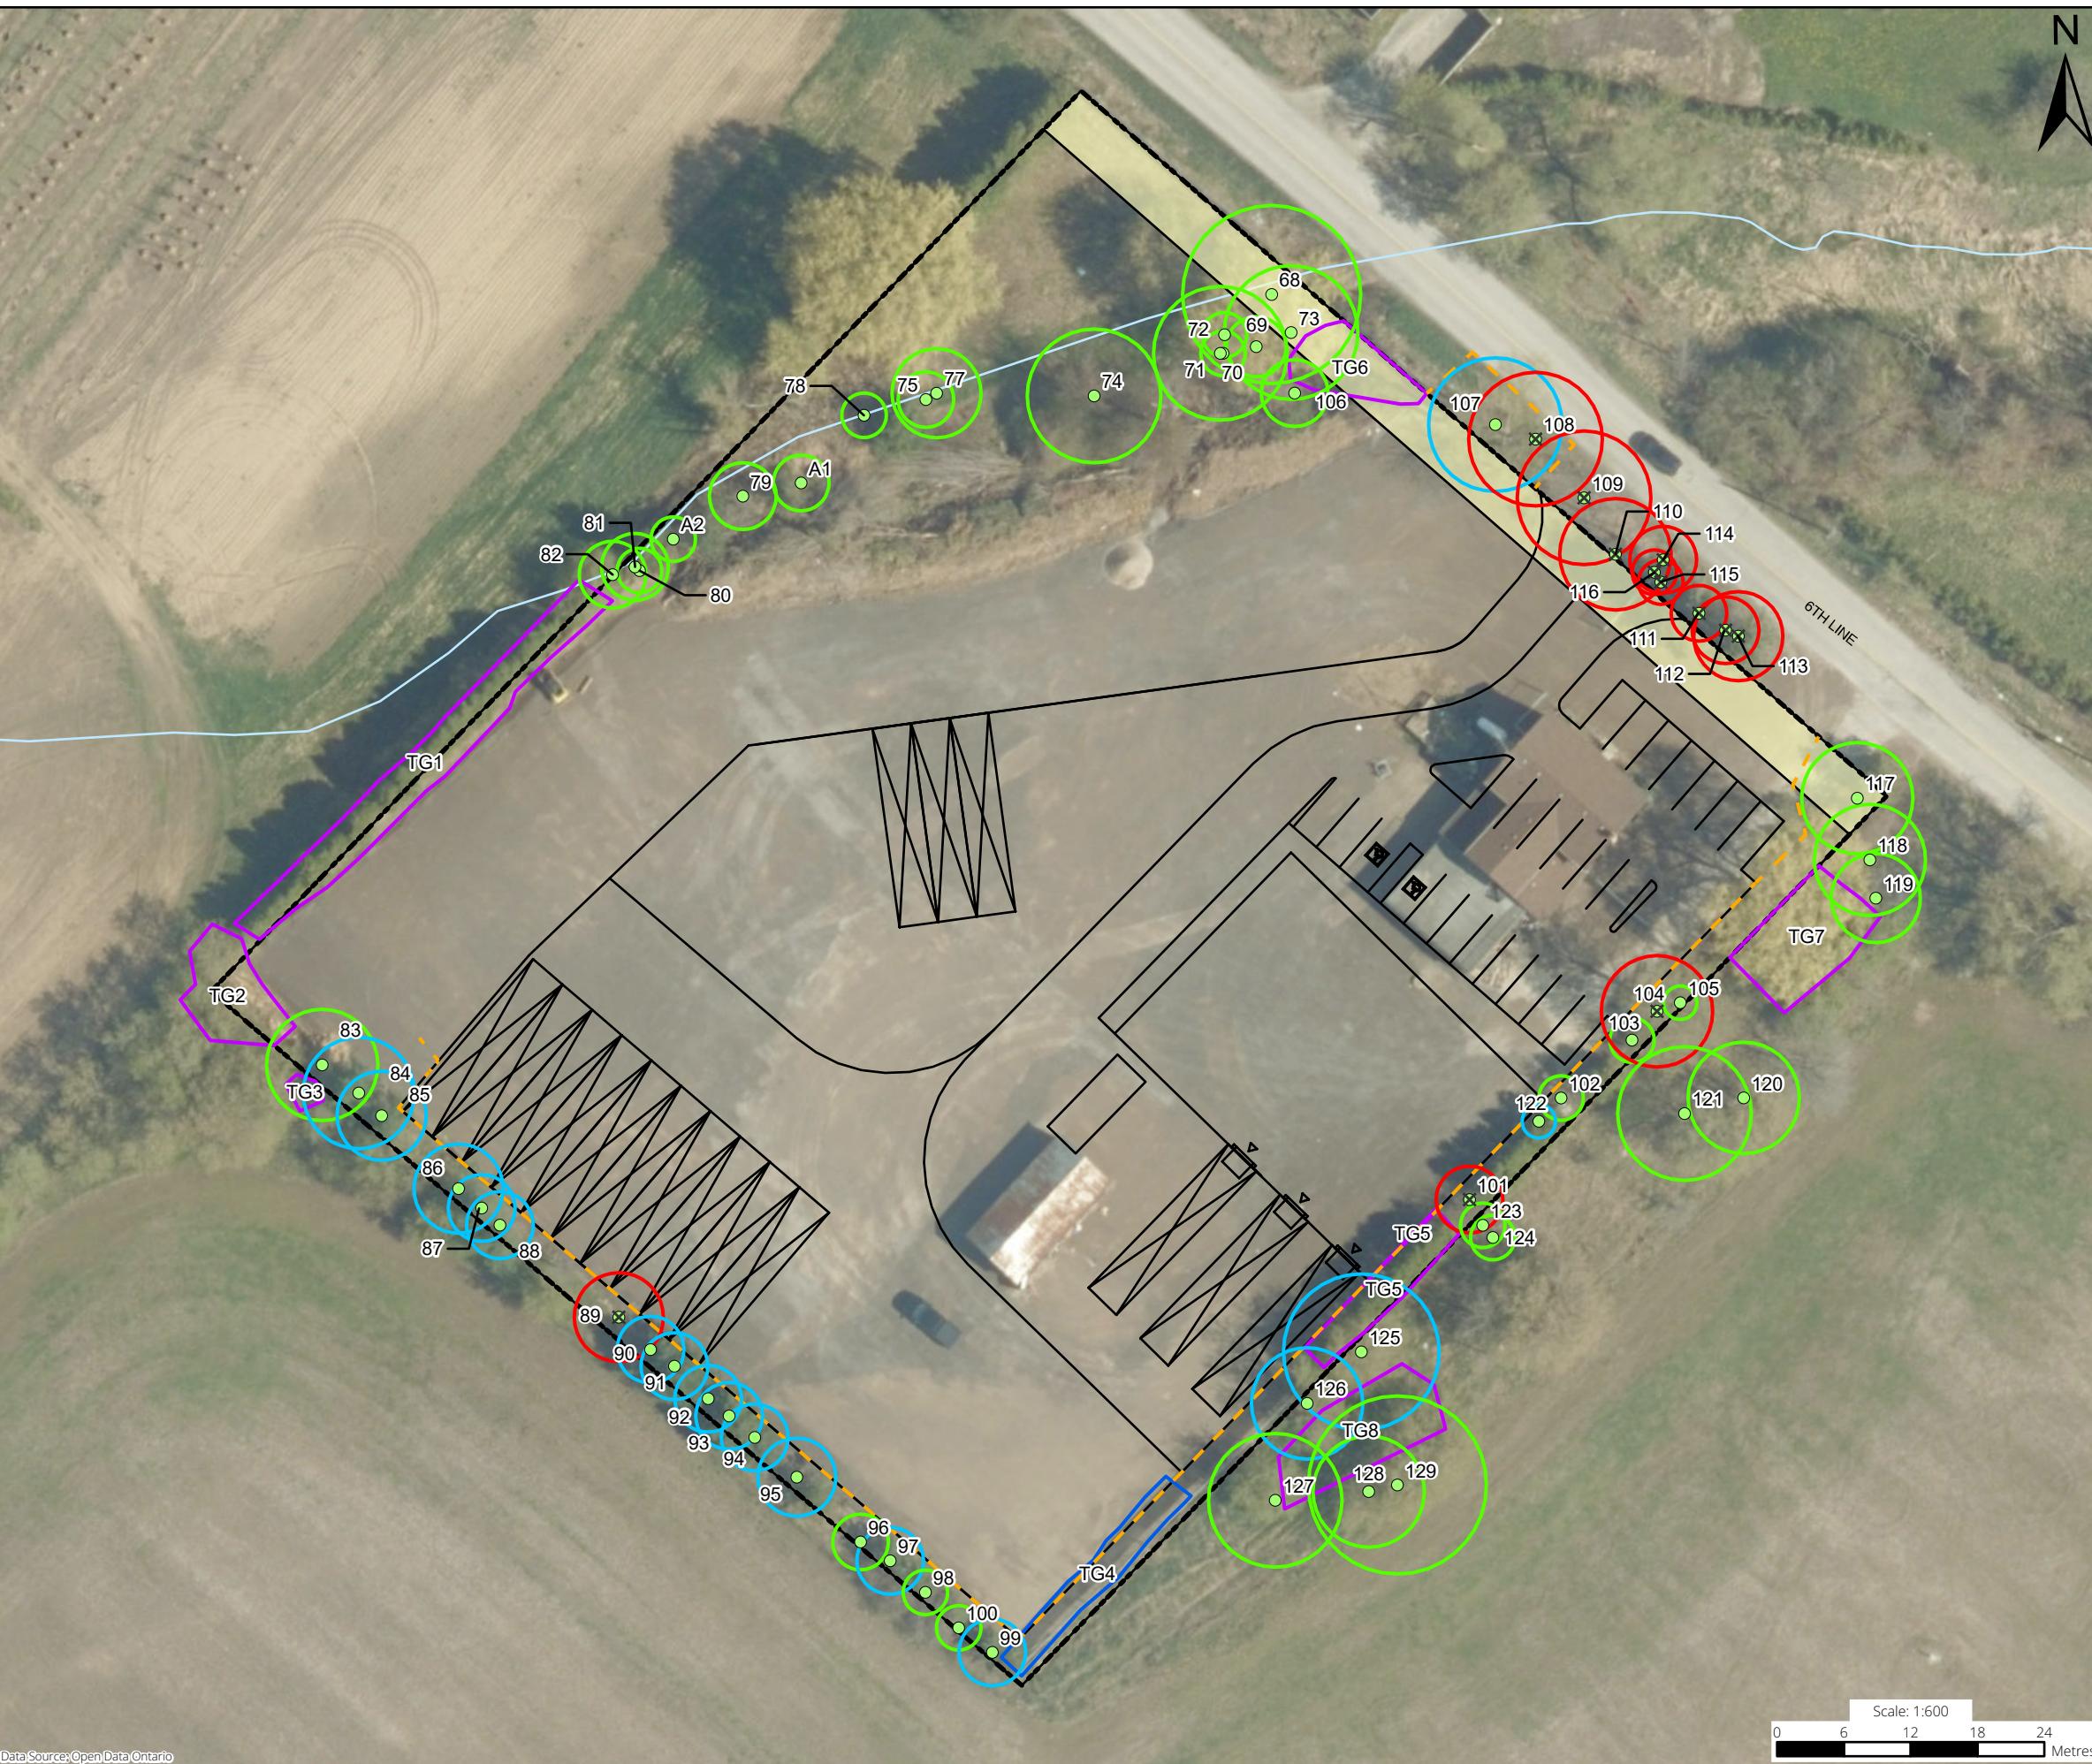
The proposed re-development encroaches into the TPZ of 17 individual trees (Trees 84 to 88, 90 to 95, 97, 99, 107, 122, 125 and 126) and one (1) tree grouping (TG4). However, the encroachments are generally minor (less than 25%) and it is anticipated that these trees can be retained provided specific preservation methods are implemented. Information for the tree, including recommended actions, is provided in Table 6-2, below. Details of recommended treatment or specific preservation methods are provided in Table 6-3, below. General protection and preservation methods, as outlined above should also be applied for these trees.

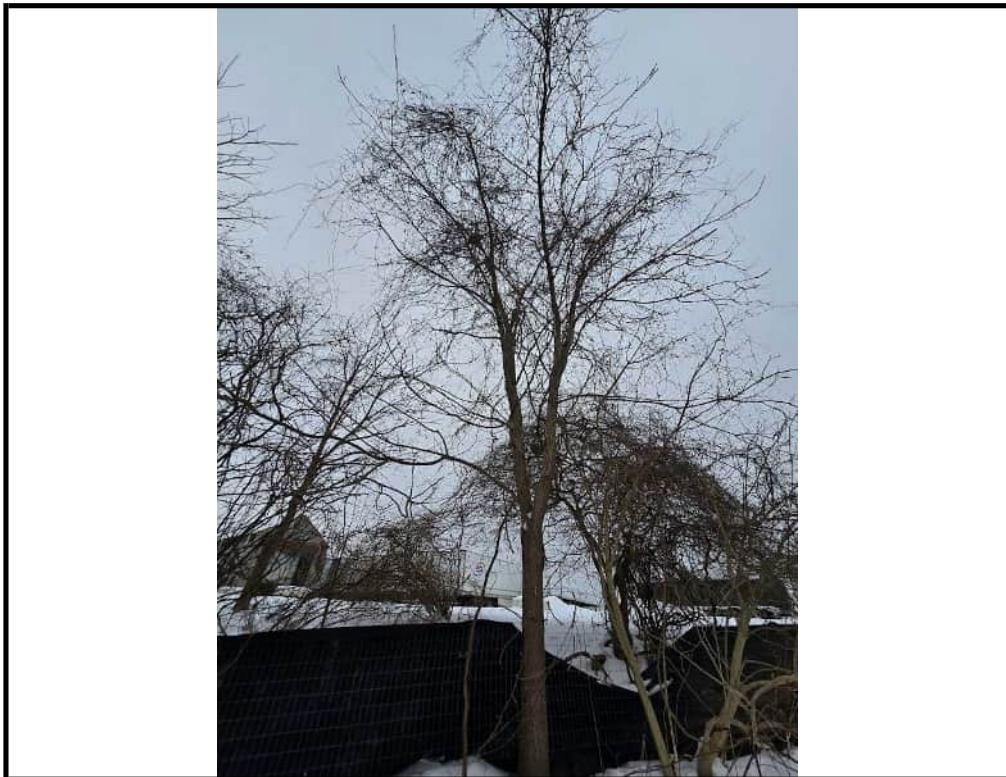
Tree #74

73	JUGLCIN	<i>Juglans cinerea</i>	Butternut	1	29	29	G	G	F	30%	9	5	6	Pr	0%	Preserve	lower dead limbs with no visible buds on branches
74	JUGLNIG	<i>Juglans nigra</i>	Black Walnut	1	25	25	G	G	G	<10%	10	5	6	Pr	0%	Preserve	grape competition, codominant branching at 2.5 m
75	JUGLNIG	<i>Juglans nigra</i>	Black Walnut	1	11	11	G	G	G	<10%	5	1.5	2.5	Pr	0%	Preserve	1 broken branch
77	PICEGLA	<i>Picea glauca</i>	White Spruce	1	22	22	G	G	G	<10%	8.5	3	4	Pr	0%	Preserve	grape competition
78	JUGLNIG	<i>Juglans nigra</i>	Black Walnut	1	6	6	G	G	G	<10%	4	1	2	Pr	0%	Preserve	
A1	PICE_SP	<i>Picea sp.</i>	Spruce sp.	1	20	20	D	D	D	100%	9	1.5	2.5	Pr	0%	Preserve	dead, no pine needles or indication of live branches
79	JUGLNIG	<i>Juglans nigra</i>	Black Walnut	1	19	19	F	G	G	<10%	9	2	3	Pr	0%	Preserve	wound with peeling back at base, grape competition
A2	PICE_SP	<i>Picea sp.</i>	Spruce sp.	2 ind.	21	21	D	D	D	100%	8	1	2	Pr	0%	Preserve	2 small dead spruce trees 5 m

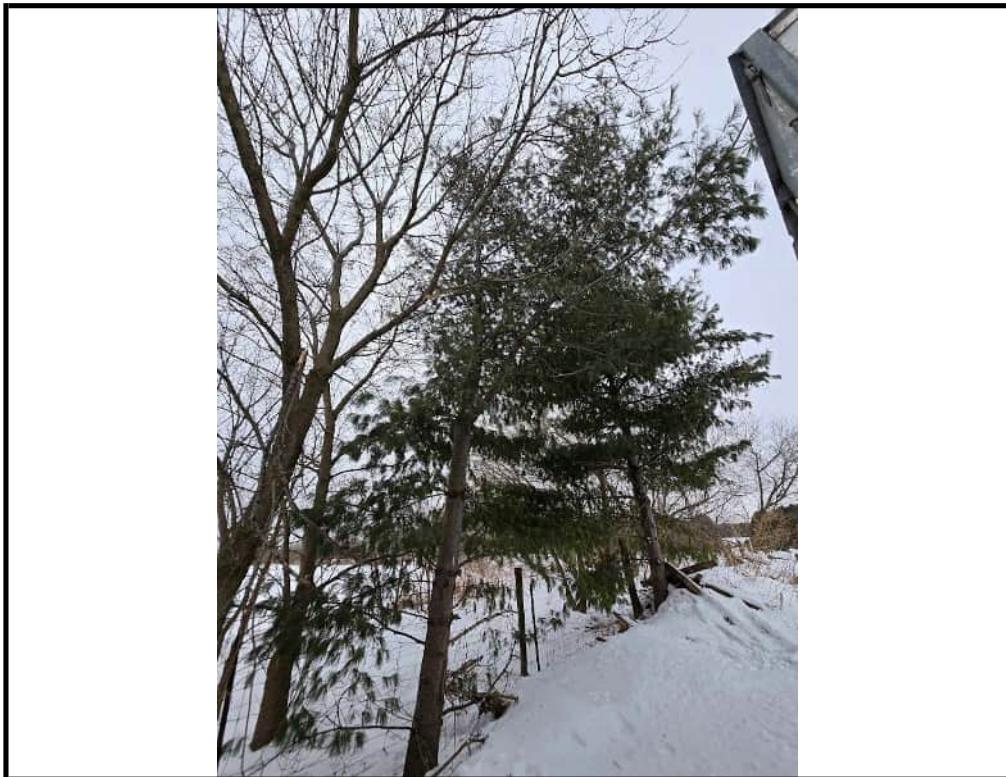
Tree #84

TREE ID	SPECIES	DBH (CM)	CONDITION	RECOMMENDED ACTION
84	Eastern White Pine	23	This tree is in good condition, with an unbalanced live crown and less than 10% deadwood. Approximately 2% encroachment into its TPZ will occur during construction. This tree should be retained and protected.	Retain and protect with specific preservation methods 1 to 5 (Table 6-3).
85	Manitoba Maple	22, 23	This tree is in good condition with co-dominant stems at 1.5 m and less than 10% deadwood. One (1) cut lower limb was observed during the inventory. Approximately 10% encroachment into its TPZ will occur during construction. This tree should be retained and protected.	Retain and protect with specific preservation methods 1 to 5 (Table 6-3).
86	Eastern White Pine	28	This tree is in good condition with less than 10% deadwood. Approximately 19% encroachment into its TPZ will occur during construction. This tree should be retained and protected.	Retain and protect with specific preservation methods 1 to 5 (Table 6-3).

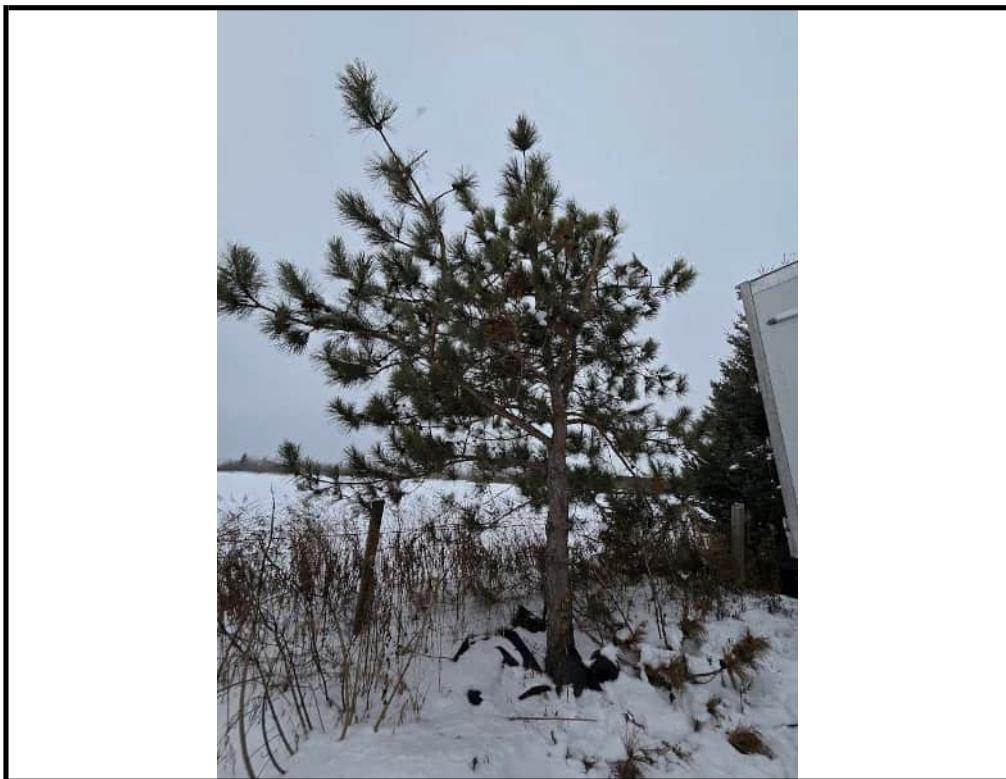
Tree #95

TREE ID	SPECIES	DBH (CM)	CONDITION	RECOMMENDED ACTION
95	Red Pine	20	This tree is in good condition with an unbalanced live crown, a few broken branches and less than 10% deadwood. Approximately 17% encroachment into its TPZ will occur during construction. This tree should be retained and protected.	Retain and protect with specific preservation methods 1 to 5 (Table 6-3).
97	Red Pine	20	This tree is in fair condition with a curved trunk, a few dead lower limbs and less than 10% deadwood. Approximately 8% encroachment into its TPZ will occur during construction. This tree should be retained and protected.	Retain and protect with specific preservation methods 1 to 5 (Table 6-3).
99	Red Pine	15	This tree is in good condition with less than 10% deadwood. Approximately 4% encroachment into its TPZ will occur during construction. This tree should be retained and protected.	Retain and protect with specific preservation methods 1 to 5 (Table 6-3).

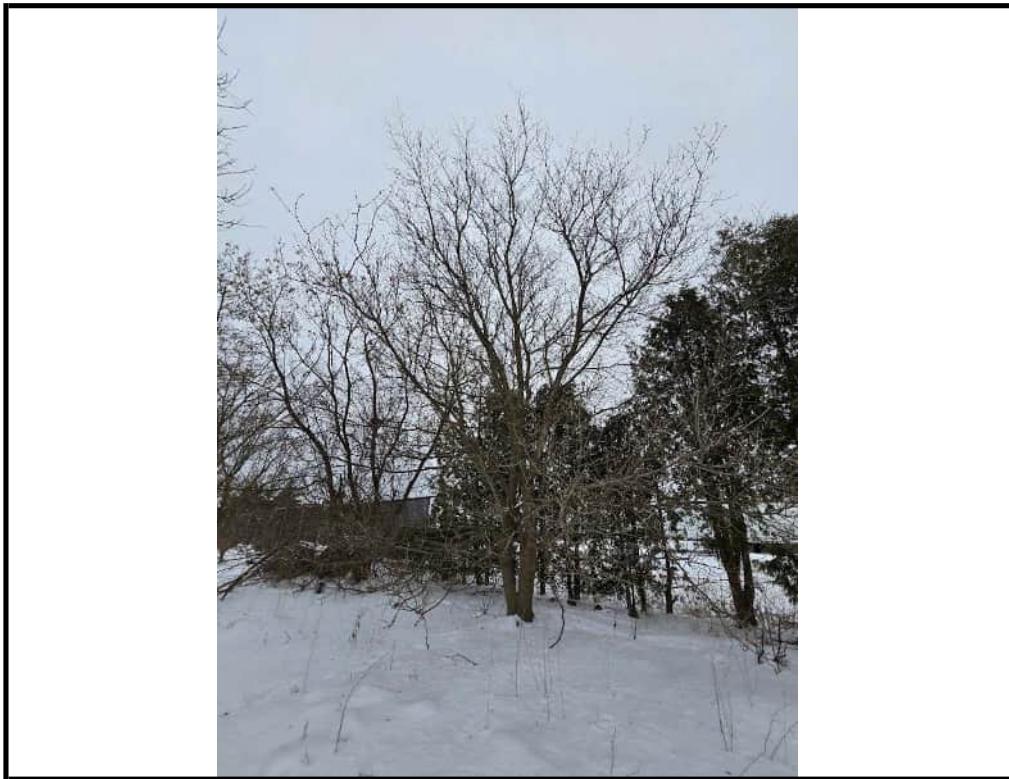
Tree # 125

TREE ID	SPECIES	DBH (CM)	CONDITION	RECOMMENDED ACTION
125	Manitoba Maple	23, 24	This tree is in good condition, co-dominant stems at 0.5 m with less than 10% deadwood. Approximately 16% encroachment into its TPZ will occur during construction. This tree should be retained and protected.	Retain and protect with specific preservation methods 1 to 5 (Table 6-3).
126	Manitoba Maple	25, 20, 20, 16	This multi-stemmed tree is in good condition, contained a single broken limb with less than 10% deadwood. Approximately 7% encroachment into its TPZ will occur during construction. This tree should be retained and protected.	Retain and protect with specific preservation methods 1 to 5 (Table 6-3).
TG4	Blue Spruce	10	This tree grouping consists of seven (7) trees which are in good condition with less than 10% deadwood. Approximately 20% encroachment into its TPZ will occur during construction. This tree should be retained and protected.	Retain and protect with specific preservation methods 1 to 5 (Table 6-3).
