# TREE INVENTORY, ANALYSIS & PRESERVATION STUDY

Development Application  
8995 Boston Church Road, Town of Milton  
2 June 2026

Plan of Condominium Application  
8995 Boston Church Road, Town of Milton

Project No.: 24152

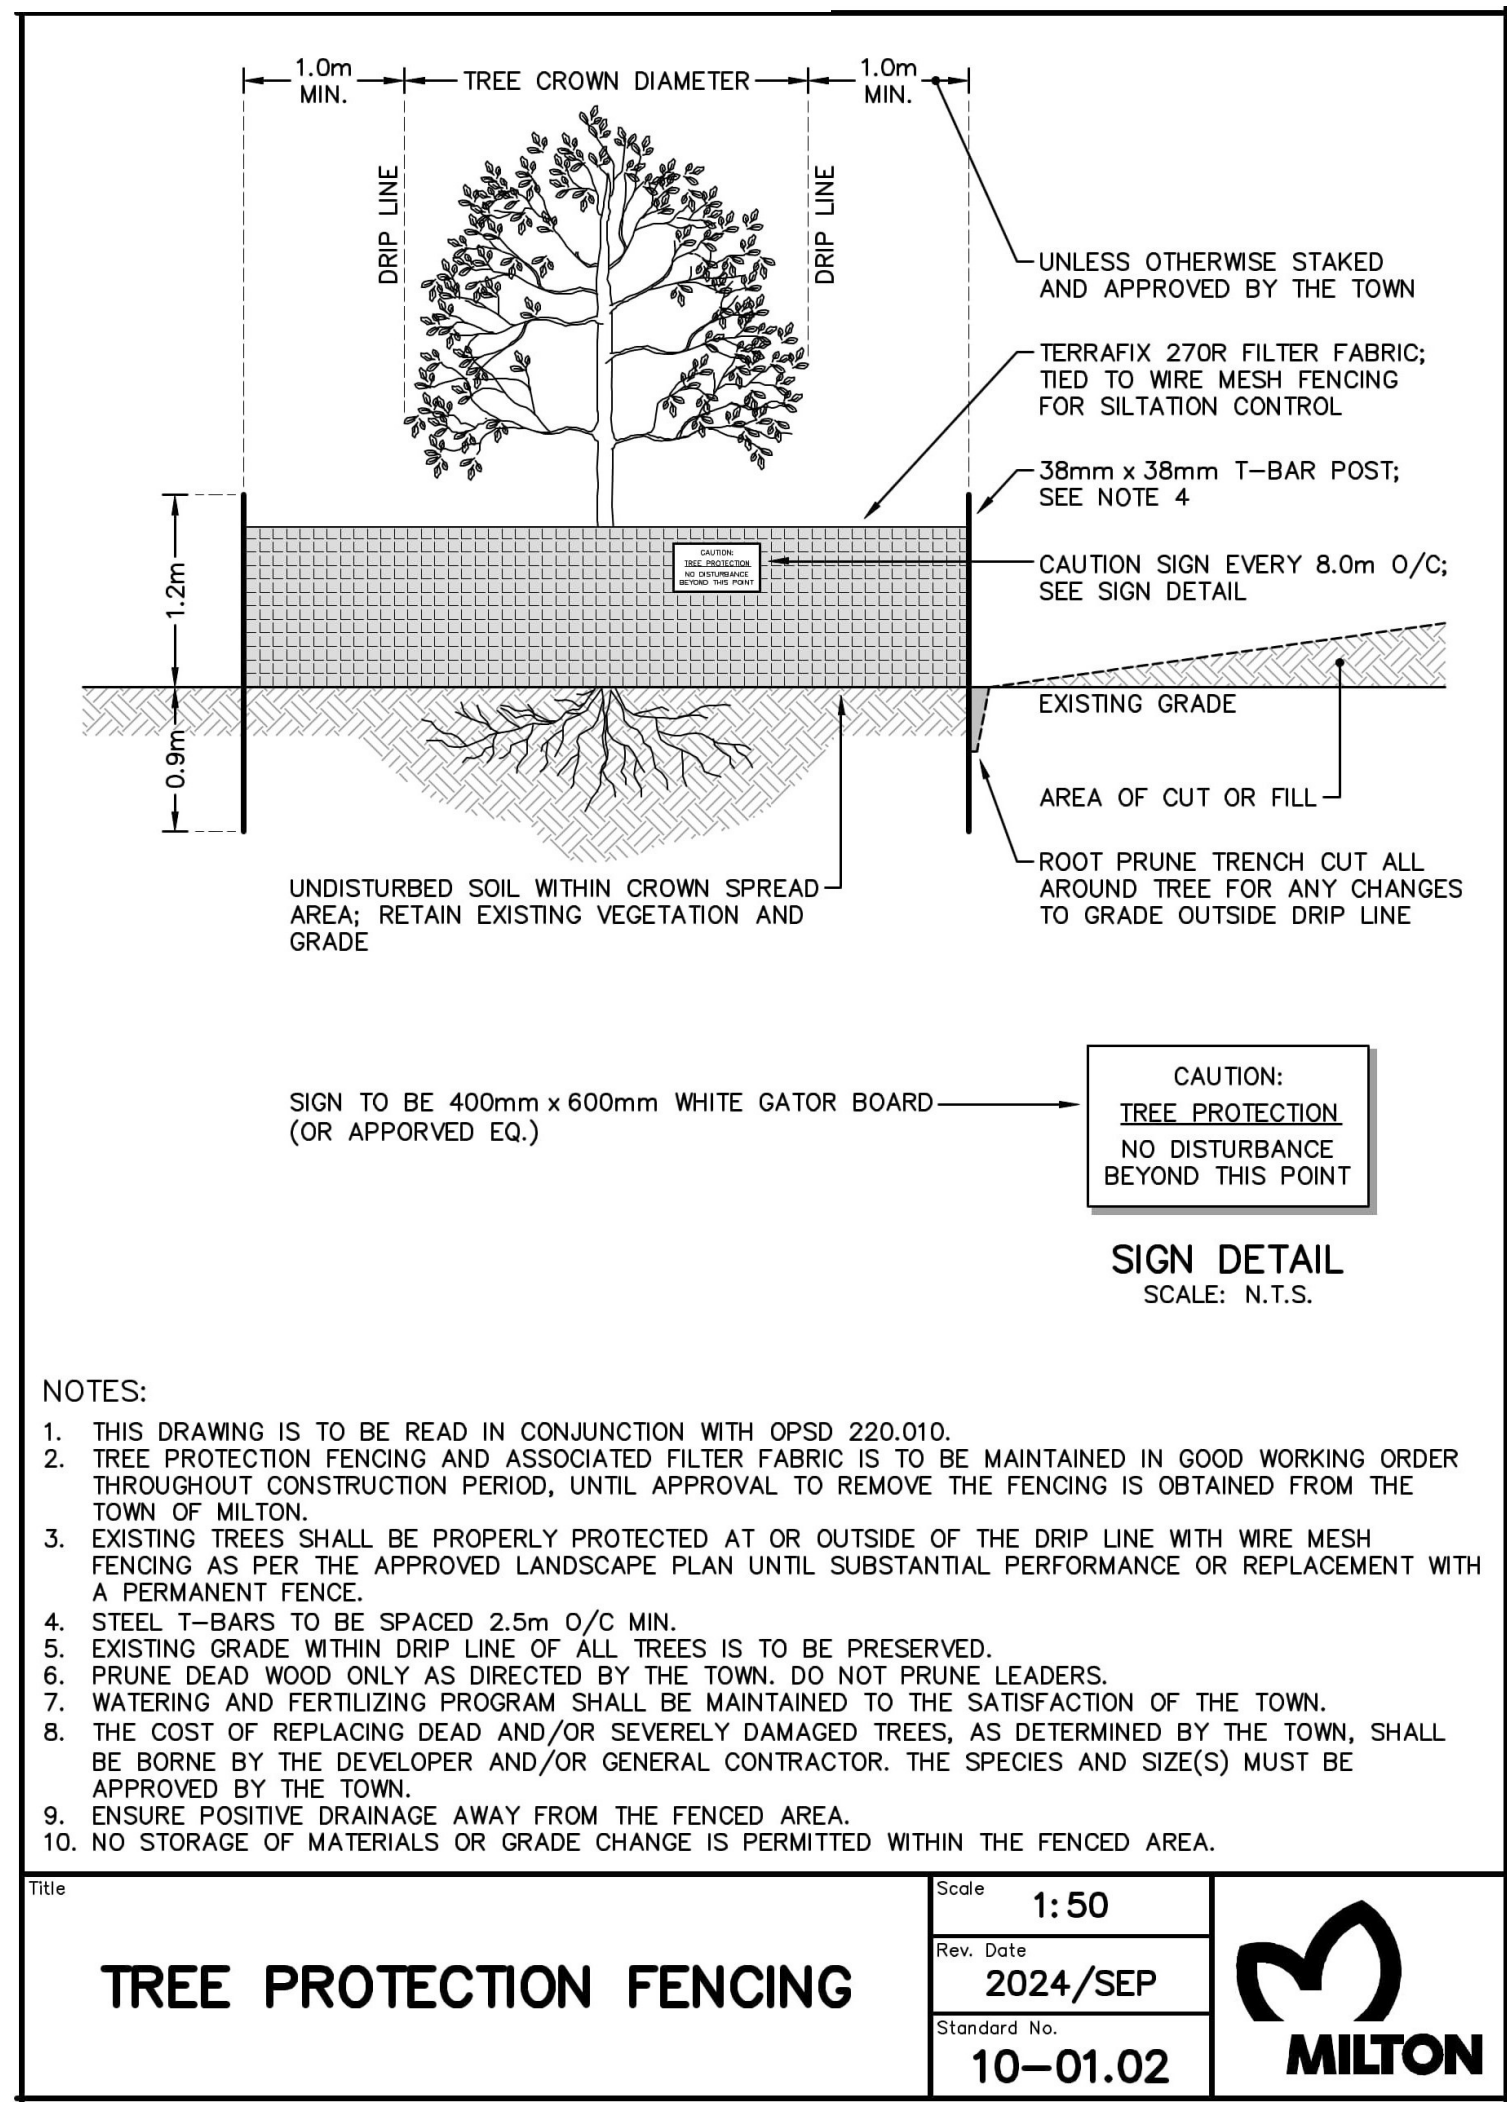
# Tree Preservation Plan

Based on the proposed site plan shown in **Figure 1**, a total of nine (9) assessed trees (20.9%) require removal to implement the proposed development plan. A rationale for the removal of each individual tree is provided in **Appendix 1**. Tree removals are primarily required to realign an on-site ditch/drainage feature and grade to the western property boundary along Boston Church Road.

Protection of the remaining 34 assessed trees (79.1%) can be accommodated by the proposed development plan. In general, tree protection on development sites is effectuated by restricting development and/or site alteration from the prescribed minimum Tree Protection Zone (TPZ). A minimum TPZ is generally accepted to be the minimum setback distance required to maintain the structural integrity of a tree's anchor roots (i.e., "root plate"). In Ontario, minimum TPZs are often established by multiplying a tree's diameter at breast height (DBH) by a factor of 6. Trees with a similar diameter (e.g., 41 to 50 cm DBH) are lumped into a single size class, with the minimum TPZ established by the largest diameter tree in that particular size class. For example, all trees which are 41 to 50 cm DBH would be afforded a minimum 3 m setback as 50 cm represents the largest tree in that size class ( $50 \text{ cm} \times 6 = 300 \text{ cm}$  or 3 m). It follows that trees on the smaller end of their respective size class would be afforded a slightly greater minimum setback than trees on the higher end. The calculated TPZ represents the radius of a circle that extends from a tree's base to the specified distance (or up to existing hard surfaces, where applicable). Minimum TPZs for each tree inventoried are shown on **Figure 1**.

- **Construction activities will treat all trees recommended for retention on Figure 1 as constraints.**
- **Tree protection fence will be installed per Figure 1 prior to the commencement of site preparation and other construction activities.**

- **Tree protection fence will remain in place and be in good condition during implementation of the proposed development plan. Tree protection fence will not be removed until all site disturbances associated with the proposed development plan have concluded.**

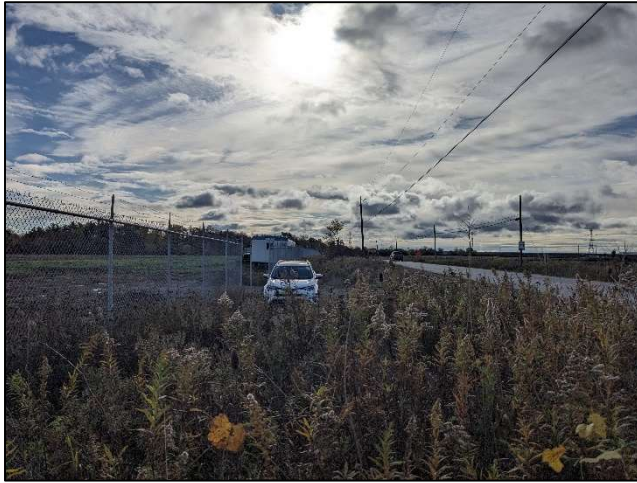
**Photo 1.** Fenceline at the intersection of Boston Church Road and Sideroad 5, facing southeast (23 October 2025).

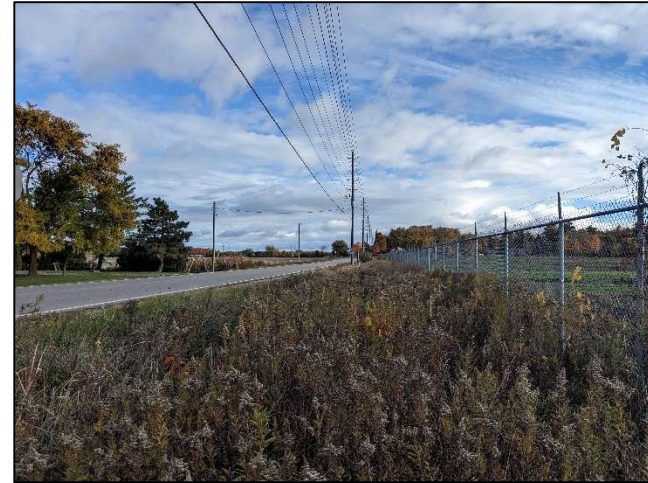
**Photo 2.** Fenceline at the intersection of Boston Church Road and Sideroad 5, facing northeast (23 October 2025).

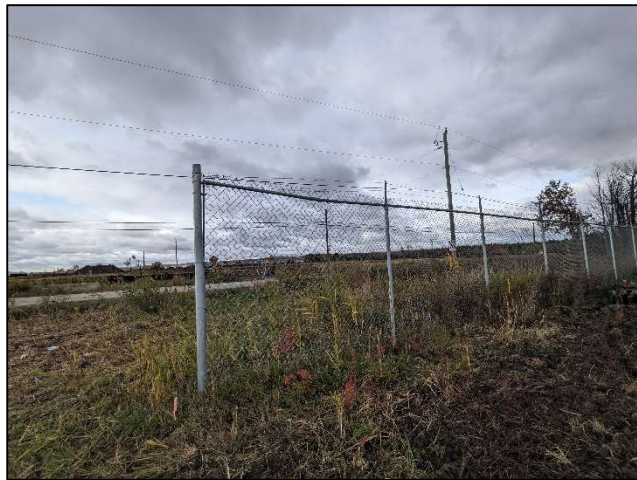
**Photo 3.** Fenceline parallel to Sideroad 5, facing northeast (23 October 2025).

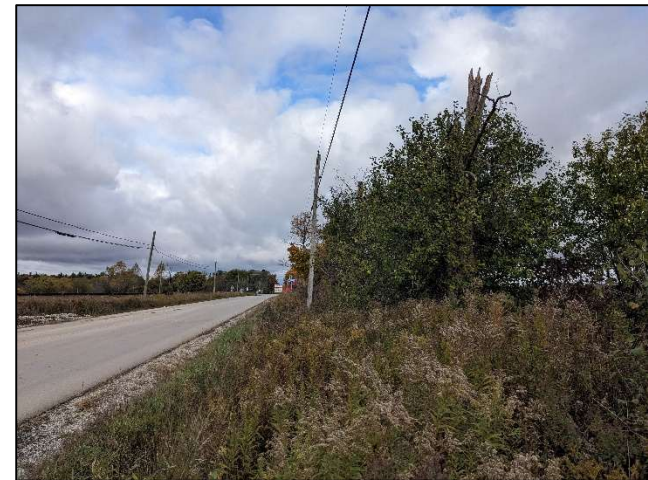
**Photo 4.** Fenceline parallel to Sideroad 5, facing northeast (23 October 2025).

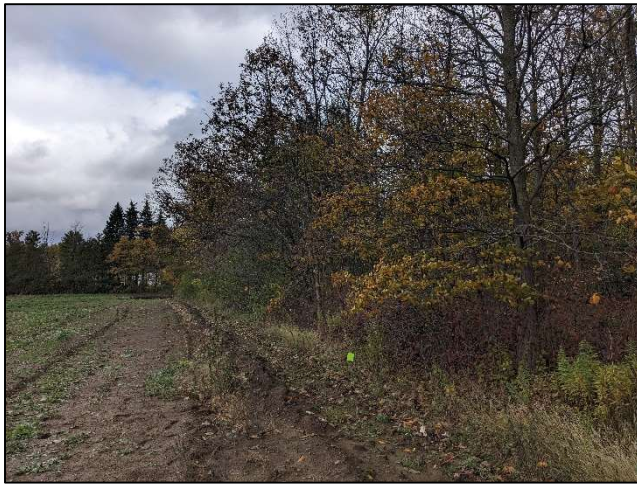
**Photo 5.** Edge of forest, facing northeast (23 October 2025).

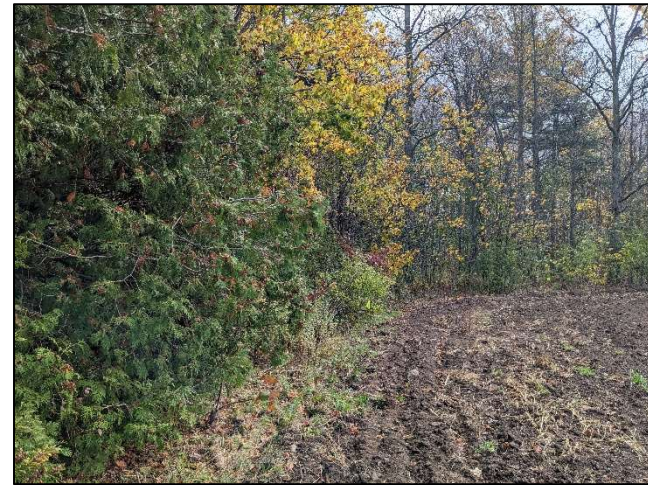
**Photo 6.** Edge of forest, facing southeast (23 October 2025).

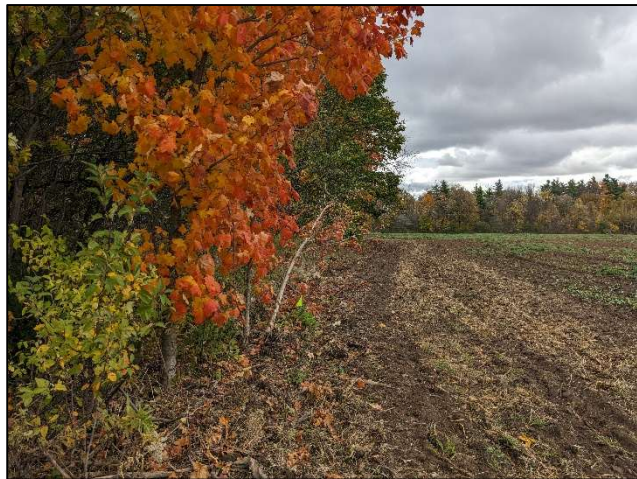
**Photo 7.** Edge of forest, facing southeast (23 October 2025).

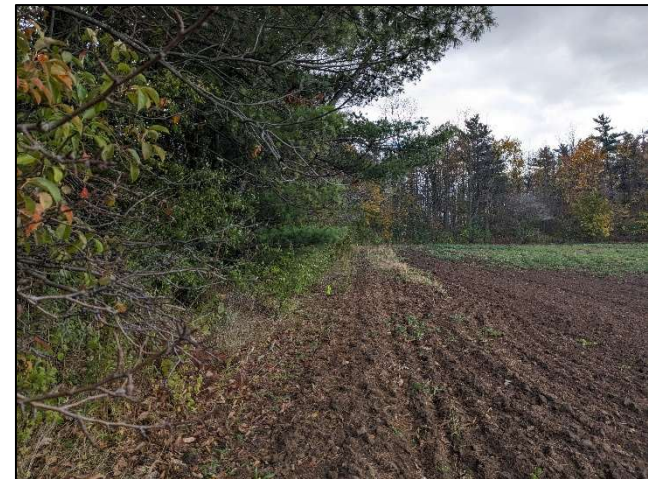
**Photo 8.** Edge of forest, facing southeast (23 October 2025).
