**PHASE ONE
ENVIRONMENTAL SITE ASSESSMENT
6360 REGIONAL ROAD 25
TOWN OF MILTON, ONTARIO**

Prepared for: **Thomas Robert Colbeck**
7050 Appleby Line
Milton, Ontario L9E 0M5

File No 1-22-0209-41
December 8, 2022

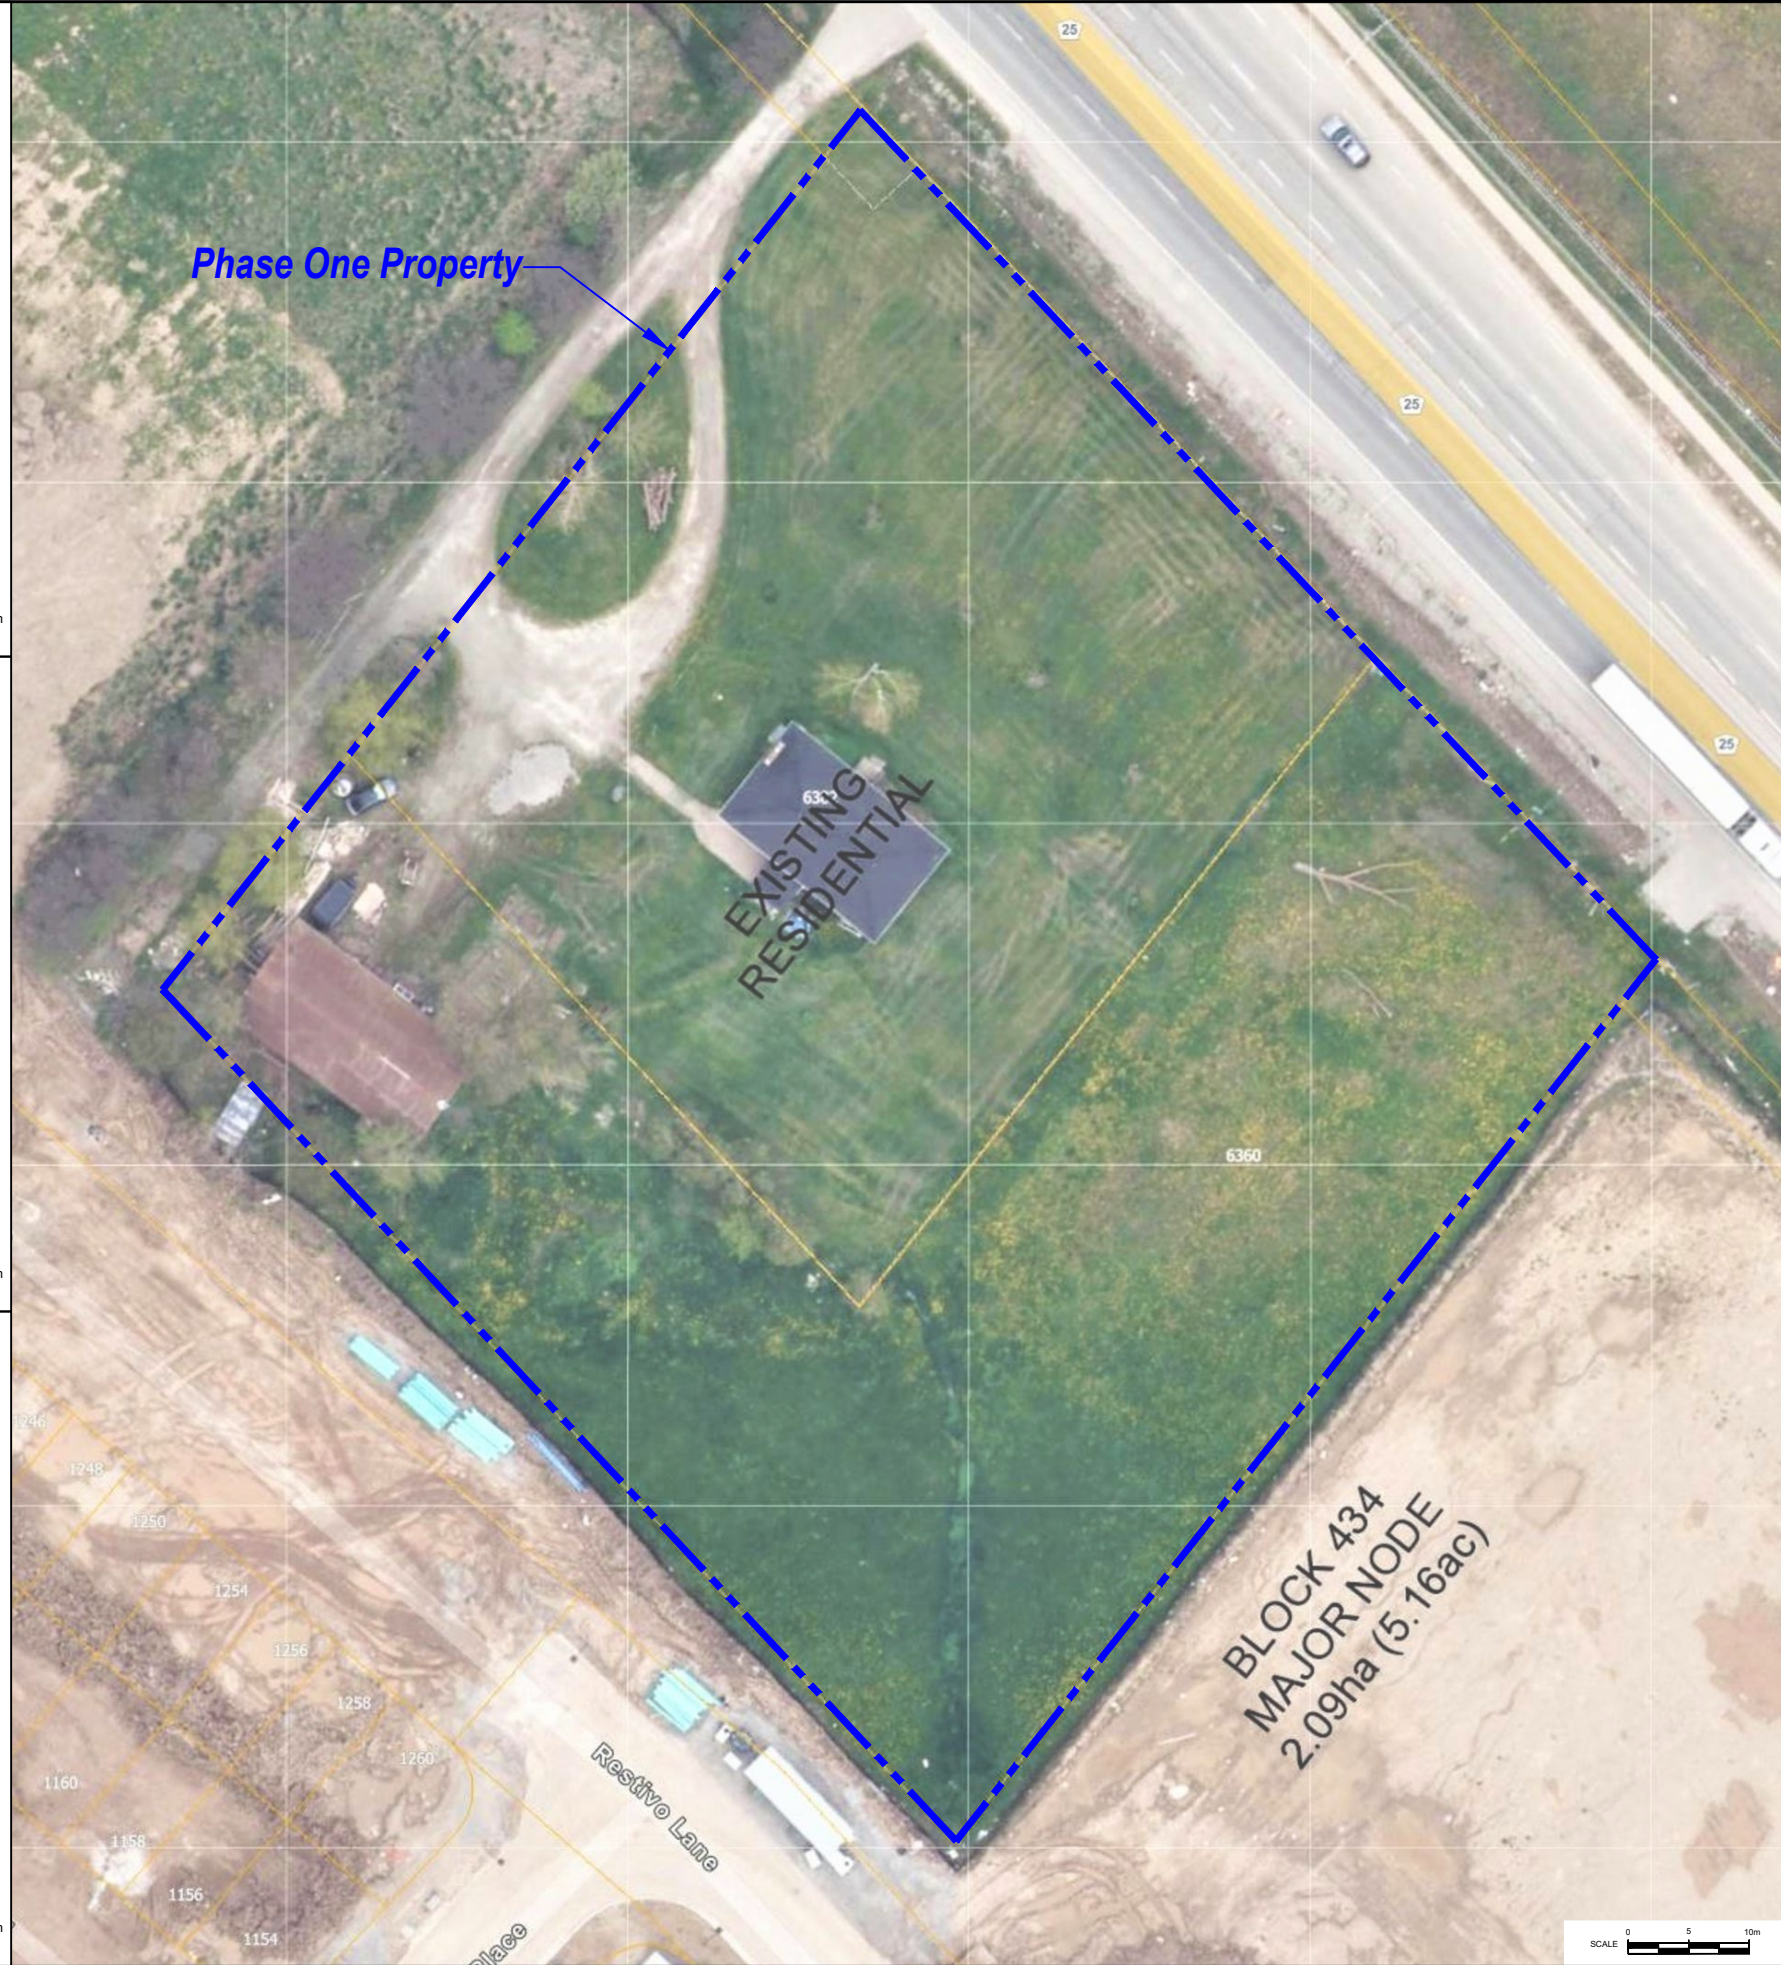
The physical area of each APEC is illustrated in Figure 5. Please note that the area illustrated does not necessarily represent the complete potential area of impact, but represents the most likely potential area of impact, and thus represents the area that would first require intrusive investigation in a Phase Two ESA should a Phase Two ESA be conducted.

Notes:
 APEC - Area of Potential Environmental Concern

Based on a review of the ERIS report, no PCAs were identified on the Phase One Property, and one (1) property within the Study Area was identified with PCAs. The locations of the PCAs are illustrated in Figure 5.

<i>The following is a description and assessment of:</i>	
i. Any areas where potentially contaminating activity on or potentially affecting the Phase One Property has occurred,	See above list of APECs and Figure 5.

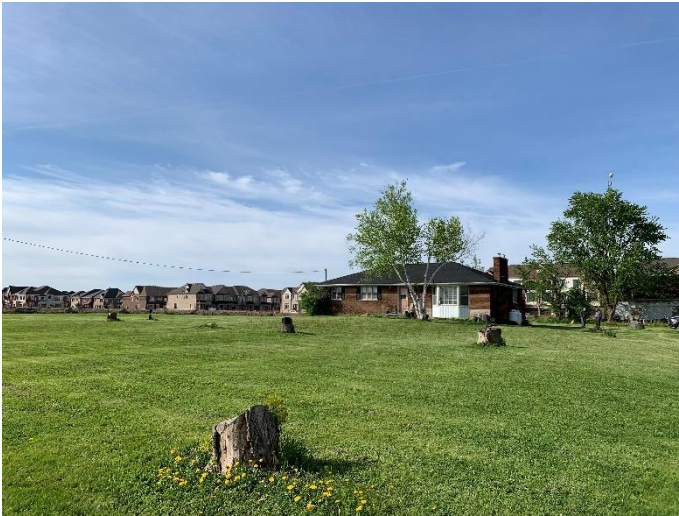
Photograph 1

Location: 6360 Regional Road 25

Description: View of the residential dwelling located on the Property.

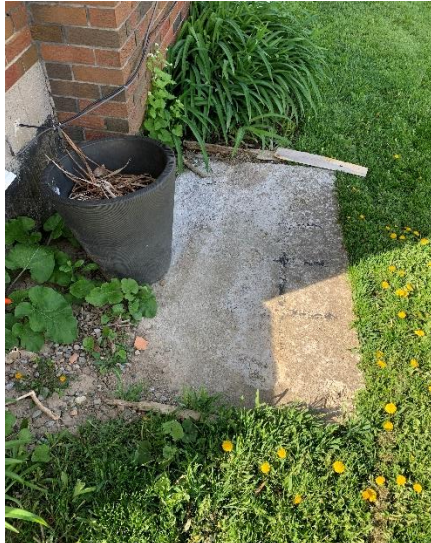
Photograph 3

Location: Historic Above Ground Storage Tank location

Description: View of the concrete pad that previously contained the AGST used to heat up the residential home. Some staining could be observed.

One historical aboveground storage tank (AST) was formerly located on the Property, as evident from concrete pad. The heating oil storage tank, located at the northwest end of the house was used to heat up the residential home. The tank has now been removed and substituted with propane gas heating system. The Concrete floor surface below the AST had no visible cracks, however, some rusting and staining was present.

Location of PCA	PCA	Details
Phase One Property (On-Site PCAs)		
6360 Regional Road 25	#28 – Gasoline and Associated Products Storage in Fixed Tanks	During the site inspection, evidence of a historic above ground heating oil storage tank was noted and confirmed with the owner of the Property.

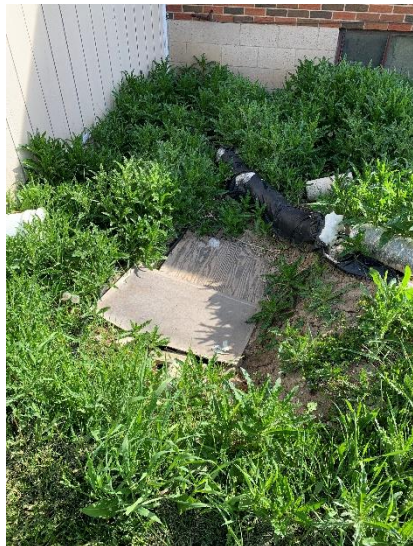
Photograph 4

Location: Behind Residential Home

Description: View of the septic tank located behind the residential home.

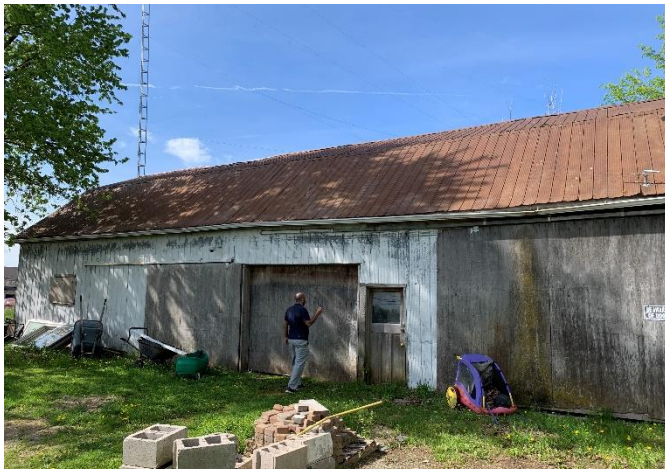
Photograph 5

Location: Barn

Description: View of the barn located at the southwest end of the Property.

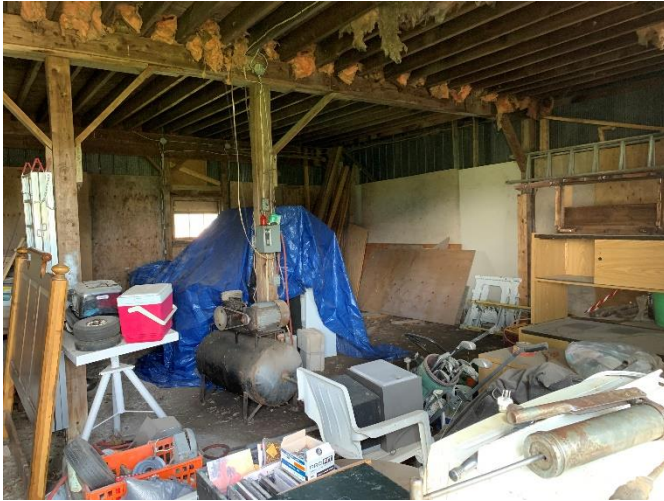
Photograph 6

Location: Barn
Viewing: South

Description: View of the barn's interior, metal roofing and concrete floor. Used as a storage space.

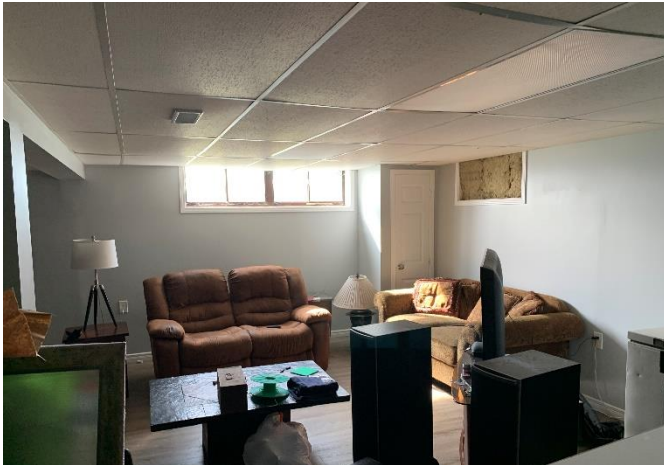
Photograph 7

Location: Basement of Residential Home
Viewing: Southwest

Description: View of basement inside the residential home, false ceiling tiles, and laminate floors. Used as a storage space.

The residential dwelling on the Phase One Property is developed with a full basement. No other below ground structure were noted during the site inspection.

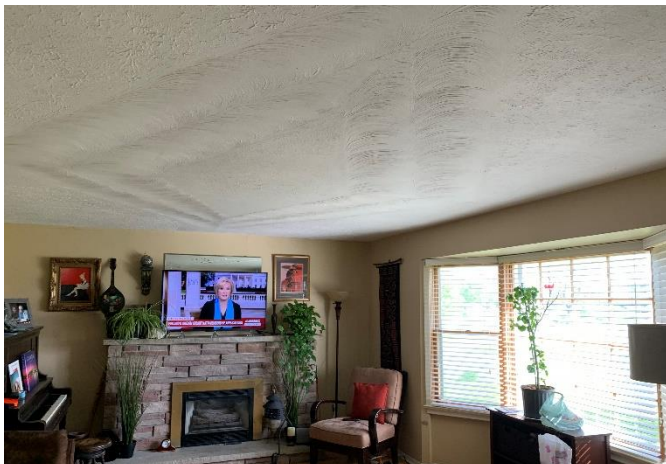
Photograph 8

Location: Living Room of Residential Home
