# PHASE ONE ENVIRONMENTAL SITE ASSESSMENT

Eastern Portion of 6728 Sixth Line, Milton, Ontario

Project #: 22-0209

Date: November 15, 2023

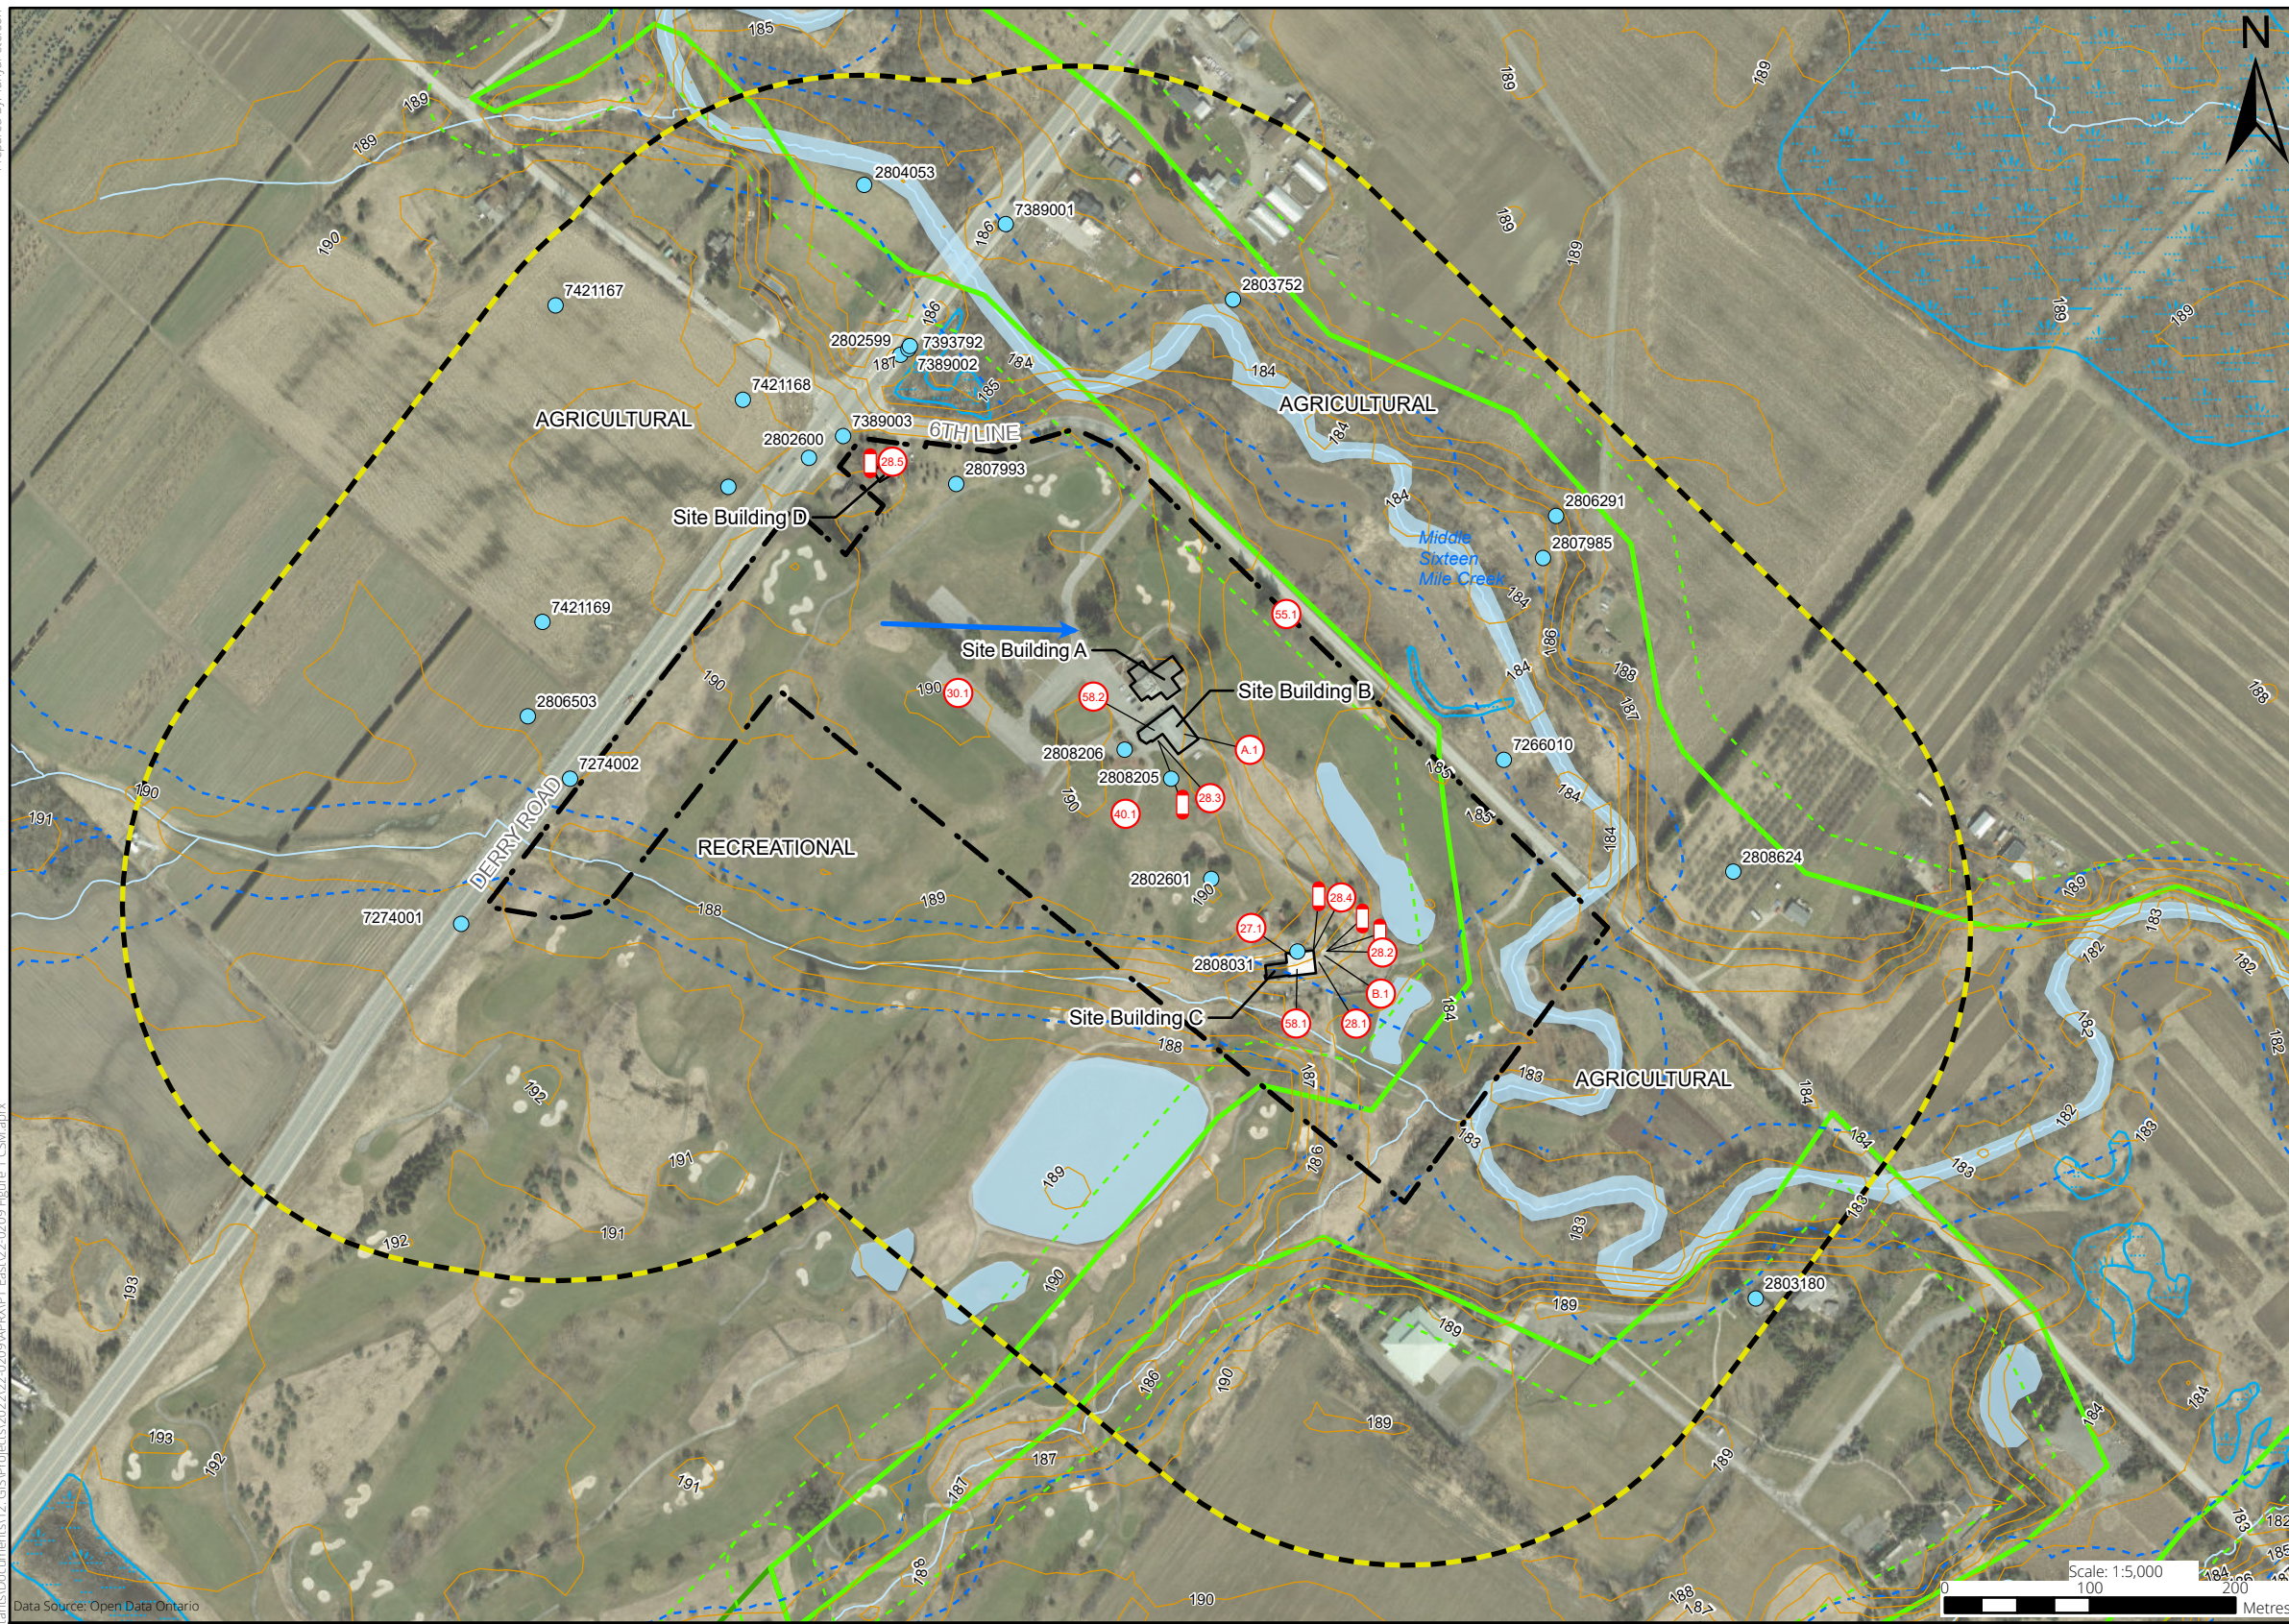
TITLE				
PHASE ONE CONCEPTUAL SITE MODEL				
PROJECT NO.	DATE	PREPARED BY	APPROVED BY	FIGURE
22-0209	NOVEMBER 2023	TP	RO	1

- POTENTIALLY CONTAMINATING ACTIVITIES (PCAs)
- (27) GARAGES AND MAINTENANCE AND REPAIR OF RAILCARS, MARINE VEHICLES AND AVIATION VEHICLES
  - (28) GASOLINE AND ASSOCIATED PRODUCTS STORAGE IN FIXED TANKS
  - (30) IMPORTATION OF FILL MATERIAL OF UNKNOWN QUALITY
  - (40) PESTICIDES (INCLUDING HERBICIDES, FUNGICIDES AND ANTI-FOULINGAGENTS) MANUFACTURING, PROCESSING, BULK STORAGE AND LARGE-SCALE APPLICATIONS
  - (55) TRANSFORMER MANUFACTURING, PROCESSING AND USE
  - (58) WASTE DISPOSAL AND WASTE MANAGEMENT, INCLUDING THERMAL TREATMENT, LANDFILLING AND TRANSFER OF WASTE, OTHER THAN USE OF BIOSOILS AS SOIL CONDITIONERS
  - (A) SPILLS
  - (B) USED MOTOR OIL STORAGE

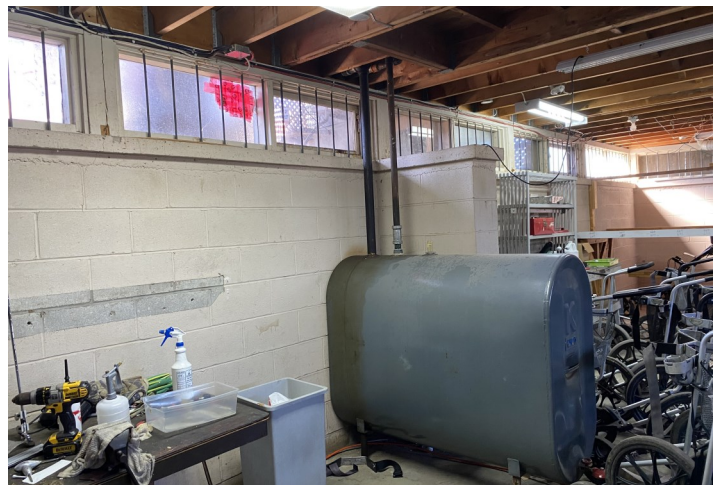
PHOTO 6: View of fuel-oil AST located in the basement of Site Building B.

- One (1) fuel oil AST (PCA 28) was located along the southwestern wall of the basement inside Site Building B, located on the east-central portion of the Site and one (1) fuel oil AST is located in the basement of Site Building D, on the northeast portion of the Site. A fuel oil spill (PCA A) of unknown volume occurred in 2017 from a fuel oil AST. Although the exact location of the spill is unknown, it is anticipated that the spill likely occurred in the vicinity of the fuel oil AST located in the basement of Site Building B. A waste management record is associated with Danosh Construction (PCA 58) for the generation, use, and/or storage of light fuels between 2018 and 2019;

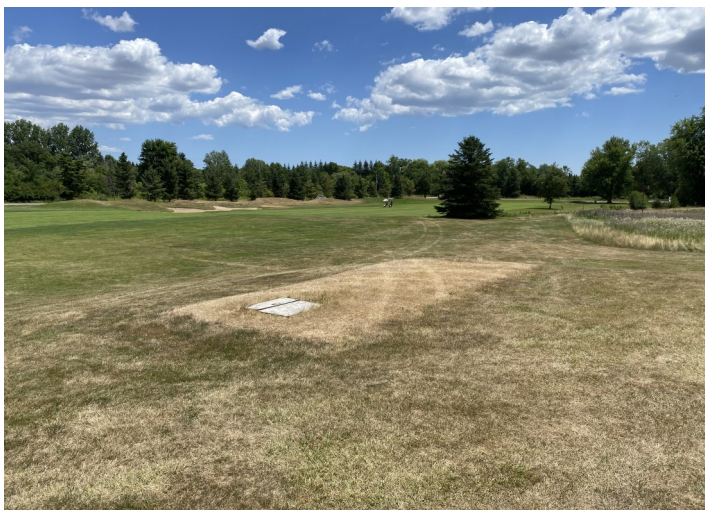
PHOTO 7: View of a septic tank located approximately 20 m east of Site Building B.

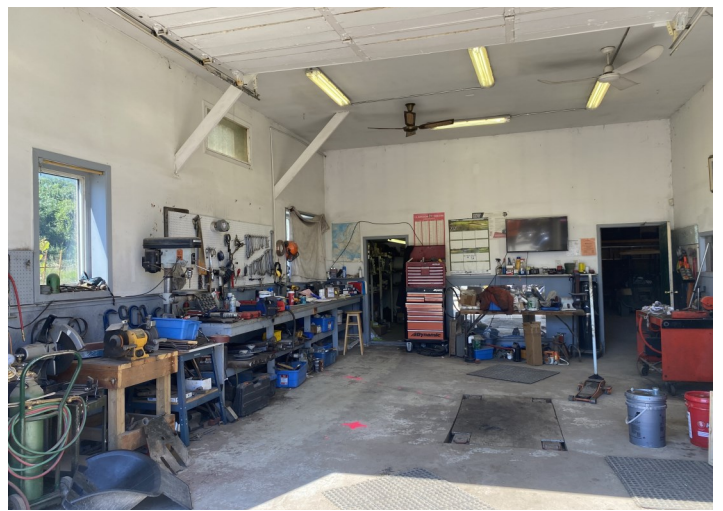
PHOTO 8: View of machine shop located within Site Building C.

CRITERION	SUMMARY OF DETAILS
OPERATIONS, INCLUDING PROCESSING OR MANUFACTURING	A portion of the Site was utilized as a maintenance shop. Operations within the Site Building included maintenance of equipment (golf carts, gators, industrial equipment utilized for grass cutting/maintenance).
STORAGE OR USE OF HAZARDOUS MATERIALS	<p>Information was not available at the time of the interview, however; at the time of the Site reconnaissance, EnVision personal noted:</p> <p>The following hazardous materials were stored within the shop area:</p> <ul style="list-style-type: none"> <li>• Approximately seven (7) 20 L pails of engine oil;</li> <li>• Approximately five (5) 20 L pails of hydraulic oil;</li> <li>• Approximately five (5) 20 L pails of diesel exhaust fluid;</li> <li>• Four (4) compress gas cylinders (acetylene and oxygen);</li> <li>• Approximately Five (5) 4 L bottles of degreaser; and</li> <li>• Approximately ten (10) cans of spray paint</li> </ul> <p>The following hazardous materials were stored within the chemical and pesticide storage sheds:</p> <ul style="list-style-type: none"> <li>• Approximately three (3) 113 L drums of revolution (plant growth);</li> <li>• Approximately ten (10) 4 L pails and three (3) 22 kg bags of fungicide;</li> <li>• Approximately three (3) 4 L bottles of GreenPig (pigment additive);</li> <li>• Approximately seventeen (17) 1 L bottles of Knockdown (antifoaming agent);</li> <li>• Approximately two (2) 1 L bottles of Inside-Out (spray tank cleaner);</li> <li>• Approximately two (2) 1 L bottles of Runway (turf marking foam);</li> <li>• Approximately five (5) 13 kg bags of granular insecticide;</li> <li>• Approximately ten (10) 400 g bottles of Pre-Strike (insect growth regulator);</li> <li>• Approximately two (2) 10 L bottles of turf herbicide;</li> <li>• Approximately three (3) 20 L bottles of Signal (blue spray pattern indicator);</li> <li>• A pallet of Grigg Garys Green Ultra (fertilizer);</li> <li>• Two (2) pallets of Agromart Magic Carpet Fertilizer;</li> <li>• A pallet of Plant Science Mineral Builder Homogeneous Fertilizer; and</li> </ul> <p>Three (3) 113 L drums of Grigg A-O-K Plus (fertilizer)</p>

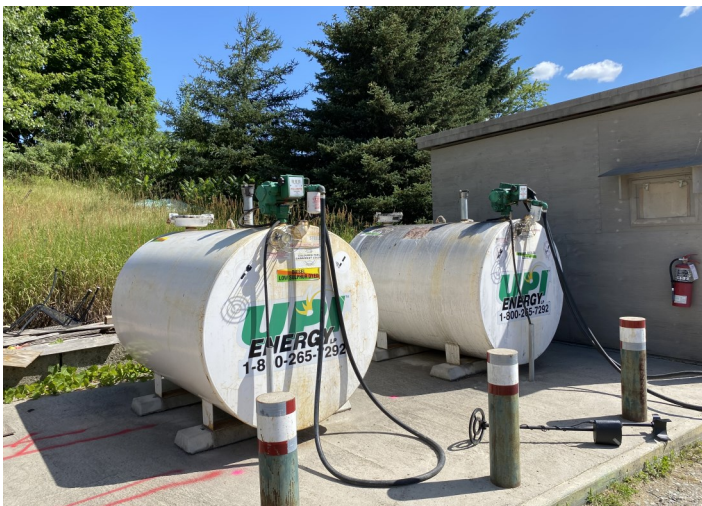
PHOTO 9: View of one (1) diesel and one (1) gasoline AST located adjacent to the east portion of Site Building C.

<b>EXTERIOR OBSERVATIONS</b>	AREAS OF STAINED SOIL, VEGETATION, OR PAVEMENT	Stained concrete blocks were observed north adjacent of the fueling ASTs located at Site Building C.
	AREAS OF STRESSED VEGETATION	There was no evidence of stressed vegetation observed.
	AREAS WHERE FILL AND DEBRIS MATERIALS HAVE BEEN PLACED OR GRADED	<p>Piles of sand, gravel, mulch, and soil were observed west of Site Building C. According to Mr. Frans, these piles are obtained from various companies (Growers Choice, Divot, James Dick) and are utilized to maintain the grounds of the golf course. These fill piles are not considered to contribute to an APEC at the Phase One Property</p> <p>Fill material of unknown environmental quality is anticipated to have been placed within the parking lot area of the Phase One Property.</p>
	POTENTIALLY CONTAMINATING ACTIVITY	<p>The following PCAs were identified on Site:</p> <ul style="list-style-type: none"> <li>• Site Building C operates as a garage for maintenance and repair of vehicles (golf carts, gators) (PCA 27).</li> <li>• A fuel-oil AST was located in the basement of Site Building B (PCA 28).</li> <li>• Two (2) gasoline and diesel ASTs were located adjacent to the eastern portion of Site Building C (PCA 28).</li> <li>• A fuel- oil AST was located in the basement of Site Building D (PCA 28).</li> <li>• Three (3) 205 L drums pails and six (6) 20 L pails containing waste motor oil waste were stored approximately 10 m east of Site Building C (PCA B); and</li> <li>• Fill material of unknown environmental quality is anticipated to have been placed within the parking lot area of the Phase One Property (PCA 30).</li> </ul>

DETAILS OF ALL SPILLS INCLUDING THE DATES, LOCATIONS, MATERIALS INVOLVED, AND VOLUMES OF MATERIAL SPILLED	Some staining was observed on concrete blocks north adjacent of the fueling ASTs located at Site Building C.
DETAILS OF LIQUID DISCHARGE POINTS SUCH AS WATER AND FRENCH DRAINS, INCLUDING THEIR LOCATIONS	No liquid discharge points were observed at the time of the site reconnaissance.
DETAILS OF OPERATIONS AT THE PROPERTY, INCLUDING PROCESSING OR MANUFACTURING AND EQUIPMENT USED IN PROCESSING OR MANUFACTURING	No processing or manufacturing of equipment was observed at the time of the site reconnaissance.

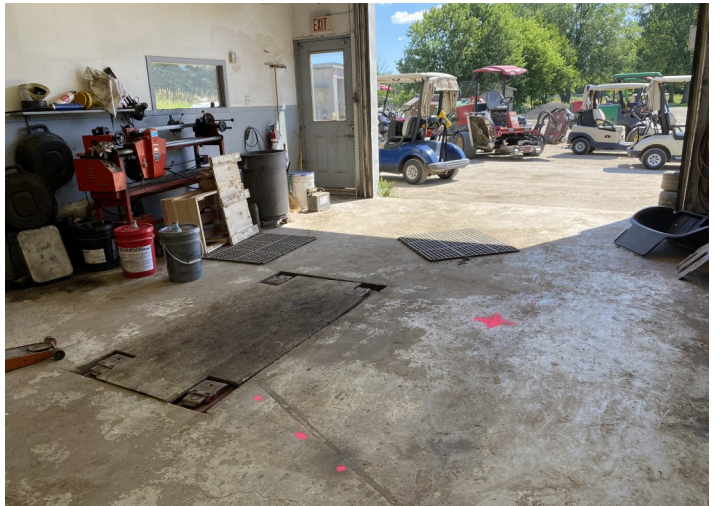
PHOTO 10: View a hydraulic lift located in Site Building C.

CRITERION	SUMMARY OF DETAILS
DETAILS OF ALL HYDRAULIC LIFT EQUIPMENT AT THE PROPERTY, INCLUDING ELEVATORS, IN-GROUND HOISTS AND LOADING DOCKS	One (1) hydraulic lift was located within Site Building C. No staining was observed in the vicinity of the hydraulic lift equipment and the concrete in the vicinity of the equipment was observed to be in good condition (i.e., no cracking or pitting).

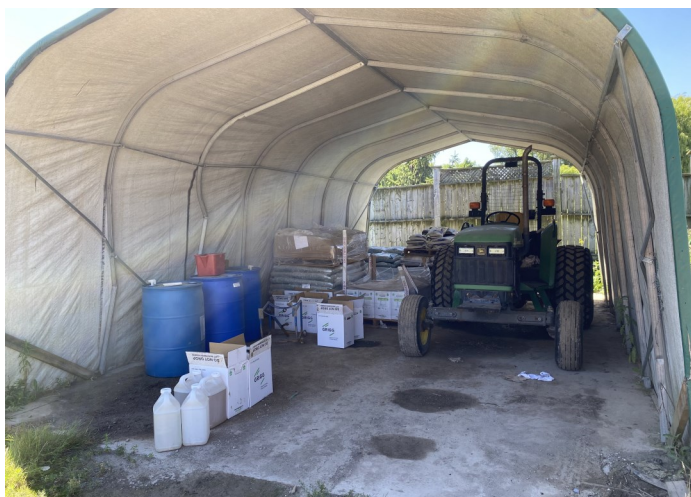
PHOTO 11: View of the pesticide shed located approximately 30 m east of Site Building C.

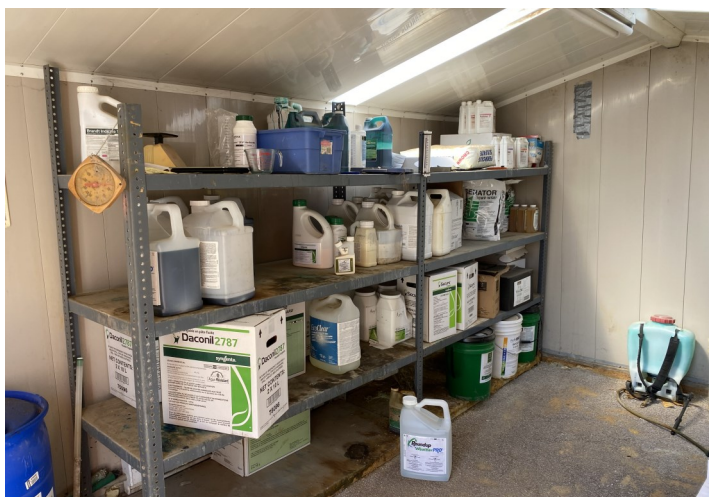
PHOTO 12: View of the interior of the chemical shed located approximately 15 m west of Site Building C.

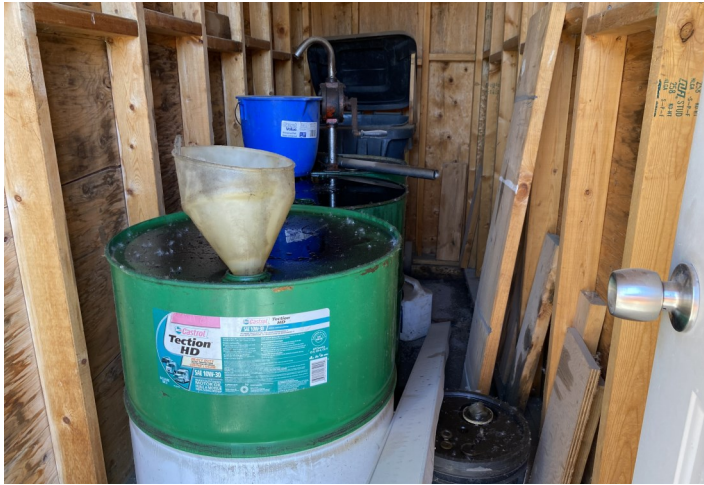
PHOTO 13: View of three (3) 205 L waste oil drums located 10 m east of Site Building C.

is associated with Trafalgar Golf and Country Club Ltd. (PCA 58) for the generation, use, and/or storage of petroleum distillates and waste crank oil & lubricants. During the site reconnaissance, three (3) 205 L waste oil drums and six (6) 20 L pails (PCA B) of oil were noted 10 m east of Site Building C;

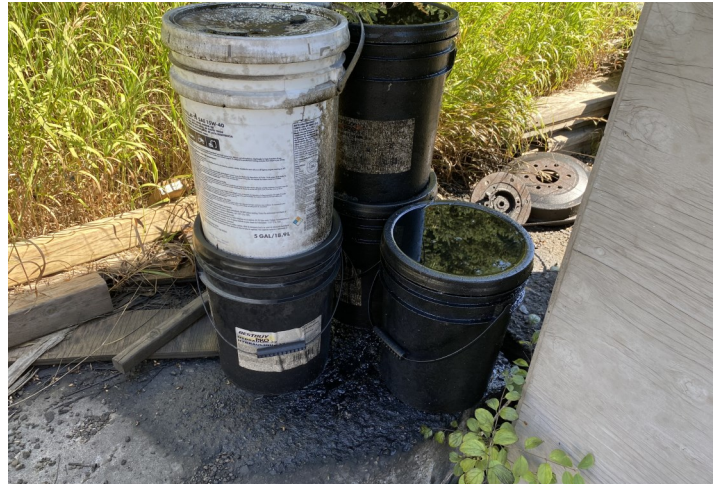
PHOTO 14: View of a gasoline spill located adjacent to the structure that houses the waste oil drums.

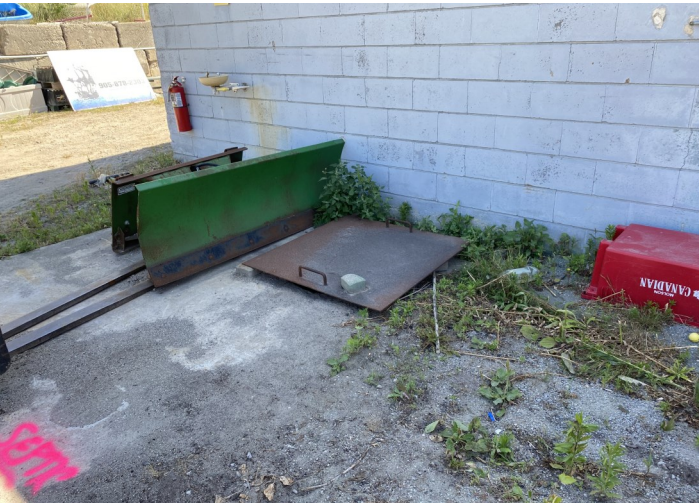
PHOTO 15: View of septic tank located adjacent to the west portion of Site Building C.

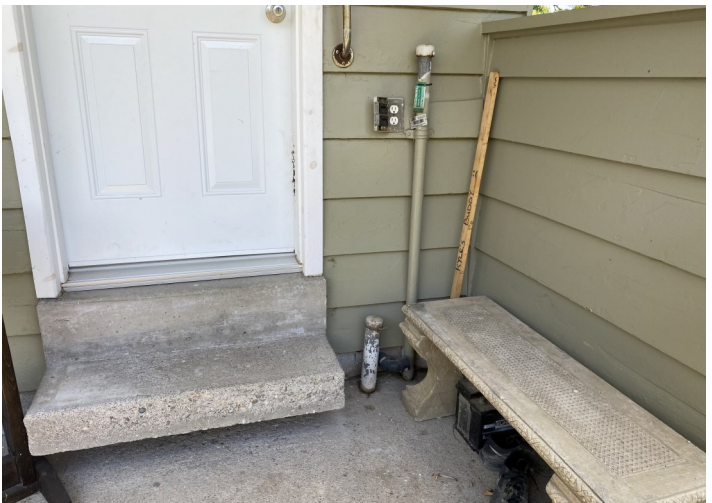
PHOTO 16: View of vent/fill pipes associated with a fuel oil AST at Site Building D.

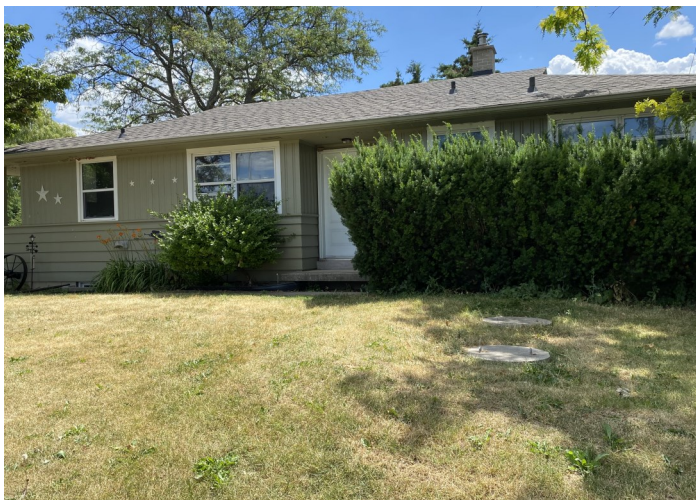
PHOTO 17: View of septic tanks located adjacent to the north portion of Site Building D.

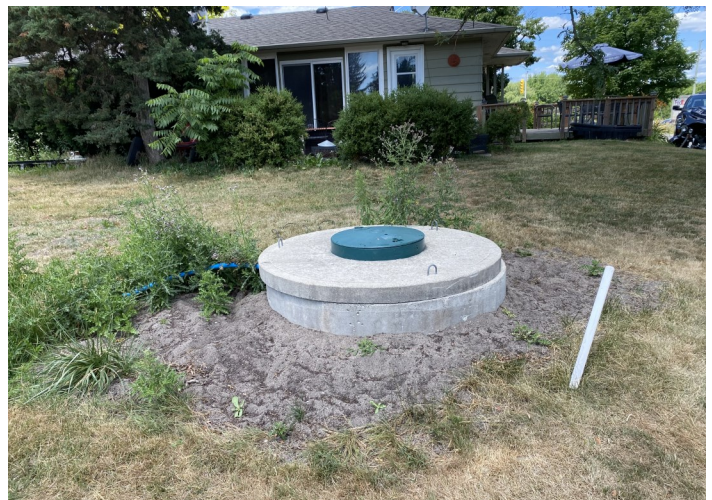
PHOTO 18: View of water well located 10 m south of Site Building D.

<b>CRITERION</b>	<b>SUMMARY OF SPECIFIC OBSERVATIONS</b>
<b>UTILITIES</b>	UNDERGROUND UTILITIES AND CORRIDORS	A water well is located south of Site Building D and supplies water to all on-Site Buildings. Three (3) septic systems are located east of Site Building B, west of Site Building C, and north of Site Building D. Underground hydro was noted to enter Site Buildings A through C from Sixth Line. Site Building D was serviced via overhead hydro. Underground communications were noted to enter Site Buildings A through D from Sixth Line. Propane gas was noted to enter Site Building A. Multiple catch basins were observed in the parking area along the western exterior of the building.
<b>INTERIOR OF STRUCTURES</b>	EXIT AND ENTRY POINTS	Site Building A: Various exit and entry points were located around the perimeter of the Site Building. Site Building B: Various exit and entry points were located around the perimeter of the Site Building. Site Building C: Two exit and entry doors were located on the eastern and western portions of the Site Building. Site Building D: Two exit and entry doors are located on the western and southern portions of the Site Building.
