August 3, 2023

File No. T7160125.003

## PHASE ONE ENVIRONMENTAL SITE ASSESSMENT UPDATE 1456 BRONTE STREET SOUTH, MILTON, ONTARIO

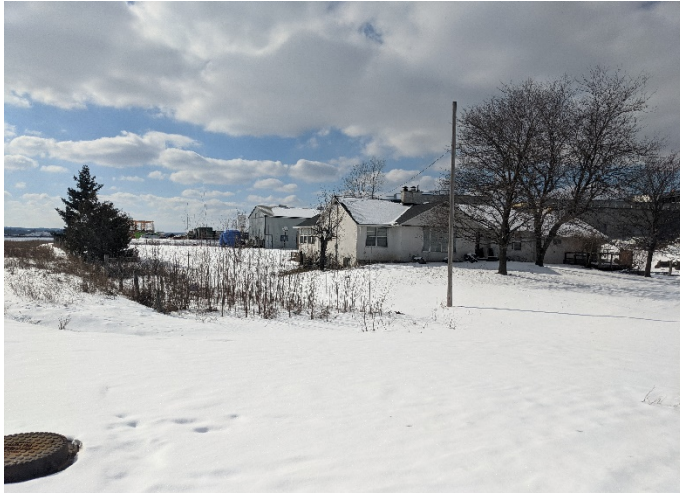
Photograph 1

Location: Phase One Property (1456 Bronte Street South)  
Viewing: Southwest  
Description: Viewing of the residential dwelling located on the Property

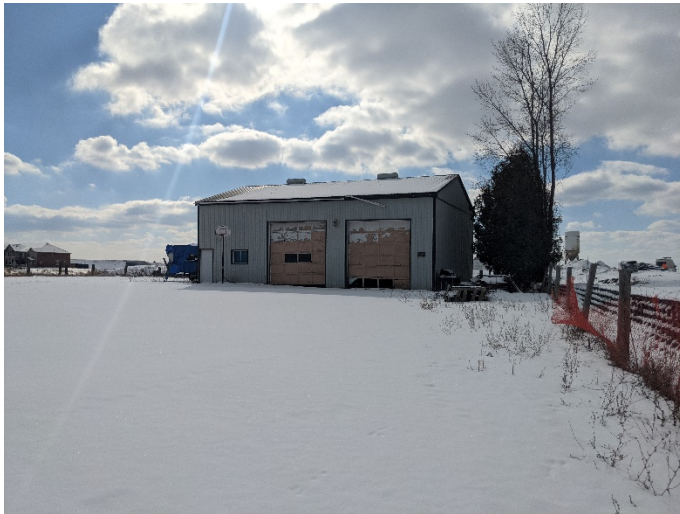
Photograph 2

Location: Phase One Property (1456 Bronte Street South)  
Viewing: South  
Description: Viewing the detached garage located on the Property

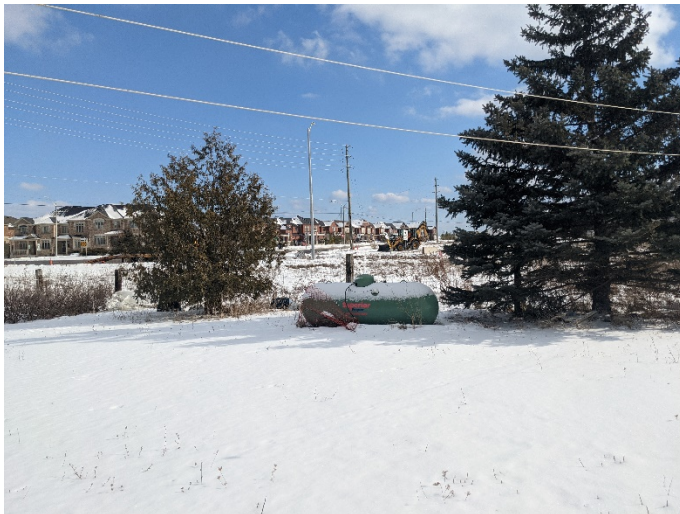
Photograph 3

Location: Phase One Property (1456 Bronte Street South)  
Viewing: East  
Description: Viewing of propane tank located on the east portion of the Property

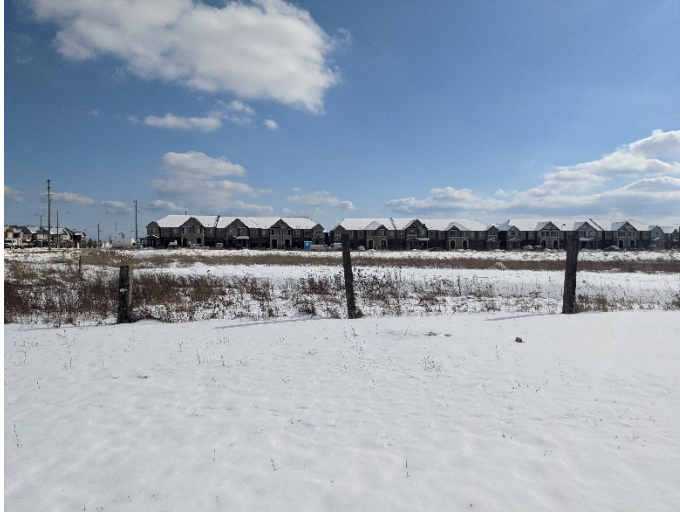
Photograph 4

Location: Phase One Study Area

Viewing: East

Description: Viewing the Adjacent Property to the east (undeveloped land with Residential Development beyond)

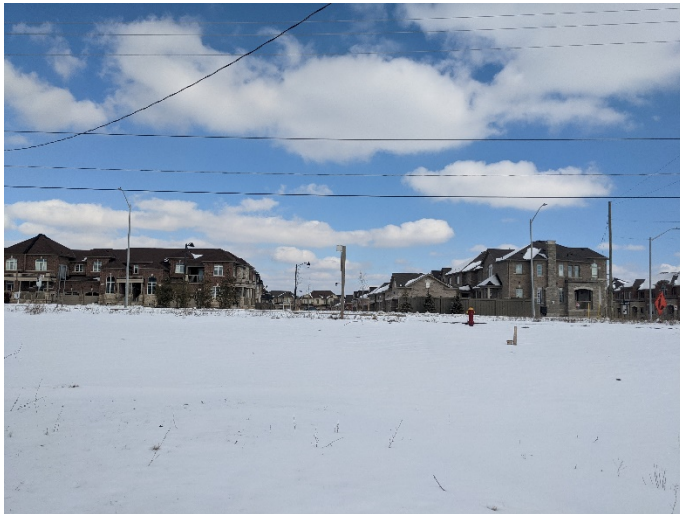
Photograph 5

Location: Phase One Study Area

Viewing: North

Description: Viewing the Adjacent Property to the north (Residential Development)

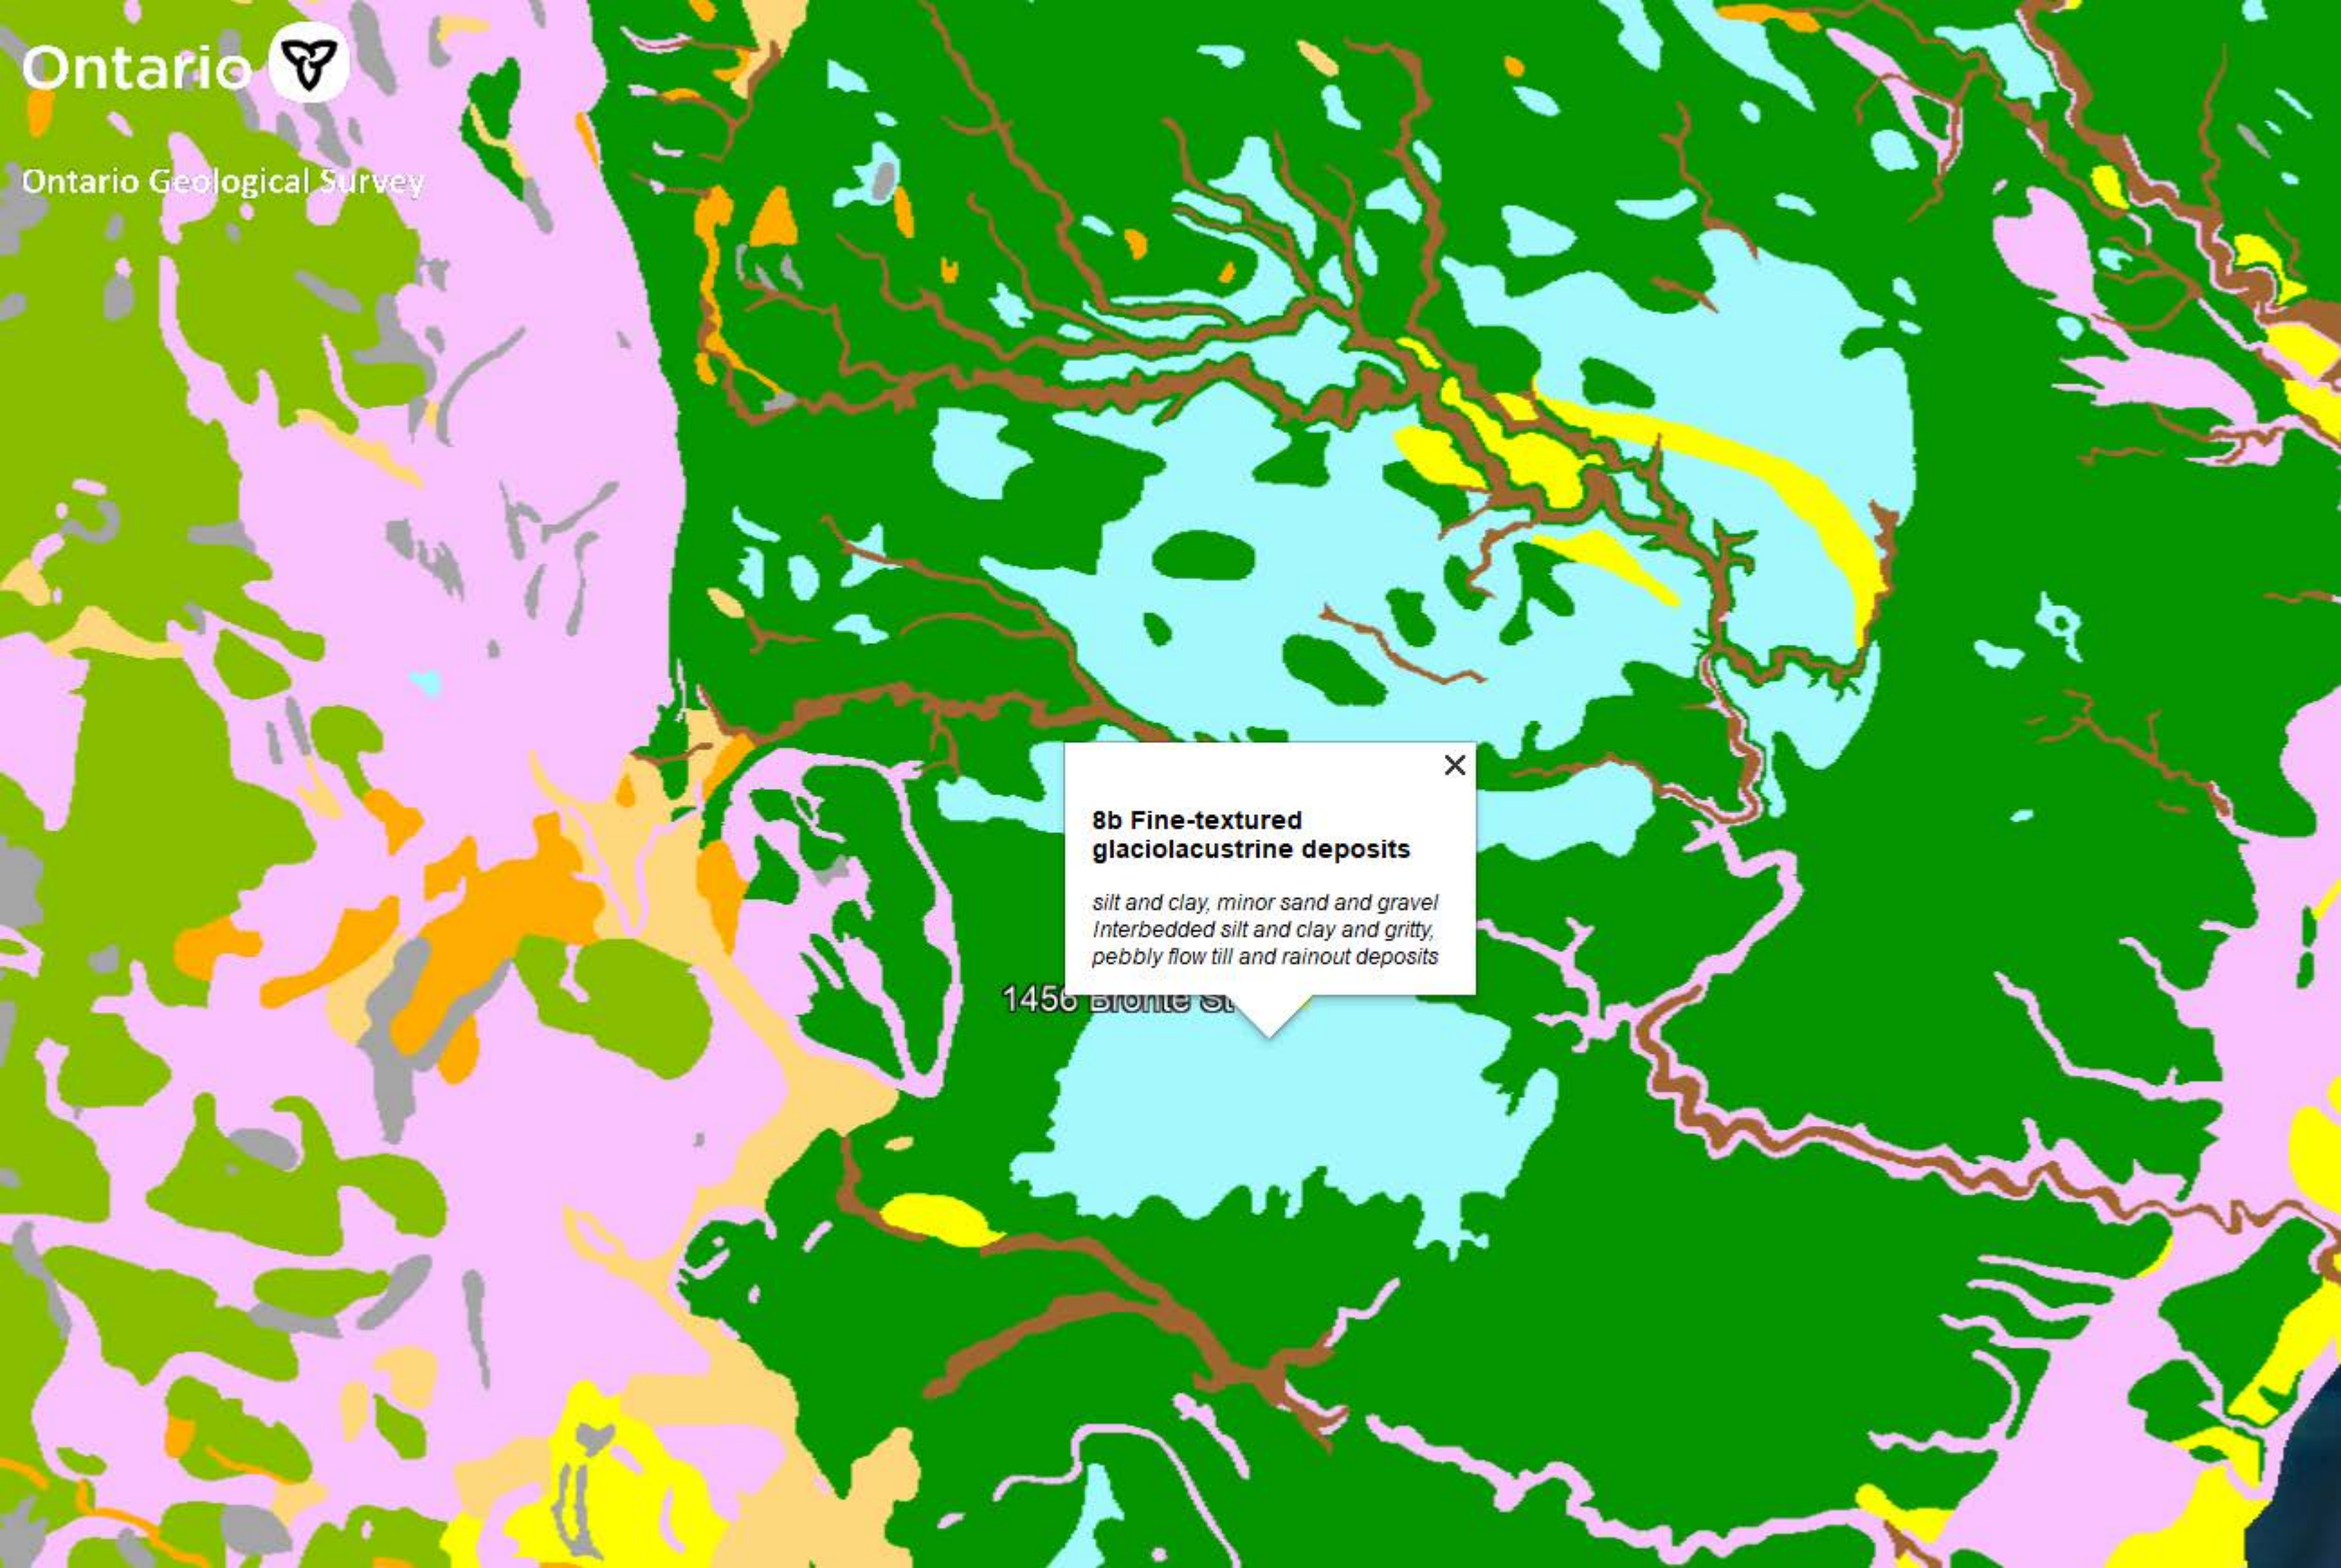
**8b Fine-textured  
glaciolacustrine deposits**

*silt and clay, minor sand and gravel  
Interbedded silt and clay and gritty,  
pebbly flow till and rainout deposits*

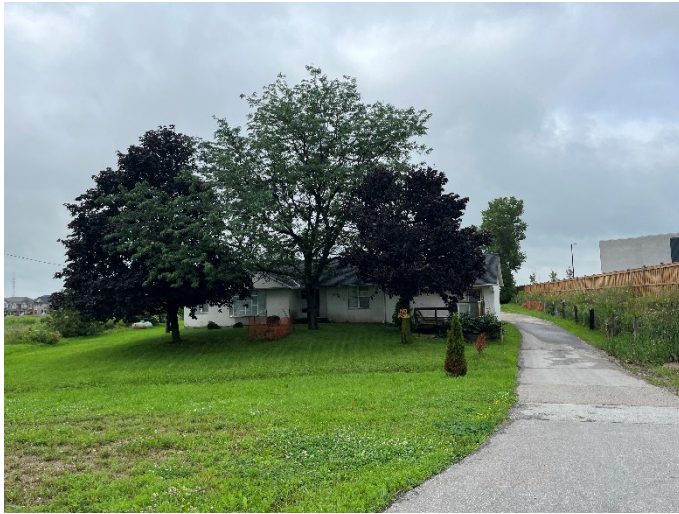
Photograph 1

Location: Phase One Property  
Viewing: Southwest  
Description: View of the one-storey dwelling located on the Property. At the time of the Site Reconnaissance the dwelling was used as a meeting place for AMJ members.

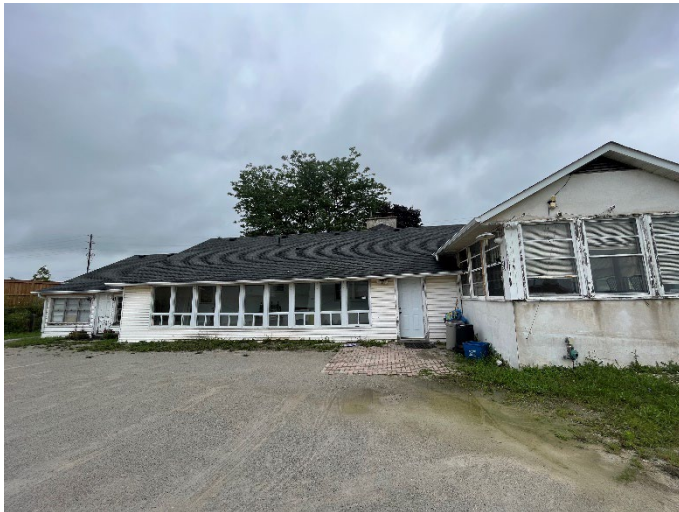
Photograph 2

Location: Phase One Property  
Viewing: Northeast  
Description: View of the rear of the dwelling and associated gravel parking area.

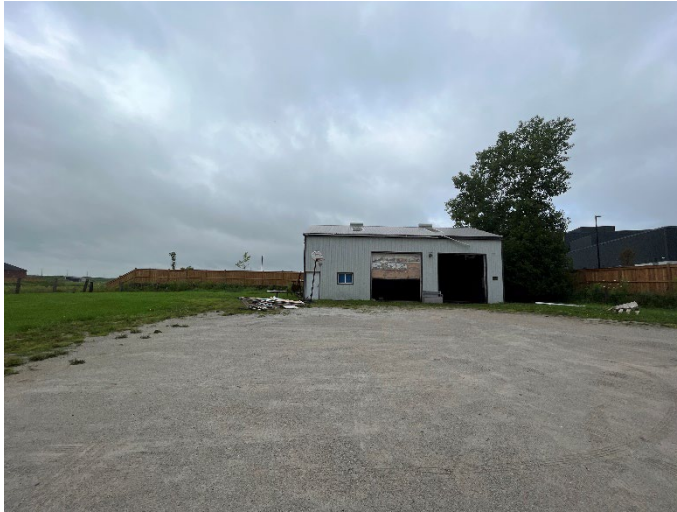
Photograph 4

Location: Phase One Property  
Viewing: Southwest  
Description: View of the garage located on the southwest portion of the Property. The garage was formerly used for gatherings, however at the time of the Site Reconnaissance it was in a state of disrepair.

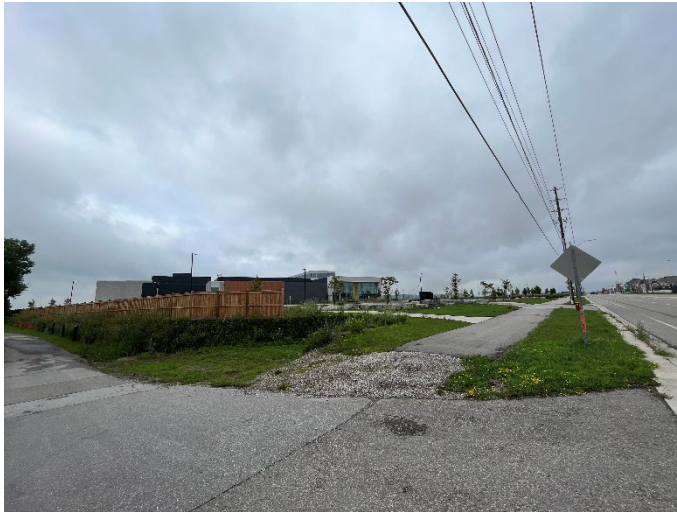
Photograph 5

Location: Southwest Adjacent Property  
Viewing: Southwest  
Description: View of the secondary school located immediately southwest of the Property.

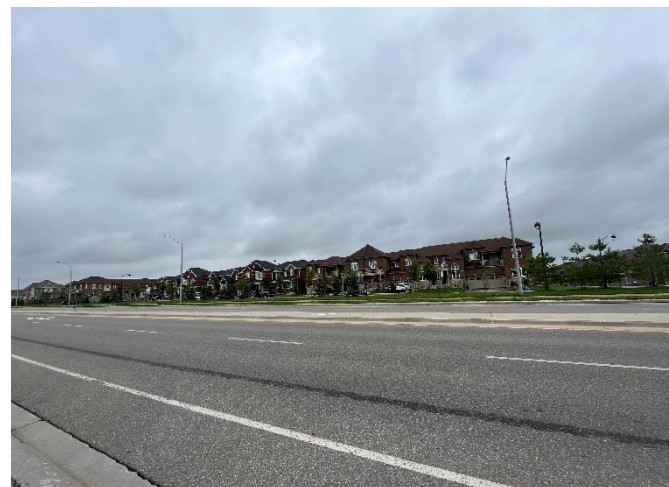
Photograph 6

Location: North of Phase One Property  
Viewing: Northwest  
Description: View of the residential subdivision located on the northeast side of Bronte Street South.
