**FUNCTIONAL SERVICING AND STORMWATER
MANAGEMENT REPORT**

150 Steeles Avenue East

Town of Milton

Project #: 21-678

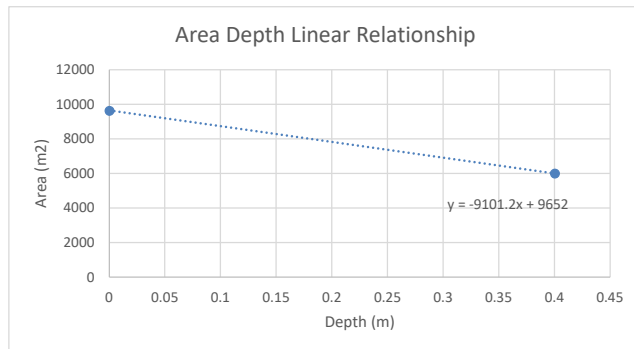
Pond area-depth relationship for linear regression:

Elevation (m)	Area (m ²)	Depth (m)
PERM POOL	201.70	5024	0.00
EXT DET	202.10	6012	0.40

The drawdown time for the Pond is 34.5 hours (1.4 days)
