# Scoped Environmental Impact Assessment

150 Steeles Avenue East,  
248, 250 & 314 Martin Street,  
Town of Milton

**Beacon Environmental Ltd.**

**2026-02-20**

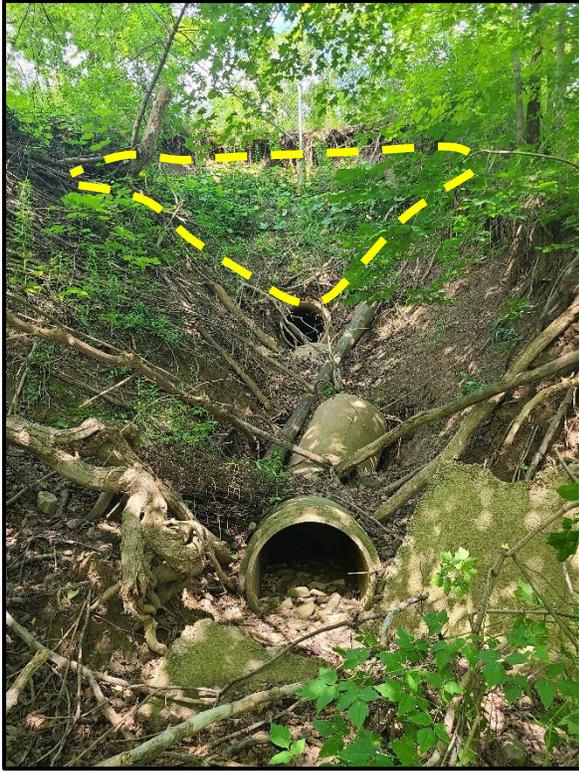
**Photograph 1. Mid- and Upper-Slope of Eroded Slope.** Upper eroded slope is indicated with yellow dashed line. Note the side slopes of this area are approximately  $\frac{3}{4}$  h:1 v. Photo facing north, taken July 18, 2023.

Opportunities to address the erosion as identified above were explored in the CEMS. It was determined that vegetating the area, to mitigate the erosion of soils was the best option that minimized impacts to the valleyland. This recommendation continues to be applicable, and a CH permit will be required for this work pursuant to O. Reg. 41/24.

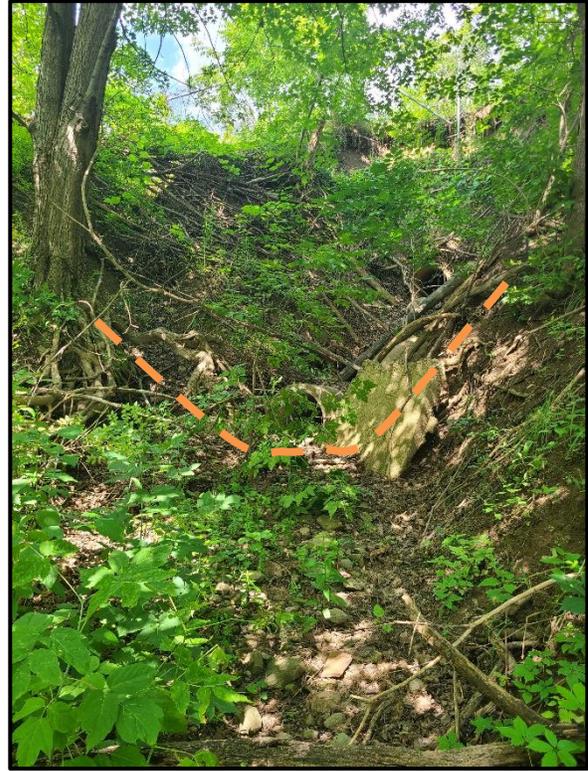
**Photograph 2. Lower Slope of Eroded Slope.** Boundary between mid- and lower-slope indicated with orange dashed line. Note the side slopes of this area are approximately  $\frac{3}{4}$  h:1 v. Photo facing north, taken July 18, 2023.

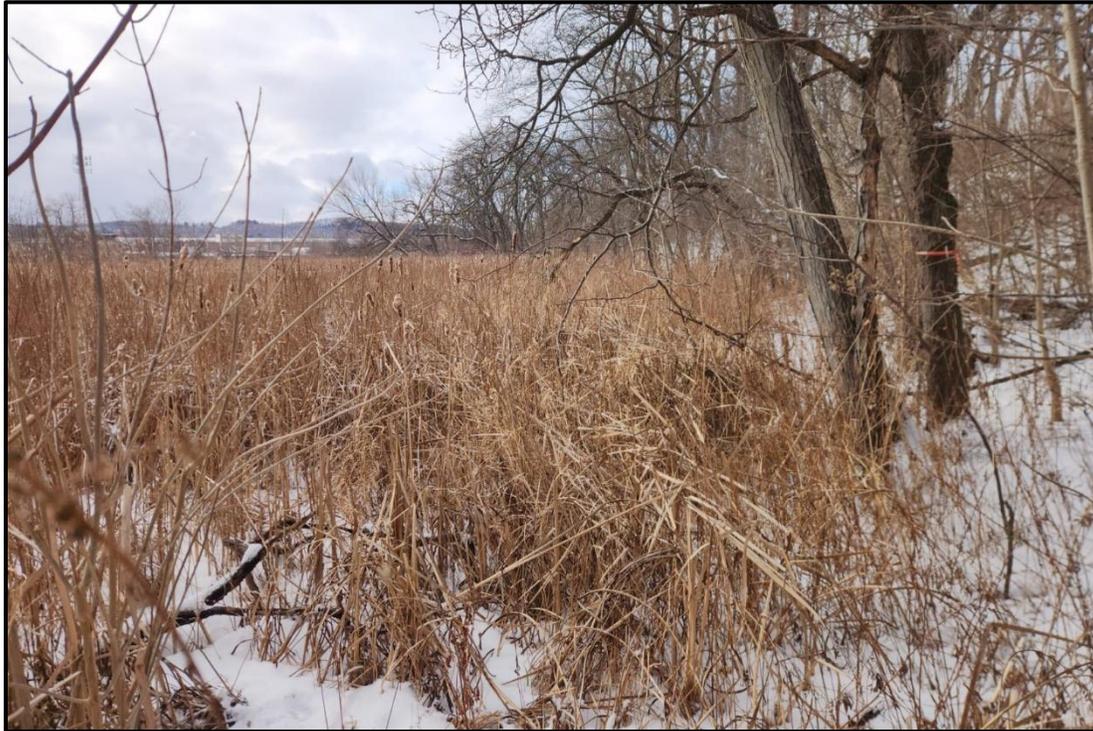
**Photograph 3. General area of proposed stormwater outlet (Alternative 1, Location B)  
January 29, 2025 (west-facing view)**

- B. An outlet at a longer distance between the SWM pond and the valley slope which would result in a longer length of pipe and a higher cost of horizontal boring, as compared to Outlet Location 1A, but would still provide sufficient grade differential to mitigate raising the existing grades on the tableland. With this outlet location, construction of the headwall would require no snags or trees greater than 15 cm DBH to be removed (**Photograph 3**).

Both outlet locations require a headwall with wingwalls and erosion protection at the edge of the wetland. Minor encroachment into the wetland would be required, resulting in a small loss of wetland soil and vegetation. The impact to the wetland for each outlet location is comparable.

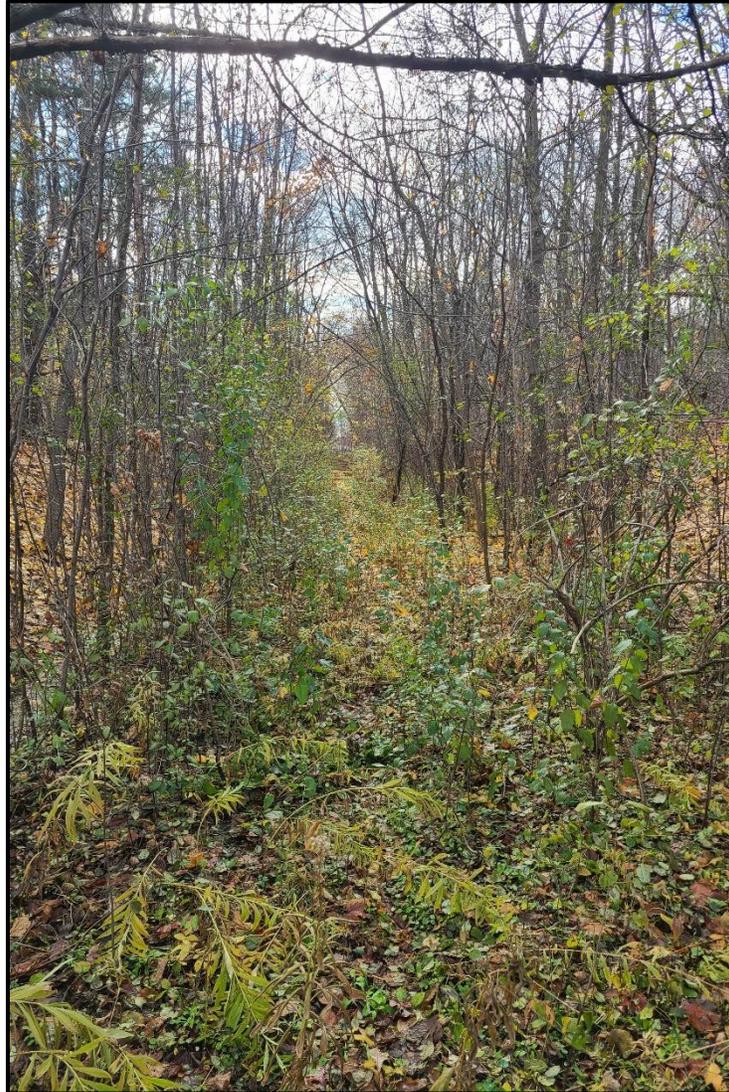
**Photograph 4. Former Rail Spur Line Populated with European Buckthorn (November 13, 2025)**

As noted earlier, the CEMS assumed that the future SWM pond would outlet to an existing swale along the former rail spur line at the eastern property limit (**Photograph 4**). However, through the detailed SWM pond design associated with the DPOS, it was determined that the grade differential to the existing swale was insufficient to accommodate the depth of the pond and associated gravity outlet. In order for the swale to be utilized for the SWM pond outlet, without changing the existing grades of the swale, the entire developed area would need to be raised by approximately 2 – 3 m. Although this option would result in no woodland or wetland removals, it was deemed to be unfeasible as the resultant grades would not be in-keeping with the adjacent, existing residential development along Martin Street.

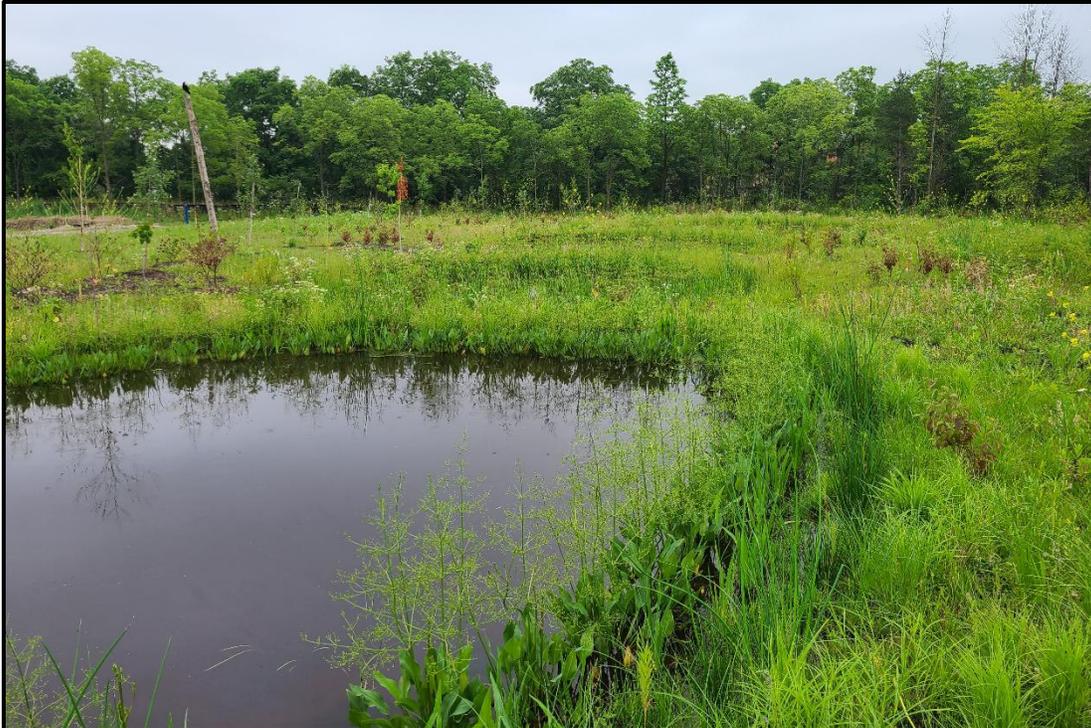
**Photograph 5. Wetland Restoration Area, July 15, 2024 (east-facing view)**

Restoration of the small tableland wetland and management of the adjacent population of invasive species was completed as of June 21, 2024, pursuant to drawings in **Appendices C1** and **C2**. This work has been completed as demonstrated by the Landscape Architect certification letter in **Appendix E**, Photographs 1, 2, and 3 in **Appendix F**, and **Photograph 5** below.

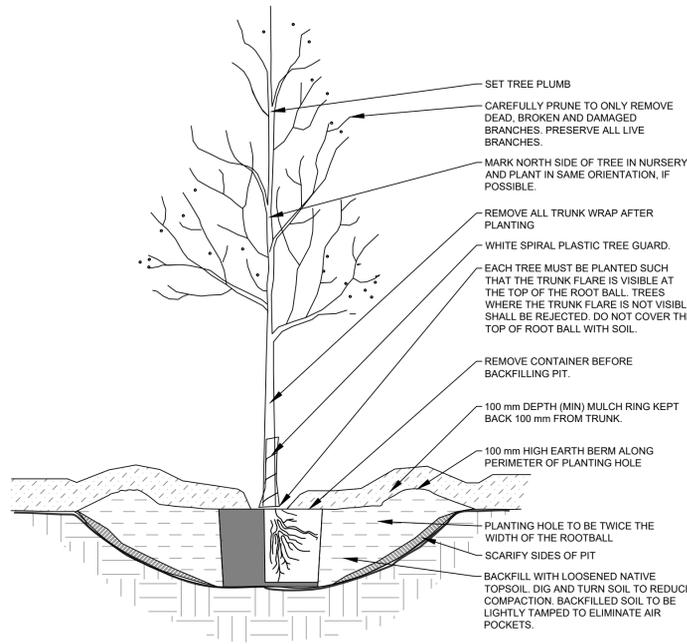
**1** DECIDUOUS TREE WHIP PLANTING DETAIL  
L-6 NTS

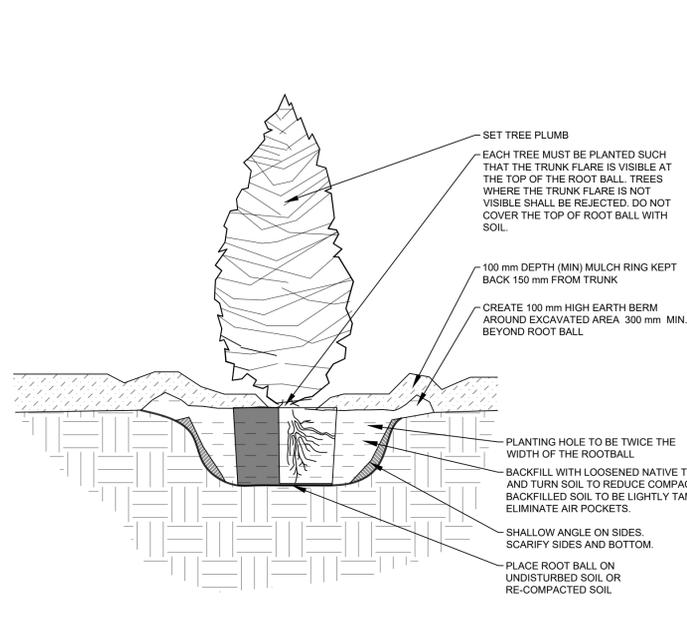
**2** CONIFEROUS PLANTING DETAIL  
L-6 NTS

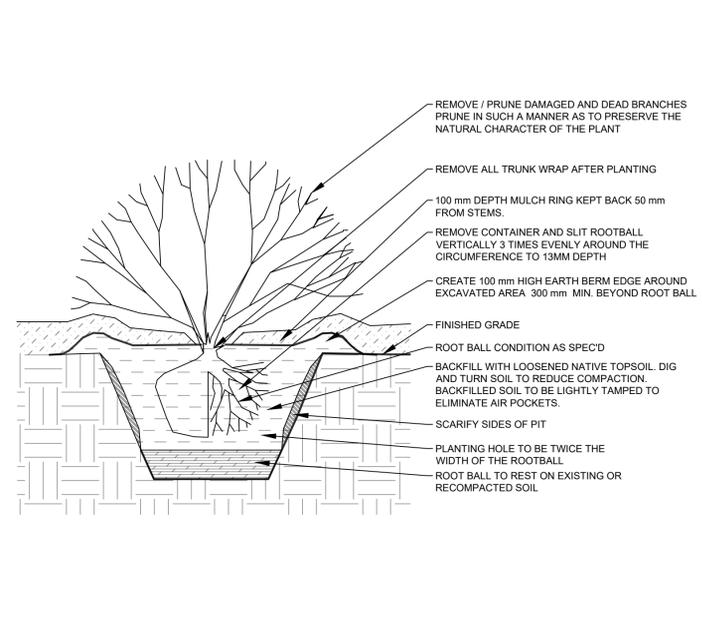
**3** DECIDUOUS SHRUB PLANTING DETAIL  
L-6 NTS

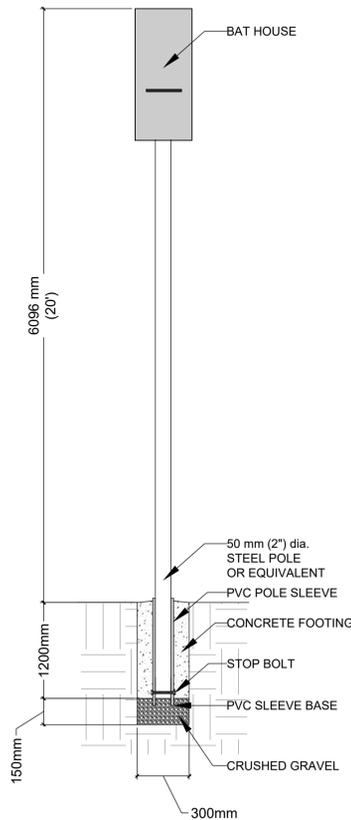
**2 BAT HOUSE POLE FOOTING DETAIL**  
 L-7 NTS

1. MINIMUM OF 6 HOURS OF DIRECT SUNLIGHT IS RECOMMENDED WITH UP TO 10 HOURS OF DIRECT SUNLIGHT BEING IDEAL.
2. POLES SHALL BE INSTALLED A MINIMUM OF 4 m AWAY FROM EXISTING AND PROPOSED TREES, IN ORDER TO MINIMIZE CHANCES OF PREDATION.
3. BAT HOUSES MUST BE INSTALLED 2-6 WEEKS PRIOR TO EVICTING BATS FROM NEARBY EXISTING STRUCTURES.
4. BAT HOUSES SHOULD BE INSTALLED IN FALL, WINTER OR EARLY SPRING, PRIOR TO THE SUMMER IN WHICH YOU INTEND THE BATS TO MOVE IN.
5. A METAL POLE SHALL BE USED IN ORDER TO DETER PREDATORS FROM REACHING THE BAT HOUSE.
6. THE HOLE DUG FOR THE POST FOOTING SHOULD BE AT LEAST 1350 mm (53") DEEP, BY 300 mm (12") WIDE. THE BOTTOM 150 mm (6") SHOULD BE FILLED WITH CRUSHED GRAVEL.

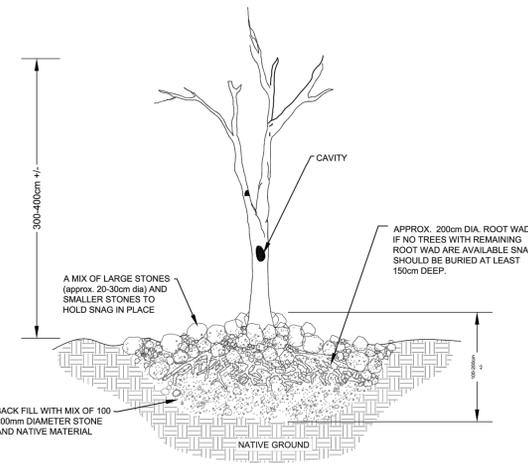
**3 SNAG DETAIL**  
 L-7 NTS

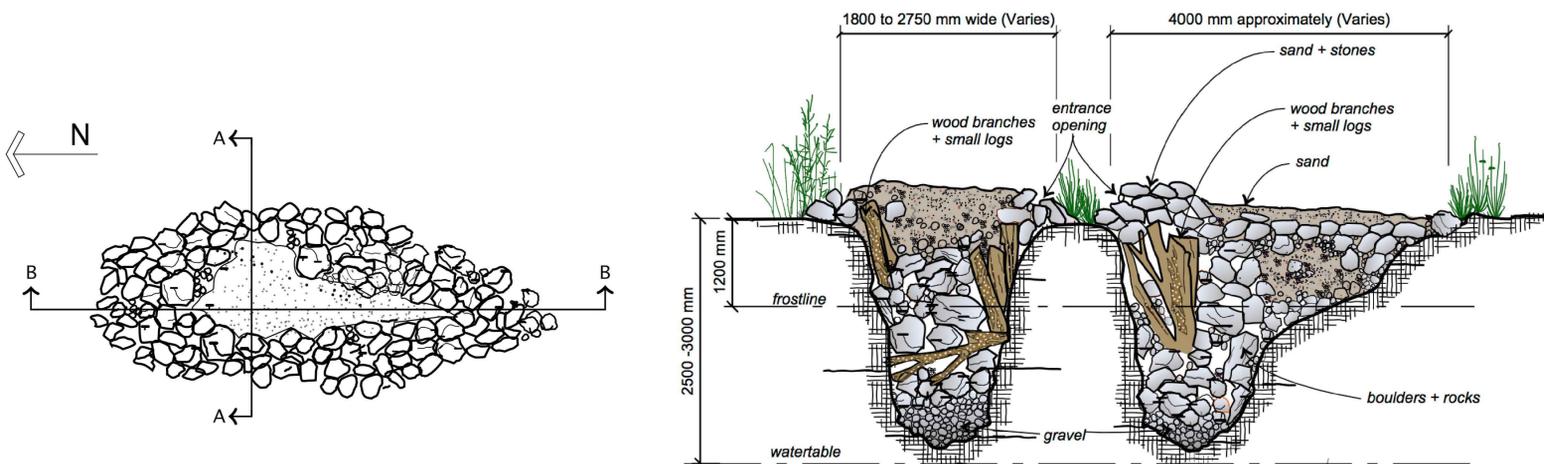
**4 SNAKE HIBERNACULUM DETAIL**  
 L-7 NTS

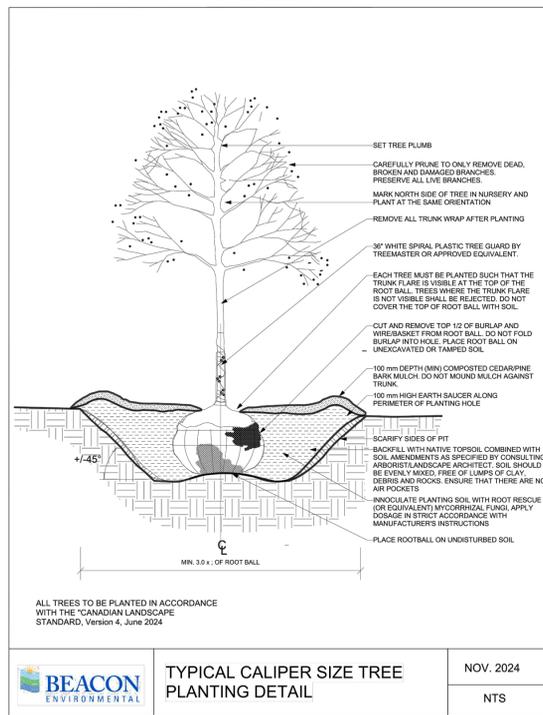
BEACON ENVIRONMENTAL  
TYPICAL CALIPER SIZE TREE PLANTING DETAIL  
NOV. 2024  
NTS

1 CALIPER DECIDUOUS TREE  
L-5 NTS

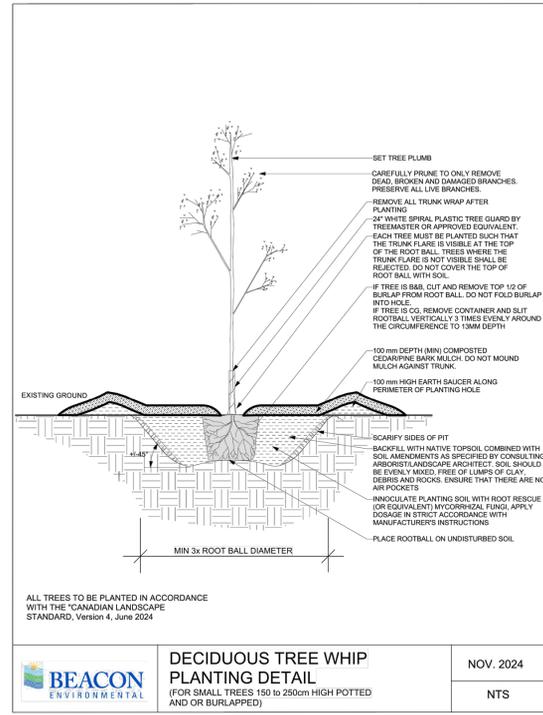
BEACON ENVIRONMENTAL  
DECIDUOUS TREE WHIP PLANTING DETAIL (FOR SMALL TREES 150 TO 250cm HIGH POTTED AND OR BURLAPPED)  
NOV. 2024  
NTS

2 DECIDUOUS TREE WHIP  
L-5 NTS

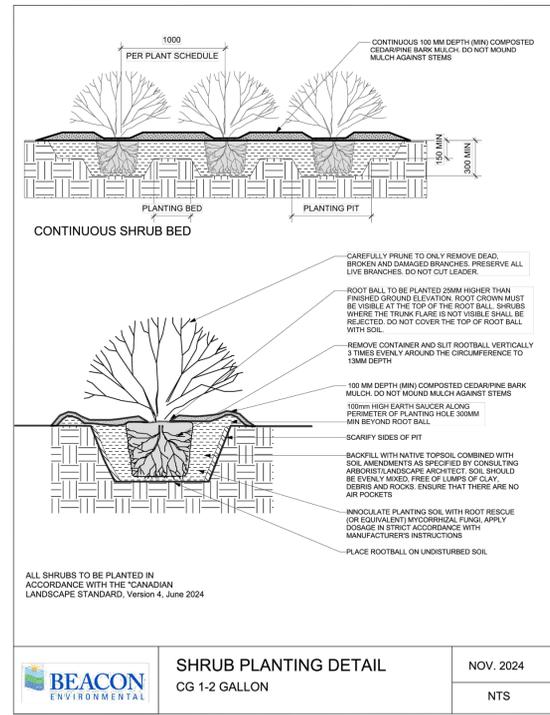
BEACON ENVIRONMENTAL  
SHRUB PLANTING DETAIL  
CG 1-2 GALLON  
NOV. 2024  
NTS

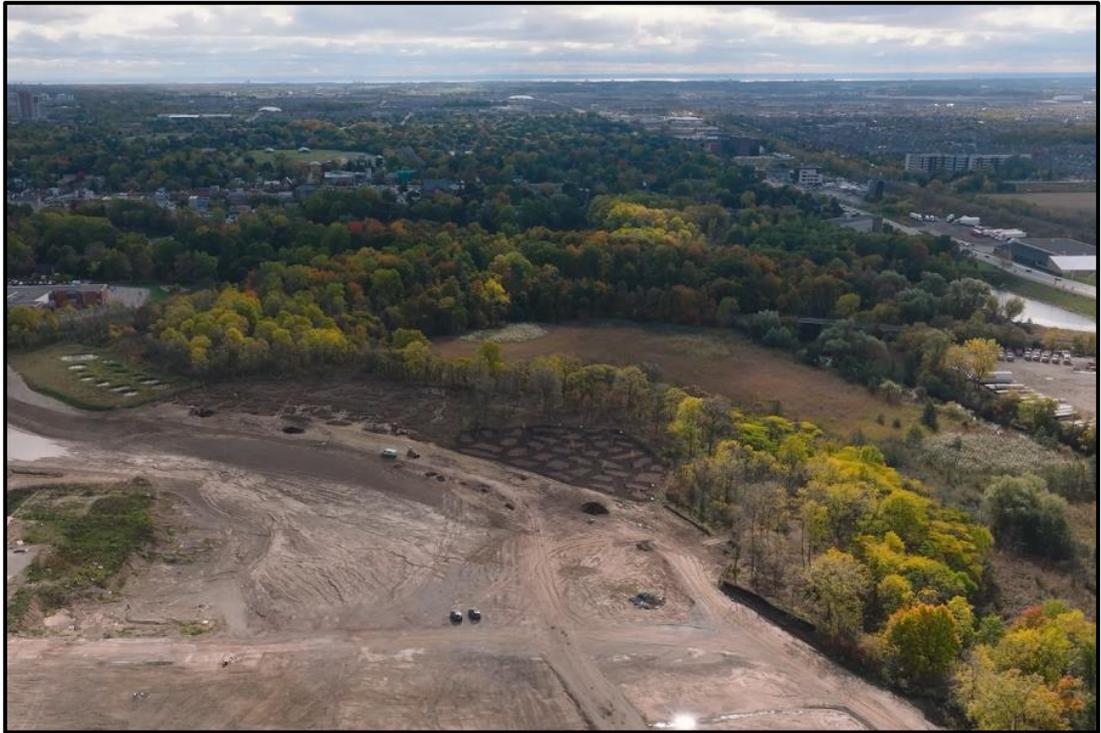
**Photograph 1. NHS Restoration and Adjacent NHS, South-Facing View (Oct 16, 2024).**

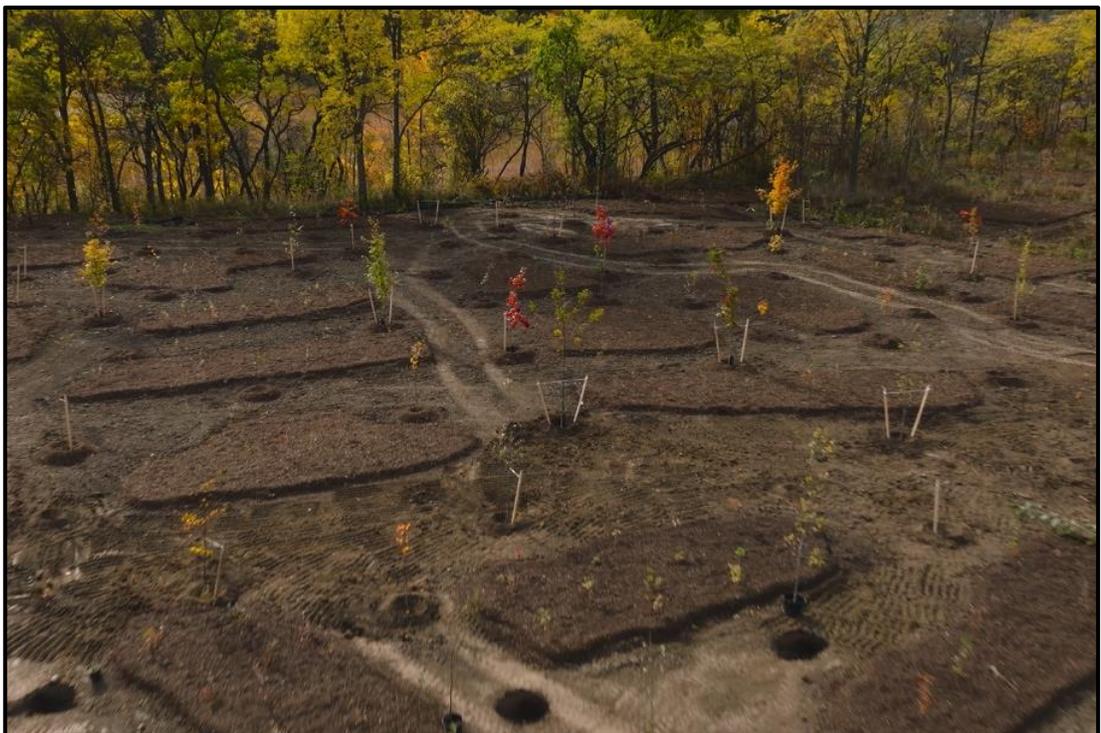
**Photograph 4. Eastern Portion of Woodland Restoration. Note photo predates topsoiling.**
