HYDROGEOLOGICAL ASSESSMENT

**Britannia Road and Bronte Street
South | Milton, Ontario**

Grounded Engineering Inc.
File No. 20-294 (Rev 8)
Issued February 24, 2026

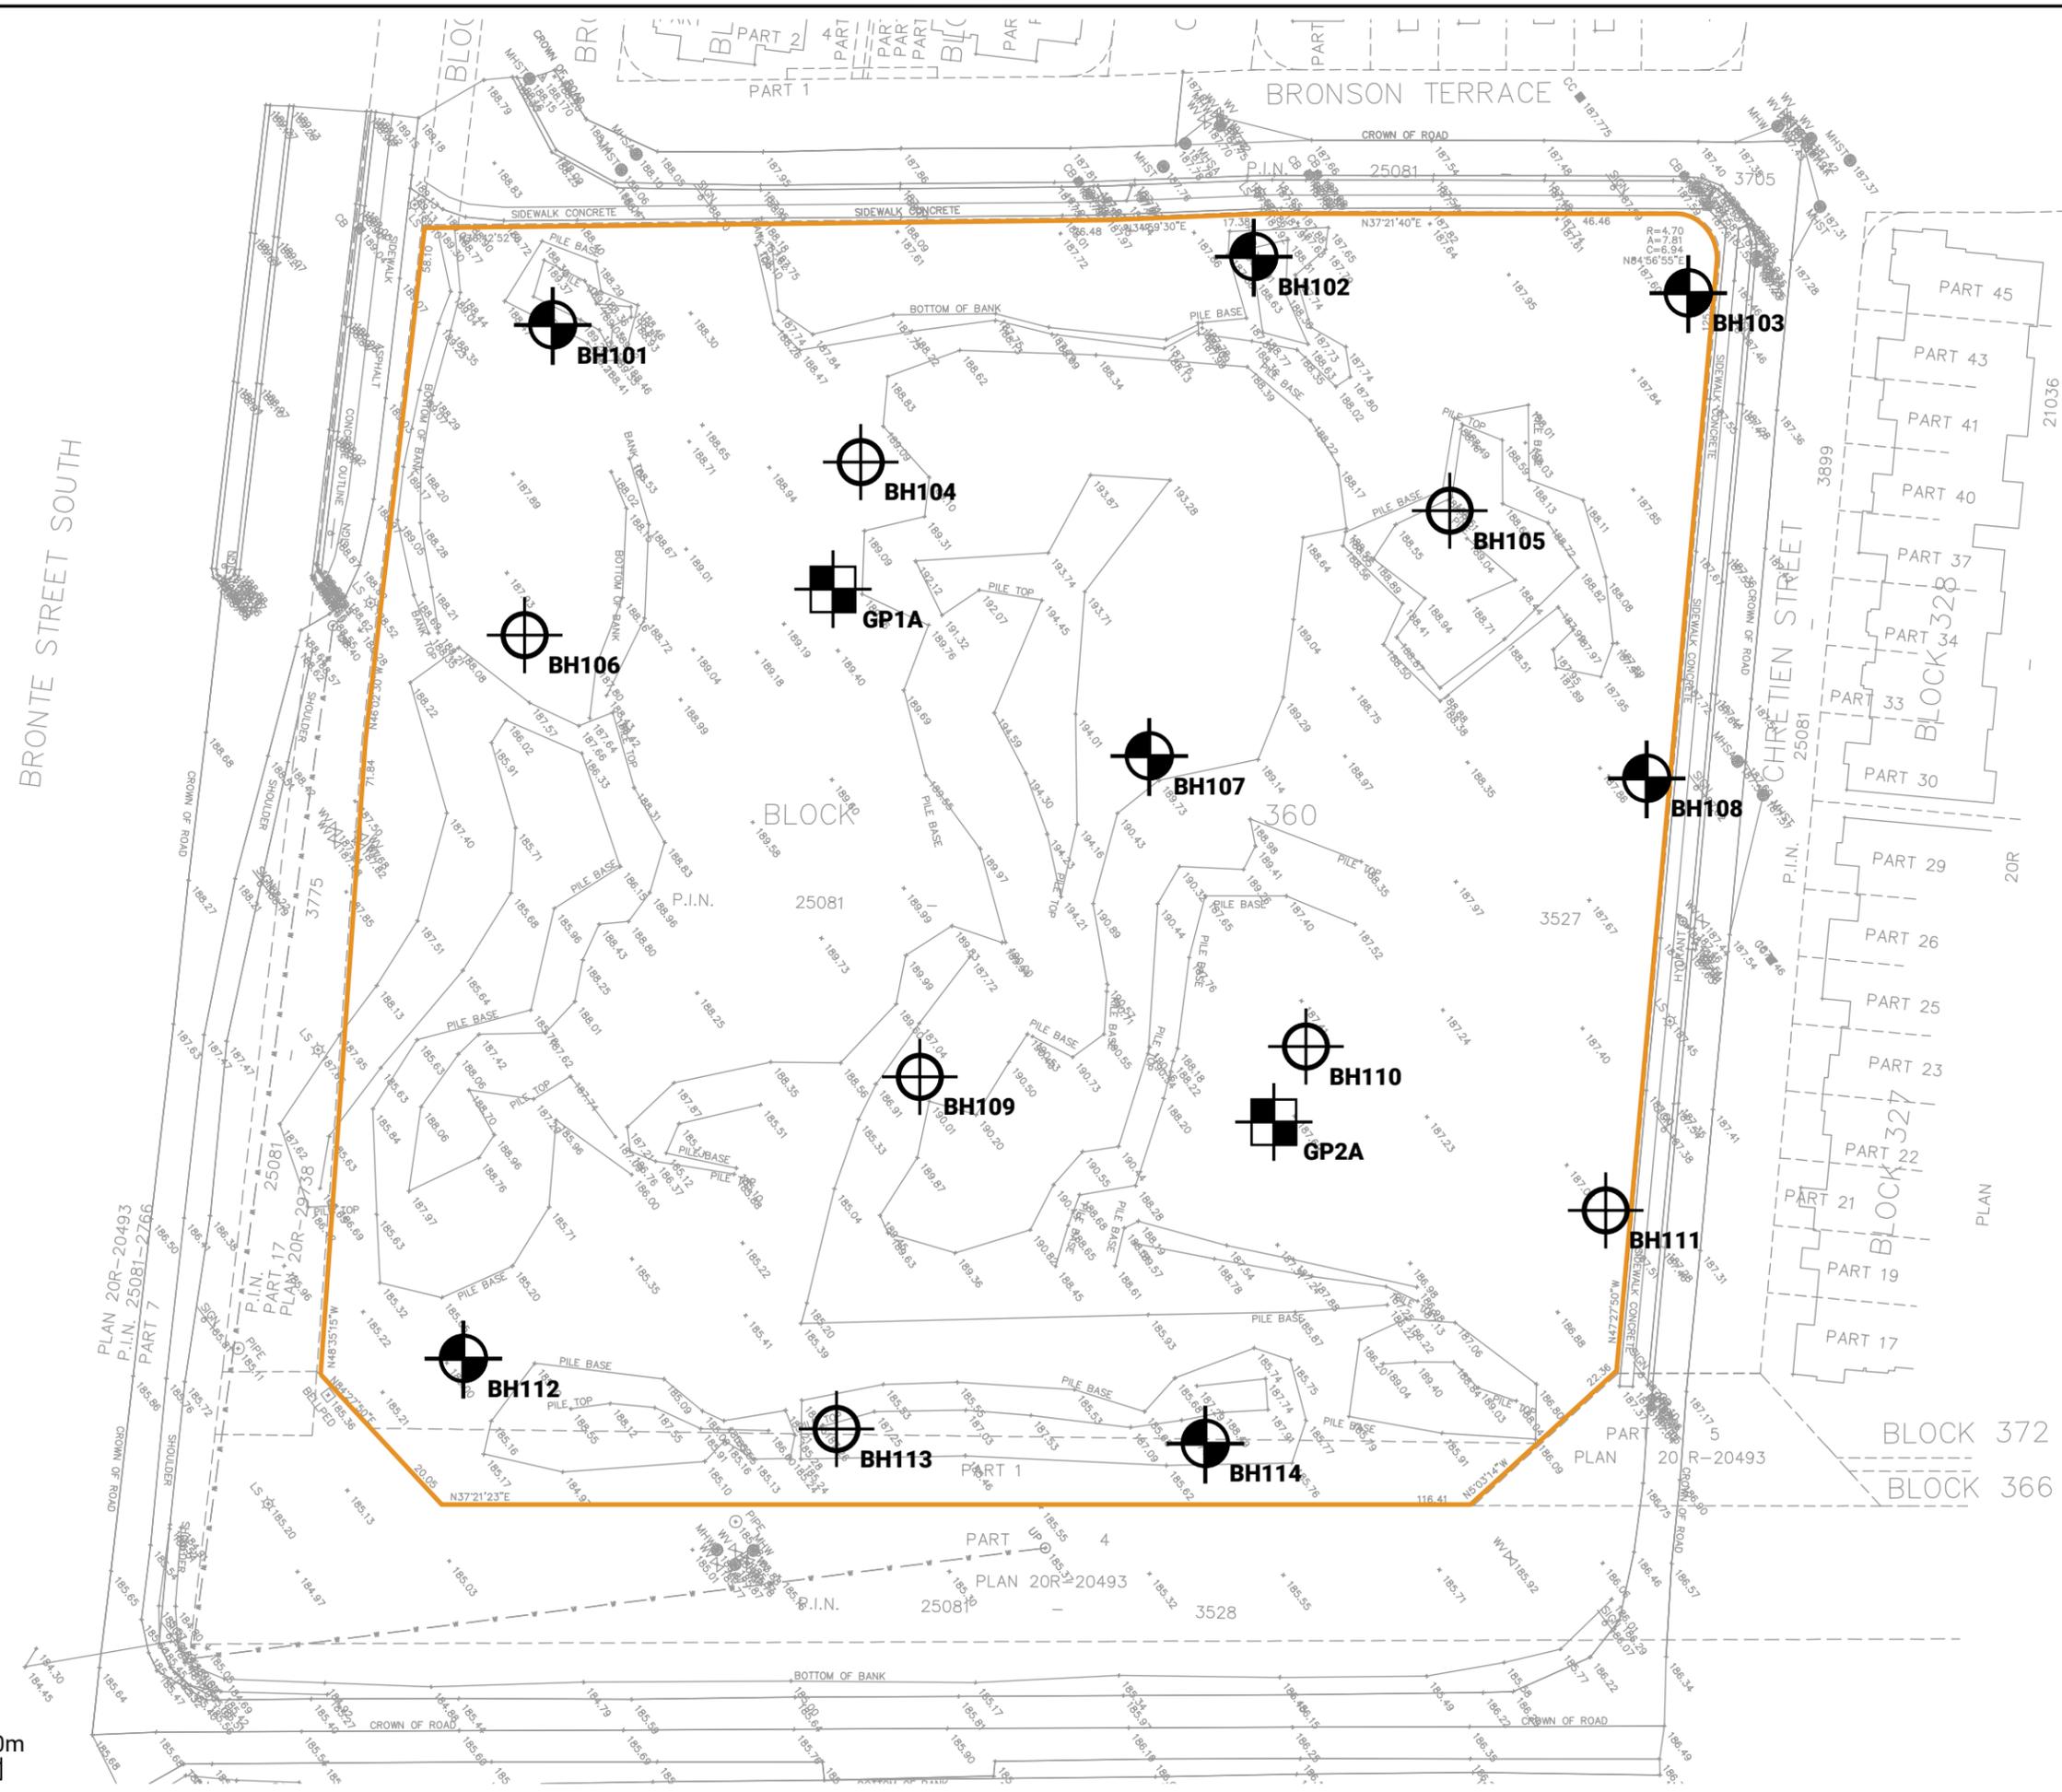
Figure No
FIGURE 2B

Figure Title
BOREHOLE AND MONITORING WELL LOCATION PLAN PROPOSED CONDITIONS (SITE PLAN)

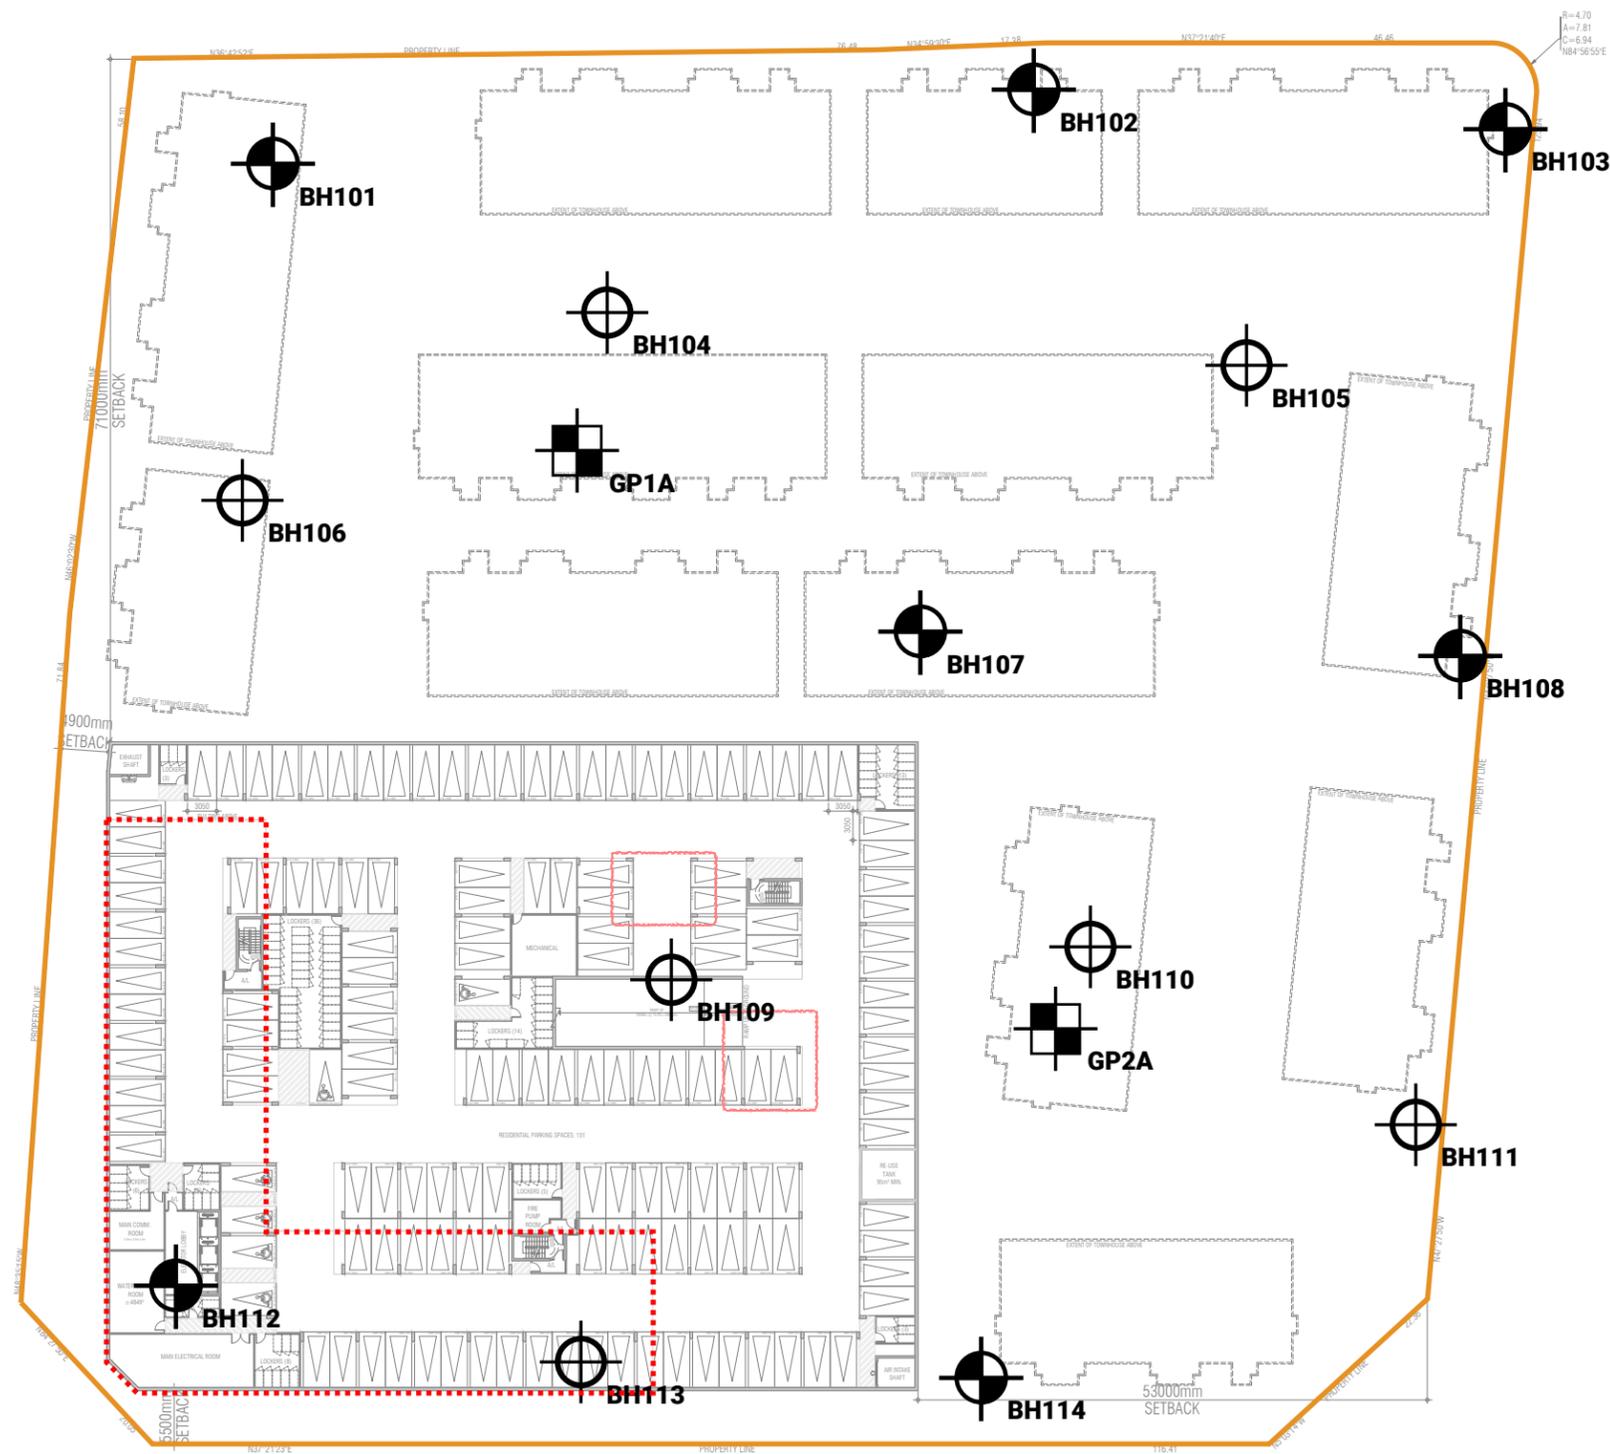
Figure No
FIGURE 2C

Figure Title
**BOREHOLE AND MONITORING
WELL LOCATION PLAN
PROPOSED CONDITIONS (P1)**

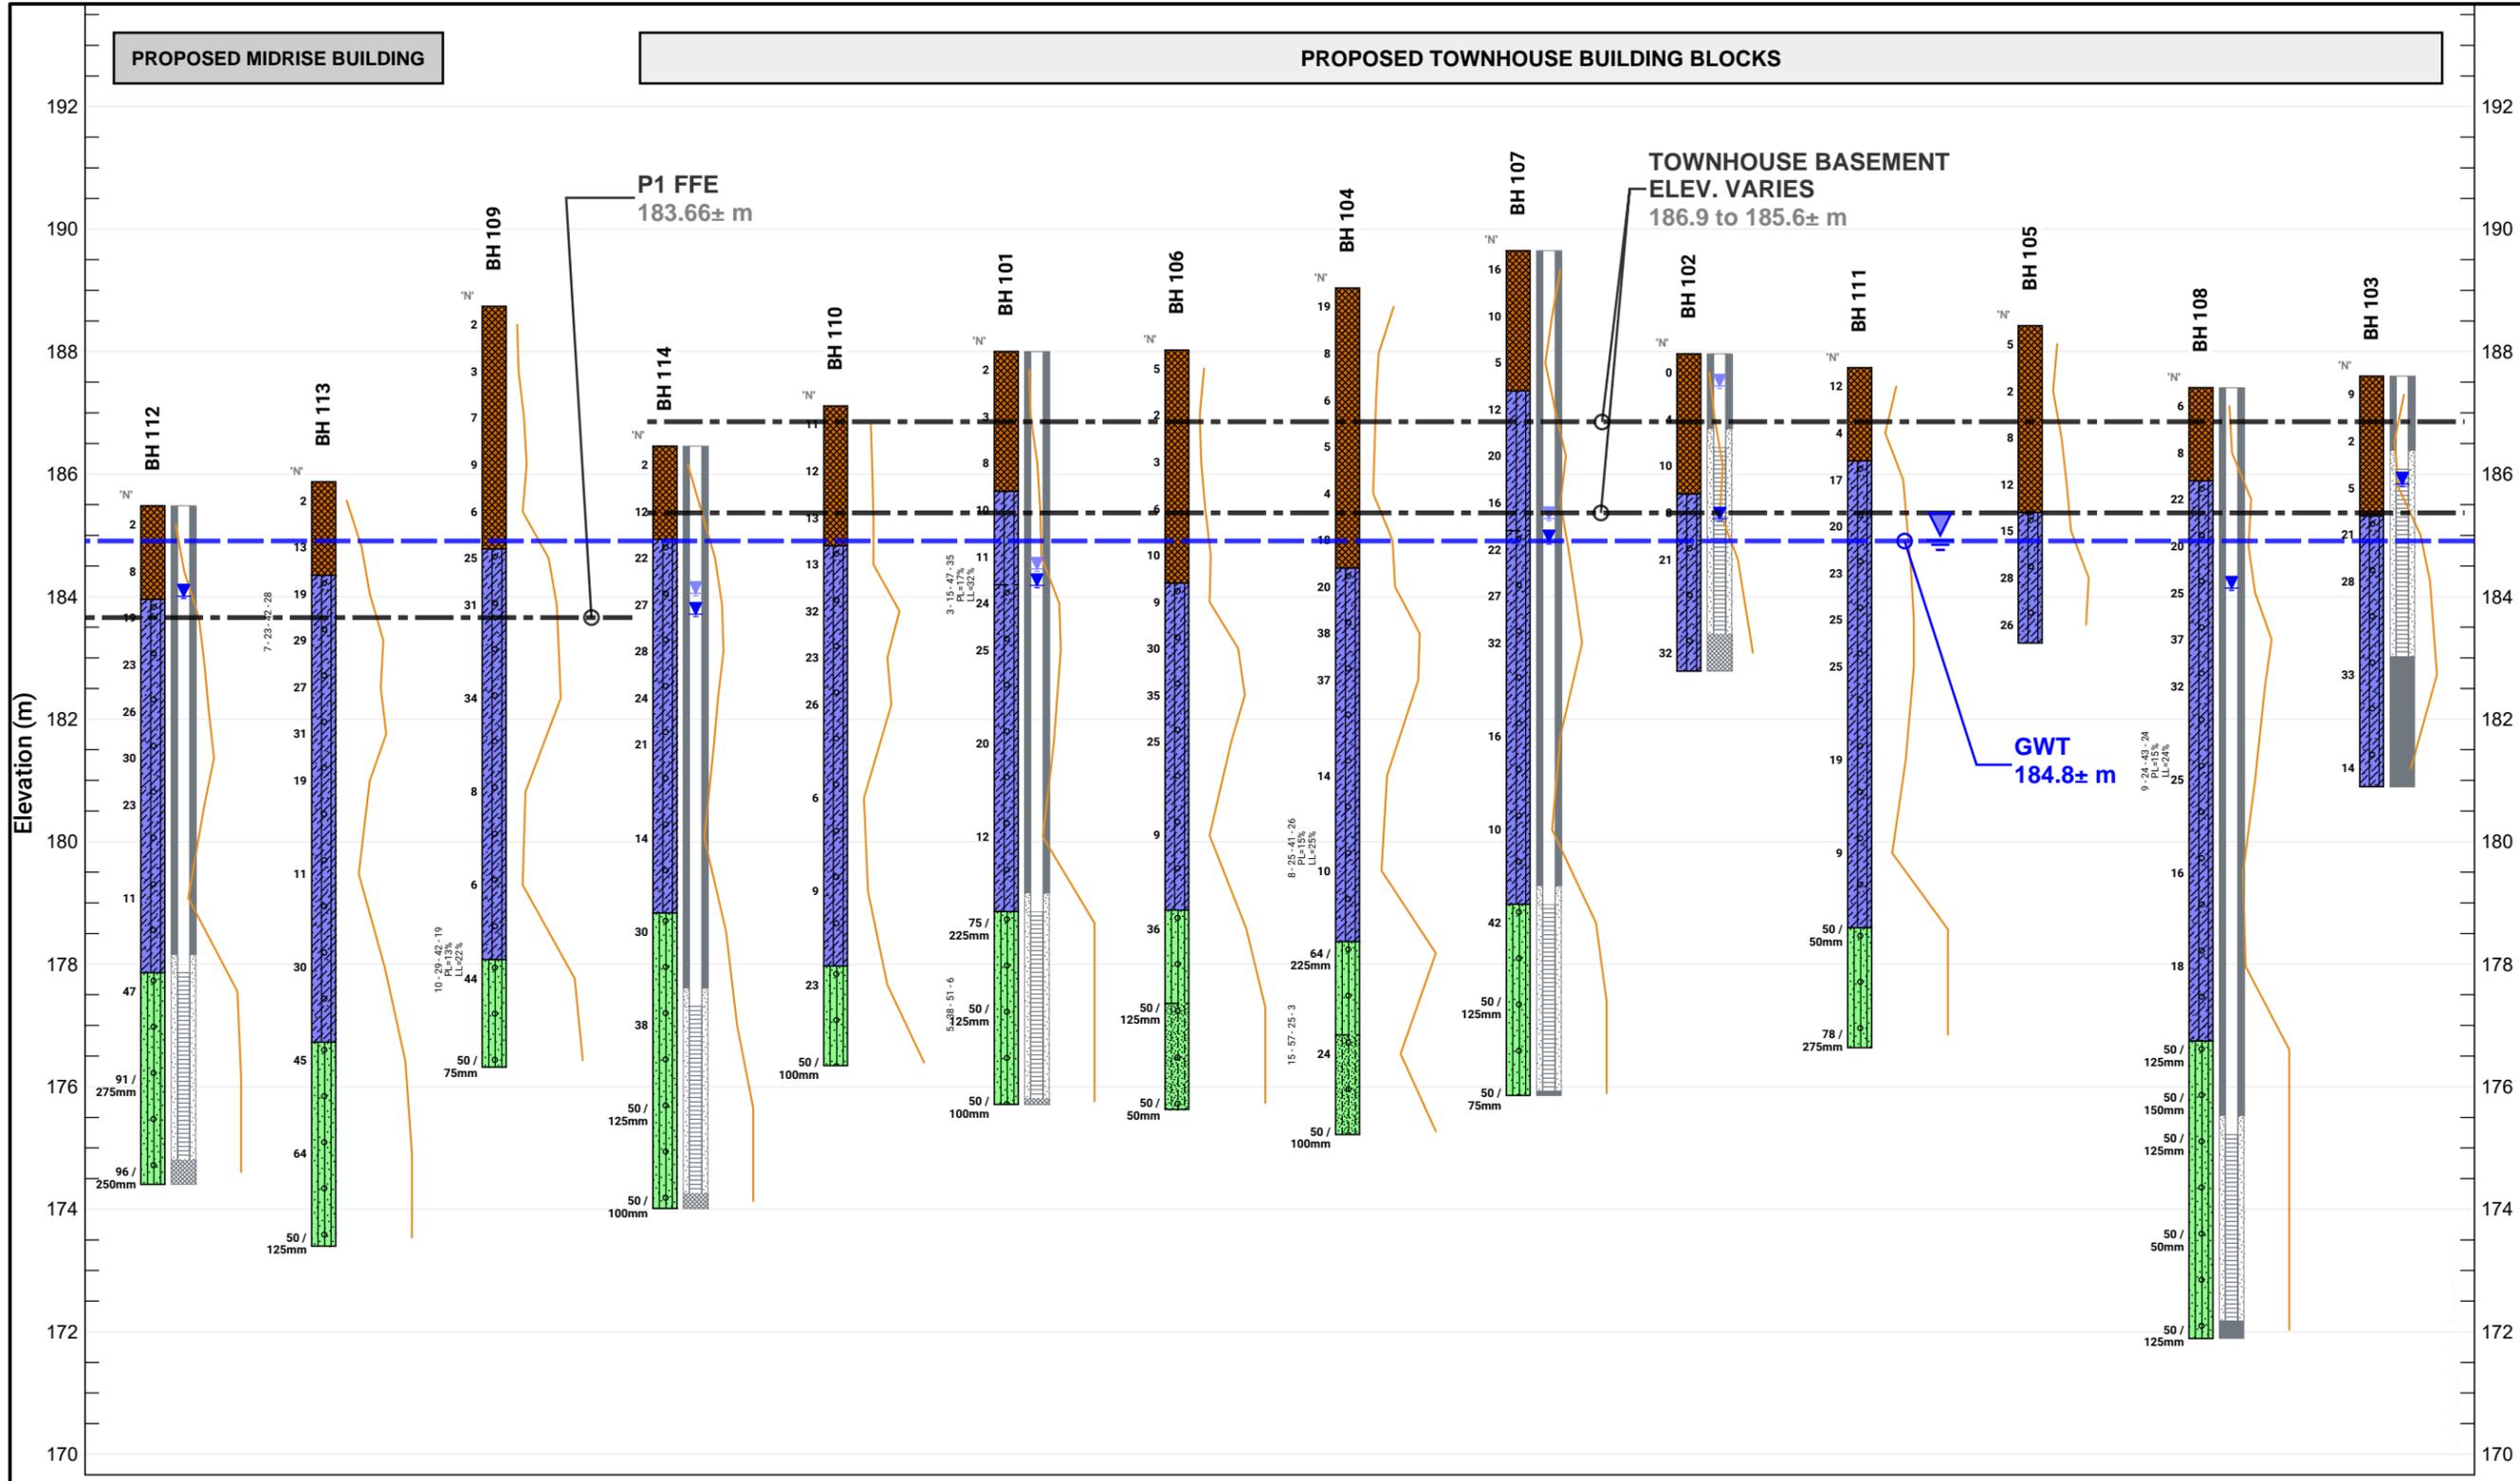
Date	FEBRUARY 2026
Scale	AS INDICATED
Job No	20-294
Figure No	FIGURE 3

Figure Title
SUBSURFACE PROFILE

- Fill
- Silty Sand Till
- Clayey Silt
- Clayey Silt Till
- Sandy Silt Till

Geological Units	Description
Earth Fill	Stockpiles of fill were noted across the site during the time of our investigation. At existing grade, all boreholes observed a layer of earth fill that extends to depths of 1.5 to 4.6 m below grade (Elev. 189.6 to 184.0 m). The earth fill varies in composition but generally consists of clayey silt and sandy silt with trace gravel. It contains trace rootlets, wood fragments, asphalt, and rock fragments. The earth fill is typically dark brown to dark brown with black, and moist.
Clayey Silt Till	Underlying the fill materials, boreholes encountered a native clayey silt glacial till at depths of 1.5 to 4.6 m below grade (Elev. 189.6 to 184.0 m) and extending to depths of 7.6 to 10.7 m below grade (Elev. 178.9 to 176.7 m). Boreholes 101, 102, and 110 observed weathering in this deposit at a depth of 2.3 m below grade (Elev. 187.3 to 185.7 m) and extending to depths of 3.0 to 3.8 m below grade (Elev. 185.0 to 184.2 m). The clayey silt till generally consists of some sand, trace gravel, and trace rock fragments. The weathered layers are generally blackish grey to dark brown with black, and moist. The unweathered till is generally reddish brown and moist.

Sandy Silt Till	Underlying the clayey silt till, boreholes encountered a dense to very dense sandy silt glacial till at depths of 7.6 to 10.7 m below grade (Elev. 178.9 to 176.7 m). The sandy silt till consists of trace clay, trace gravel, and trace rock fragments. It is typically reddish brown and moist. In Boreholes 104 and 106, the sandy silt till transitions to a silty sand glacial till at depths of 12.2 and 10.7 m below grade (Elev. 176.8 and 177.3 m). The silty sand till consists of trace to some gravel and trace clay. It is reddish grey and wet. The sandy silt to silty sand till extended beyond the depth of investigation (Elev. 176 to 172 m).

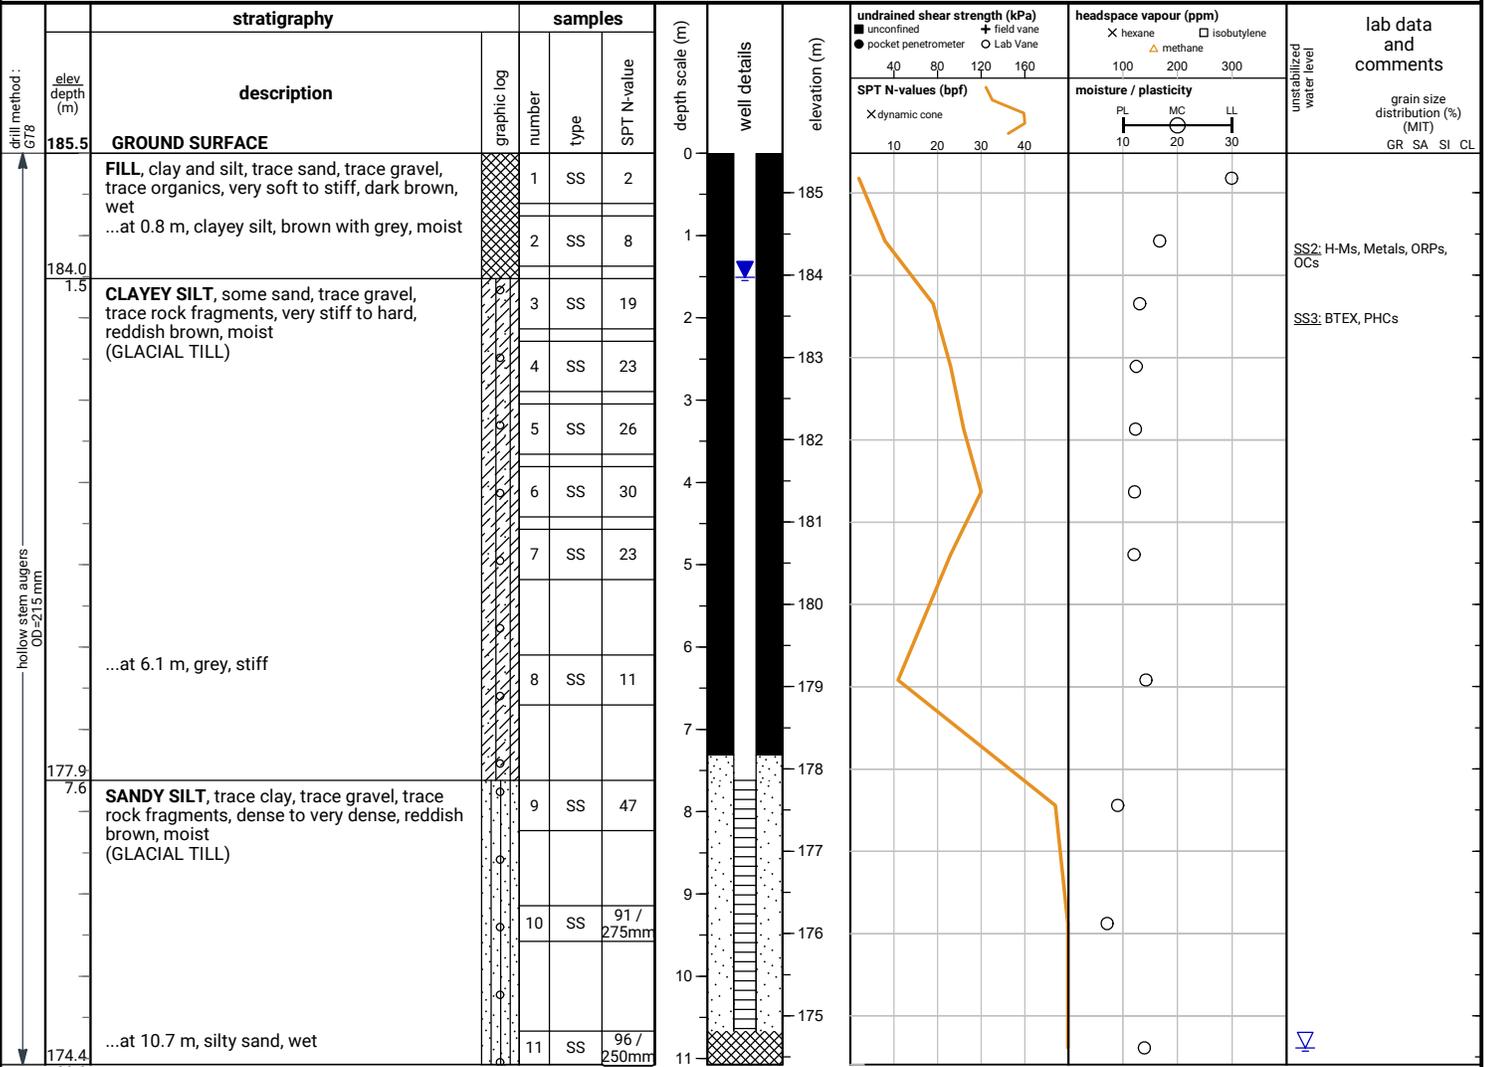
Unstabilized water level measured at 10.9 m below ground surface upon completion of drilling.

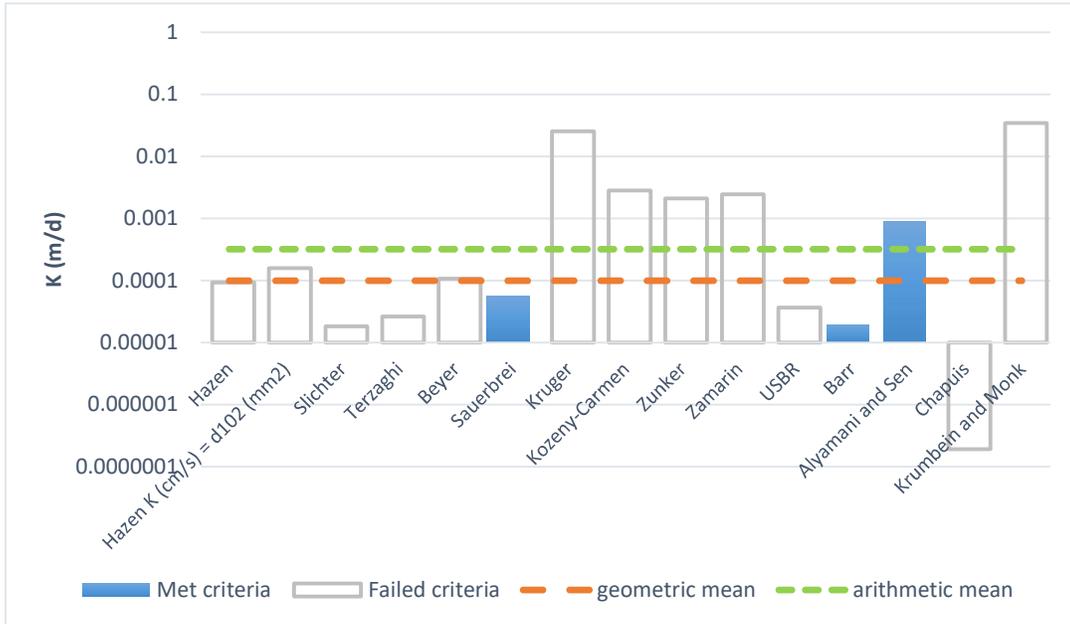
Poorly sorted clay with fines

Estimation of Hydraulic Conductivity	cm/s	m/s	m/d	de
Hazen	1.1E-07	1.1E-09	0.00	
Hazen K (cm/s) = d ₁₀ (mm)	1.8E-07	1.8E-09	0.00	
Slichter	2.1E-08	2.1E-10	0.00	
Terzaghi	3.0E-08	3.0E-10	0.00	
Beyer	1.2E-07	1.2E-09	0.00	
Sauerbrei	6.5E-08	6.5E-10	0.00	
Kruger	2.9E-05	2.9E-07	0.03	
Kozeny-Carmen	3.3E-06	3.3E-08	0.00	
Zunker	2.4E-06	2.4E-08	0.00	
Zamarin	2.8E-06	2.8E-08	0.00	
USBR	4.2E-08	4.2E-10	0.00	
Barr	2.3E-08	2.3E-10	0.00	
Alyamani and Sen	1.0E-06	1.0E-08	0.00	
Chapuis	2.2E-10	2.2E-12	0.00	
Krumbein and Monk	4.0E-05	4.0E-07	0.03	
geometric mean	1.1E-07	1.1E-09	0.00	
arithmetic mean	3.7E-07	3.7E-09	0.00

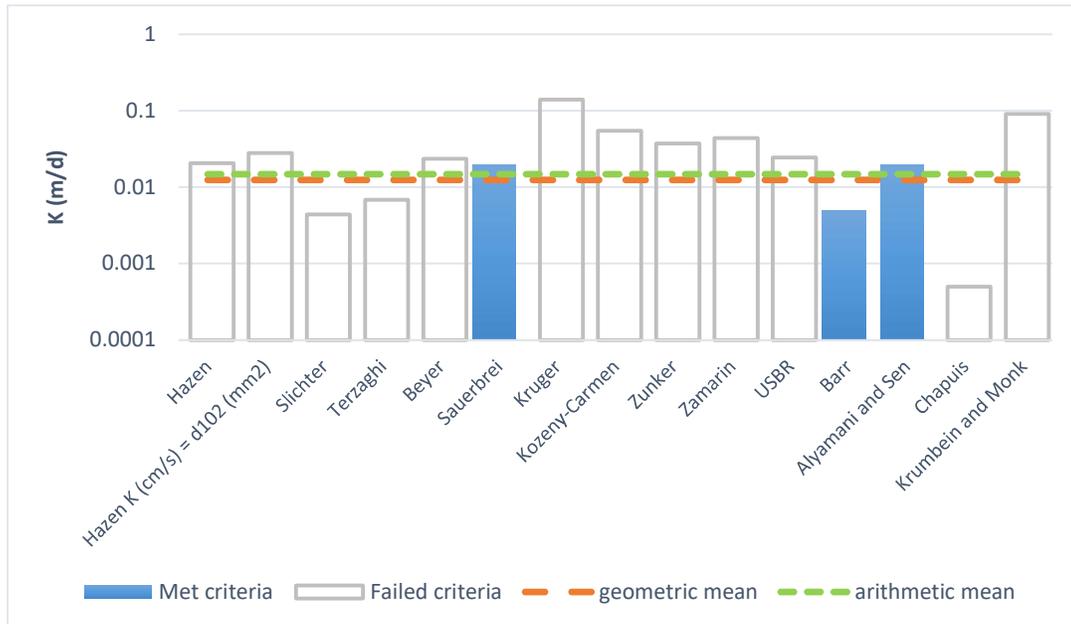
Poorly sorted sandy silt low in fines

Estimation of Hydraulic Conductivity	cm/s	m/s	m/d	de
Hazen	2.4E-05	2.4E-07	0.02	
Hazen K (cm/s) = d ₁₀ (mm)	3.2E-05	3.2E-07	0.03	
Slichter	5.1E-06	5.1E-08	0.00	
Terzaghi	7.9E-06	7.9E-08	0.01	
Beyer	2.7E-05	2.7E-07	0.02	
Sauerbrei	2.3E-05	2.3E-07	0.02	
Kruger	1.6E-04	1.6E-06	0.14	
Kozeny-Carmen	6.3E-05	6.3E-07	0.05	
Zunker	4.3E-05	4.3E-07	0.04	
Zamarin	5.1E-05	5.1E-07	0.04	
USBR	2.8E-05	2.8E-07	0.02	
Barr	5.7E-06	5.7E-08	0.00	
Alyamani and Sen	2.3E-05	2.3E-07	0.02	
Chapuis	5.8E-07	5.8E-09	0.00	
Krumbein and Monk	1.1E-04	1.1E-06	0.09	
geometric mean	1.4E-05	1.4E-07	0.01	
arithmetic mean	1.7E-05	1.7E-07	0.01

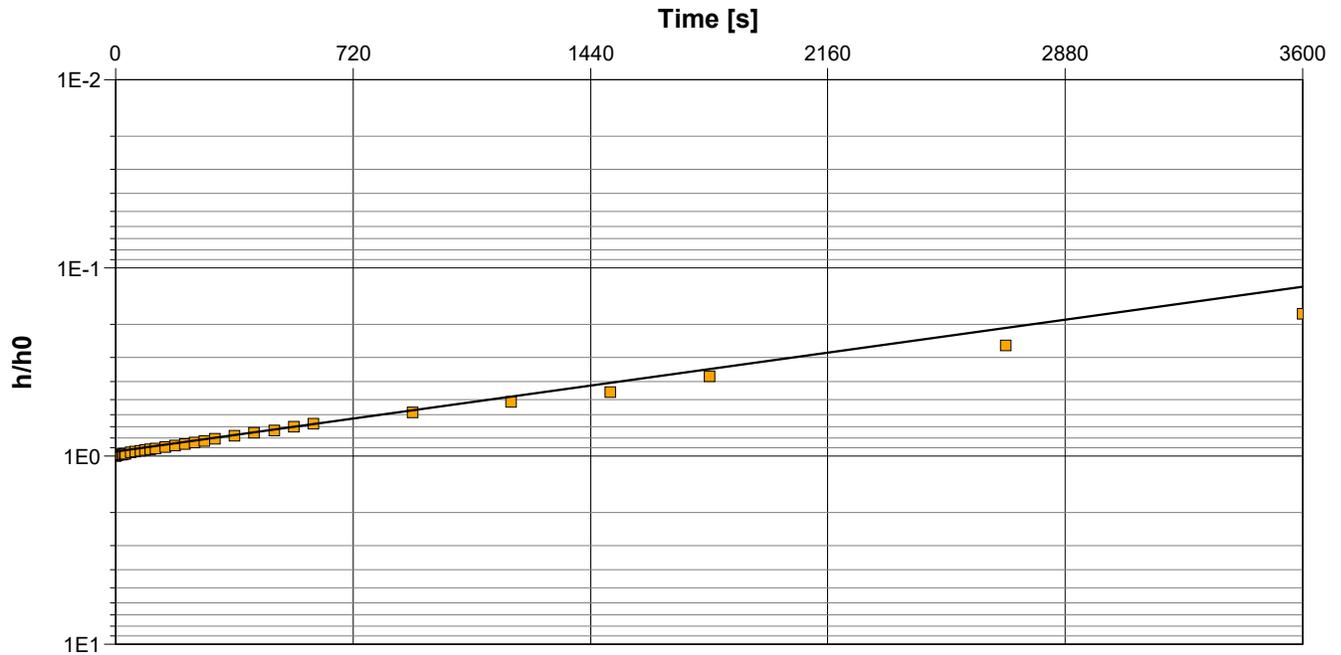
Calculation using Bouwer & Rice

Observation Well	Hydraulic Conductivity [m/s]
BH101	2.15×10^{-7}

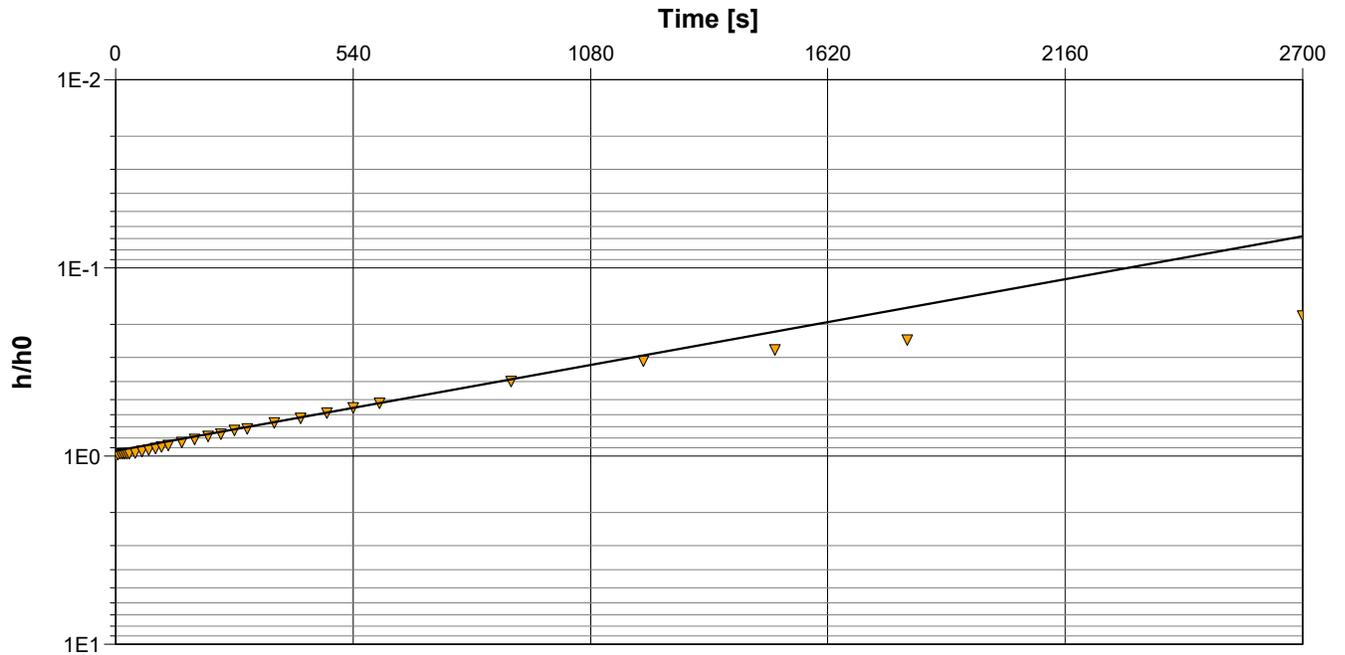
Calculation using Bouwer & Rice

Observation Well	Hydraulic Conductivity [m/s]
BH108	3.73×10^{-7}

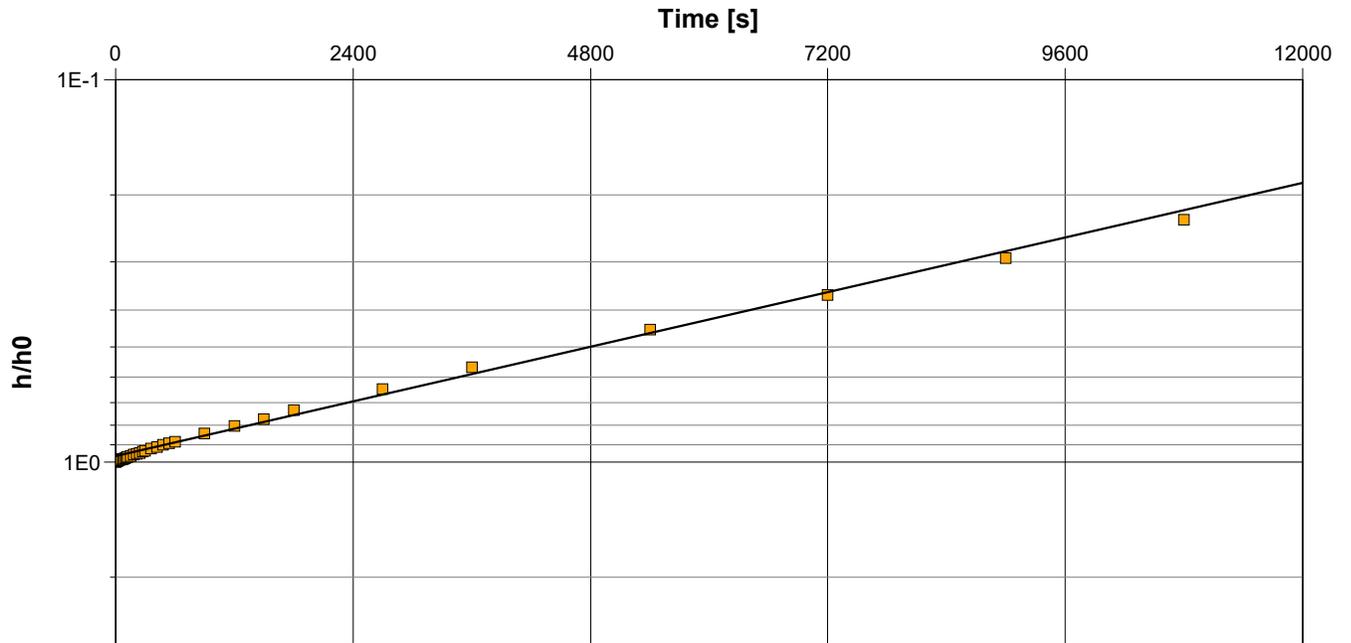
Calculation using Bouwer & Rice

Observation Well	Hydraulic Conductivity [m/s]
BH112	5.25×10^{-8}

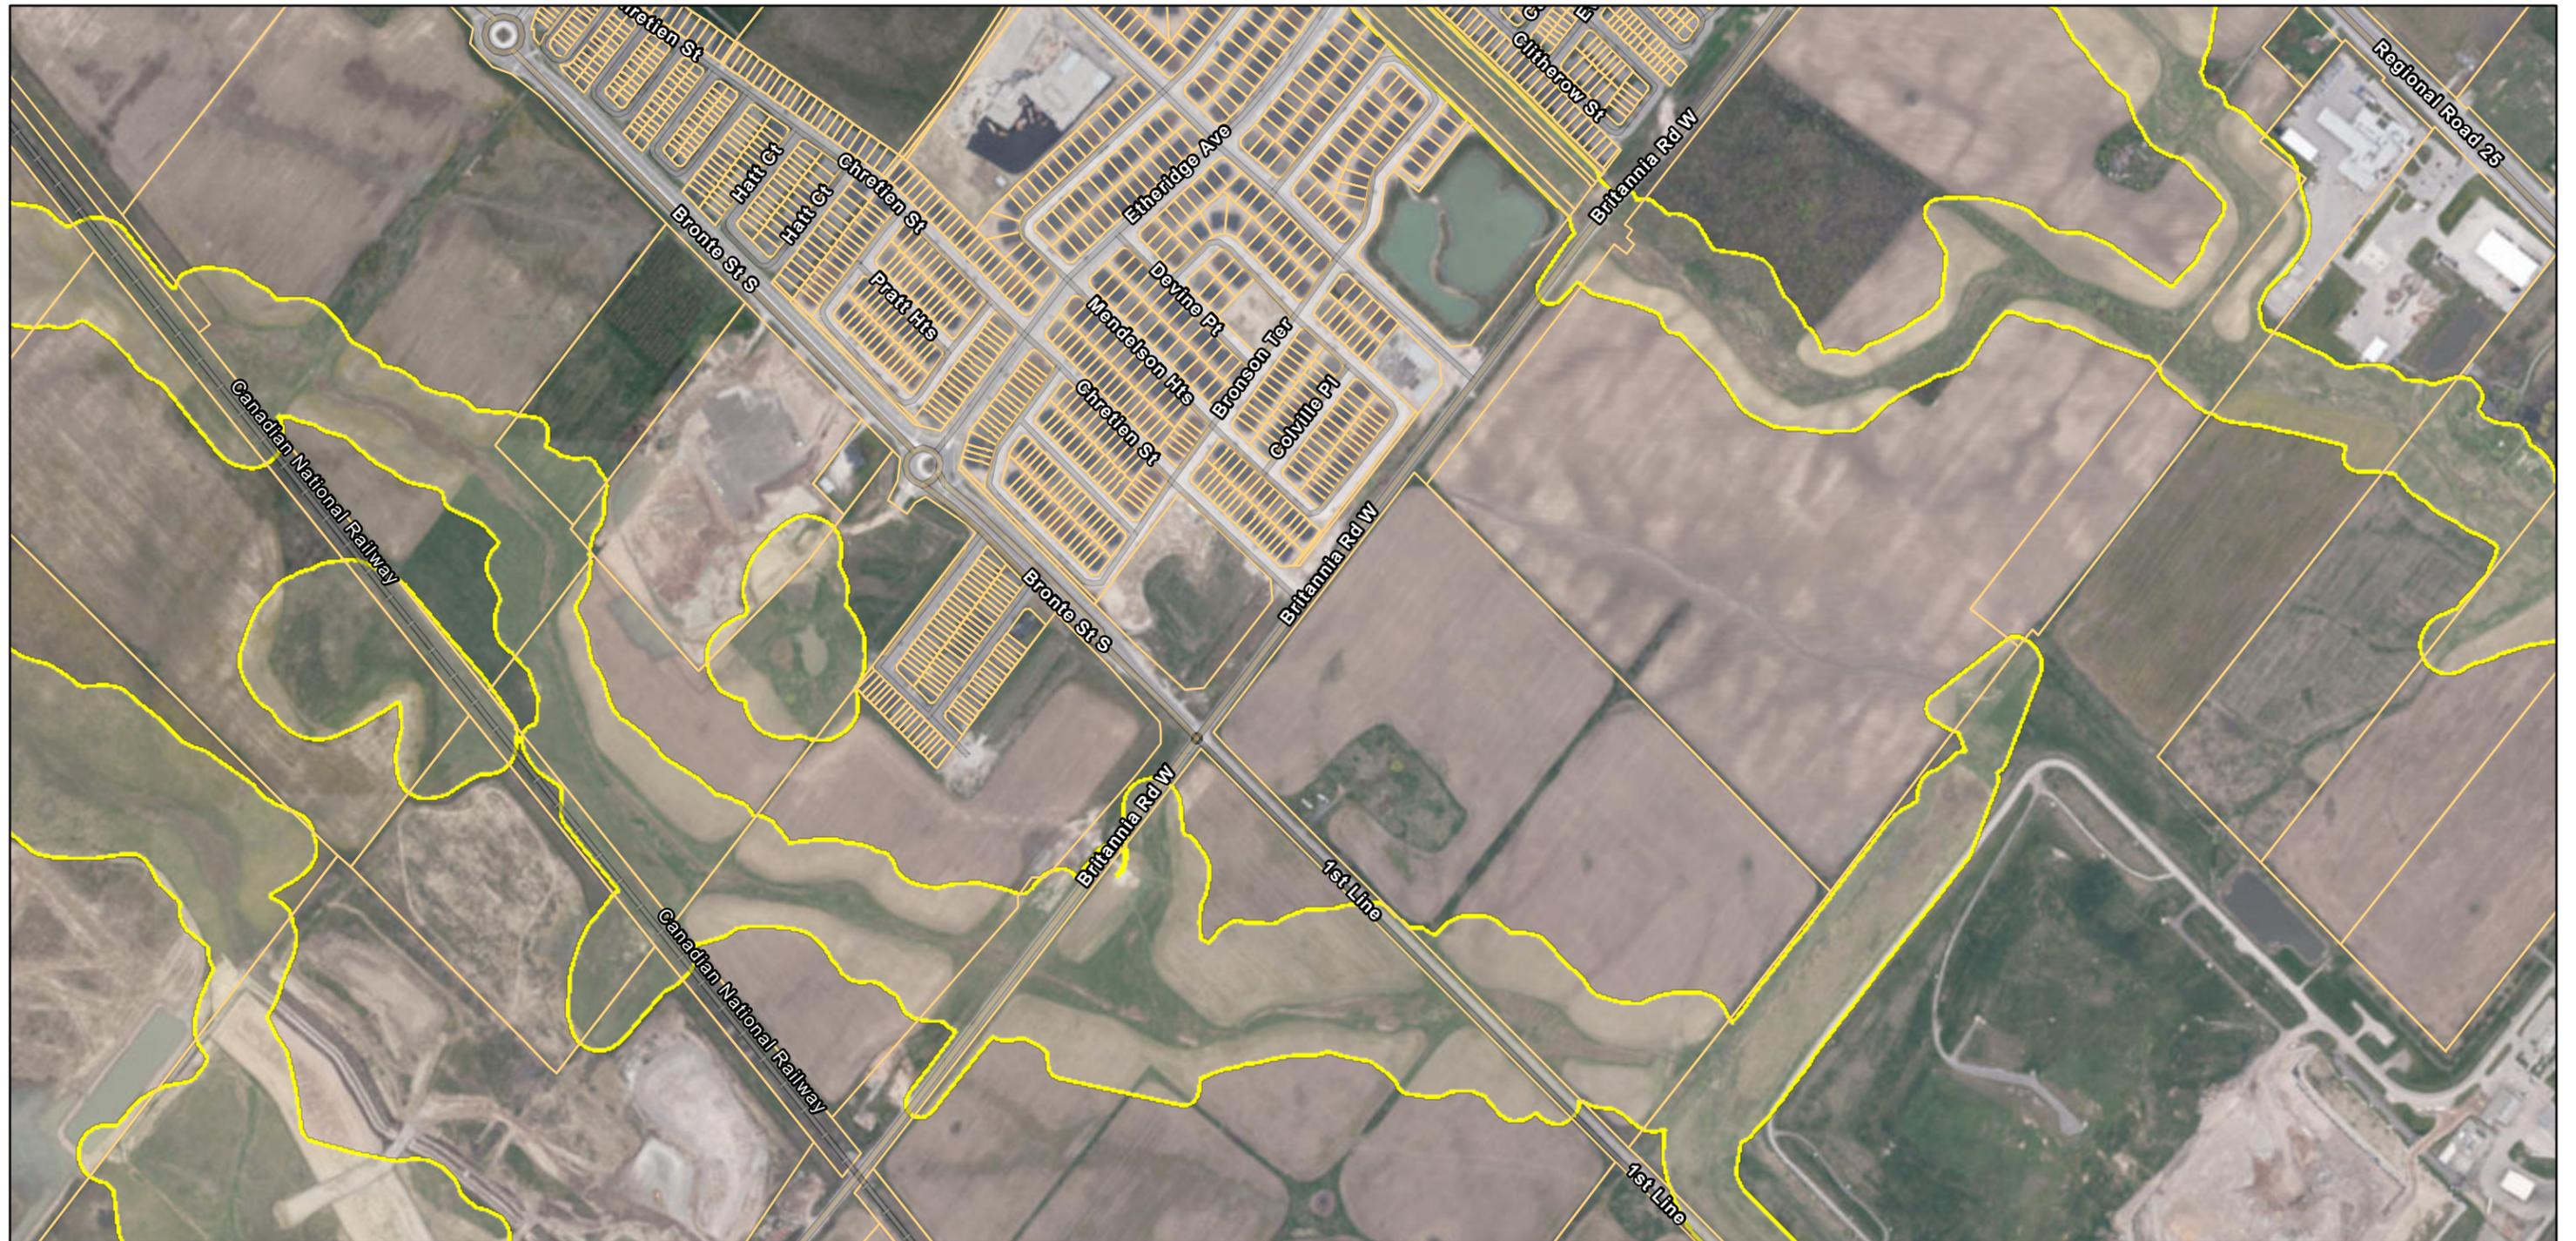
Conservation Halton Regulations Mapping

- Parcels
- Approximate Regulation Limit
- Spill Arrows
- Spill Lines
- Conservation Halton

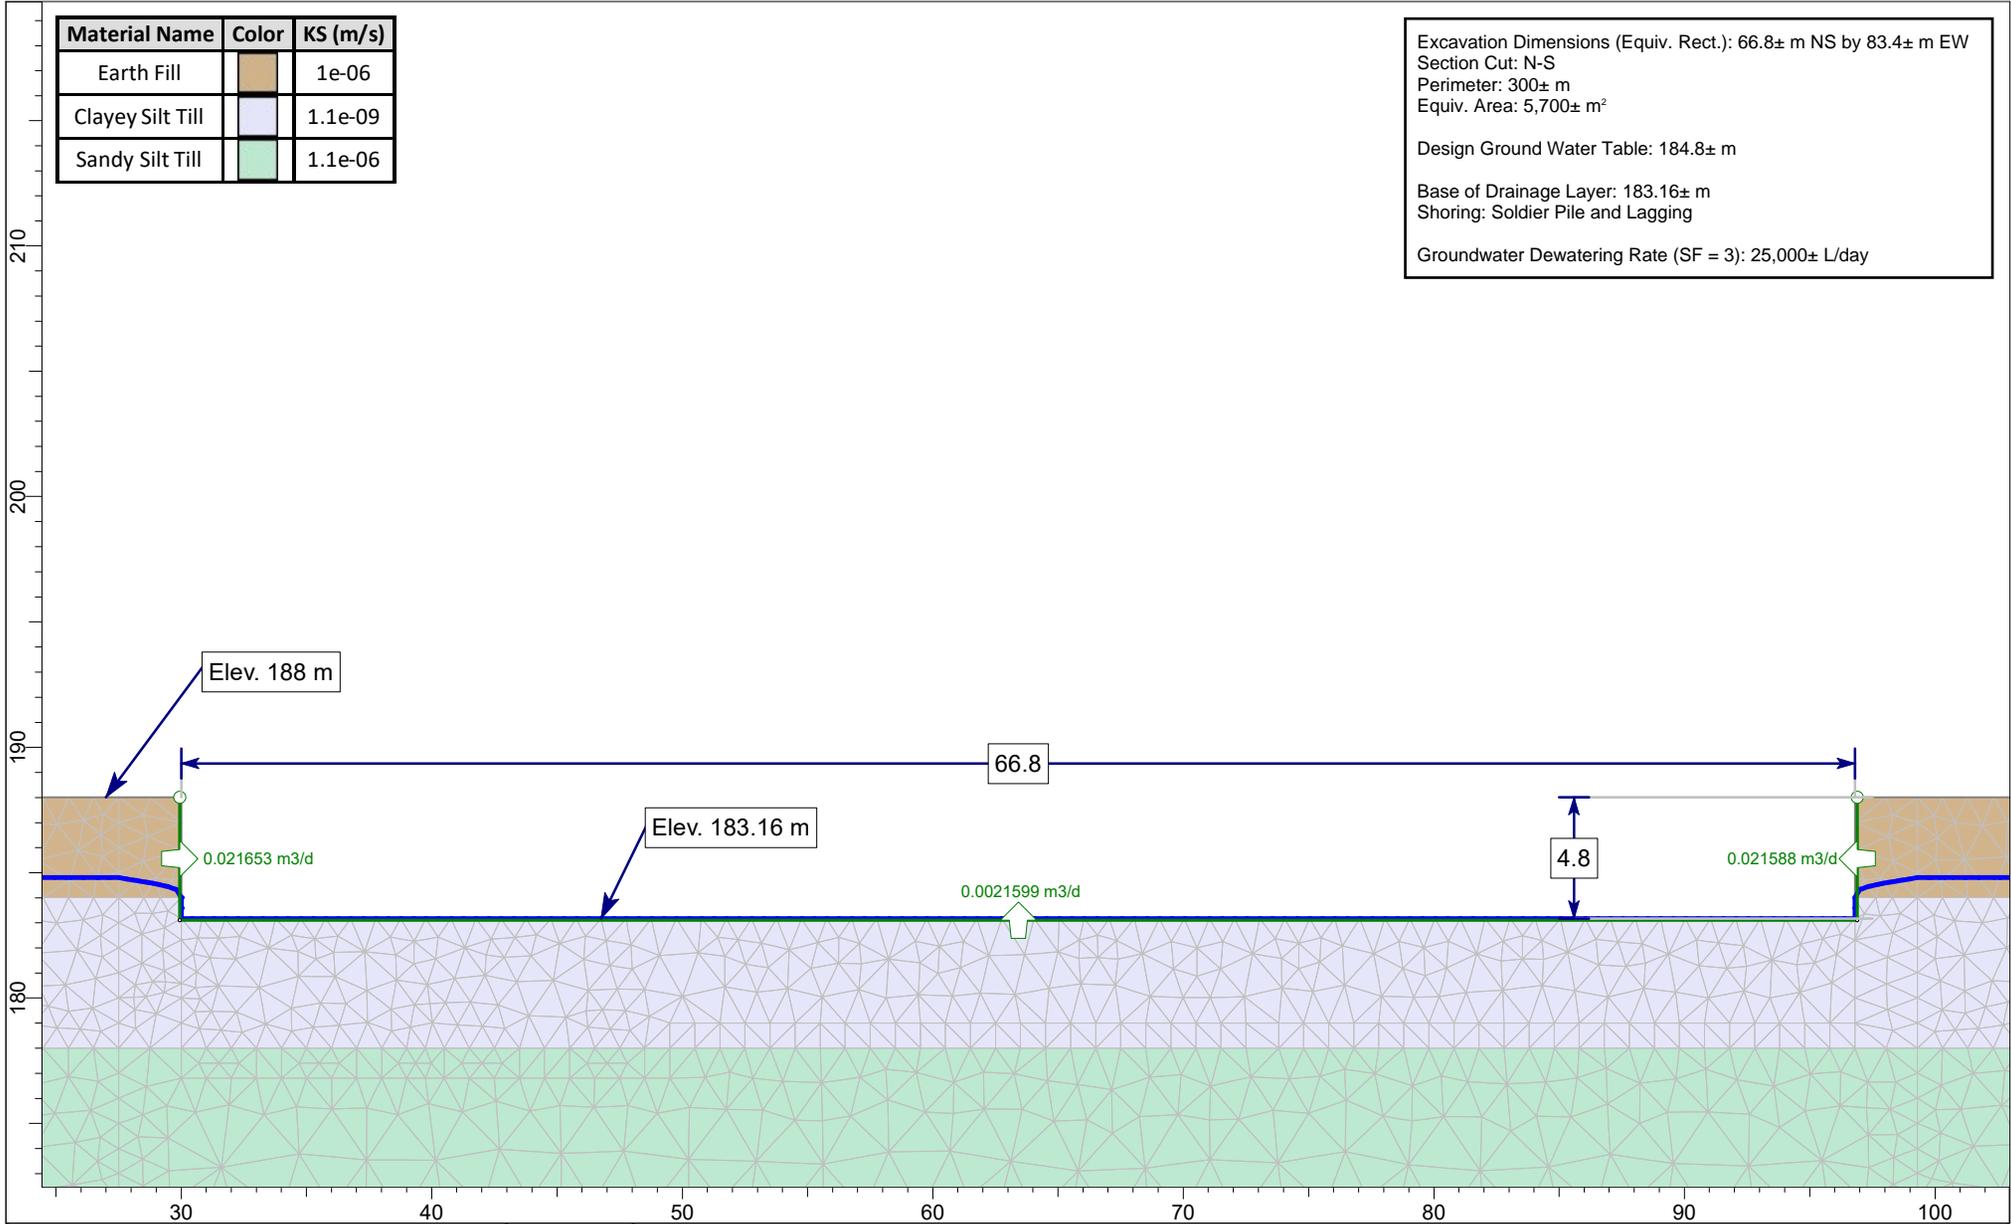
Excavation Dimensions (Equiv. Rect.): 66.8± m NS by 83.4± m EW
 Section Cut: N-S
 Perimeter: 300± m
 Equiv. Area: 5,700± m²
 Design Ground Water Table: 184.8± m
 Base of Drainage Layer: 183.16± m
 Shoring: Soldier Pile and Lagging
 Groundwater Dewatering Rate (SF = 3): 25,000± L/day

File	20-294 Shearling Heights (Britannia Rd & Bronte St), Milton, ON			
	Analysis	Dewatering: P1, Permeable Shoring - Long-Term			
	Ref.				
	RS2 File	20-294 FEM - AK.slmd	Scale	1:300	Eng

- For midrise building foundations made on the clayey silt till, positive dewatering is not anticipated. Dewatering will be limited to sump and pumps for excavations made within the clayey silt till.
- The townhouse bulk excavation is above the groundwater table, with foundation excavations in clayey silt till which will not yield free-flowing water. These are excluded from the finite element model as they will yield negligible groundwater seepage. In the short term, the townhouse basements are assumed to only yield rainfall.
- In the long term, the townhouse basements are above the groundwater table, and are assumed to only collect infiltrated stormwater.
- A Factor of Safety of 3 was used for all groundwater seepage volume calculations.

Long Term (Permanent) Groundwater Quantity – Safety Factor of 3 Used					
Groundwater Seepage		Infiltration Design Rainfall Event (32 mm)		Total Daily Water Takings	
L/day	L/min	L/day	L/min	L/day	L/min
25,000	17.4	7,000	4.9	32,000	22.2
