PHASE ONE ENVIRONMENTAL SITE ASSESSMENT

**Britannia Road and Bronte Street
South | Milton, Ontario**

Grounded Engineering Inc.

File No. 20-294-201

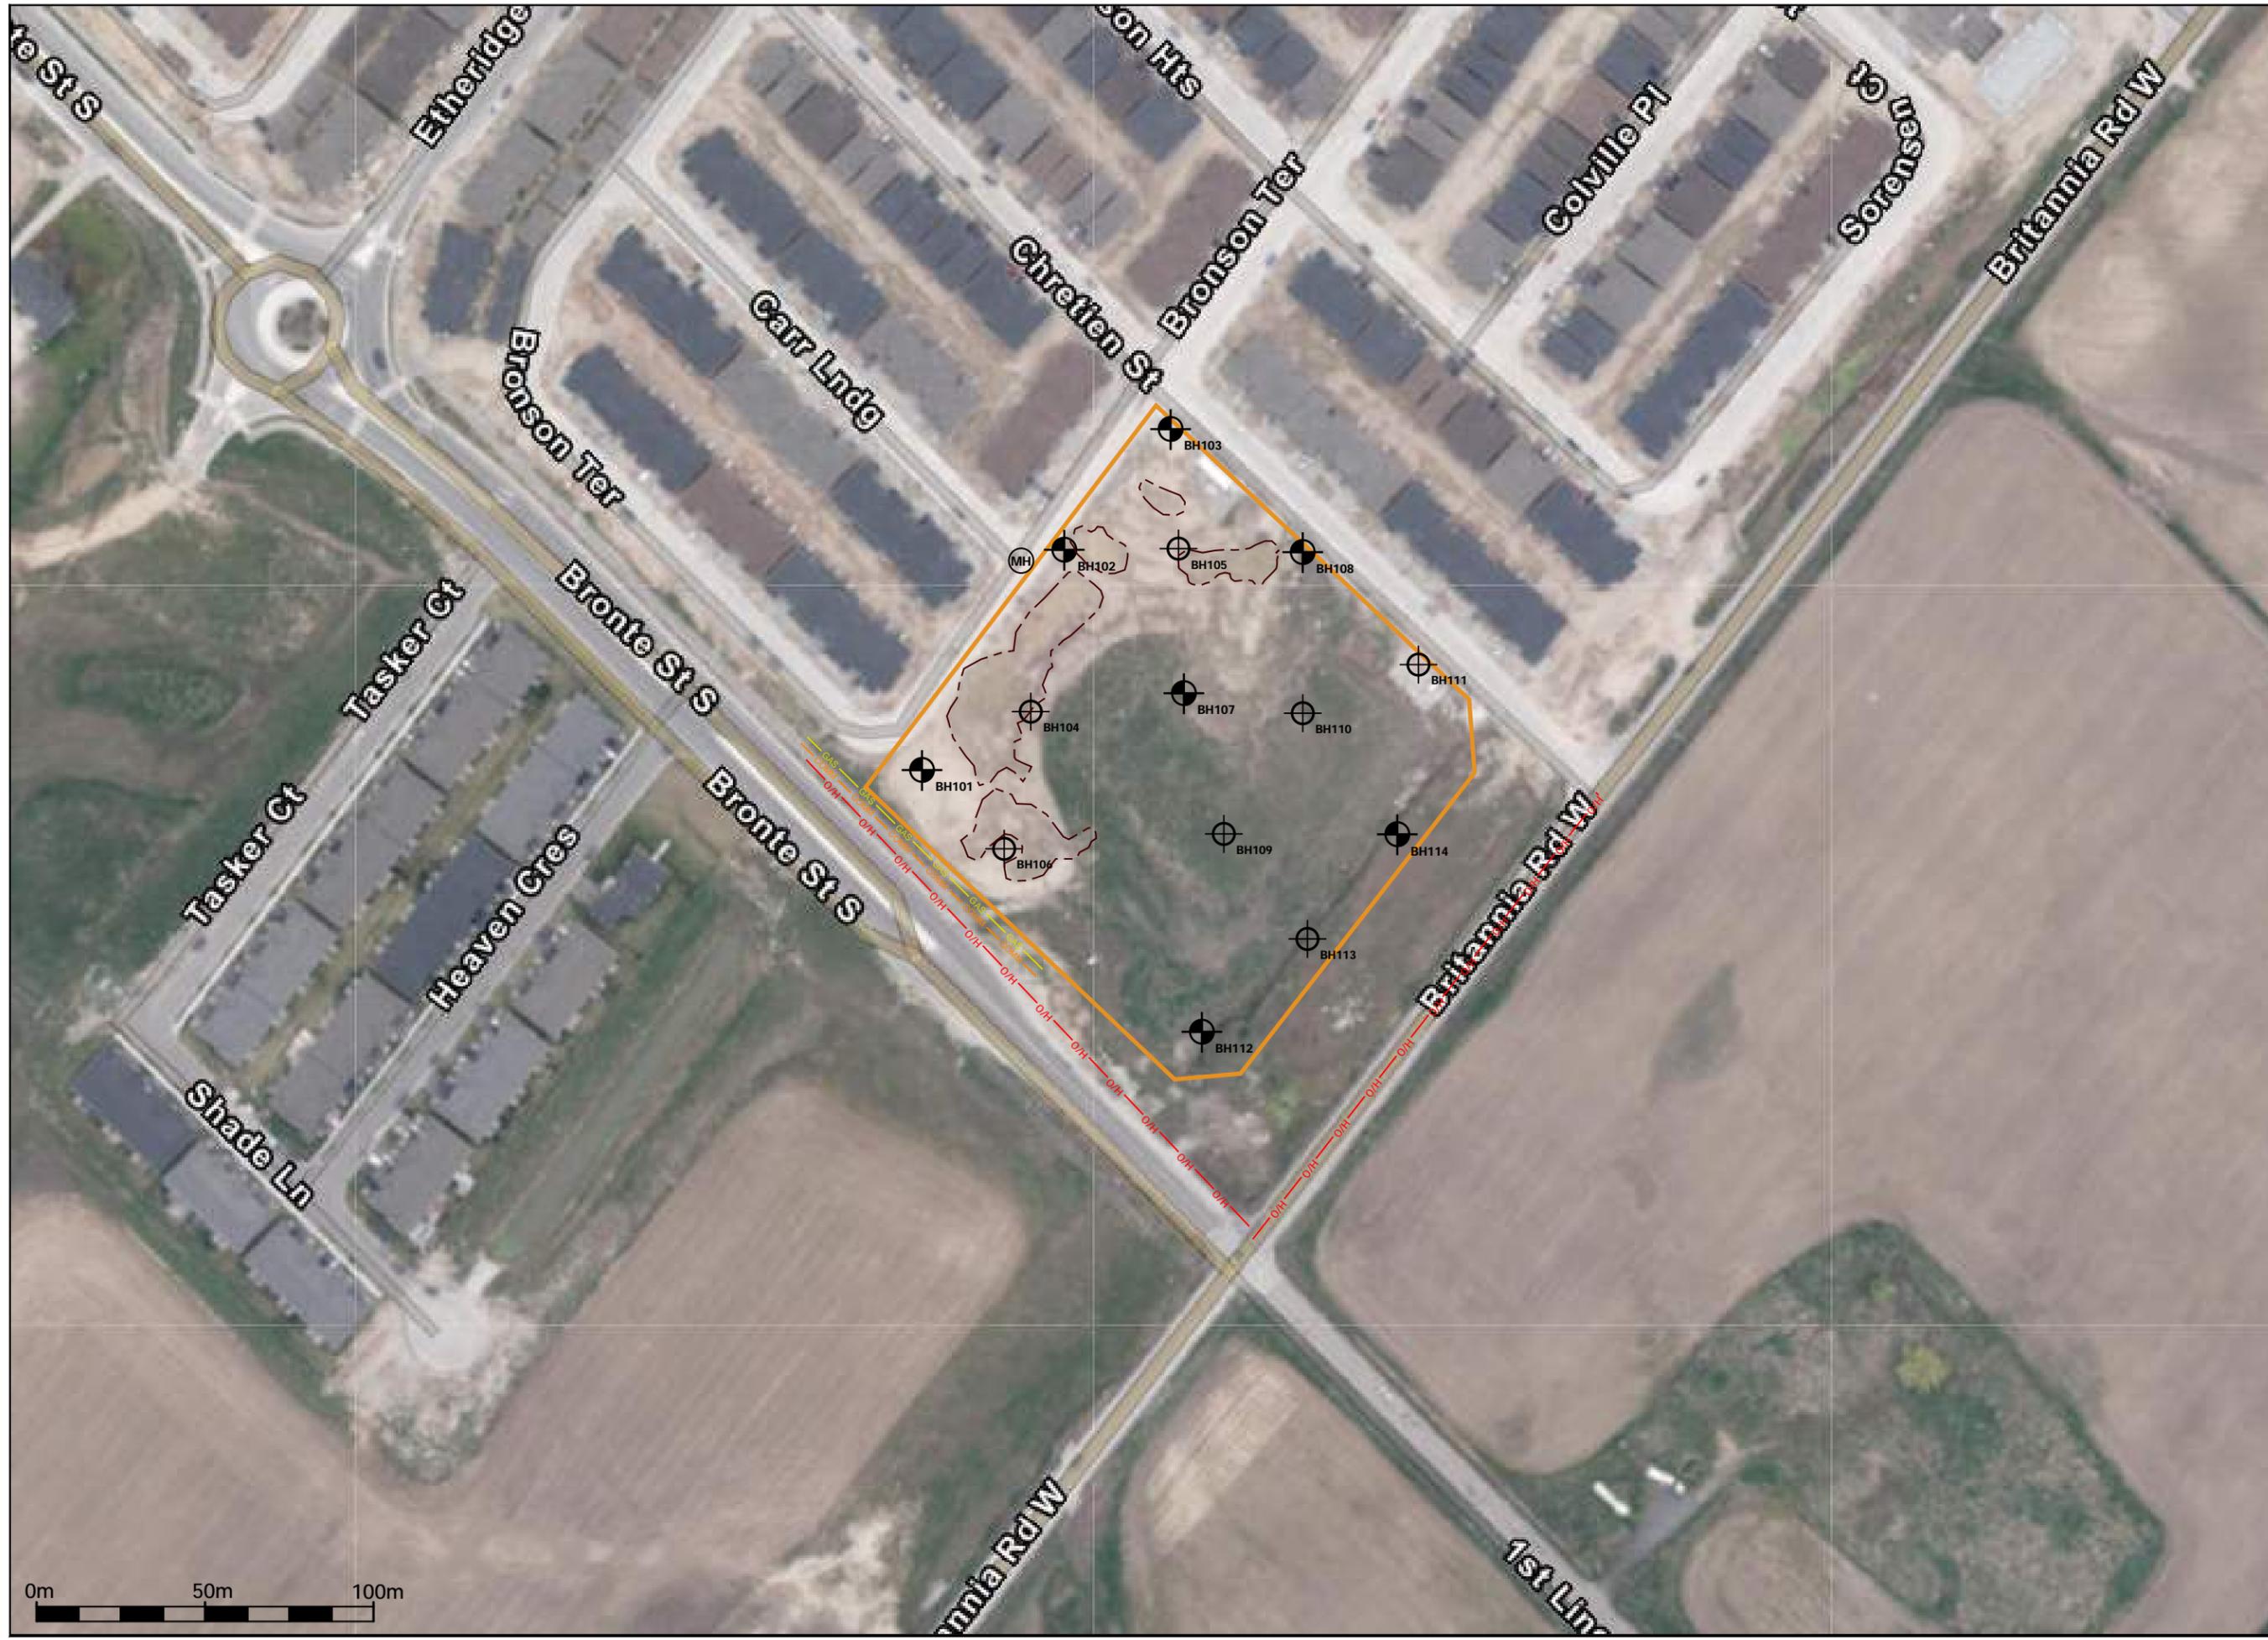
Figure No
FIGURE 2

Temporary stockpiles of reworked native soil, reportedly generated from the excavation of non-impacted native soils from adjacent residential development, were noted during the site visit and are shown on Figure 2. A baseline chemistry investigation was conducted in 2021 and this material was analyzed as part of that investigation. All soil assessed met the Site Condition Standards (Table 2 RPI) as per O.Reg 153/04. It is the opinion of the QP that the reworked native material is not a PCA.

The site reconnaissance did not identify any PCAs on the Property. Temporary stockpiles, reportedly generated from the excavation of reworked native soils from adjacent residential development, was observed onsite. A baseline chemistry investigation was conducted in 2021 and this material was analyzed as part of that investigation. It is the opinion of the QP that the reworked native material is not a PCA. The location of the stockpiles is noted on Figure 2.

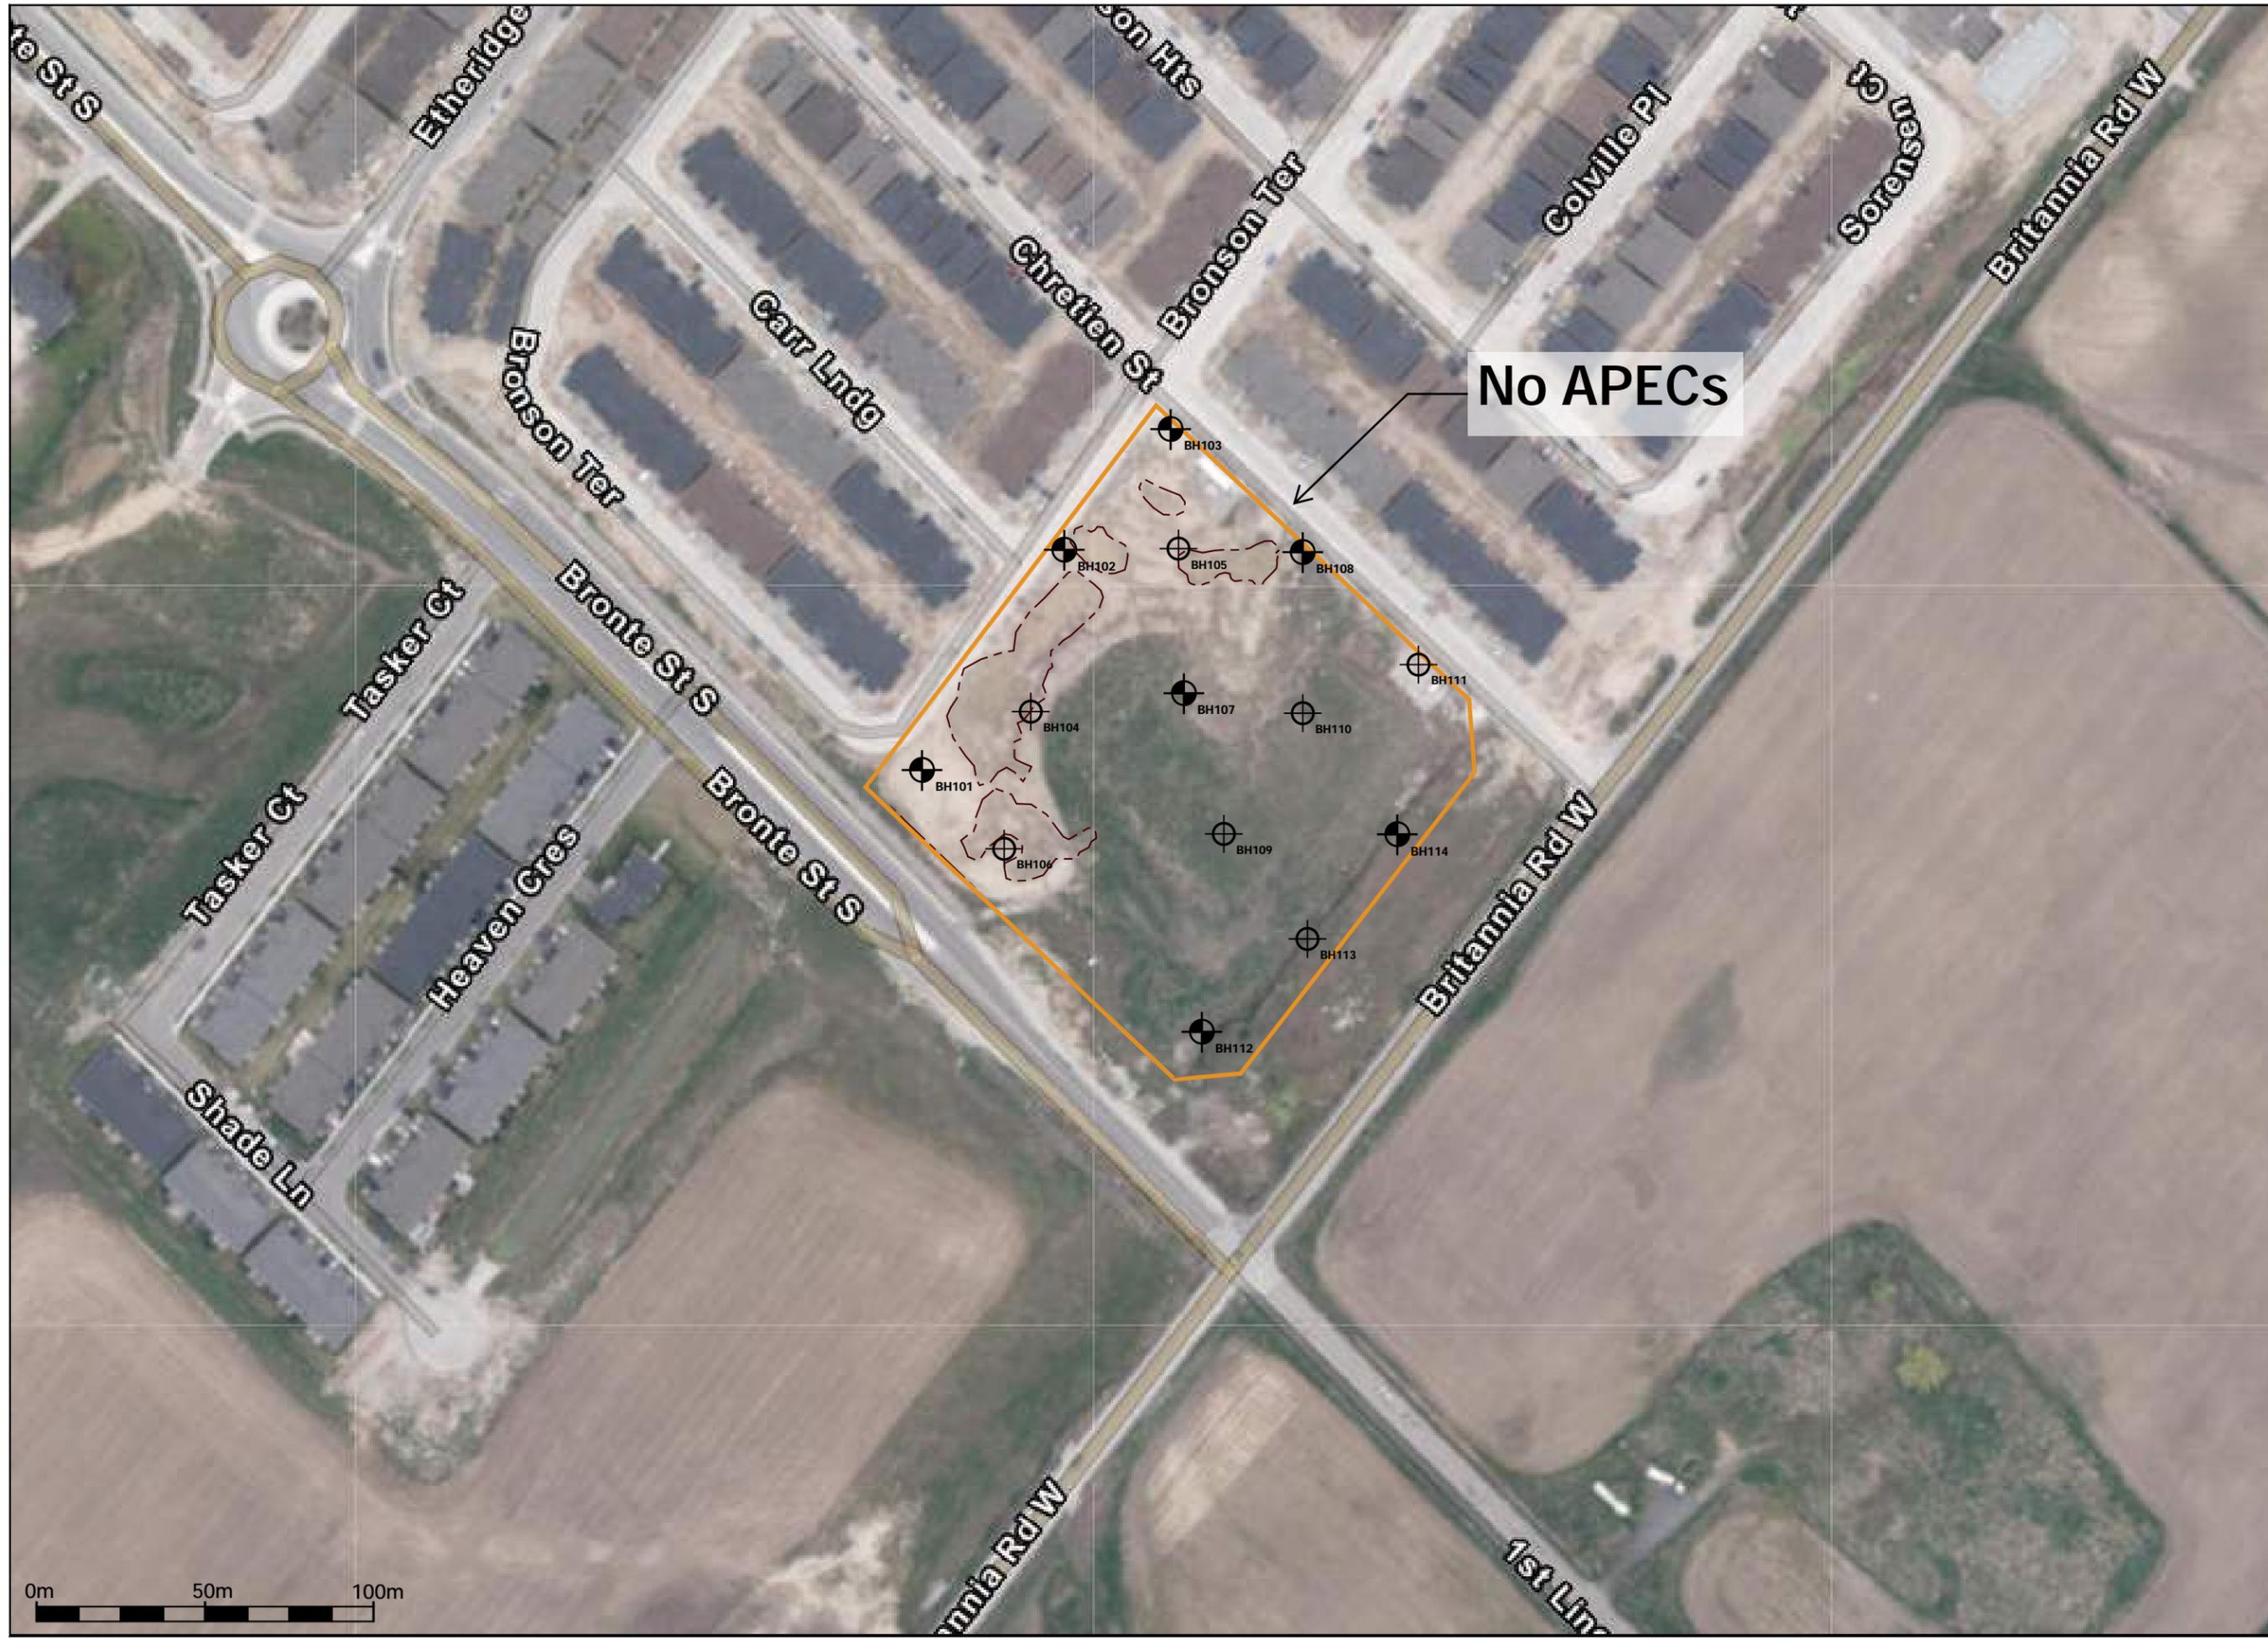
Figure No
FIGURE 4

Areas where any PCA has occurred, and locations of tanks in the Phase One Study Area	The location of PCAs and tanks, if any, is shown on Figure 4.
APECs on the Phase One Property	The location of APECs on the Phase One Property is shown on Figure 5.
Narrative Description and Assessments	
Any areas where Potentially Contaminating Activity (PCAs) on, or potentially affecting, the Phase One Property have occurred	No on-site or off-site PCAs that potentially affect the Property were identified.
Any Contaminants of Potential Concerns (CoPCs)	No CoPCs were identified.
The potential of underground utilities (if any present) to affect contaminant distribution and transport	The Property is undeveloped, no evidence of underground utilities was observed, furthermore no CoPCs were identified on the Property, therefore there is no potential for

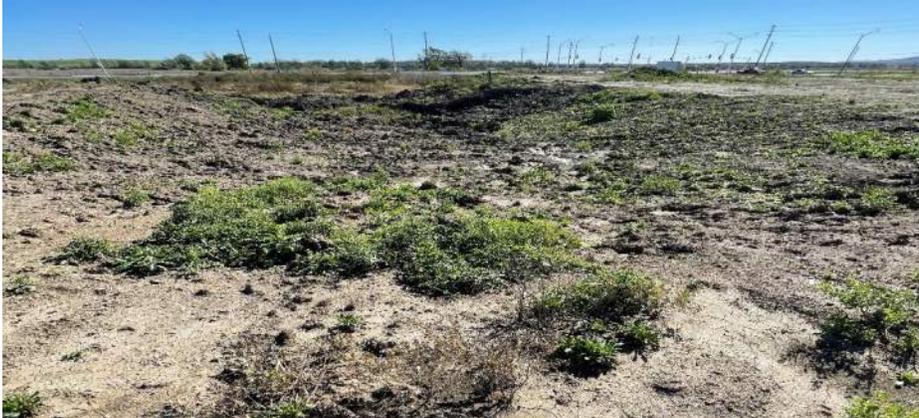
Photograph 1

Location: Phase One Property

Direction: South

Description: vacant land, adjacent overhead hydro is visible

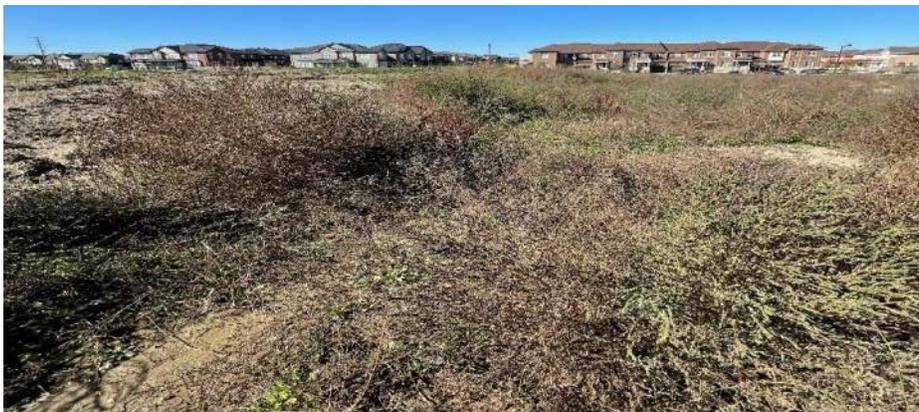
Photograph 2

Location: Phase One Property

Direction: North

Description: vacant land, adjacent residential neighbourhood is visible

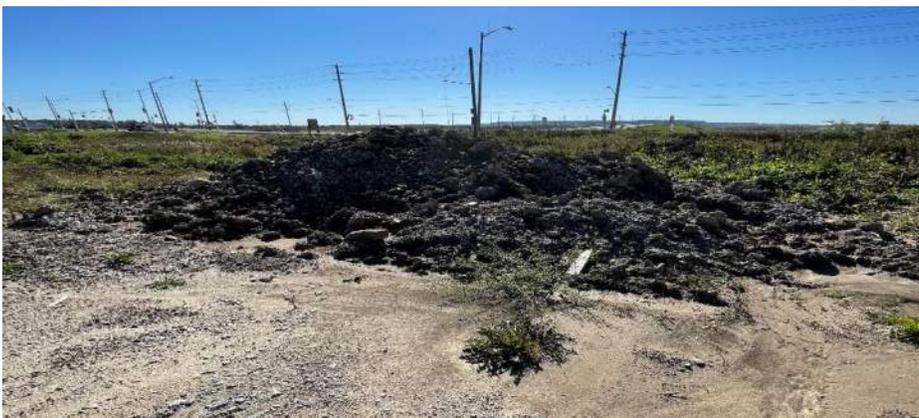
Photograph 3

Location: Phase One Property

Direction: Southwest

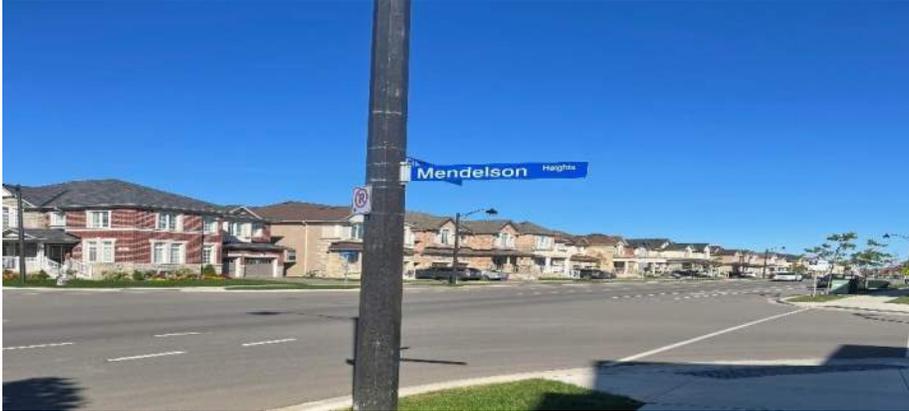
Photograph 4

Location: Phase One Study Area

Direction: Northeast

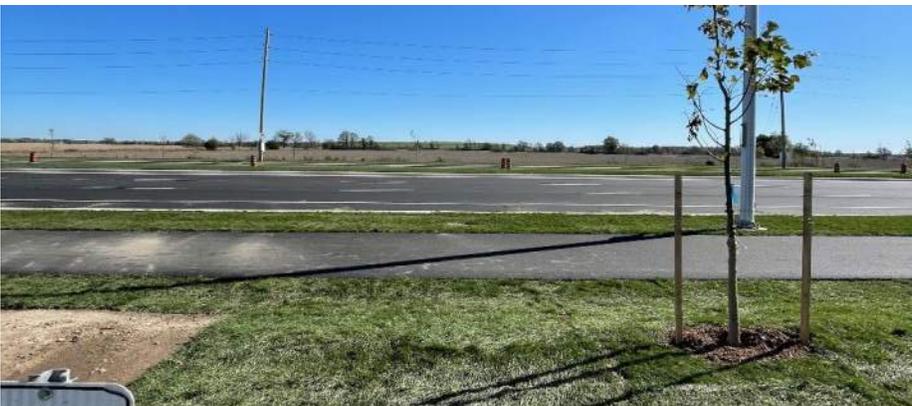
Photograph 5

Location: Phase One Study Area

Direction: South

Description: Adjacent agricultural land
