Landscape Concept 550 Ontario Street Milton, ON

July 05, 2021

PROJECT 550 Ontario Street South

SHEET Tree Protection Plan

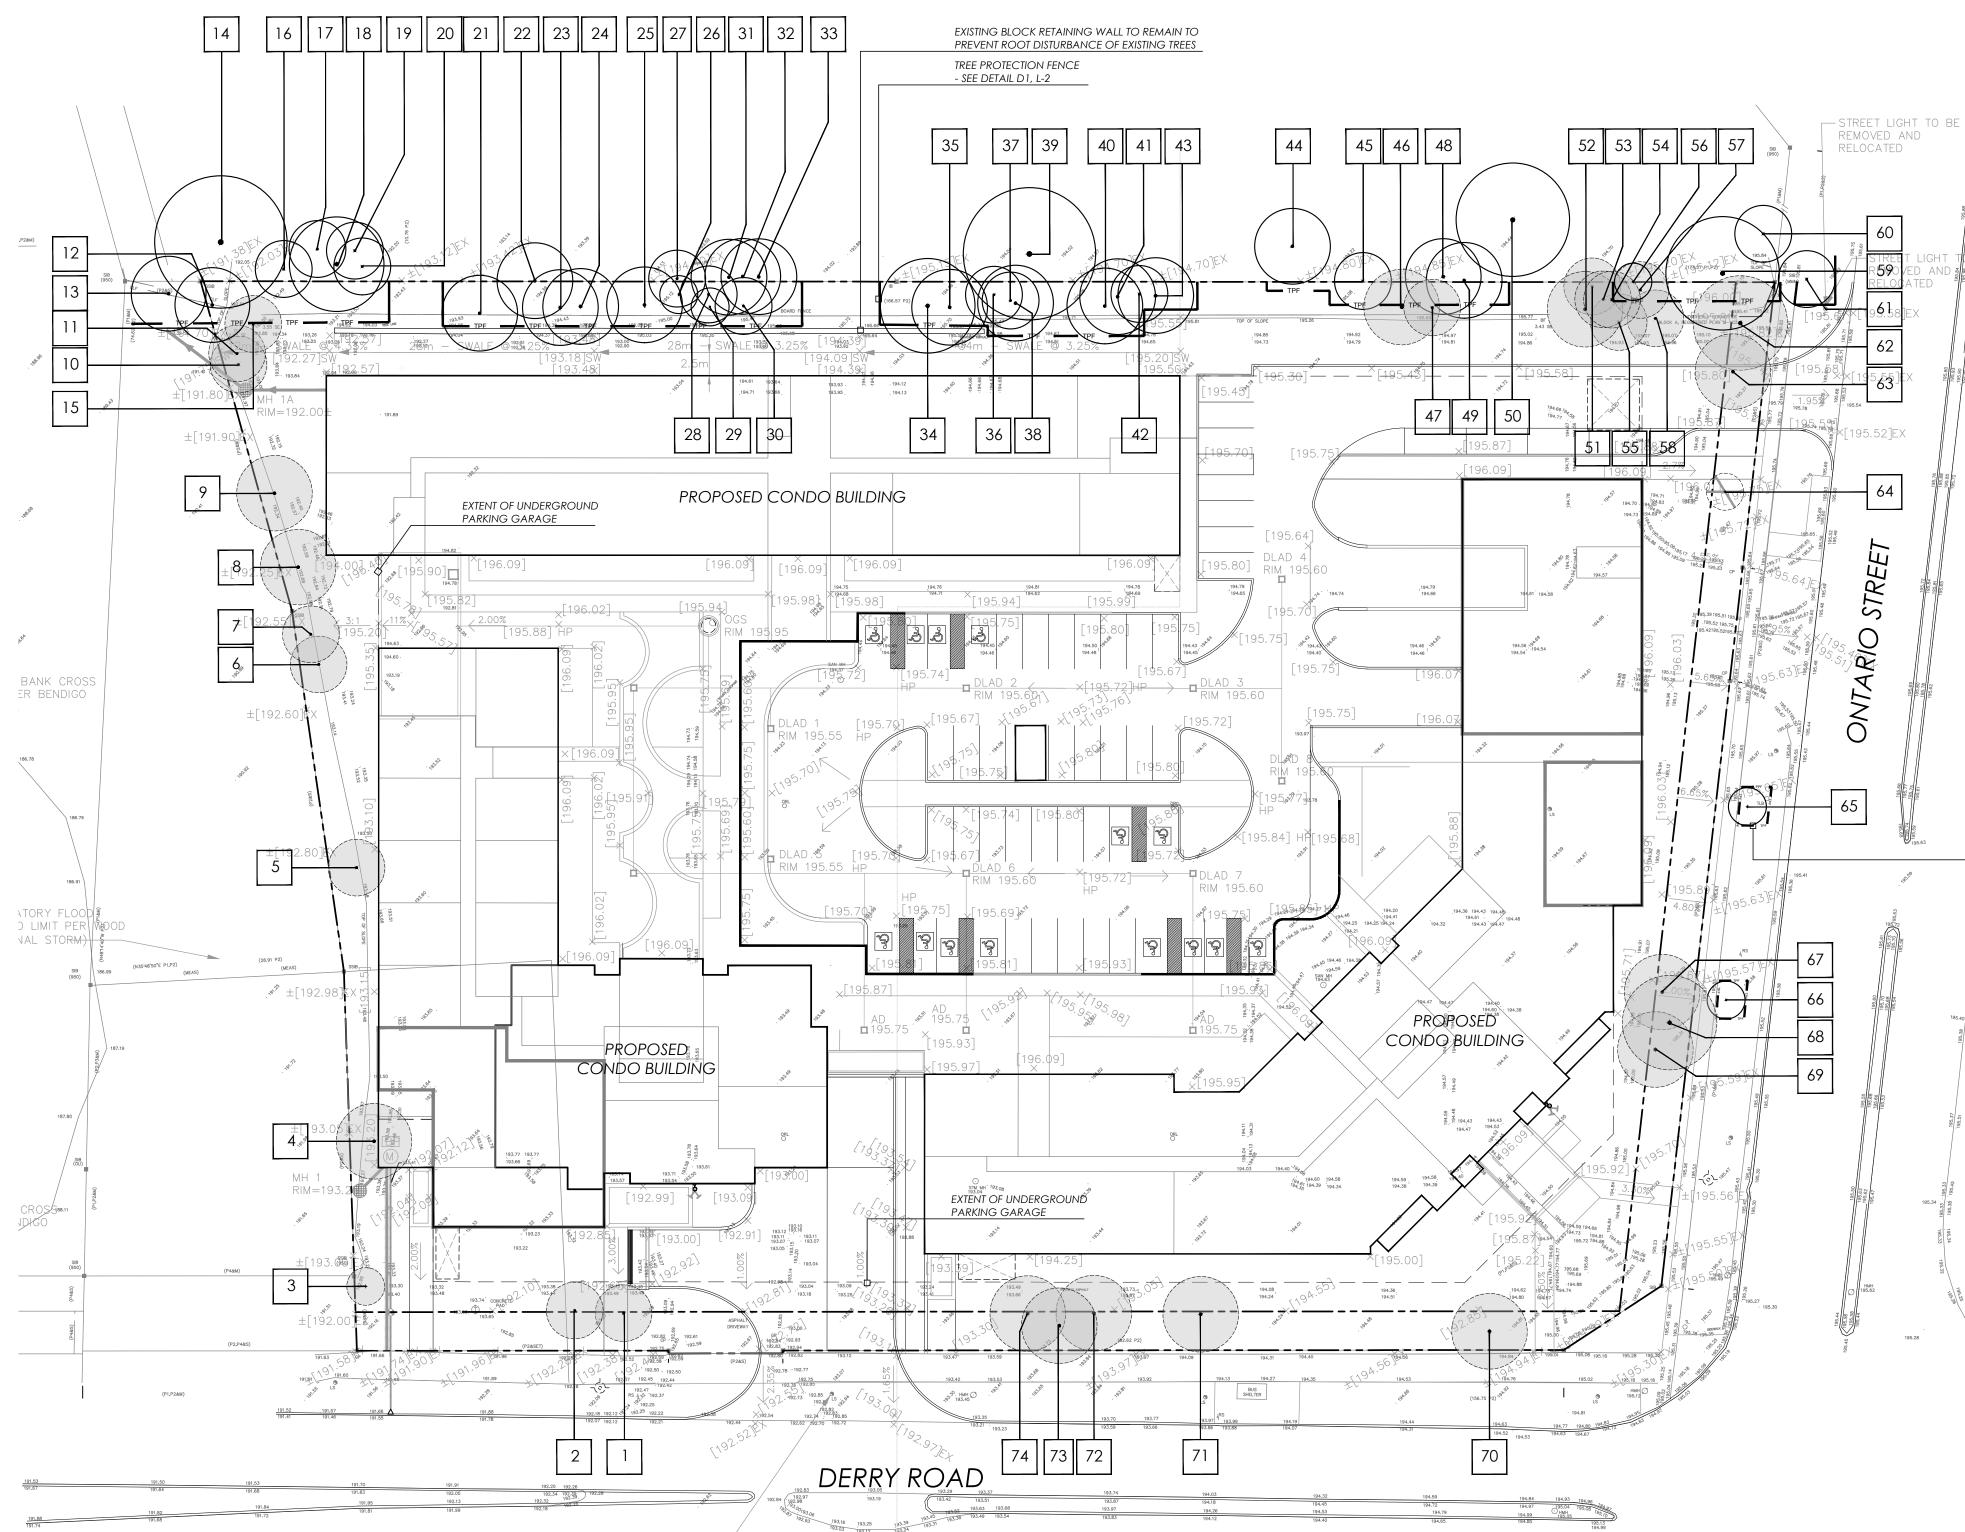
The decision to remove or retain a tree is subject to the forecasted development impacts, the structural condition of the tree (e.g. cracks, cavities, decay, weak branching, leaning, hazard potential), the biological condition of the tree (e.g. pest or disease concerns, overall health) and the suitability of the tree in its location (e.g. hardiness, soil conditions, salt tolerance, visual obstruction, available soil volume)

NOTE: Vegetation inventory undertaken by Jeremy Jackson, ISA Certified Arborist (ON-1089A) on February 10, 2021.

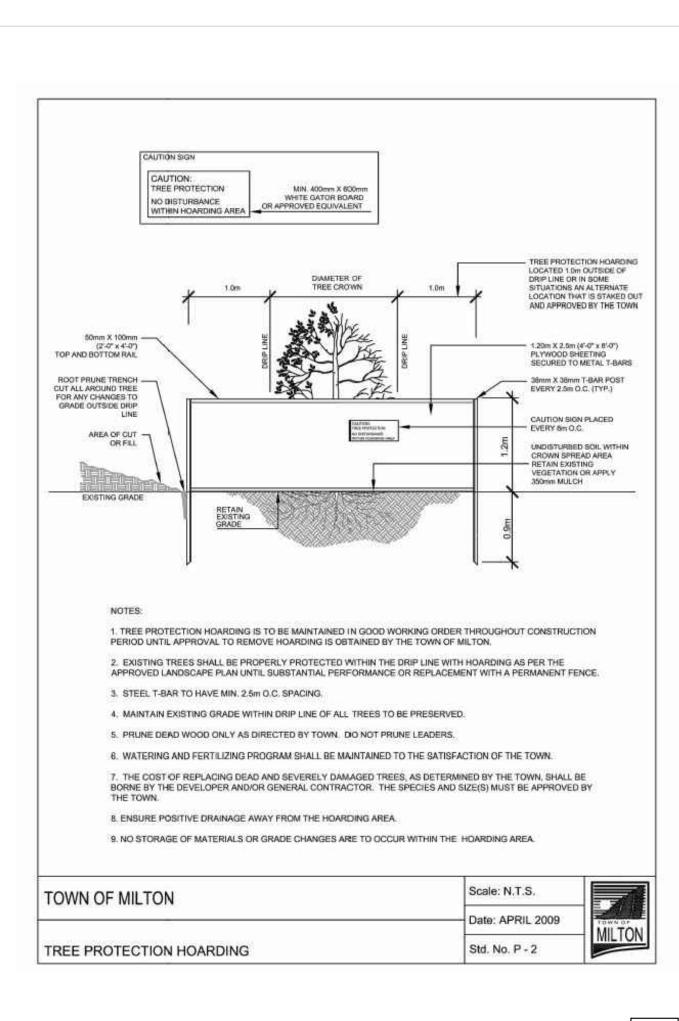
Town of Milton Tree Protection Hoarding SCALE: NTS

#### TREE PROTECTION FENCE - SEE DETAIL D1, L-2
