**Phase I Environmental Site Assessment  
7072 6<sup>th</sup> Line  
Milton, Ontario**

**Report #7231  
September 29, 2022**

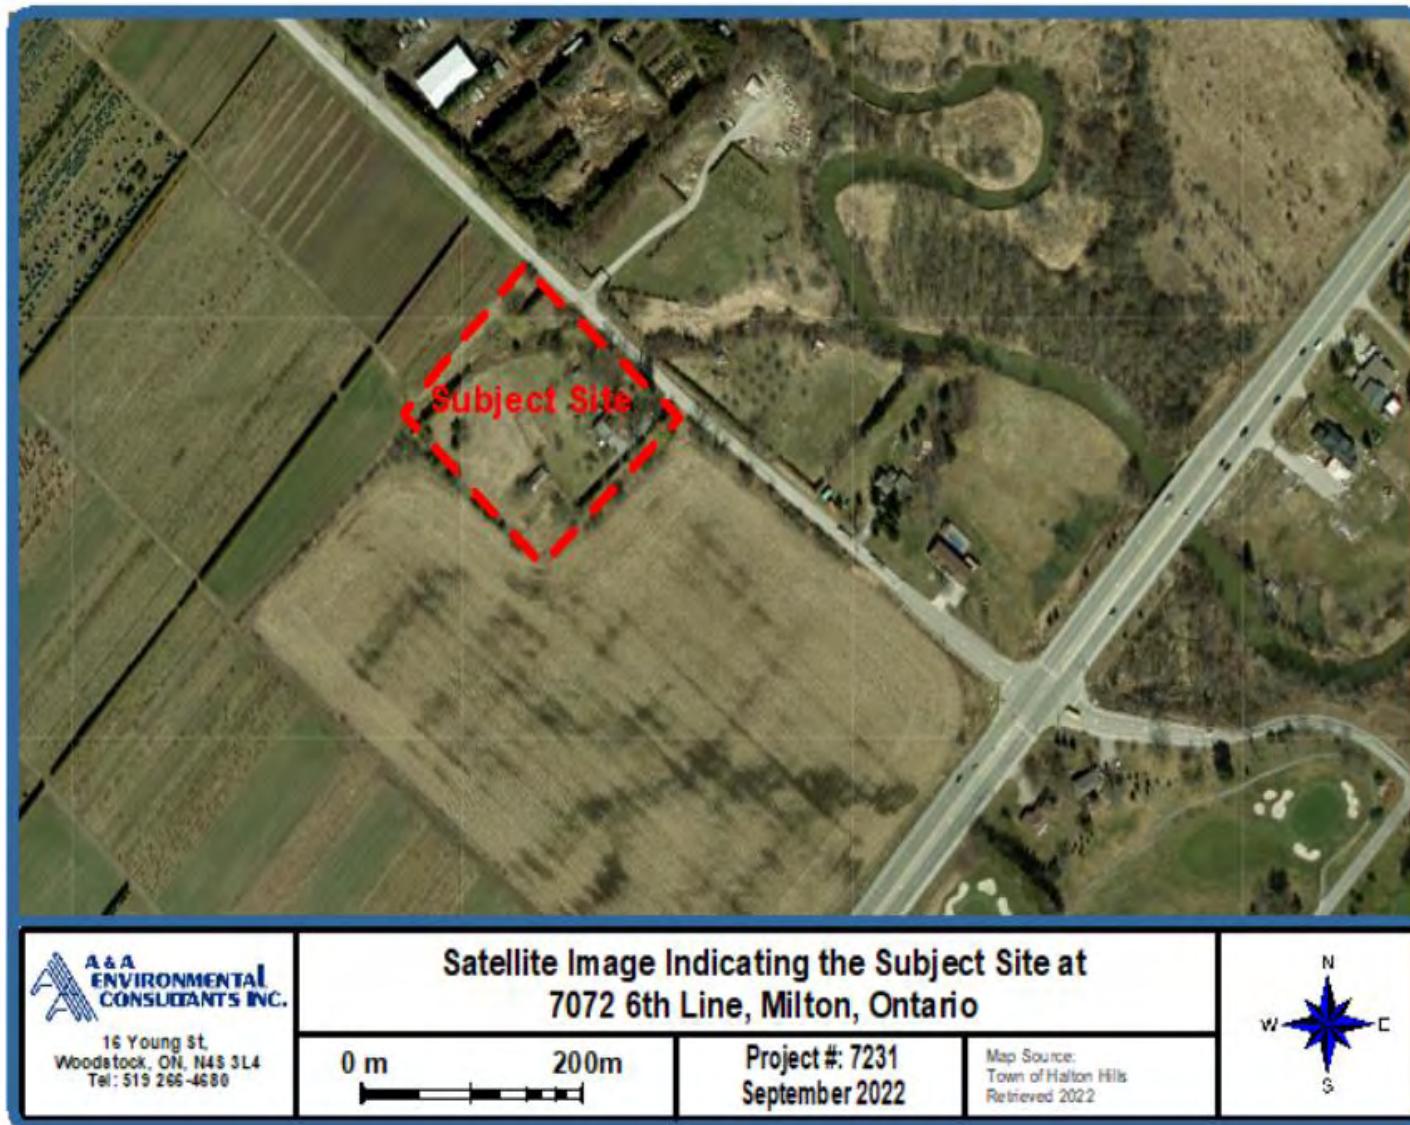
Figure 3 – Topographic Map of Subject Study Area

The topography of the subject site is fairly level, with some sloping observed to the west towards a ditch along 6<sup>th</sup> Line. The subject site is recorded as being approximately 187 masl on the topographic map (Figure 3), with the surrounding subject study area sloping from approximately 200 masl to the west to 184 masl to the east, near Middle Sixteen Mile Creek. Surface water drainage on the site is expected to flow towards a ditch along 6<sup>th</sup> Line. Within the greater subject study area, groundwater is inferred to flow east towards Middle Sixteen Mile Creek.

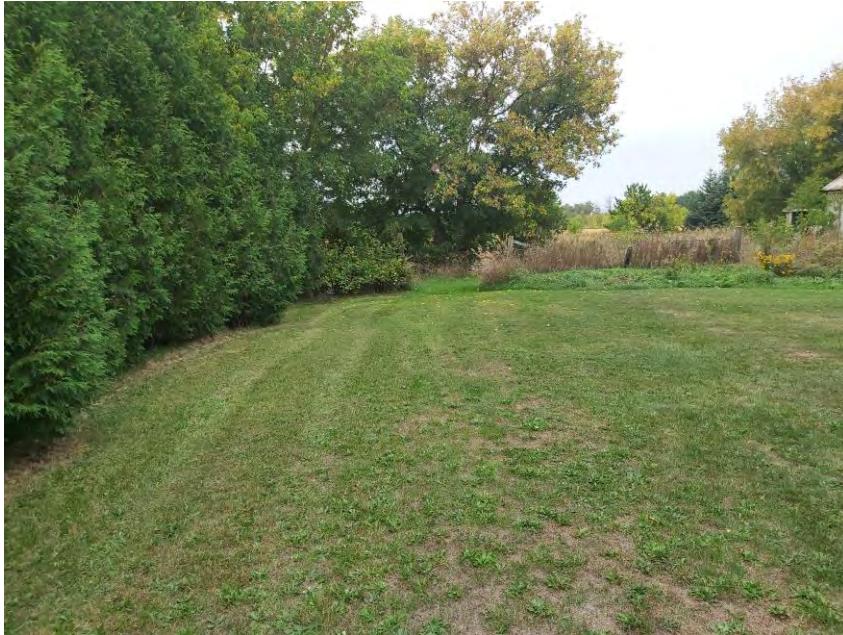
**Looking at the grass lawn area and trees/shrubs on the subject site**

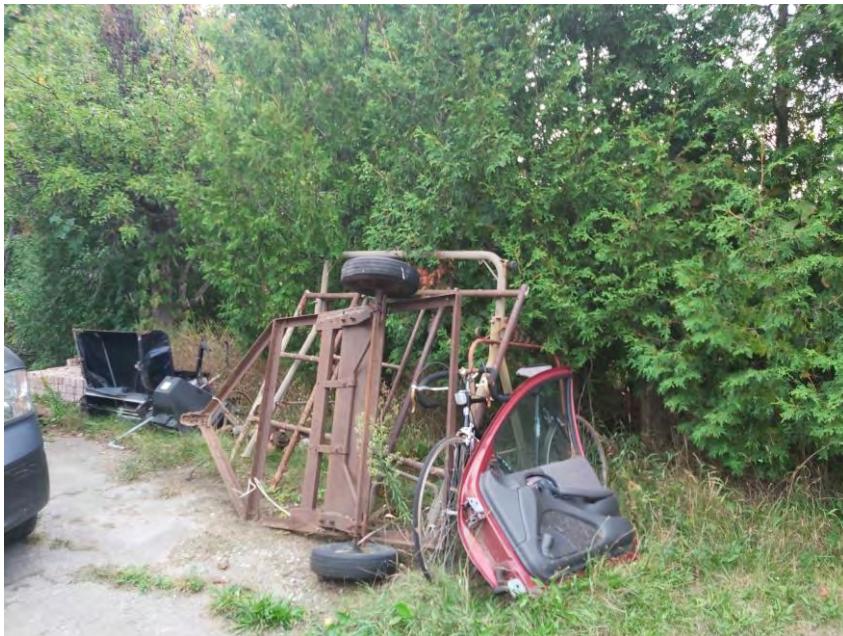
**Looking at material located outside on the subject site**

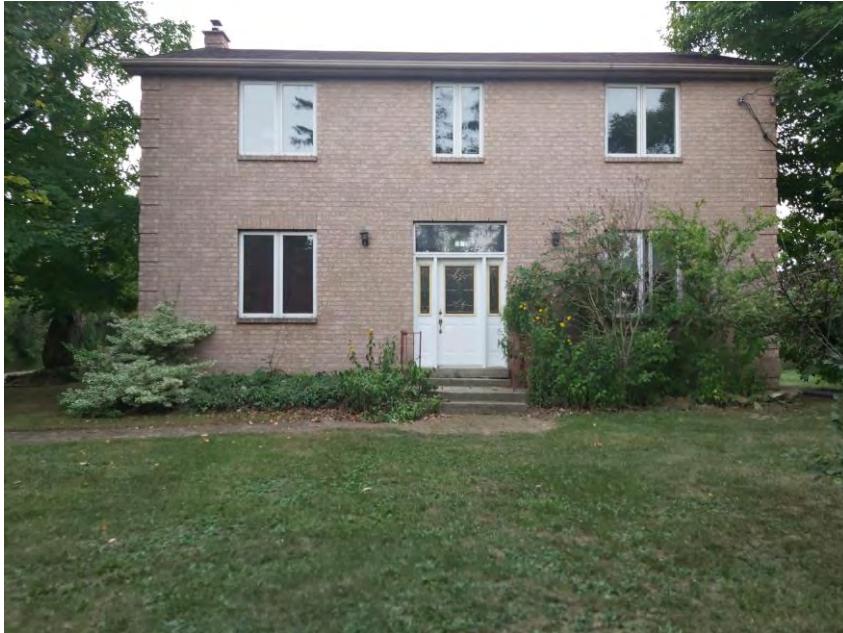
There is a one two-storey residential building on site with a basement area. The building has brick and concrete blocks walls, concrete and stone foundation and shingle roof.

**View of the residence located on the subject site**

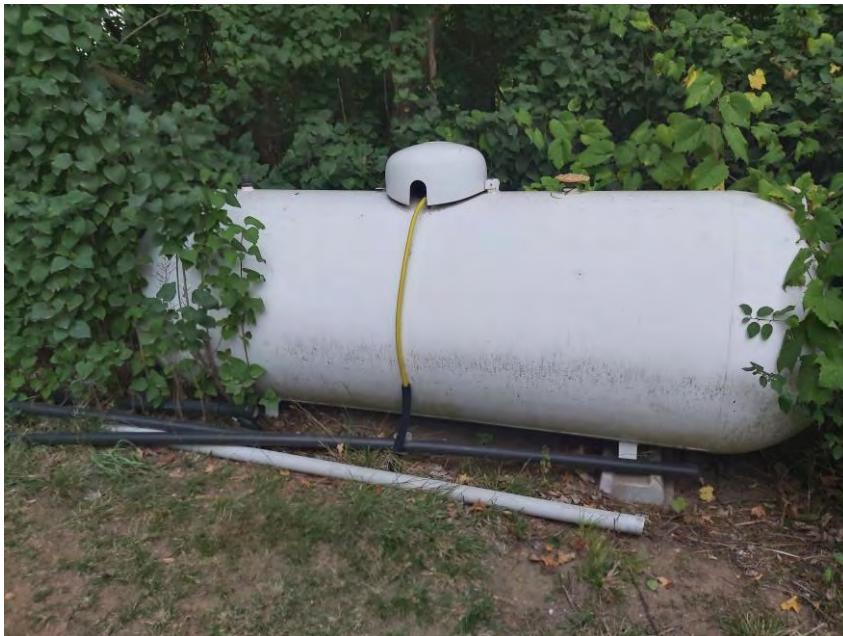
One propane AST was observed on the site. Propane is not considered to be a PCA creating an APEC on the site.

**Looking at the propane AST located on the subject site**

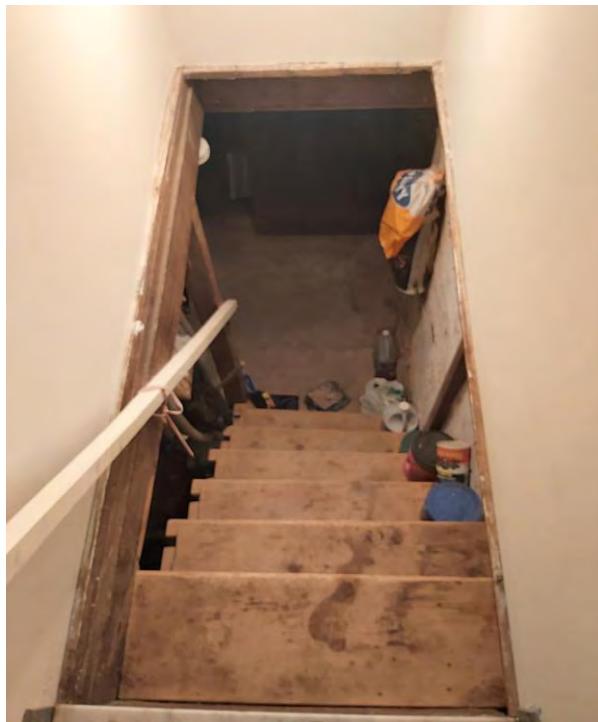
**Looking at the staircase leading to the basement**

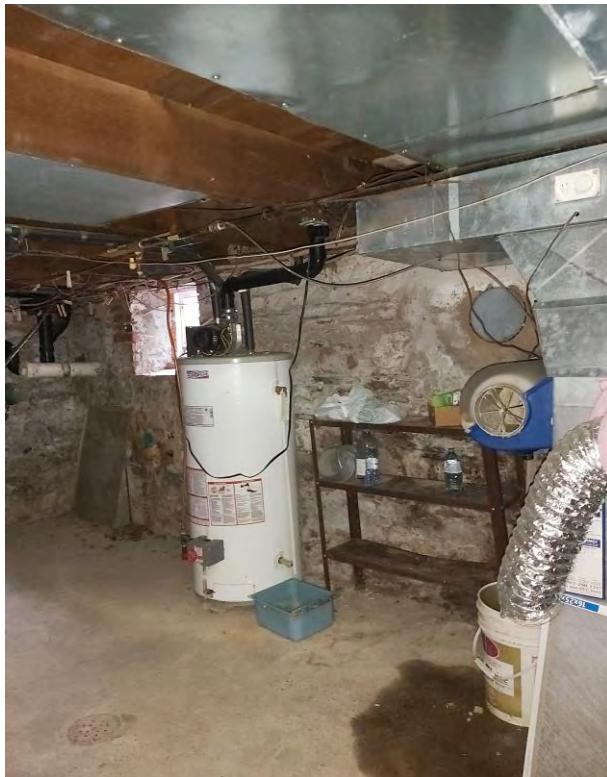
A leak was observed in the basement area adjacent to the furnace.

**View of the boiler located in the basement area on the subject site**
