# **Phase Two Environmental Site Assessment (Final)**

8995 Boston Church Road,  
Ontario L9T 9C7

**BC5L Inc.**

**25-1242-01**

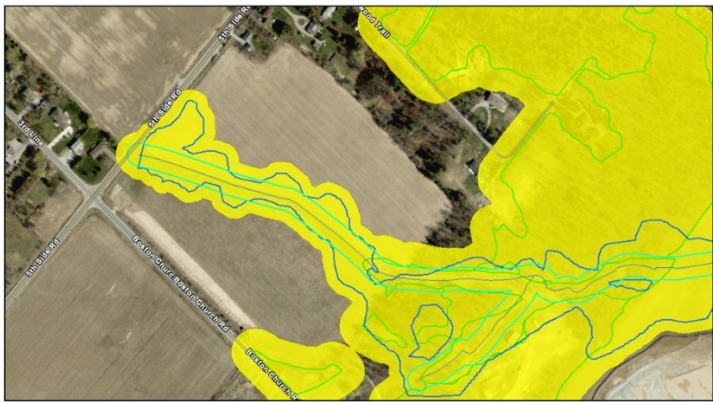
Image 1. Conservation Halton Regulation Mapping

| Condition | Evaluation |
|---|---|
| <b>Area of natural significance</b> | <p>Based on the Conservation Halton Regulation Mapping, the drainage trench and area around it in the Property lies in regulated areas.</p> <p>6/10/2025, 4:19:20 PM</p> <p> <span>Approximate Regulation Limit</span> <span>Stable Top of Bank (STOB) Hazard</span> <span>Headwater Floodplain Hazard</span> <span>Spill Lines</span><br/> <span>Shoreline 100 year Flood Elevation Hazard</span> <span>Wetland Hazard</span> <span>Meander Belt Hazard</span> <span>Waterflow</span><br/> <span>Shoreline Dynamic Beach Hazard</span> <span>Spill Zone Hazards</span> <span>Consent Conservation Halton</span> <span>Non-Regulated</span><br/> <span>Shoreline Hazard</span> <span>Floodplain Hazard</span> <span>Spill Arrows</span> <span>Regulated</span><br/> <span>Conservation Halton</span> </p> <p>0 0.03 0.06 0.11 mi<br/>1:4,514<br/>0 0.04 0.08 0.17 km</p> <p>Source: Env. Tech. Comm. Group, F.A.O. NOAA, USGS, © GeoBridging, copyright, and the GIS User Community, Conservation Halton, 2025, Peel Region, Town of Oakville, Mississauga, Conservation Halton</p> <p>Conservation Halton, 2025<br/>Conservation Halton, 2025</p> |

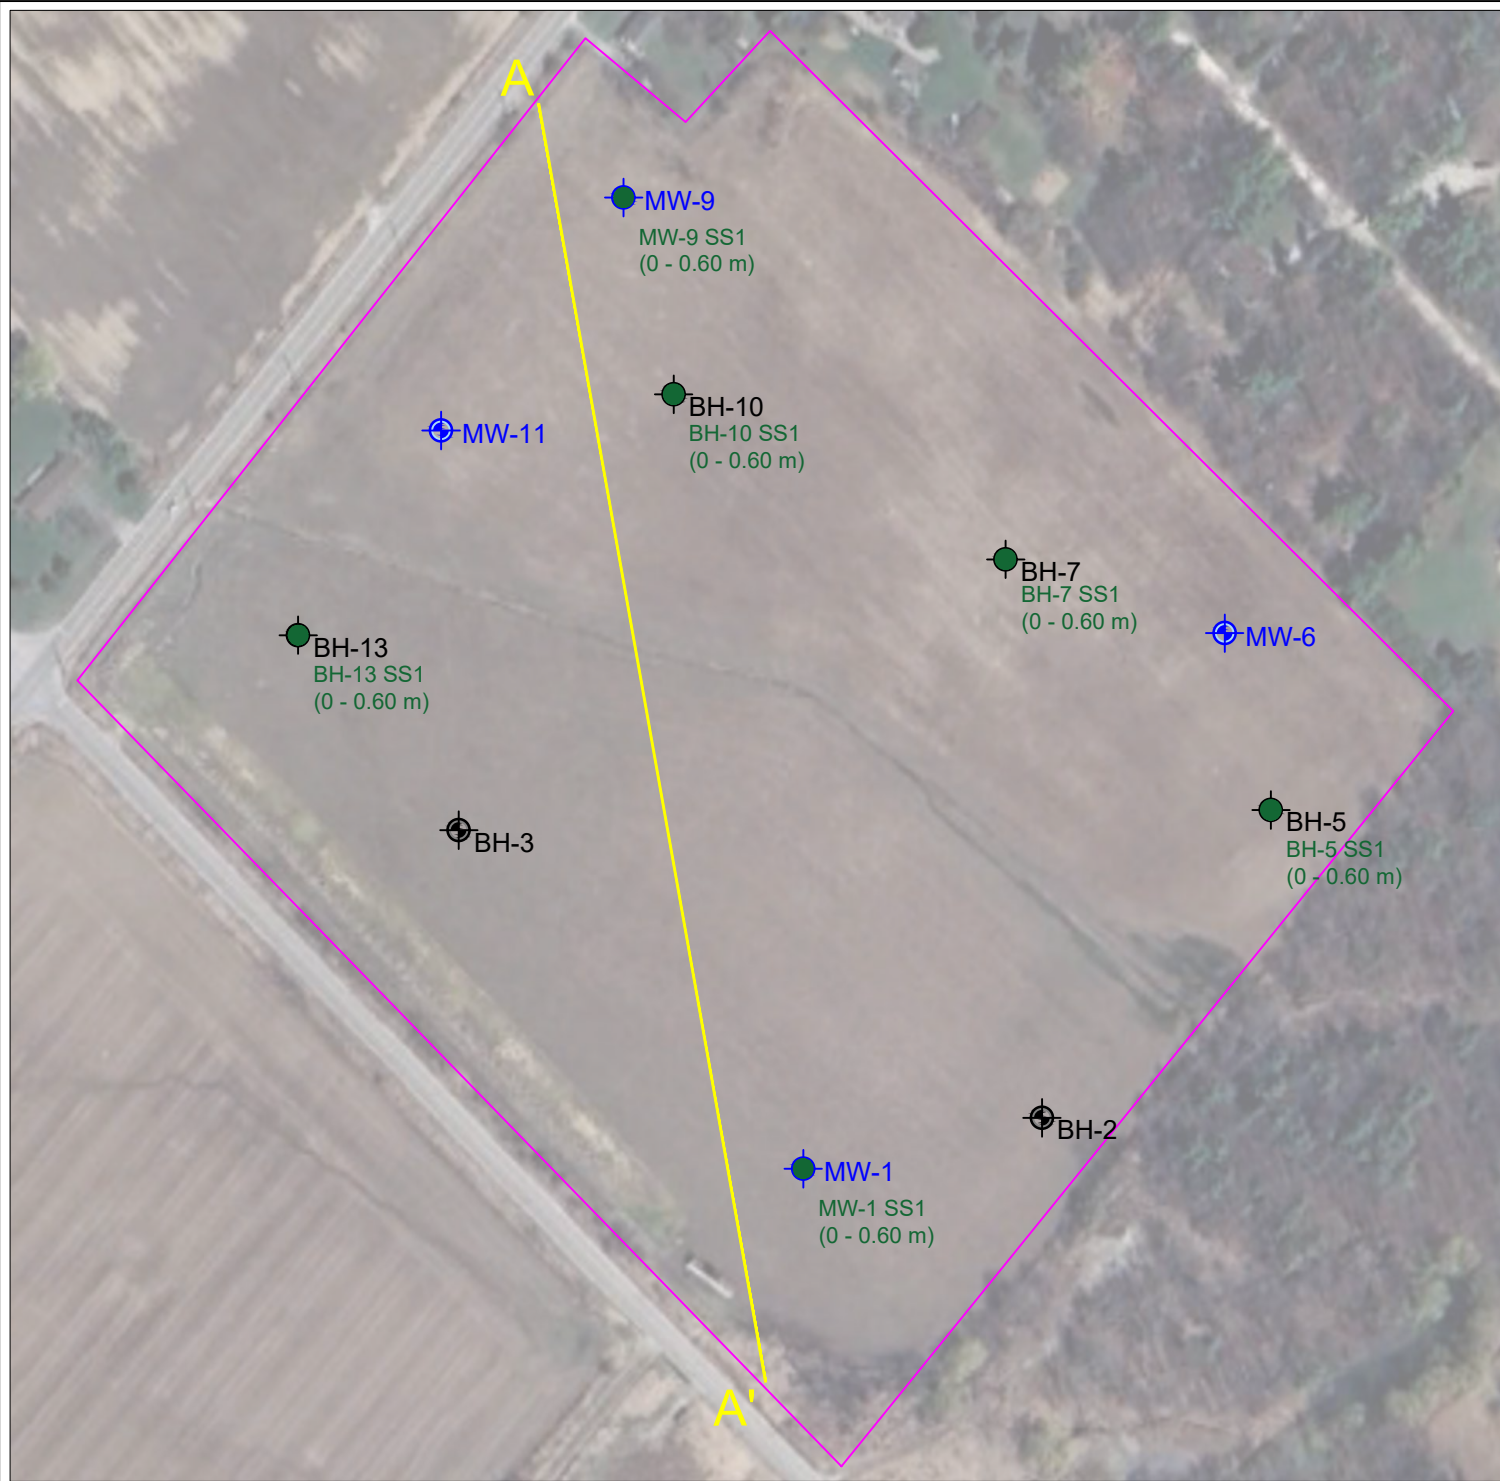
| Soil Analytical Results Metals and Pesticides | Figure 5 |

Sample ID BH1 - SS1  
(Depth) (0 - 0.60m)  
Parameter - result ug/g (55 ug/g)  
Parameter - result ug/g (Limit Table 1 SCS)

SCS (Site Condition Standards) refer to Standards of  
Table 1: : Full Depth Background Site Condition Standards – Soil (All  
Textures) – Agriculture or Other Property Use.

For the six (6) submitted samples for M&Is, all the results remained below the detection limits or fell within the specified comparison criteria, MECP Table 1: Full Depth Background Site Condition Standards – Soil (All Textures) – Agriculture or Other Property Use.

For the six (6) submitted samples for OCs, all the results remained below the detection limits or fell within the specified comparison criteria, MECP Table 1: Full Depth Background Site Condition Standards – Soil (All Textures) – Agriculture or Other Property Use.
