# Indian Creek and Sixteen Mile Creek Tributaries Fluvial Geomorphological Assessment

Milton Link  
Milton, Ontario

GEO Morphix Project No. PN26021

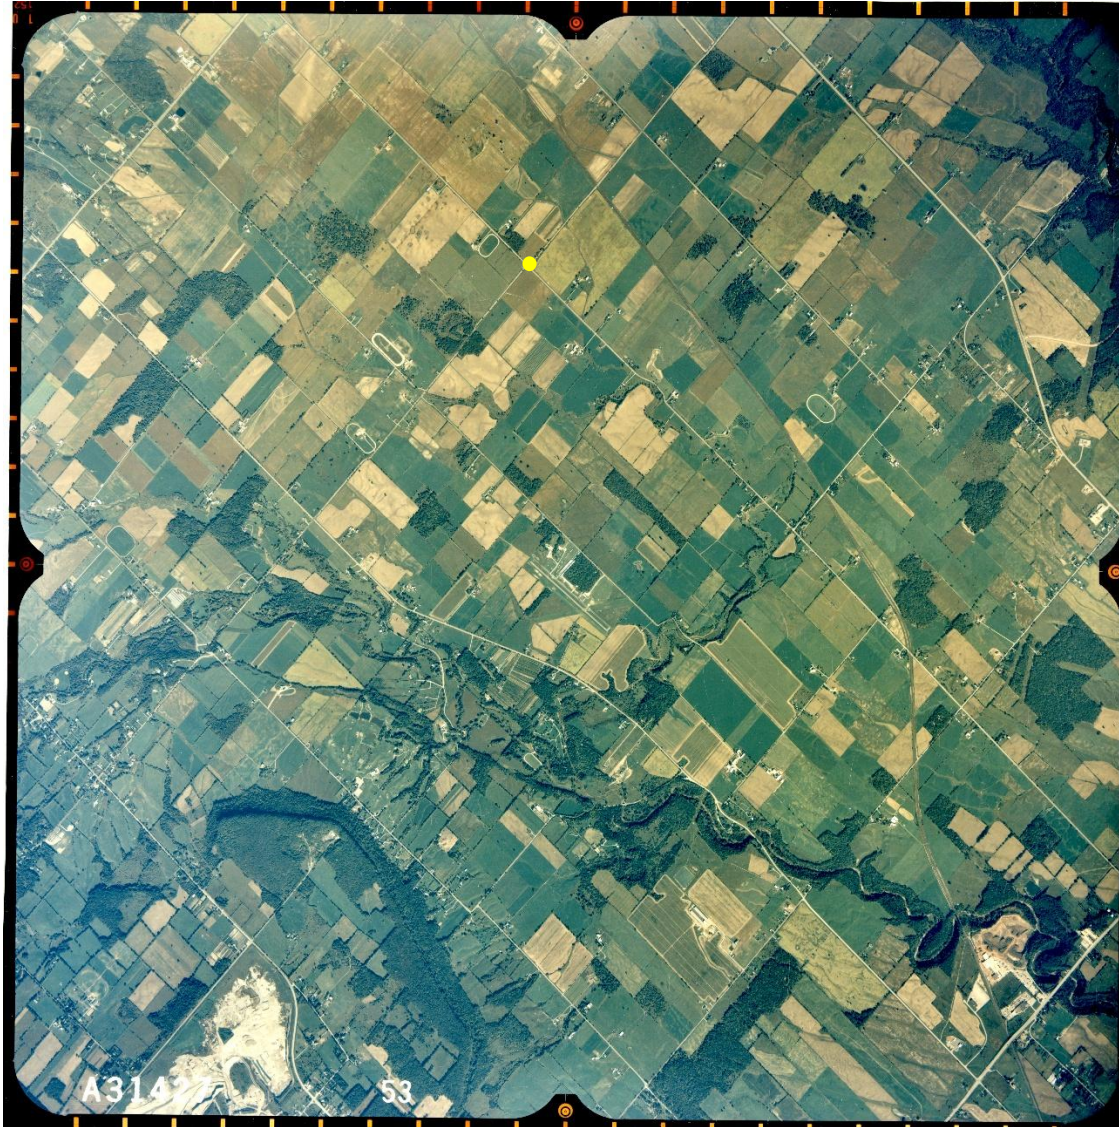
**Year:** 1985

**Location:** Town of Milton, ON

**Yellow Point:** Intersection of Tremaine Road and Britannia Road

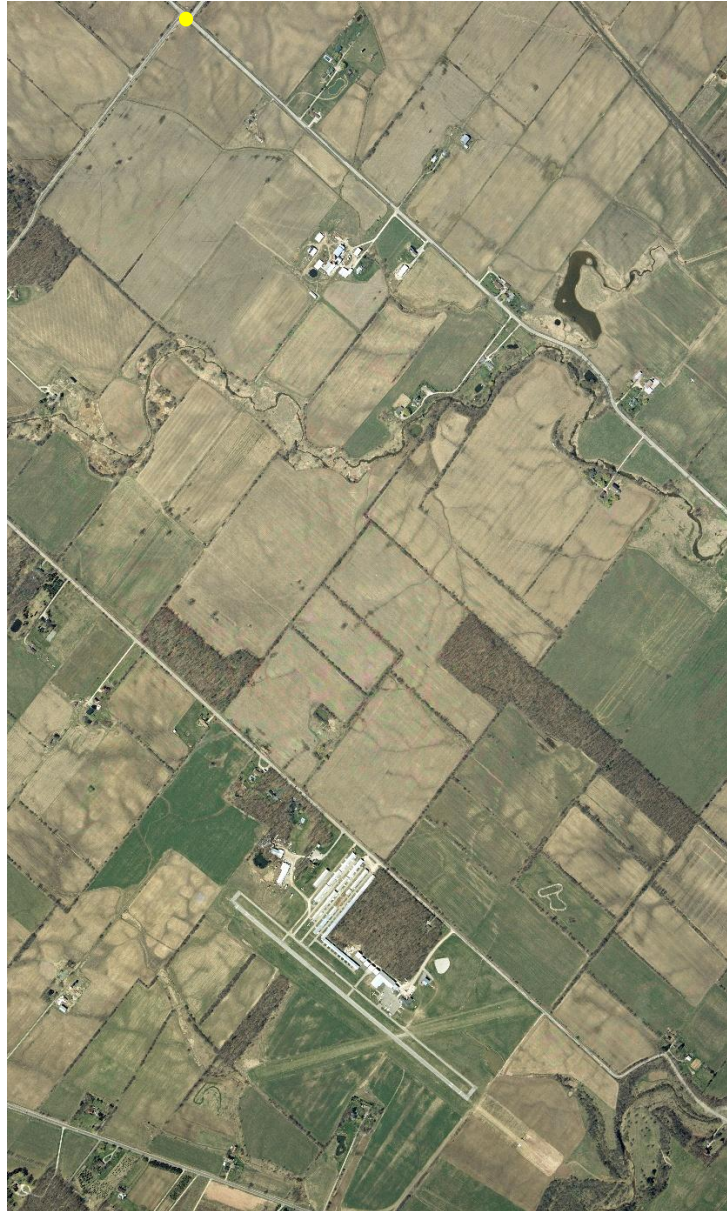
**Year:** 1999

**Location:** Town of Milton, ON

**Yellow Point:** Intersection of Tremaine Road and Britannia Road

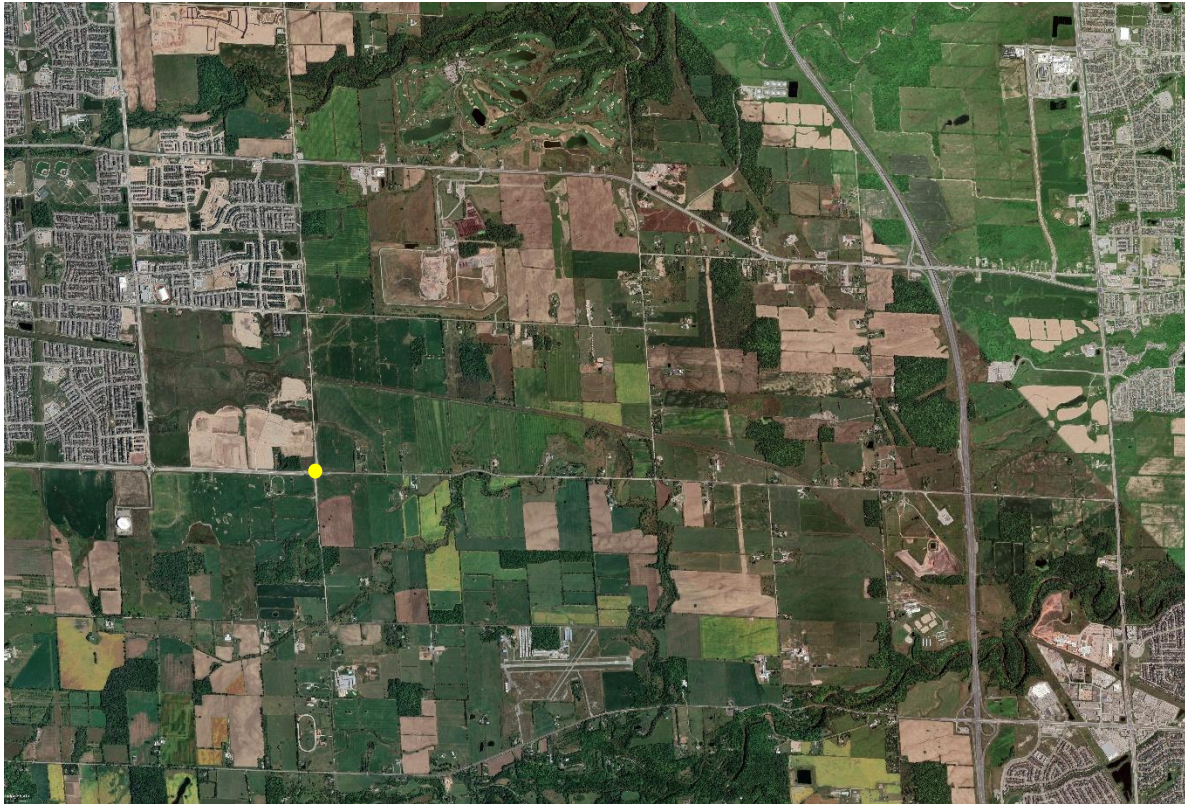
**Year:** 2020

**Location:** Town of Milton, ON

**Yellow Point:** Intersection of Tremaine Road and Britannia Road

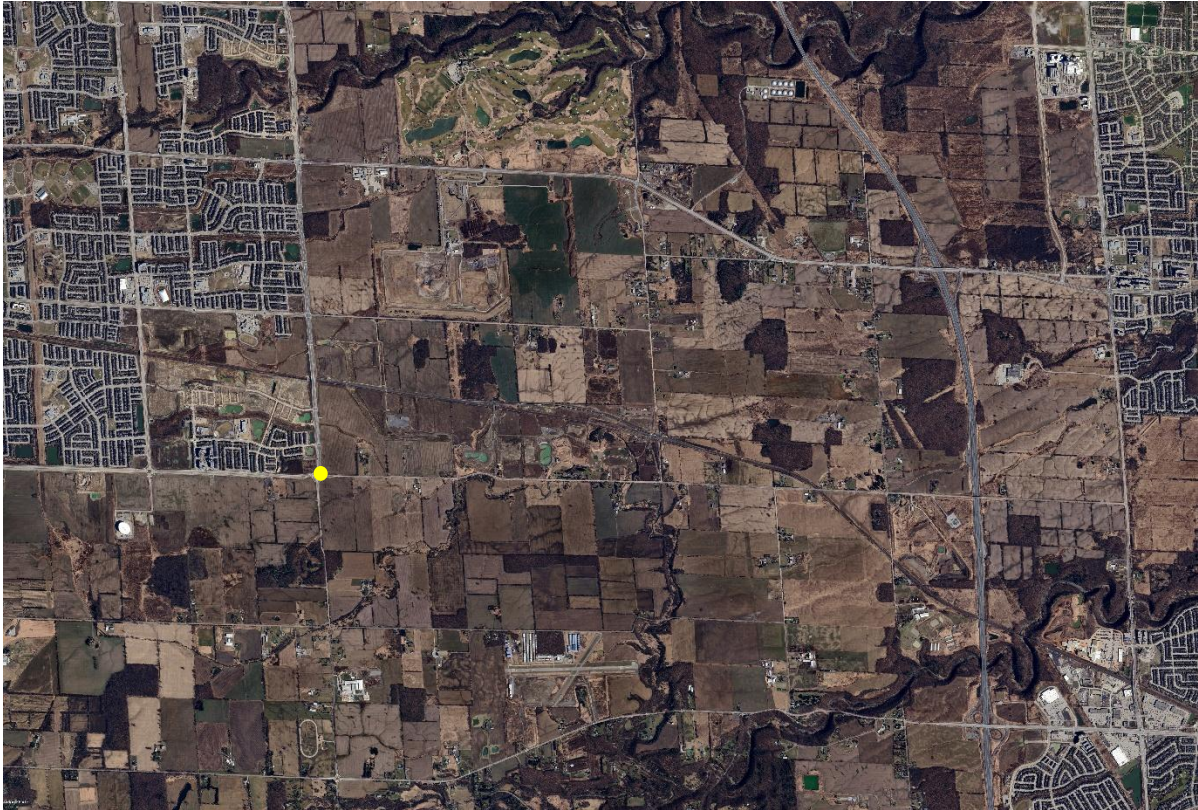
**Year:** 2024

**Location:** Town of Milton, ON

**Yellow Point:** Intersection of Tremaine Road and Britannia Road

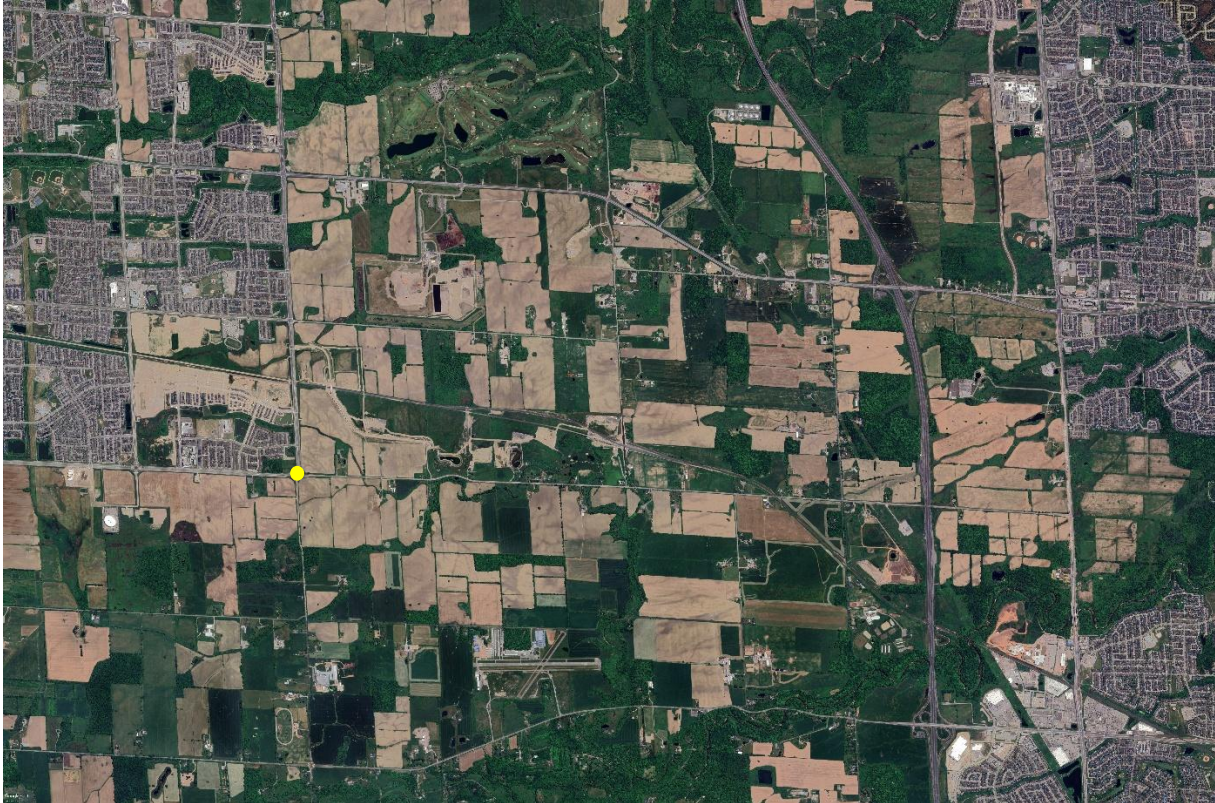
**Year:** 2025

**Location:** Town of Milton, ON

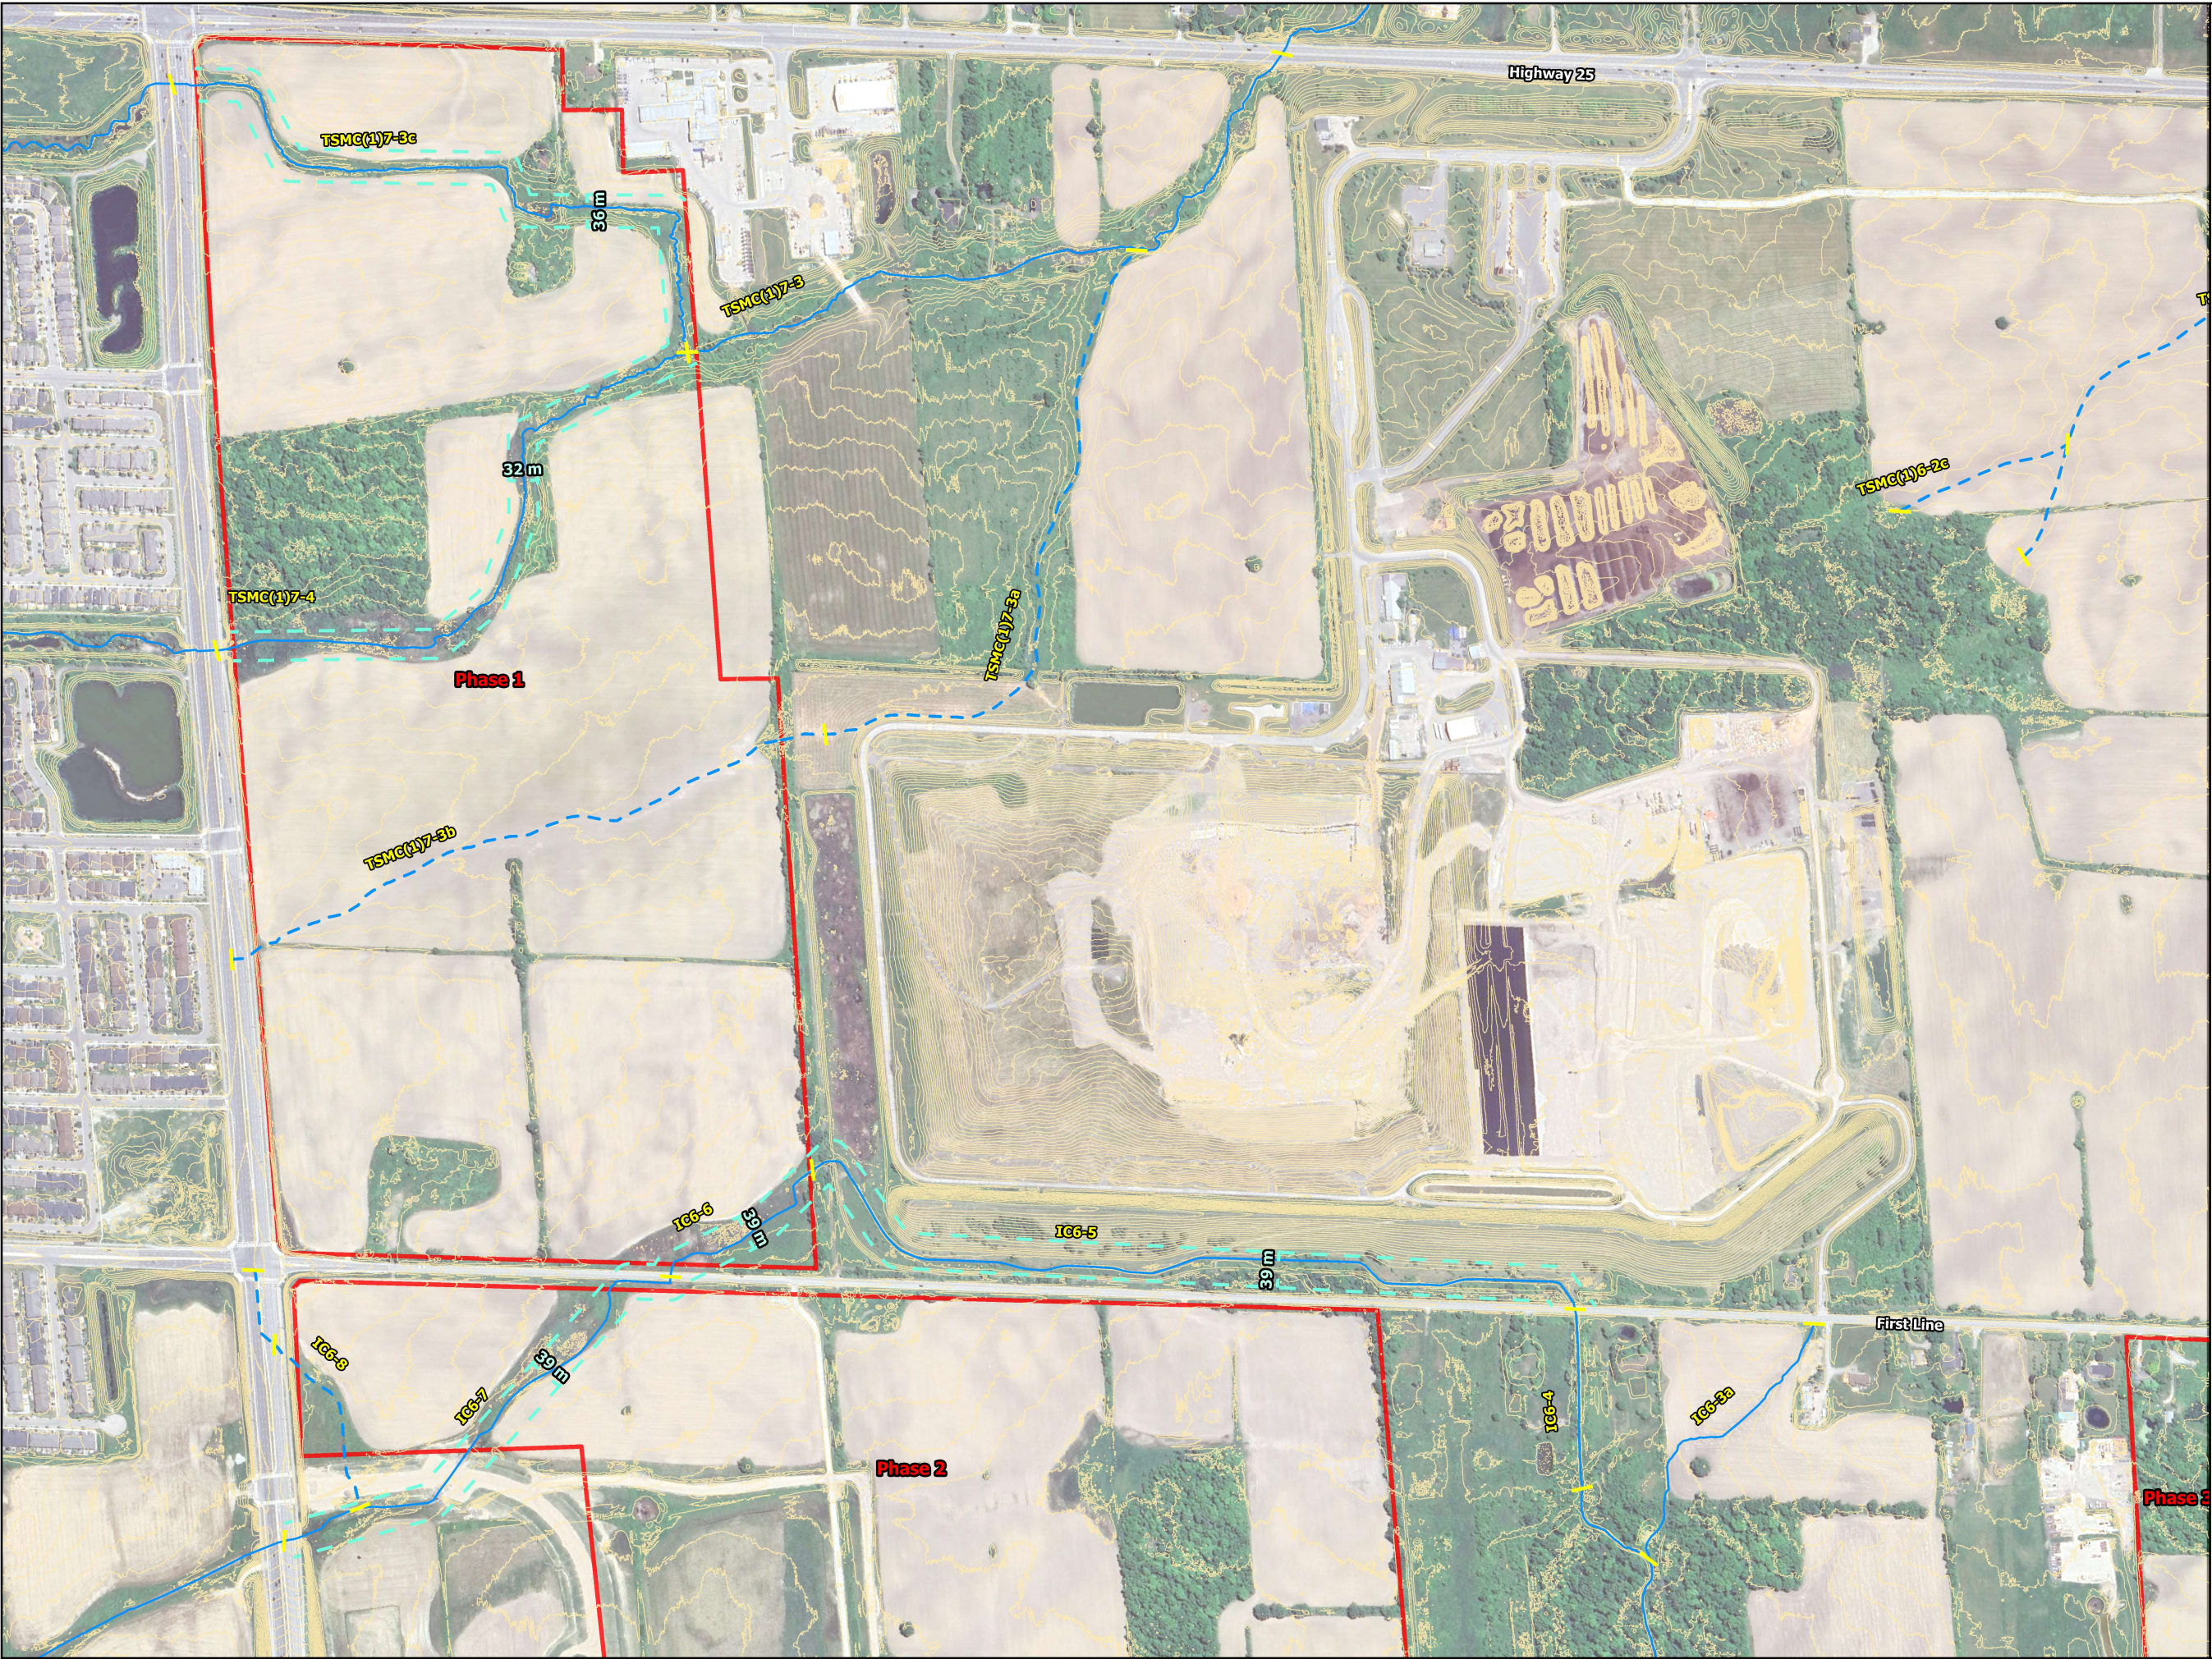
- Reach Break and ID
- 0.5 m Contour
- Watercourse (Not Field Assessed)
- Drainage Feature (Not Field Assessed)
- Preliminary Meander Belt Width
- Approximate Study Area

Based on these findings, we recommend applying a preliminary existing conditions meander belt width of 36 m for **Reach TSMC(1)7-3c** based on the Ward Drainage Area (2001) model. This recommendation is larger than the existing conditions meander belt width previously delineated for this reach under the SUS (2015). The SUS provided this meander belt width based on digital mapping sources and indicated the recommendation should be reviewed and potentially refined in future study. We therefore consider the proposed 36 m preliminary recommendation to be highly conservative and also subject to refinement in future study. We also note that this reach is proposed for realignment, as described further in **Section 6.0**. Given the potential realignment of the reach, the meander belt width is likely to be re-examined as part of the design process, given there would be possible changes to channel slope, hydrology, planform, and cross-sectional geometry of the reach, each of which would result in a meander belt width that is different from existing conditions.

We recommend applying a preliminary existing conditions meander belt width of 32 m for **TSMC(1)7-4**. This recommendation exceeds the outputs from the TRCA and Ward models.

As a conservative approach, we recommend applying a preliminary 39 m meander belt width, as calculated using the TRCA model, for **IC6-6**. Given that drainage area and flow information could not be derived for reaches **IC6-5** and **IC6-7**, we recommend applying the 39 m meander belt width for **IC6-6** to these reaches as a preliminary approach to erosion hazard delineation. This is a highly conservative approach given the gradient of **IC6-6** is substantially higher than that of **IC6-5** and **IC6-7** (0.002 and 0.003 respectively, as per 2023 LiDAR data).
