# **Heritage Impact Assessment – Milton Link**

## **Final Report**

160941099

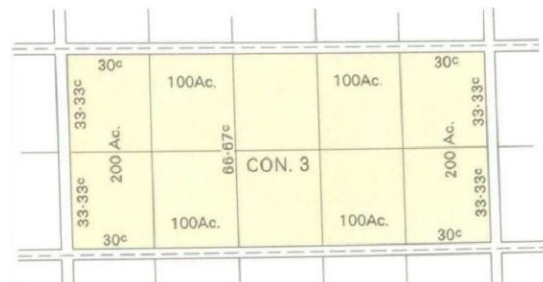
**Plate 1: Single front survey system (Dean 1969)**

The Township of Trafalgar was surveyed in two parts. Samuel Wilmot completed the first survey in 1806, using the single front system in an area in the township referred to as the Old Survey (Plate 1). The single front survey system was popular between 1783 and 1818 and used extensively along the north shore of Lake Ontario, creating deep and narrow lots with road allowances fronting each concession and every fifth lot (Dean 1969, Weaver 1968: 14). Prior to the first survey, as early as the 1790s, squatters were noted in the township (Case 1970). The township was named Trafalgar in honour of the Battle of Trafalgar, that was part of the naval campaign of the Napoleonic Wars and took place on October 21, 1805, when the Royal Navy battled a combined fleet of French and Spanish ships. The battle resulted in a widely celebrated British victory under the leadership of Vice-Admiral Horatio Nelson, who was mortally wounded in battle. The Township of Trafalgar and the adjacent Township of Nelson were named in honour of the victory (Gardiner 1899: 243-244). The remainder of the township was surveyed in 1819, using the double front system (Plate 2). The double front survey system was used in Upper Canada between 1815 and 1829. Each lot contained 200 acres of land and measured 30 chains by 66.67 chains with a road allowance in front of each concession and every fifth lot (Weaver 1968: 15-16).

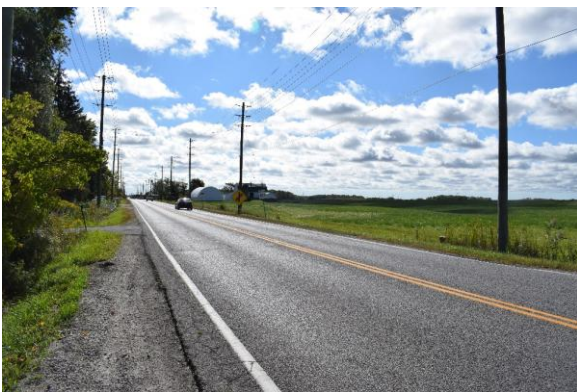
**Photo 1: Tremaine Road, looking southwest**

Adjacent to the Study Area Tremaine Road is a two-lane roadway paved with asphalt with gravel shoulders and hydro poles on its west and east sides (Photo 1 and Photo 2). Between Burnhamthorpe Road West and Lower Base Line Road West, it traverses a rural landscape with large farmstead parcels including severed properties with mid to late 20<sup>th</sup> century residences and contemporary residential infill lots. The CN Railway line crosses Tremaine Road just south of 2<sup>nd</sup> Side Road.

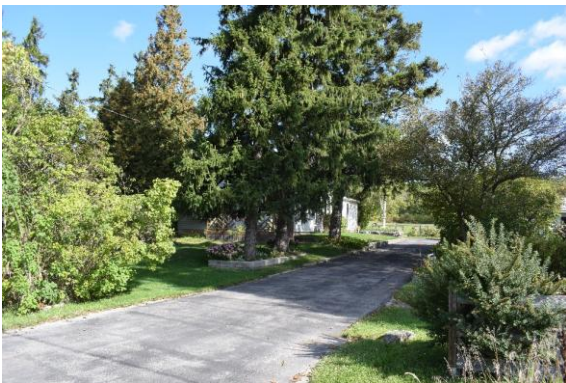
**Photo 3: Driveway, looking northeast**

The property contains a residence and an outbuilding. Views of the residence are obstructed from the public right of way by vegetation including a mixture of deciduous and coniferous trees and bushes. The property has an asphalt driveway, wood fencing, and ornamental gardens (Photo 3). The outbuilding was constructed after 1972 and is a one storey structure with a gable roof clad with asphalt shingles (Photo 4). Its exterior is clad in vinyl siding.

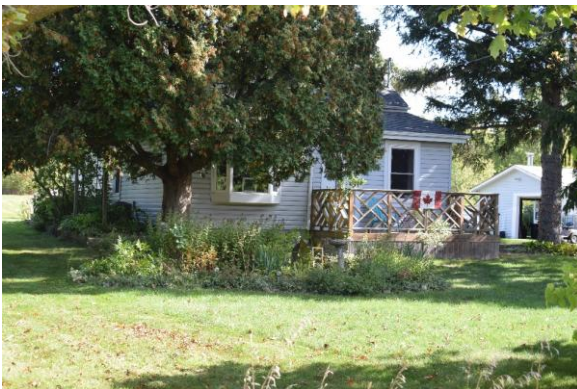
**Photo 5: Front and north elevations, looking southeast**

The residence is a one and one half storey structure with a medium-pitched side gable roof with asphalt shingles (Photo 5 to Photo 7). The structure has a vinyl siding exterior with vinyl windows. The front (west) façade has a central entrance with a replacement door. A one storey addition joins the rear elevation. The structure has a parged foundation.

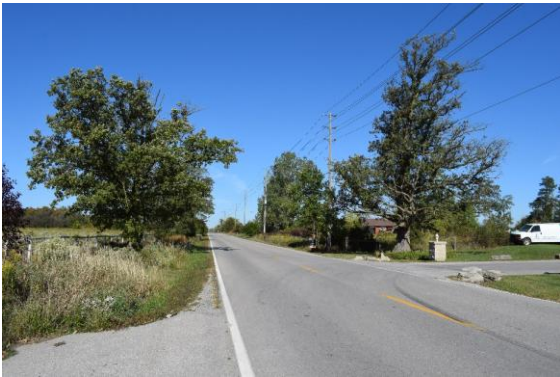
**Photo 8: First Line, looking northeast**

First Line, between Lower Base Line Road West and Britannia Road, is a two-lane roadway with gravel shoulders and hydro poles mostly on its east side (Photo 8 and Photo 9). The roadway transverses a rural landscape with larger farmstead parcels and agricultural fields, mixed with smaller severances with mid to late 20<sup>th</sup> century and contemporary residential infill lots.

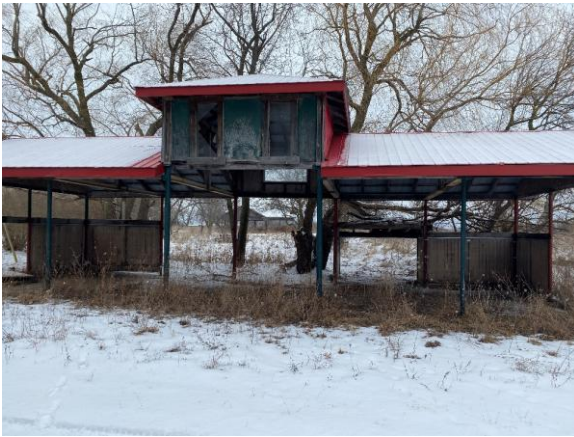
**Photo 16: Equestrian outbuilding,  
looking south**

The property contains a residence, barn, horse arena, outbuildings, and fields. The outbuildings and the layout of the property are associated with its former use as an equestrian facility. The structures on the property are set back from First Line and accessed by a long tree-lined driveway that is flanked by fields (Photo 10 and Photo 11). To the north of the driveway before residence is an enclosed area with a pool, pool house, and metal chain link and wood fencing (Photo 12 and Photo 13). Across from the driveway from the pool area is a wood pavilion structure with a cross gable roof (Photo 14 and Photo 15). The property contains several small outbuildings related to its former use as an equestrian facility (Photo 16 and Photo 17). These are wood and steel frame structures with wood and metal cladding.

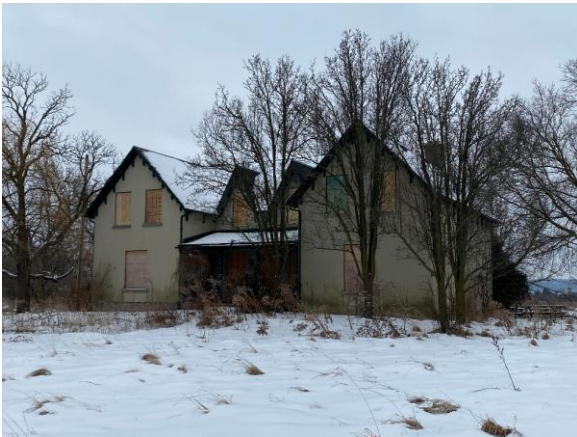
**Photo 18: Residence, looking southwest**

The residence is a one and one half storey structure with a cross gable roof with asphalt shingles (Photo 18). The west (rear) elevation has two contemporary brick chimneys at each gable peak. The south chimney stack is exposed, while the north chimney stack top is visible from the exterior at the gable peak. The structure has an I-shaped plan. It has a stucco exterior with a rubble stone foundation that is parged with concrete (Photo 19). All windows and doors on the exterior have been boarded-up. They are all in rectangular openings with replacement metal windows.

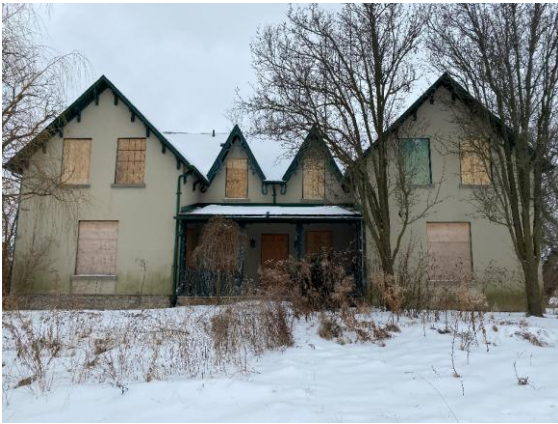
**Photo 20: Front façade, looking west**

The front (east) façade has three separate bays (Photo 20). The north and south bay each have a front facing gable, while the centre bay has a covered partial porch with paired gable peaks. The gabled eaves have decorative wood brackets and the two gable peaks have wood bargeboard. The gabled bays have a paired windows on the first storey and two windows on the second storey. The central bay has a covered wood porch on a concrete and stone foundation with wood columns (Photo 21). The porch has exposed decorative wood rafters (Photo 22). The south and central entrance each have a wood panelled entry door. The central entry door is flanked by two windows.

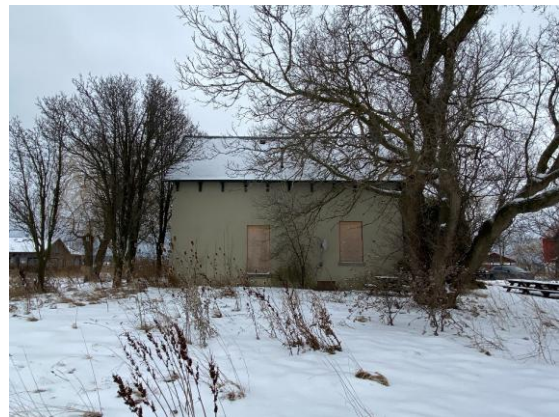
**Photo 23: North elevation, looking south**

The north elevation has two first storey windows and a basement window (Photo 23). The rear elevation is a simpler version of the front façade with no decorative brackets or gable peaks (Photo 24). The rear façade has three separate bays. The north and south bay each have a rear facing gable. The north gabled bay has a one window on its first storey, and two on its second storey. The south gabled bay has two second storey windows. The central bay has a covered wood porch on a stone foundation (Photo 25). The wood porch has exposed decorative rafters (Photo 26). The north entry door is wood panelled with 12 lites. The basement is accessed from the porch by a set of concrete and stone steps (Photo 27). The south elevation has decorative wood brackets and a centre gable peak with decorative bargeboard (Photo 28 and Photo 29). The exterior has two first storey windows and one window on the second storey in the gable peak.

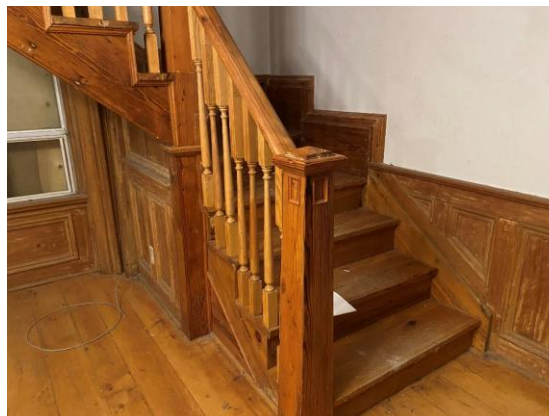
**Photo 33: Central front hall staircase with boxed newel**

The first storey of the residence contains a central front hall with staircase to the second storey flanked by rooms in the gabled bays (Photo 30 to Photo 33). A dinning room and kitchen is located in the north gabled bay (Photo 34 to Photo 41), and two living room areas and a central powder room are located in the south gabled bay are (Photo 42 to Photo 50). Throughout the first storey is original or period appropriate wood flooring, wood baseboard, wood window and door mouldings, and interior wood doors. The front hall has a wood quarter landing staircase with boxed newel and wood balustrades. The kitchen has contemporary tile flooring, a wood built-in pantry, wood kitchen cupboards, and a door over the west window. Between the north and south living room is a small powder room with contemporary tiling. The north living room has a small brick fireplace with marble hearth and cladding, and a wood mantle.

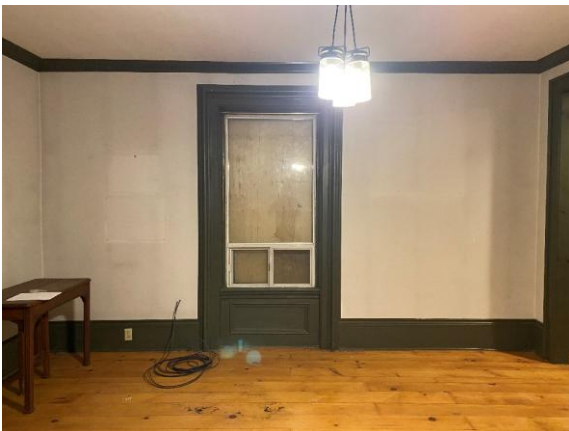
**Photo 44: Front living room, looking south**

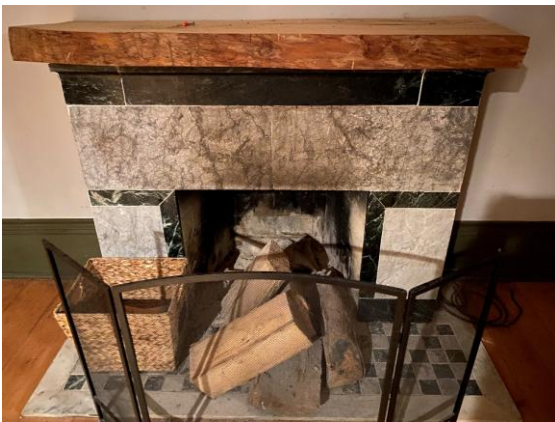
**Photo 50: Close-up of rear living room fireplace, looking west**

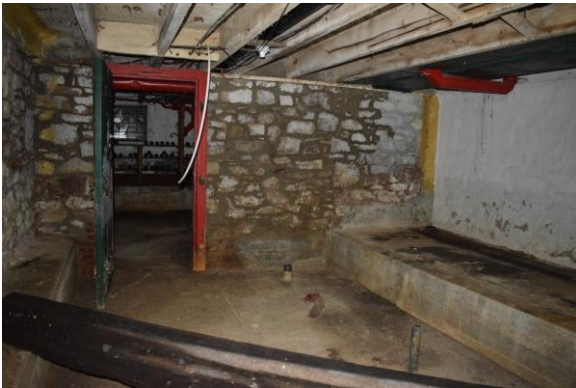
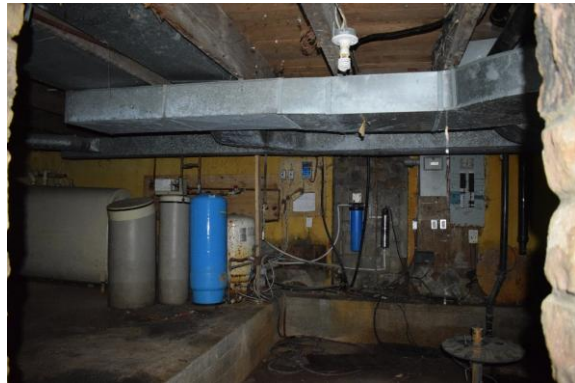
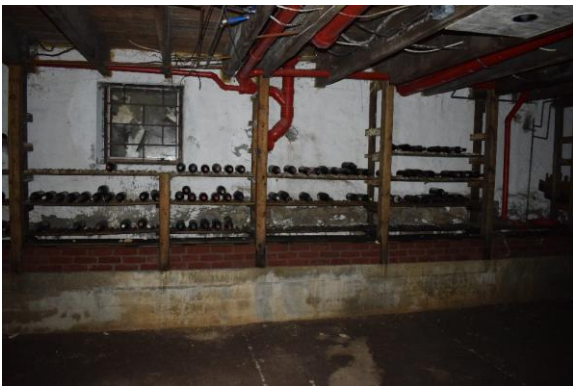
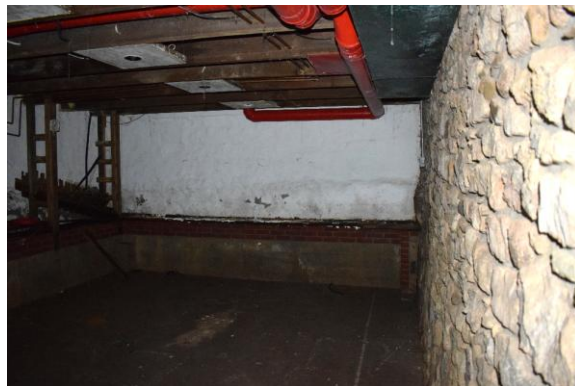
**Photo 62: Basement central portion, looking northeast**

**Photo 63: Basement south portion, looking south**

**Photo 64: Basement north portion, looking north**

**Photo 65: Basement north portion, looking east**

rubble stone foundation walls, with areas of parging and red brick (Photo 62 to Photo 66). The first storey is supported by machine cut wood beams (Photo 67 and Photo 68).

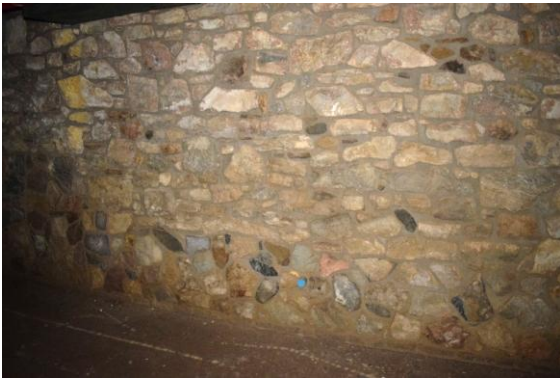
**Photo 66: Basement north portion rubble stone wall, looking southeast**

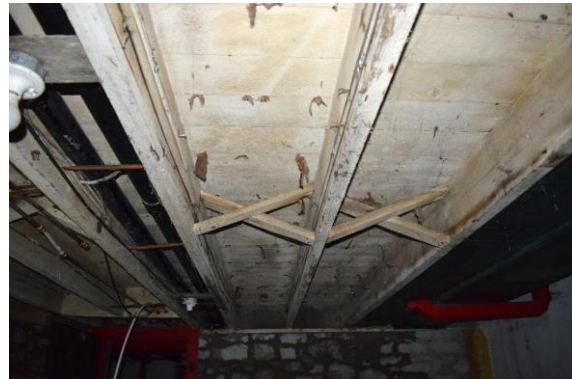
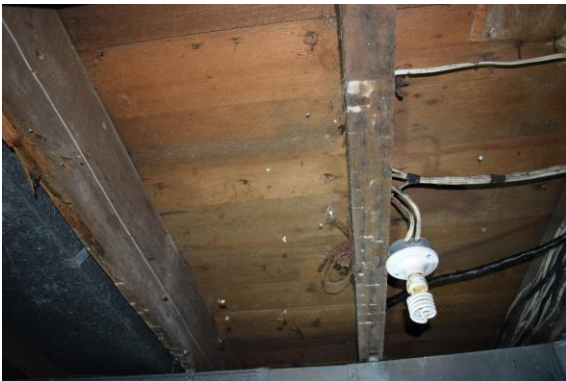
**Photo 67: Basement joists**

**Photo 68: Basement joists**

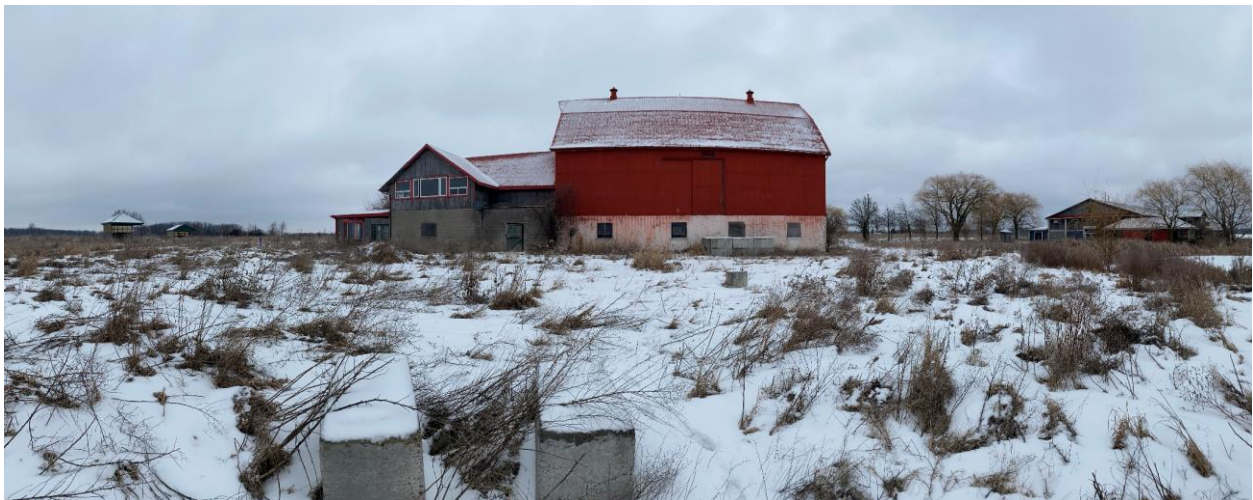
**Photo 69: Barn, looking east**

The barn is composed of an original south portion with a gambrel roof and a north addition with a cross gable roof (Photo 69). The original portion of the barn is clad in metal and has two metal ventilators. The exterior of the barn is clad with metal, and it has a concrete block foundation (Photo 70 to Photo 73). The lower storey within the concrete block foundation has rectangular window openings with concrete sills. Some of the windows are wood frame while some have been boarded up. An entrance on the

south elevation has a set of wood double doors. Access to the upper storey is through central sliding doors on the west and east elevations. The east elevation has a steel staircase that provides access to the upper storey.

The 19<sup>th</sup> century barn at 5122 First Line was modified in the late 20<sup>th</sup> century with a concrete block foundation, steel beams in its lower storey, metal cladding, and a rear addition. Its heritage integrity has been compromised through these alterations.

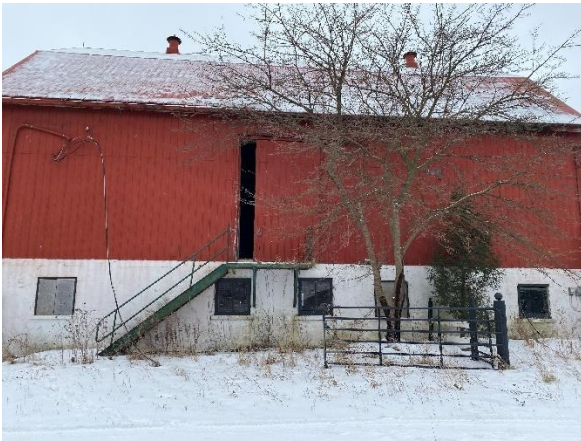
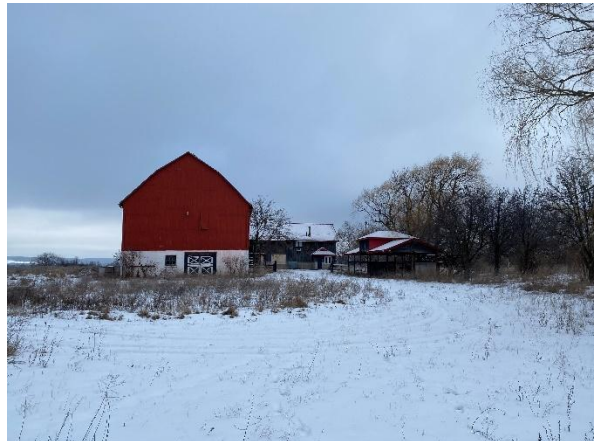
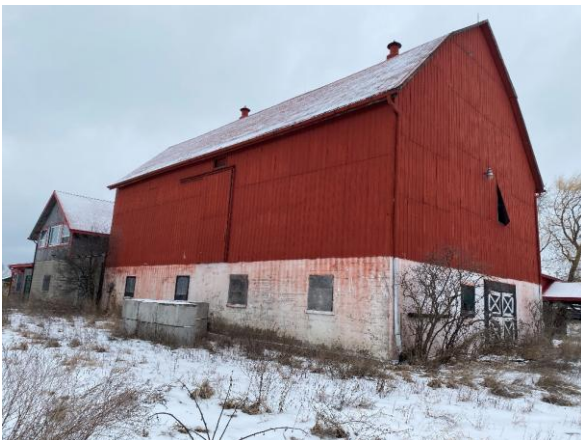
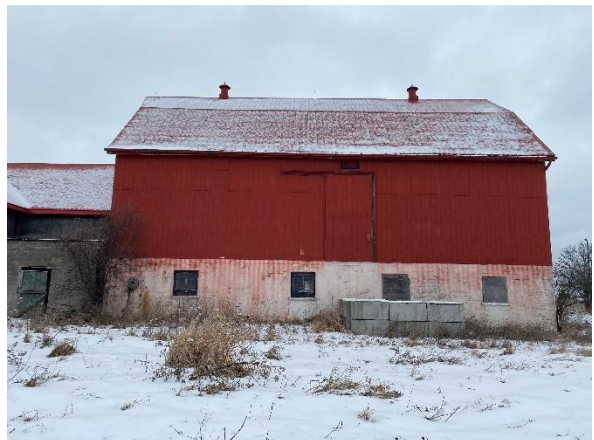
**Photo 70: Barn, looking west**

**Photo 71: Barn, looking north**

**Photo 72: Barn, looking northeast**

**Photo 73: Barn, looking east**

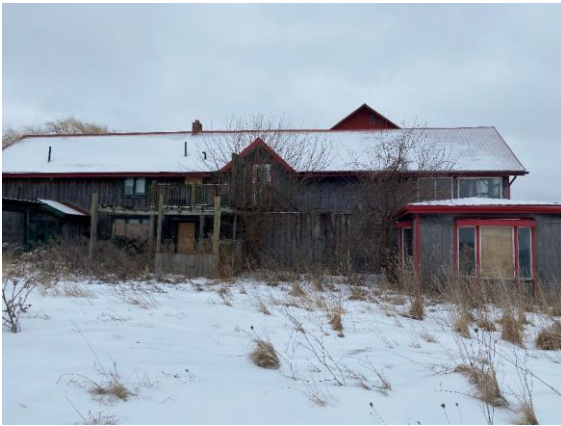
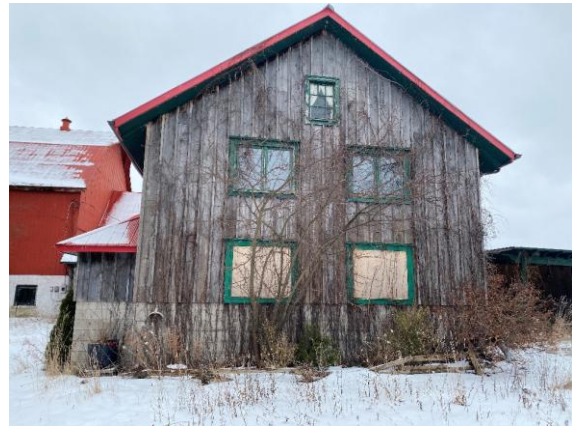
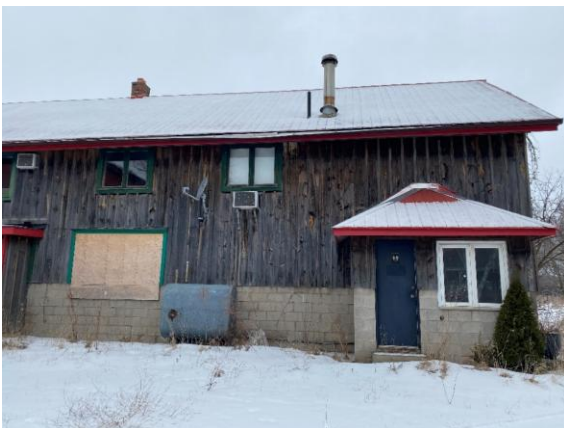
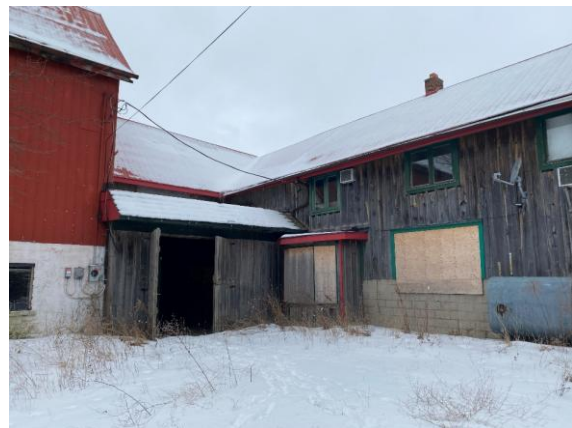
**Photo 74: Barn addition, looking south**

**Photo 75: Barn addition, looking west**

**Photo 76: Barn addition, looking north**

**Photo 77: Barn addition, looking northwest**

Attached to the north elevation of the barn is a two storey structure with a concrete block foundation (Photo 74 to Photo 77). At its north elevation is a one storey addition with a hipped roof. The addition's roof is clad in metal and the two storey portion has a brick chimney. The exterior of the addition is clad in vertical barnboard and board and batten. It has a mixture of vinyl and wood doors and windows.

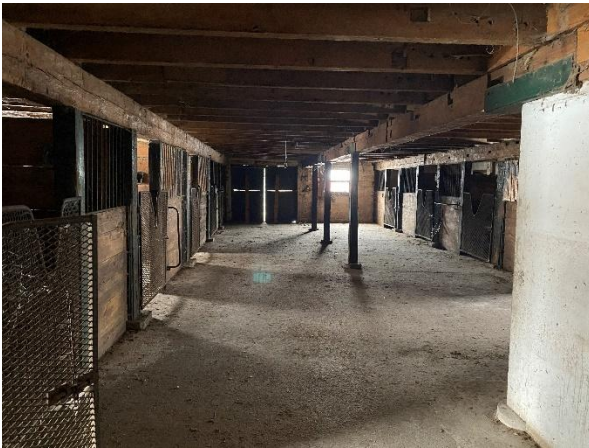
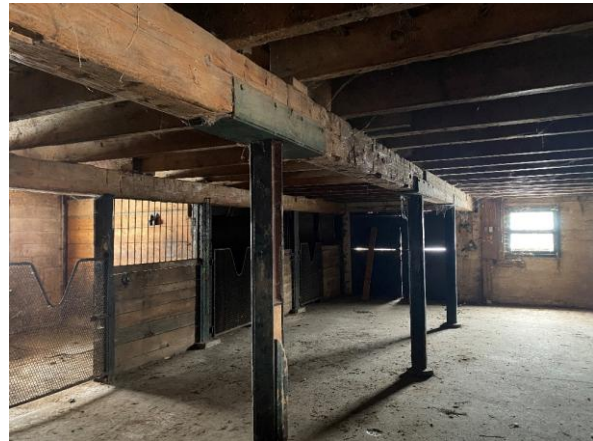
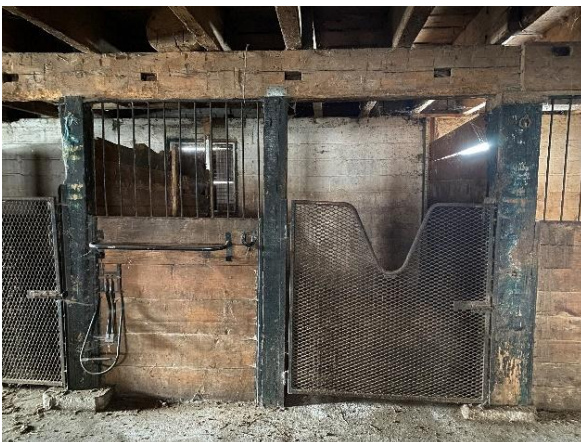
**Photo 78: Lower storey, looking south**

**Photo 79: Lower storey, looking southeast**

**Photo 80: Lower storey, horse stable, looking west**

The lower storey of the south portion has a concrete floor, steel posts, hand-hewn wood beams, and wood horse stables (Photo 78 to Photo 80). The hand-hewn beams were altered in the early 20<sup>th</sup> century with the steel supports. The lower storey of the north portion has concrete flooring, steel and wood horse stables, and a steel frame ceiling (Photo 81 and Photo 81). The upper storey or threshing floor of the barn is supported by a simple two-posts-per-bent timber frame structure with wood flooring (Photo 83 to Photo 87). All the posts and beams are hand-hewn. The wood posts and beams are

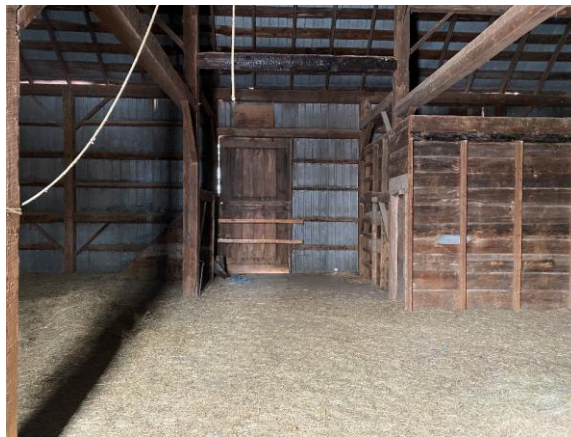
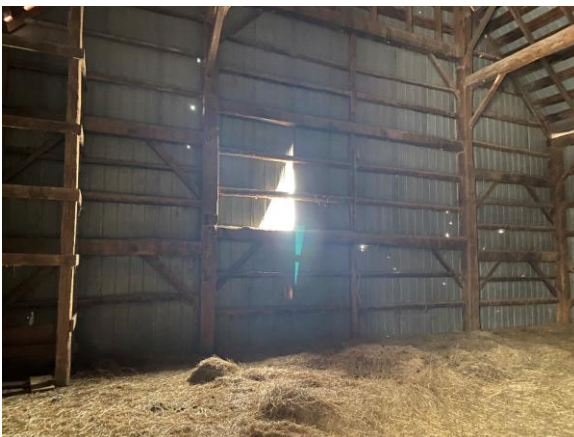
**Photo 83: Upper storey, looking west**

**Photo 84: Upper storey, looking southwest**

secured in place by mortise and pins. The northwest portion of the barn has an enclosed area while the remaining portions of the addition were not accessible during the site visit.

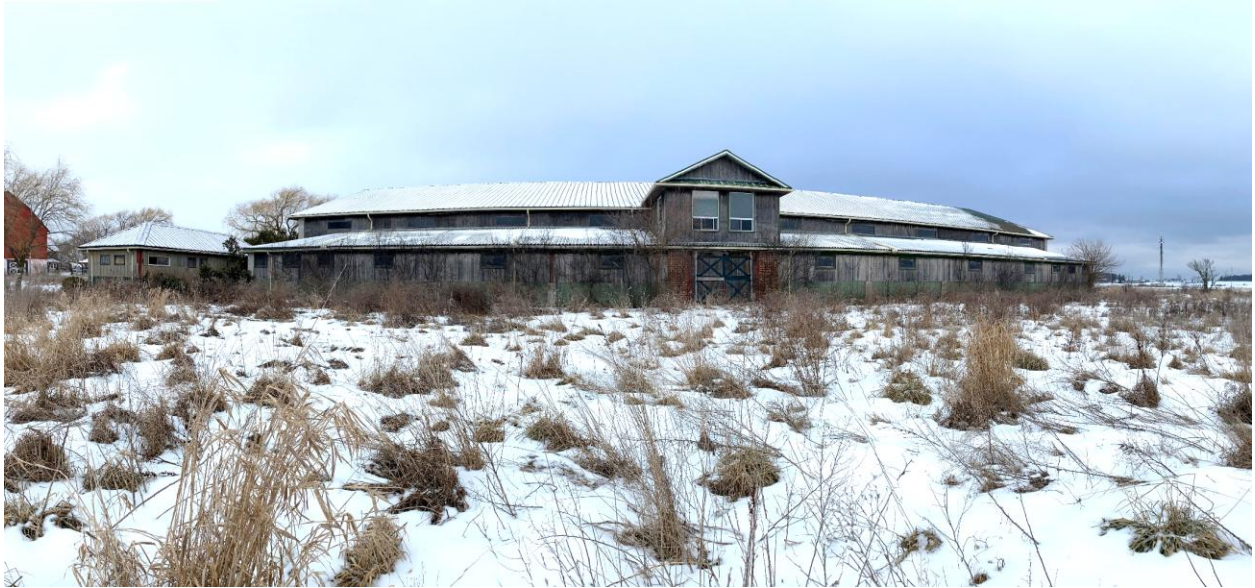
**Photo 88: Riding Arena, looking east**

The Riding Arena is situated to the south of the Barn. It is a large structure with a central gable roof clad in metal with one storey on the west and east sides with shed roofs clad in metal (Photo 88 to Photo 93). The structure is clad in vertical barnboard and has a concrete block foundation. The north and south gable ends have a central entrance with wood double doors, rectangular transoms, rectangular fixed windows, and a pediment with central fixed diamond window. The pediment is supported by concrete block columns. The west and east sides have double entry doors at the north and south elevations. Centrally placed on the west side is a two storey viewing portion with gabled roof, metal windows, and lower wood double entry doors. The south side has central wood double entry doors. The exterior has rectangular fixed wood frame windows.

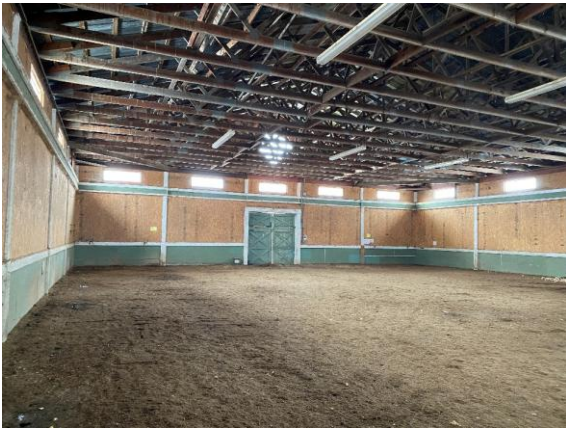
**Photo 94: Riding Arena, looking northeast**

The Riding Arena is an open wood frame structure, with plywood clad walls, wood pilaster mouldings, and a dirt floor (Photo 94 and Photo 95). The west and east sides contain the horse stables composed of wood and steel stables, plywood walls, drywalled ceilings, and concrete floors (Photo 96 and Photo 97).

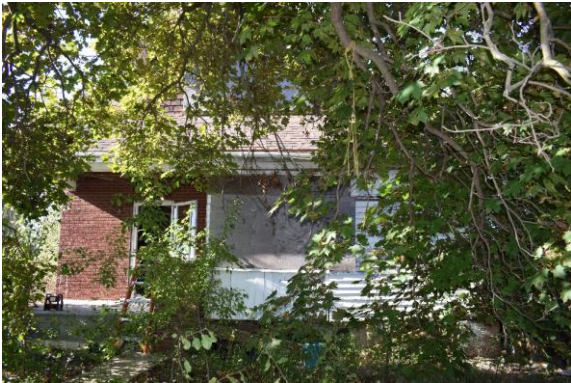
**Photo 103: Front façade, looking west**

The front façade has a covered porch that has been altered with the north portion enclosed and clad with aluminum siding (Photo 103 and Photo 104). The south open portion has two brick piers, one wood column, and a wood ceiling. The front entrance has a three-lite wood panelled entry door with a brick voussoir. The north elevation has one window on each storey (Photo 105). The west elevation has an enclosed porch with horizontal wood cladding (Photo 106). The rear entrance has a wood half glass entry door (Photo 107). The south elevation has four asymmetrically placed windows, due to

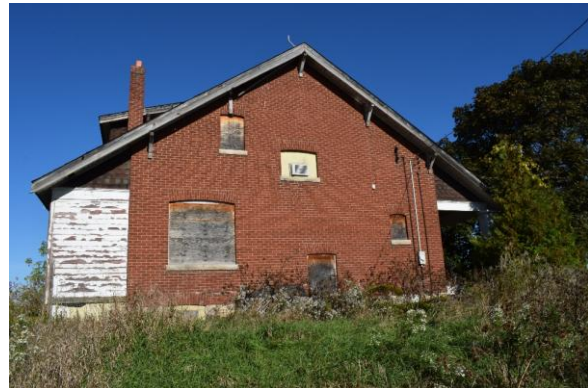
**Photo 108: South elevation, looking northeast**

the interior stairwell (Photo 108). The elevation also includes a side entrance with a half glass entry door.

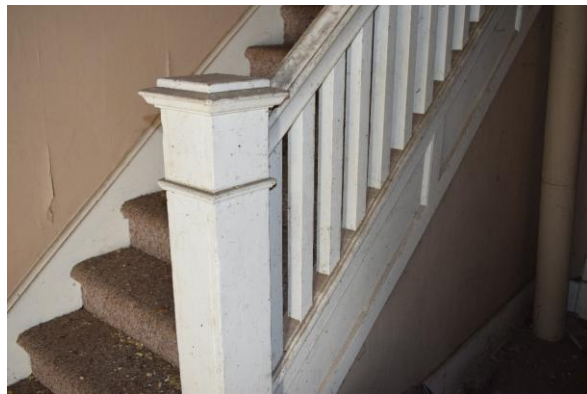
**Photo 116: Boxed newel post**

The second storey is accessed by a set of wood quarter-landing stairs with boxed newels and simple wood balustrade (Photo 116 and Photo 117). The second storey has three bedrooms and a bathroom (Photo 118 to Photo 121). It also has original wood flooring in the hallway, wood mouldings and trim, and wood panelled entry doors.

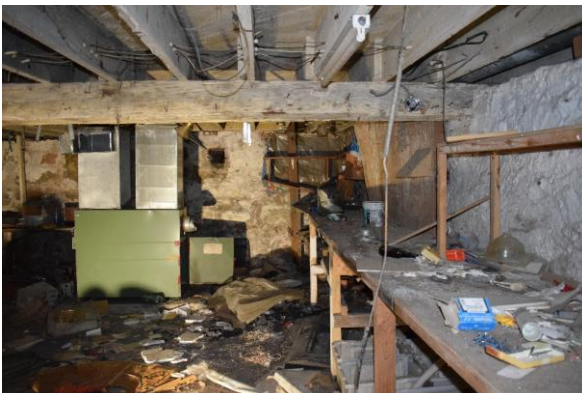
**Photo 123: Basement, looking north**

wood wainscotting. The basement has parged stone walls, wood posts and machine cut wood beams, and concrete flooring (Photo 123 to Photo 125). The southwest portion of the basement as an enclosed concrete area.

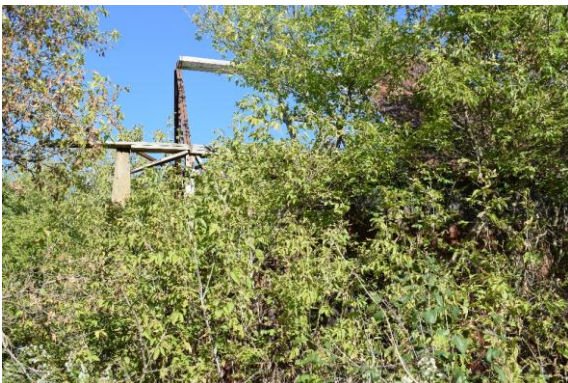
**Photo 126: Barn ruins, looking north**

The barn ruins are set approximately 95 metres to the rear (west) of the residence. Based on recent aerial photographs, the barn collapsed between 2013 and 2015. The ruins are now mostly overgrown with vegetation (Photo 126 to Photo 128).
