## Milton Link Phase One, Milton, Ontario

Preliminary Hydrogeological Investigation and Water Balance Assessment

BRM-23015226-A0

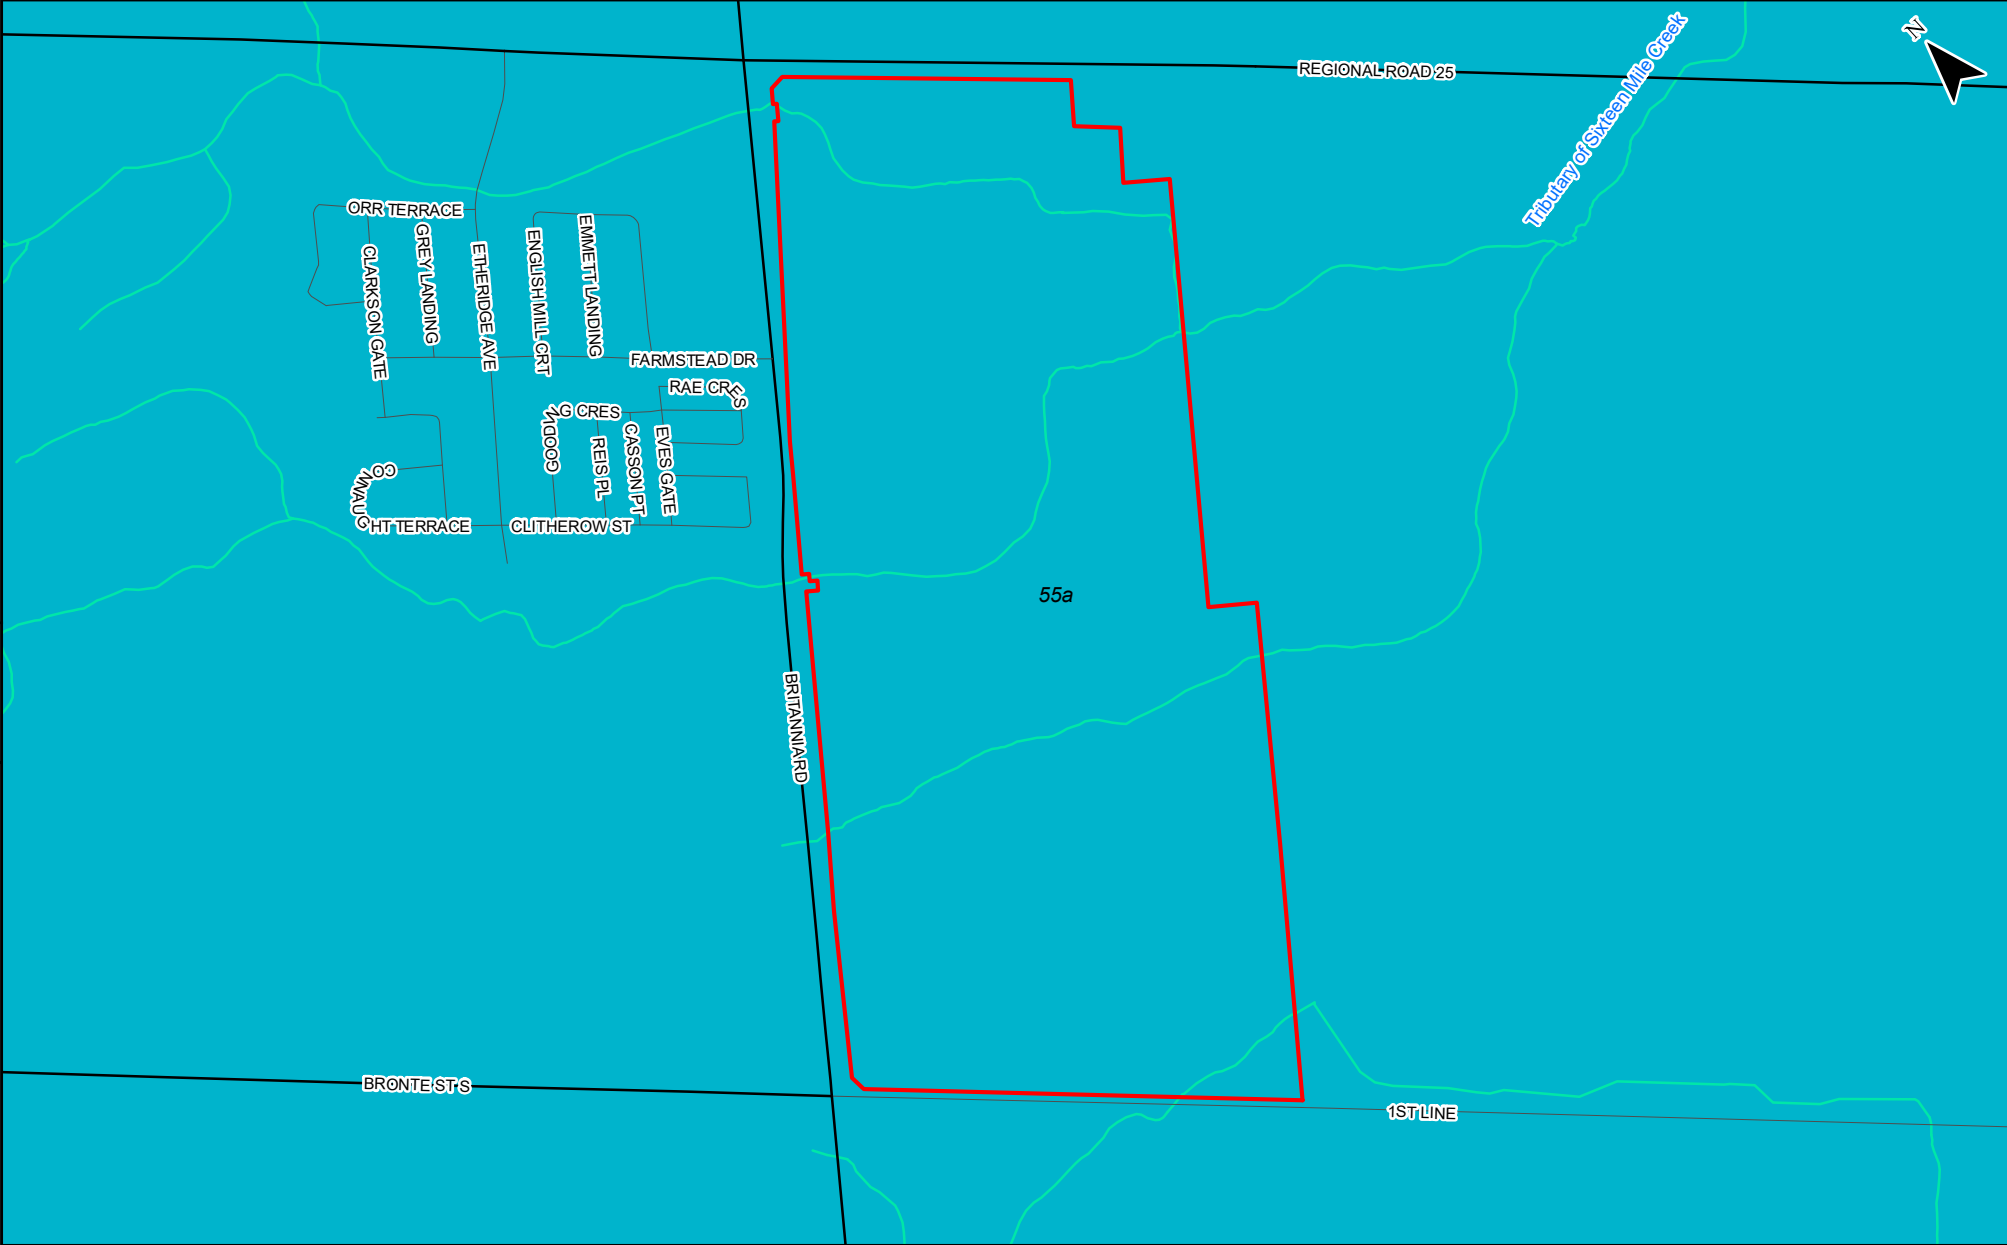
| <p>SCALE:</p> <p>0 130 260 390 520 650 m</p> | | <p>LEGEND:</p> <p><span style="border: 2px solid red; display: inline-block; width: 20px; height: 10px;"></span> APPROXIMATE SITE BOUNDARY</p> <p><span style="background-color: #0070C0; display: inline-block; width: 20px; height: 10px;"></span> 55a: (SHALE, LIMESTONE, DOLOSTONE, SILTSTONE)</p> <p><i>Queenston Formation</i></p> | <p>BEDROCK GEOLOGY</p> | <p>FIGURE:</p> <p>2D</p> |

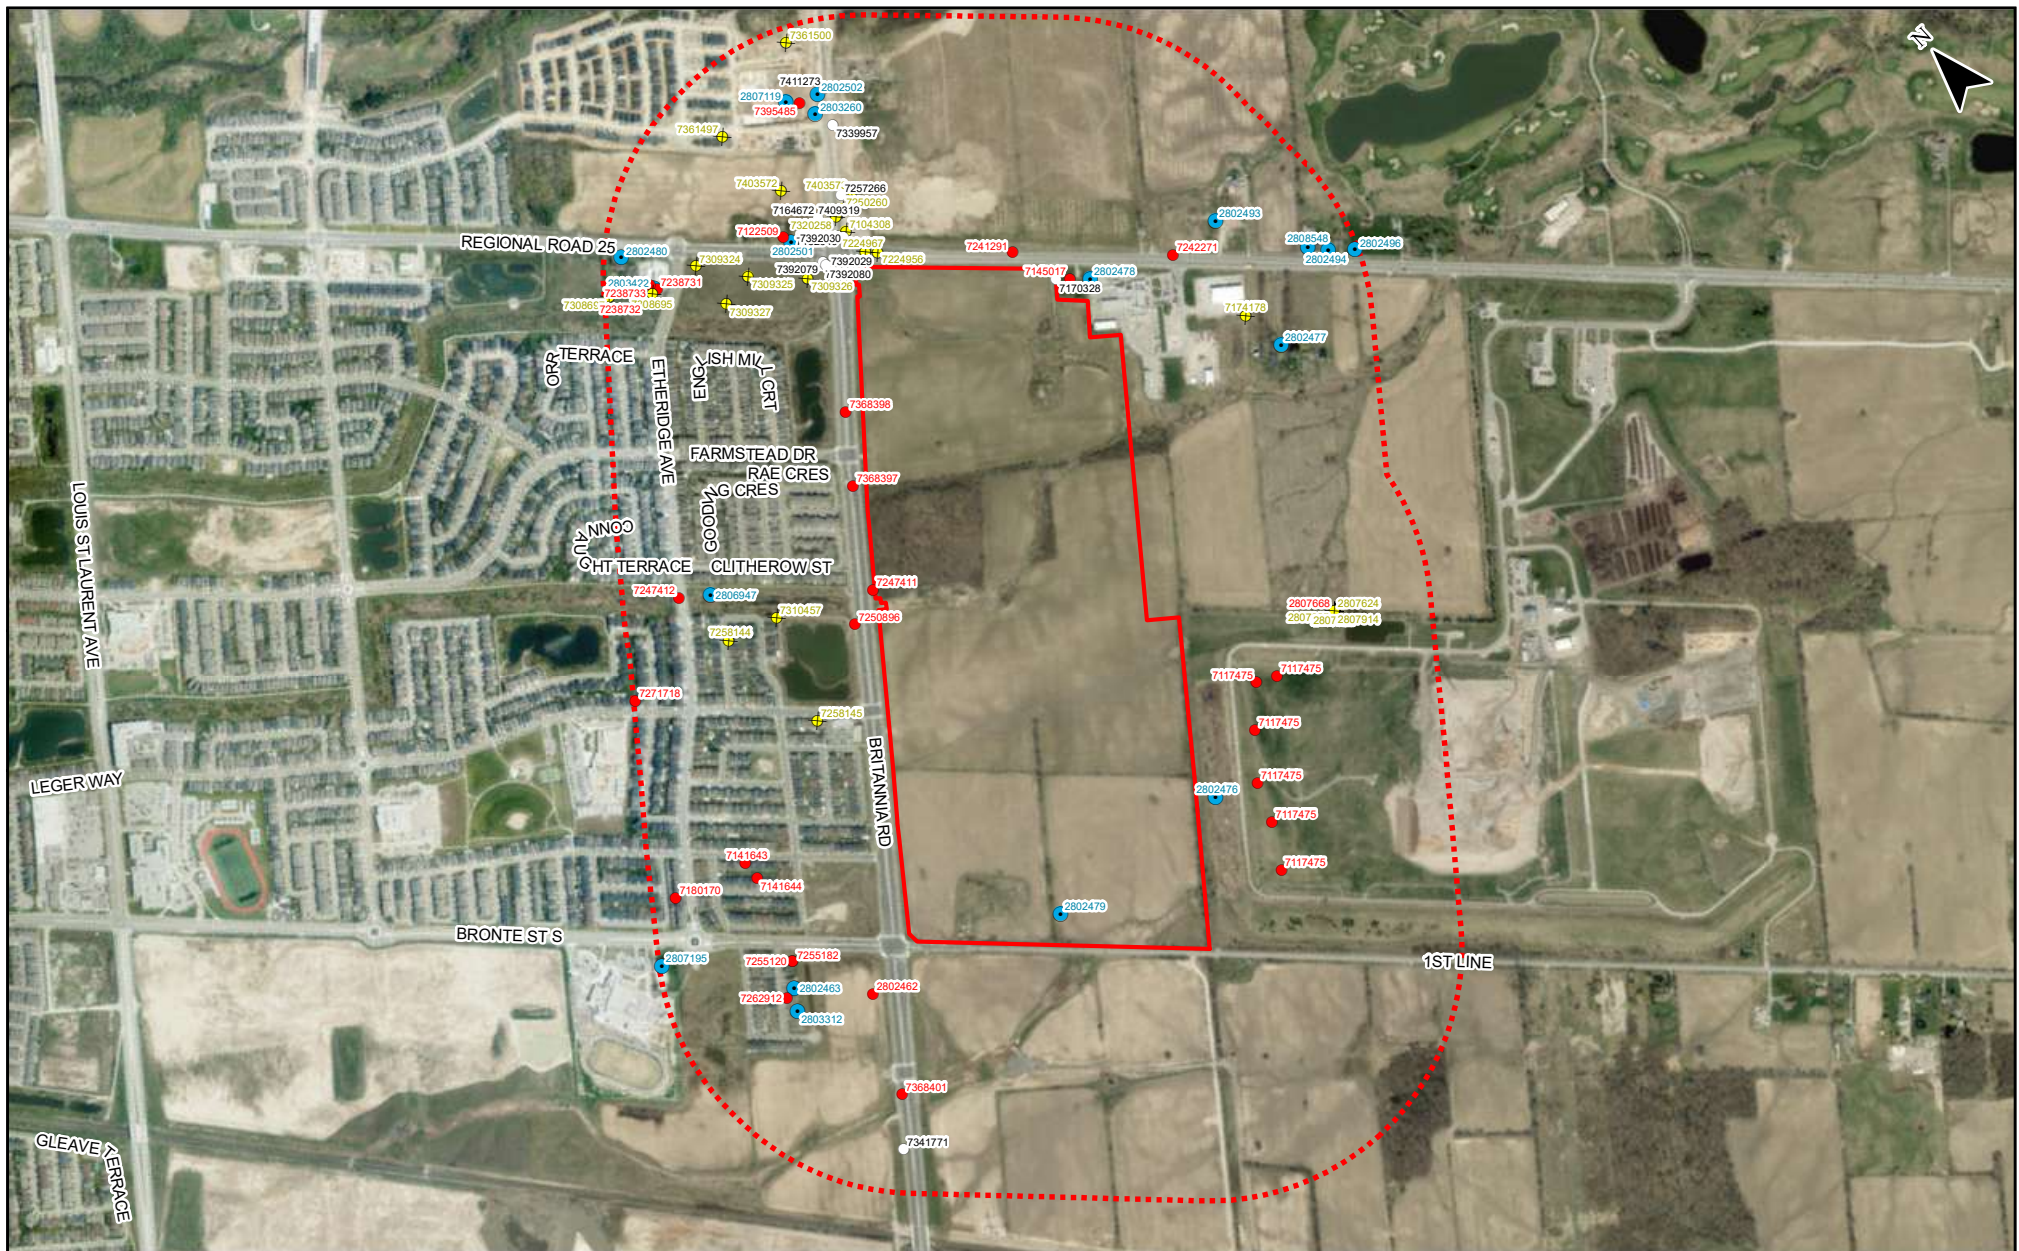
| SOURCE:<br>BASED ON GOOGLE EARTH IMAGERY DATED 2023,<br>AVAILABLE WELL RECORD INFORMATION AS OF JUNE 2023. | | |

The Well Identification Numbers (Well ID No.) of the water supply wells (18) are 2802479, 2802463, 2802476, 2802477, 2802478, 2802480, 2802493, 2802494, 2802496, 2802501, 2802502, 2803260, 2803312, 2803422, 2806947, 2807119, 2807195 and 2808548 located between 518 m to 1,135 m from the Site centroid. It is recommended to complete a baseline residential well survey to verify results of the MECP WWR searches and to confirm current conditions and use of wells in 500 m zone of the Site.
