## Milton Link Phase Two, Milton, Ontario

Preliminary Hydrogeological Investigation and Water Balance Assessment

BRM-23015226-A0

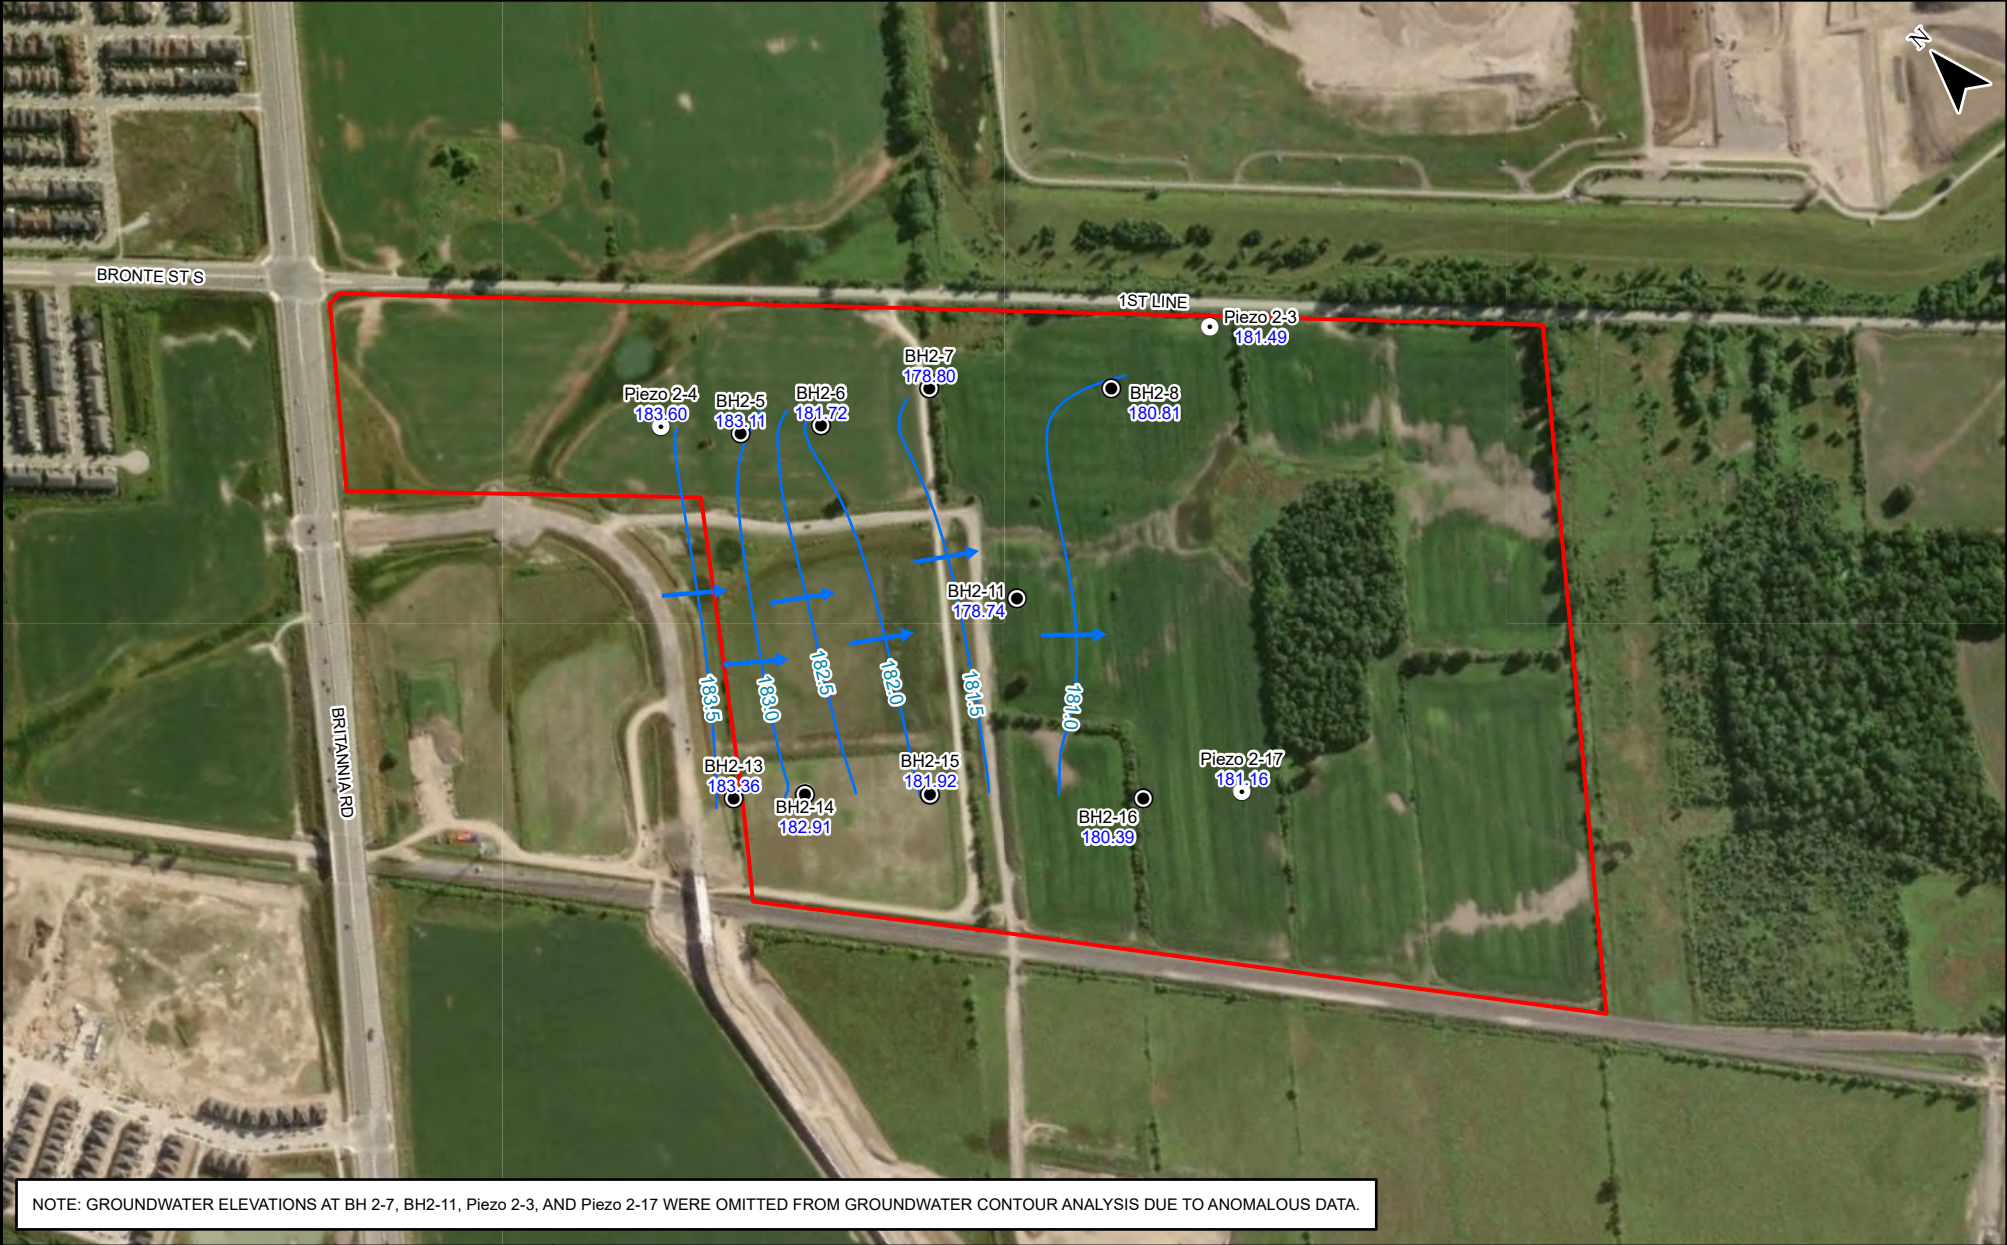
NOTE: GROUNDWATER ELEVATIONS AT BH 2-7, BH2-11, Piezo 2-3, AND Piezo 2-17 WERE OMITTED FROM GROUNDWATER CONTOUR ANALYSIS DUE TO ANOMALOUS DATA.

| SCALE:<br><div>0100200300400500m</div> | | | LEGEND:<br><div><div>●</div> BOREHOLE / MONITORING WELL (EXP, 2024)<br/><div>○</div> PIEZOMETER (EXP, 2024)<br/><div>—</div> GROUNDWATER CONTOUR<br/><div>→</div> GROUNDWATER FLOW DIRECTION<br/><div>[XX.XX]</div> GROUNDWATER ELEVATION (m asl) AS MEASURED ON JULY 12, 2024<br/><div>□</div> APPROXIMATE SITE BOUNDARY</div> | GROUNDWATER CONTOUR PLAN | FIGURE:<br>6 |

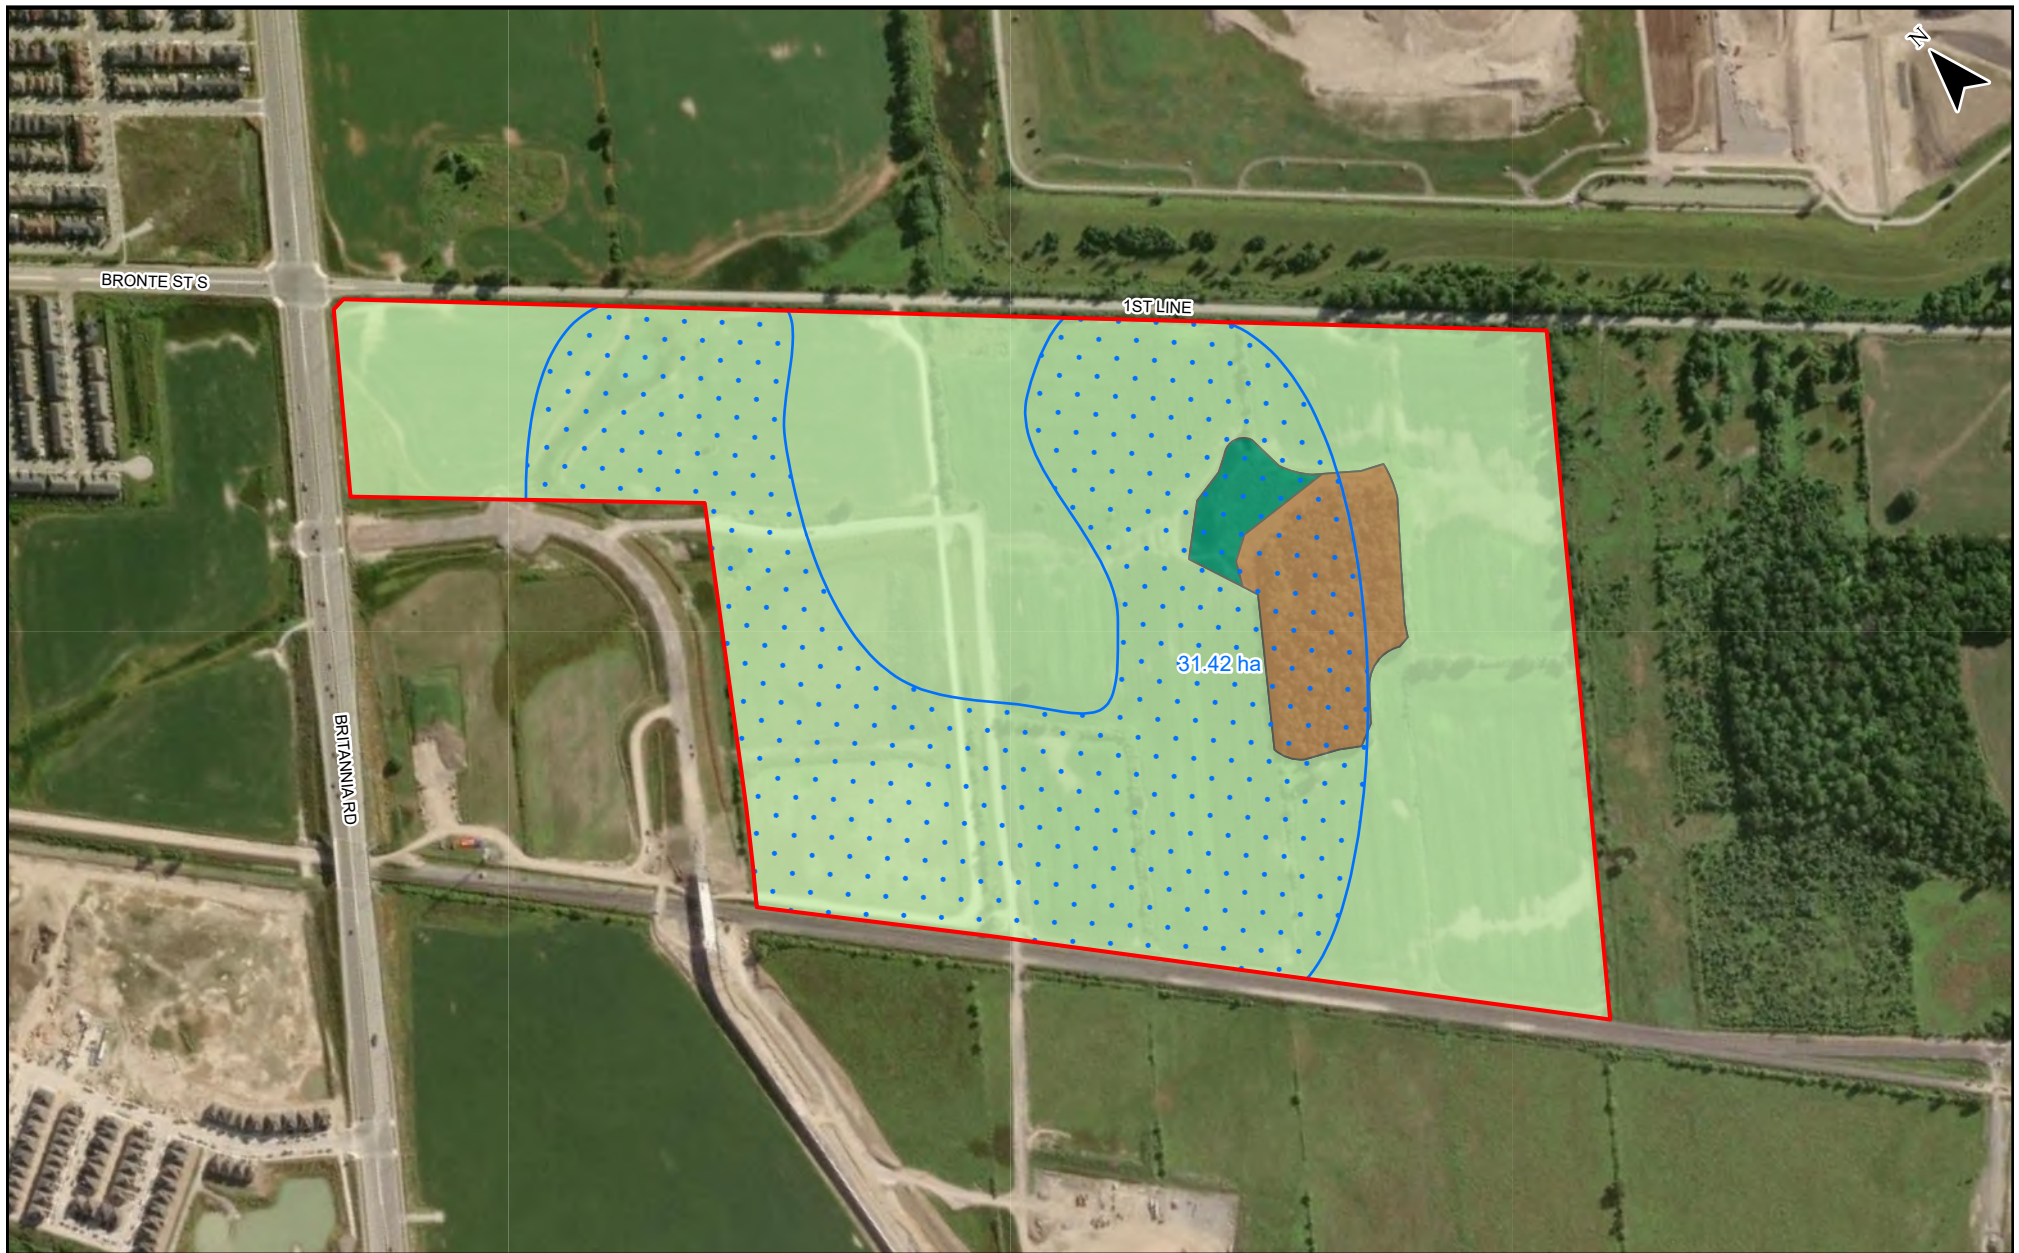
EXISTING LAND USE  
AND HIGH WATER LEVEL AREAS

The areas provided in Table 5-1 above were determined based on a review of available Site plans and these estimates are considered appropriate for assessing the water balance. According to Table 5.1, under pre-development conditions 48.6% of the Site area is pervious and available for groundwater infiltration (Figure 7).

In areas with water table at or above surface and less than approximately 1.0 m below surface, the infiltration rate would be considered negligible for existing and proposed grade. Water levels above ground surface were not reported and water levels less than 1 m below ground surface were not reported while monitoring water levels at this Site except at Piezometers 2-3, 2-4 and 2-17 and BH2-5, BH2-8, BH2-13, BH2-14, BH2-15 and BH2-16. The area of high water levels was mapped and excluded for infiltration.

Using this method, a total infiltration factor for the Site was estimated by using the individual sub-factors, which are representative of the topography, soil type and land cover conditions (Figures 2 and 7). Appendix F-3 provides a summary of the sub factors and total factor based on the Site conditions. The infiltration sub-factors were determined for estimating pre-development infiltration rates of the entire Site.

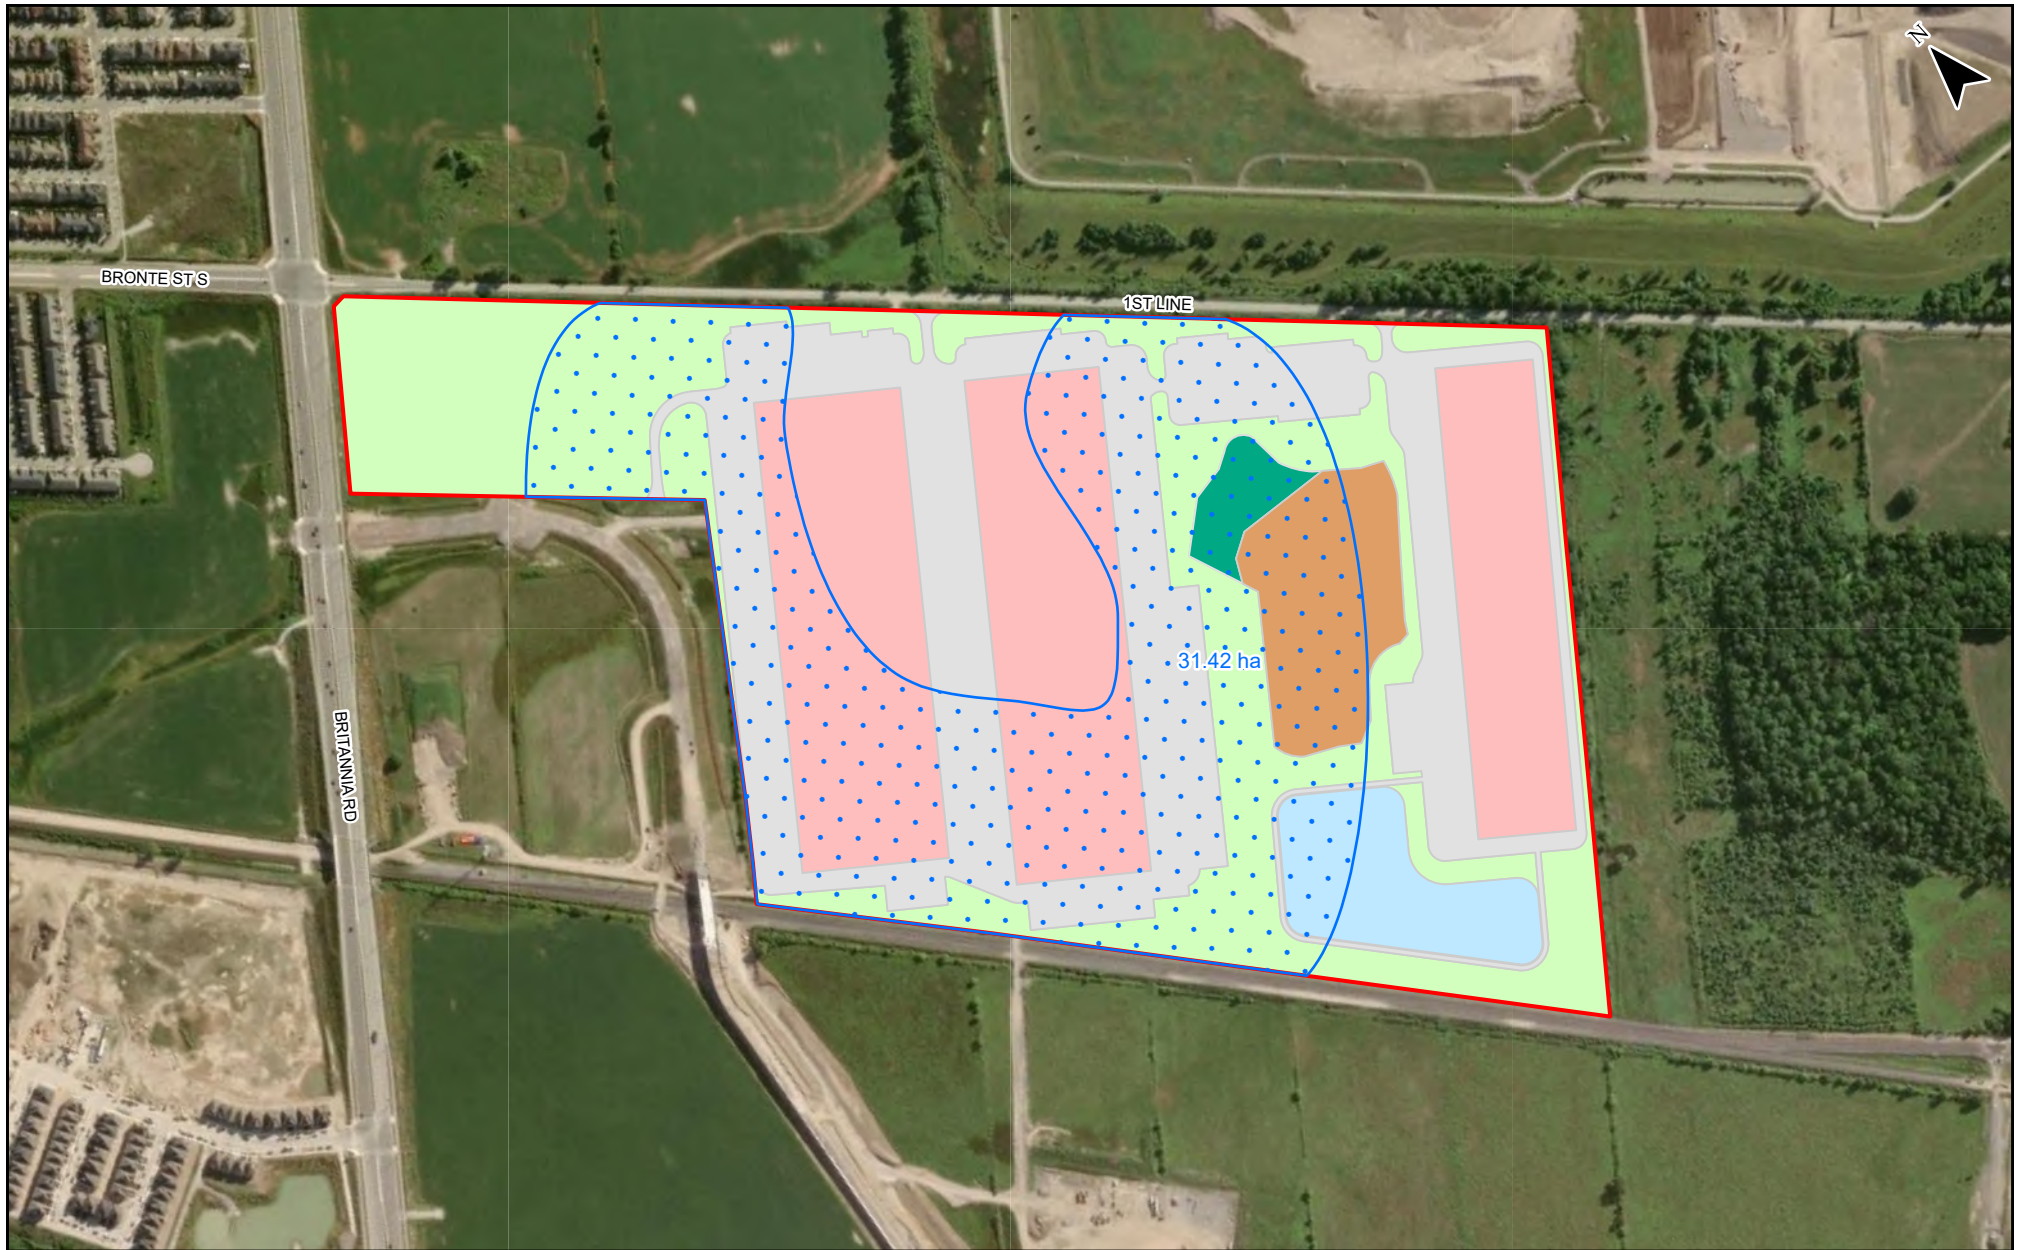
Under post-development conditions, the total pervious area is reduced from 48.6% to 37.4% of the total Site area (Tables 5-1 and 5-2 and Figure 8).

| SCALE:<br>0 100 200 300 400 500<br>m | | LEGEND:<br><div> <div></div> BUILDING <div></div> APPROXIMATE SITE BOUNDARY </div> <div> <div></div> LANDSCAPE <div></div> HIGH WATER LEVEL AREA </div> <div> <div></div> PAVEMENT </div> <div> <div></div> STORMWATER MANAGEMENT POND </div> <div> <div></div> WETLAND </div> <div> <div></div> WOODLOT </div> | | PROPOSED LAND USE<br>AND HIGH WATER LEVEL AREAS | FIGURE:<br>8 |

Based on the proposed development drawings, the total area of pervious surfaces under post-development conditions is approximately 234,600 m<sup>2</sup>, representing approximately 37.4% of the total Site area of 627,771 m<sup>2</sup> (Table 5-2). The remaining 393,171 m<sup>2</sup> will not contribute to infiltration in the post-development phase (approximately 62.6% of the total land area).
