PHASE I ENVIRONMENTAL SITE ASSESSMENT 6583 TRAFALGAR ROAD MILTON, ONTARIO

Prepared for: **Hannover Trafalgar Farms Limited**
1039 Fourth Line,
Milton, ON
L9T 6P9

File No.: 7-20-0004-41
February 05, 2020

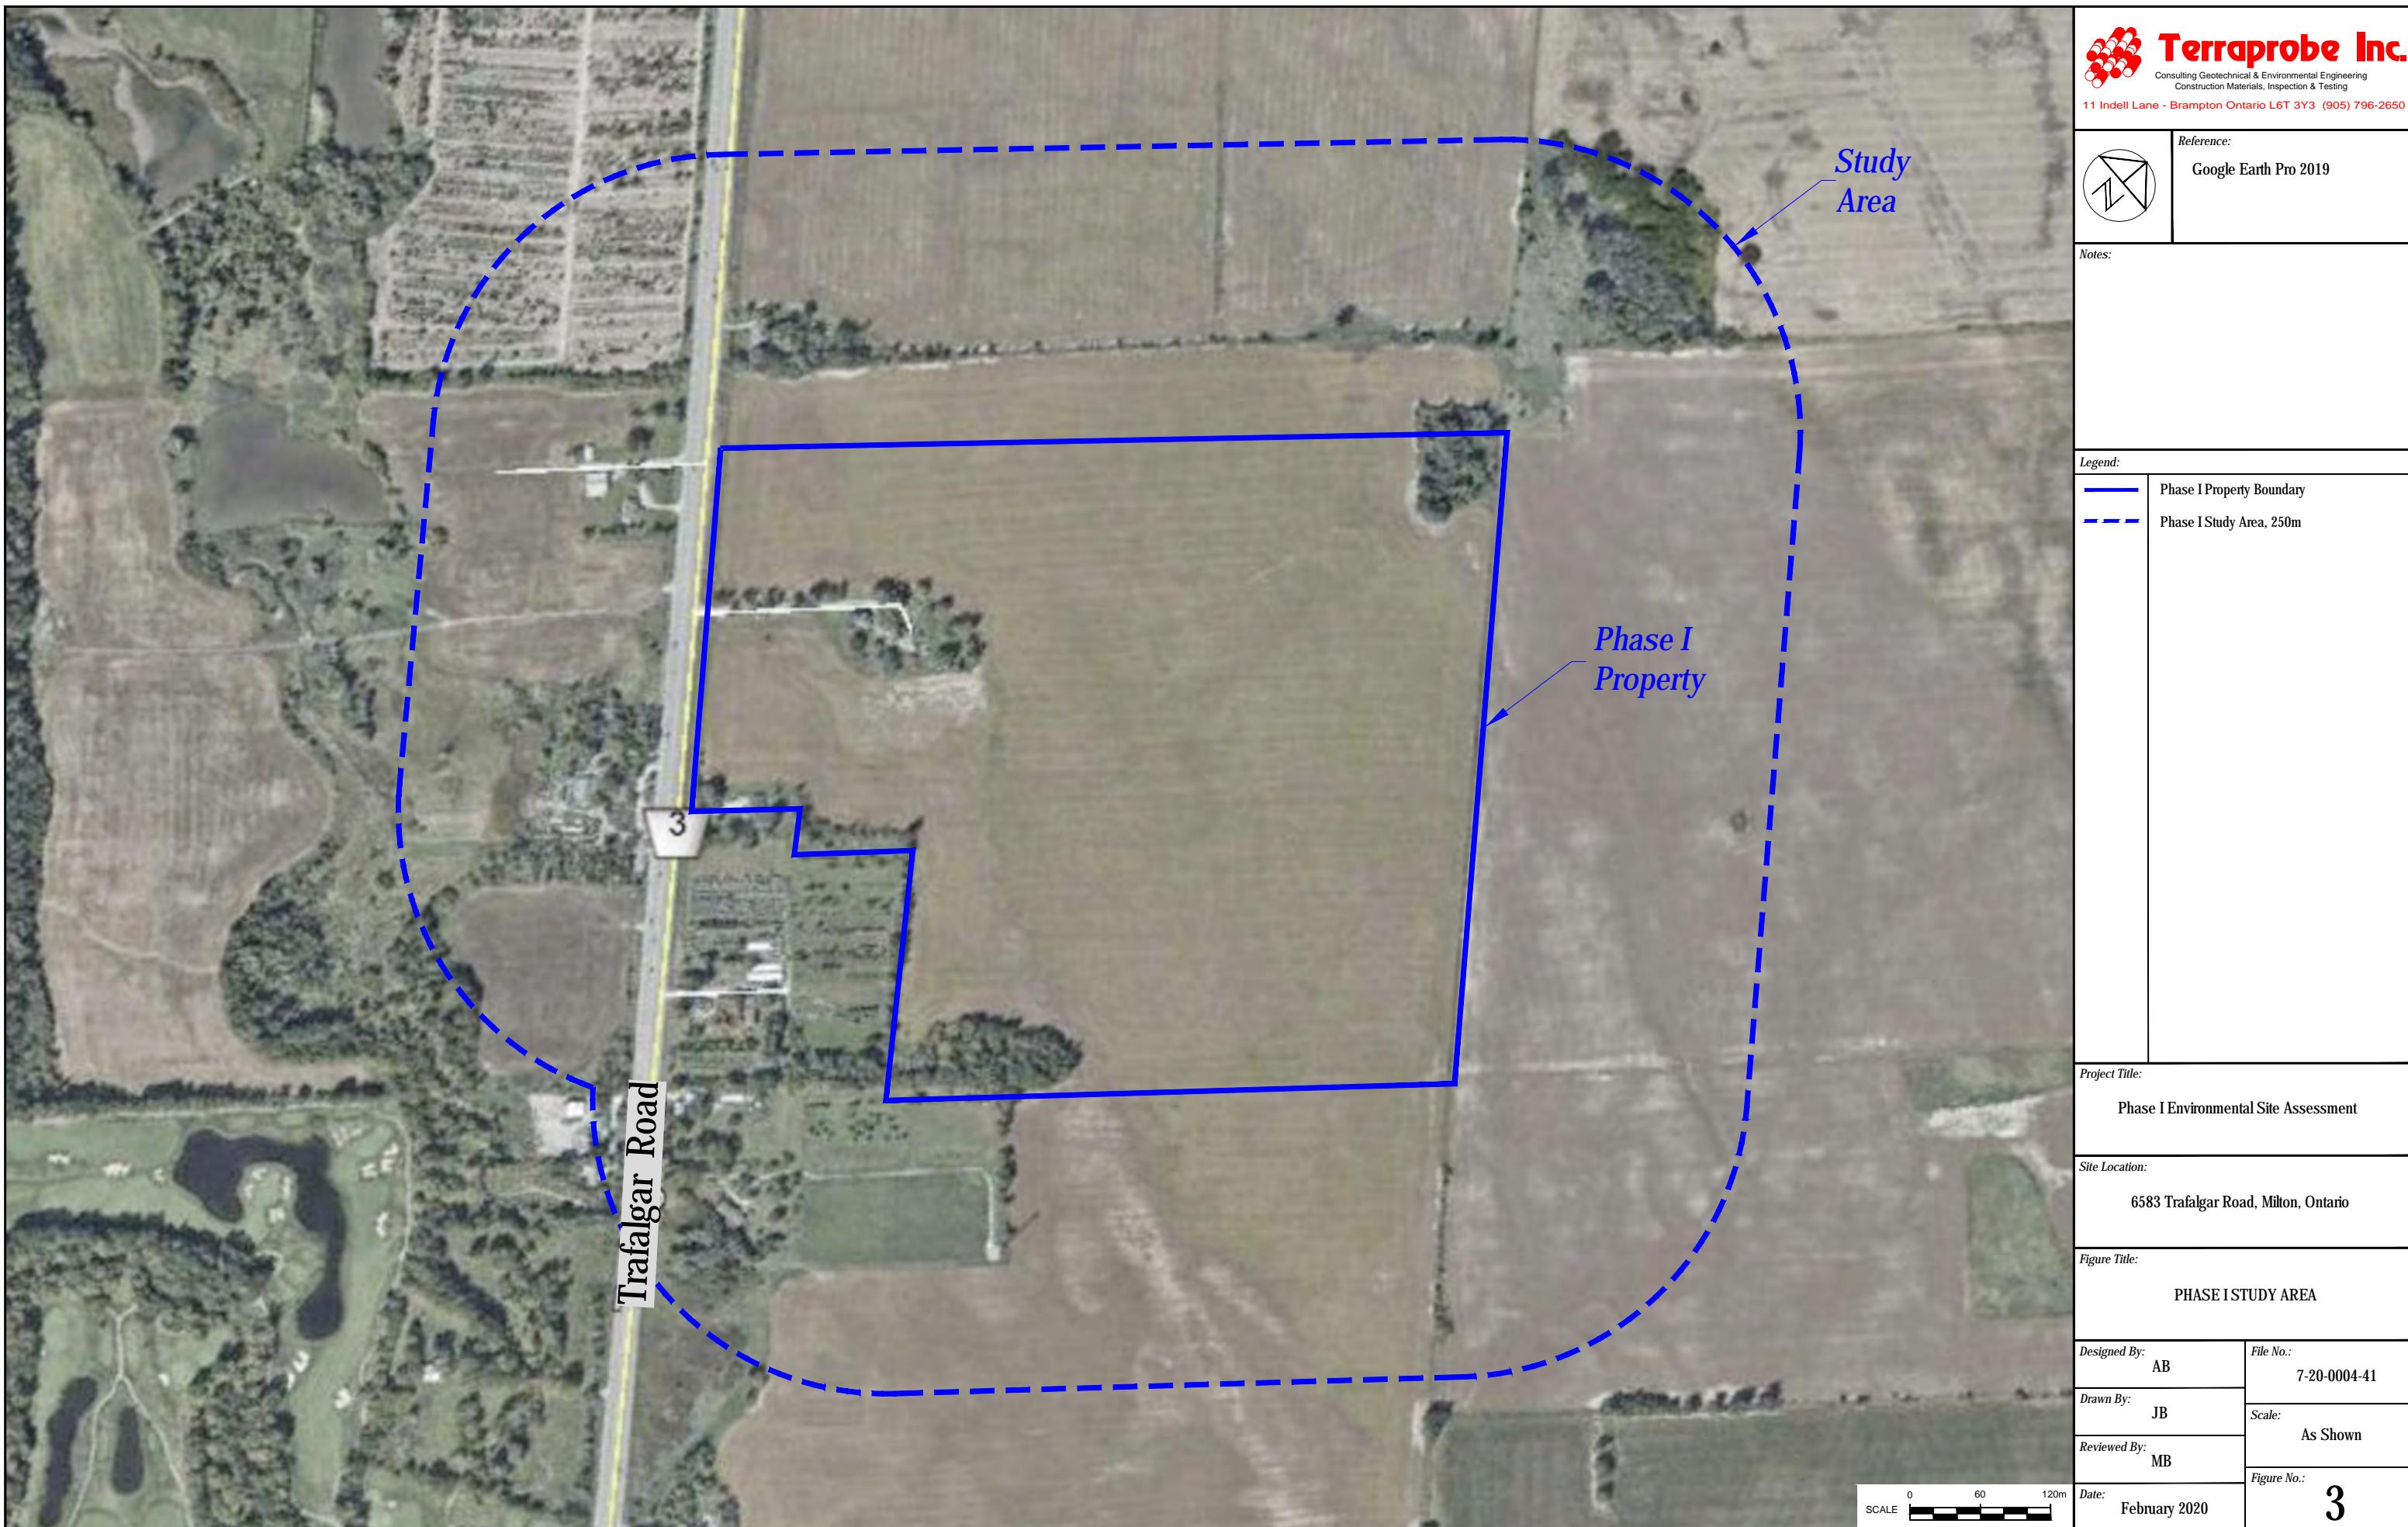
Phase I Property Boundary	
Project Title:	Phase I Environmental Site Assessment
Site Location:	6583 Trafalgar Road, Milton, Ontario
Figure Title:	PHASE I PROPERTY
Designed By:	AB
Drawn By:	JB
Reviewed By:	MB
File No.:	7-20-0004-41
Scale:	As Shown
Figure No.:	2
DATE:	February 2020

At the time of the assessment, the southwest portion of the Property was developed with a two-storey residence and associated outbuilding. The remainder of the Property was in agricultural use. The Property was developed for its current use prior to 1946. Property features are presented on Figure 2.

The site reconnaissance included a walking tour of the Property, as well as compiling written and photographic records. Site features are presented on Figure 2, and site photographs are presented in Appendix H.

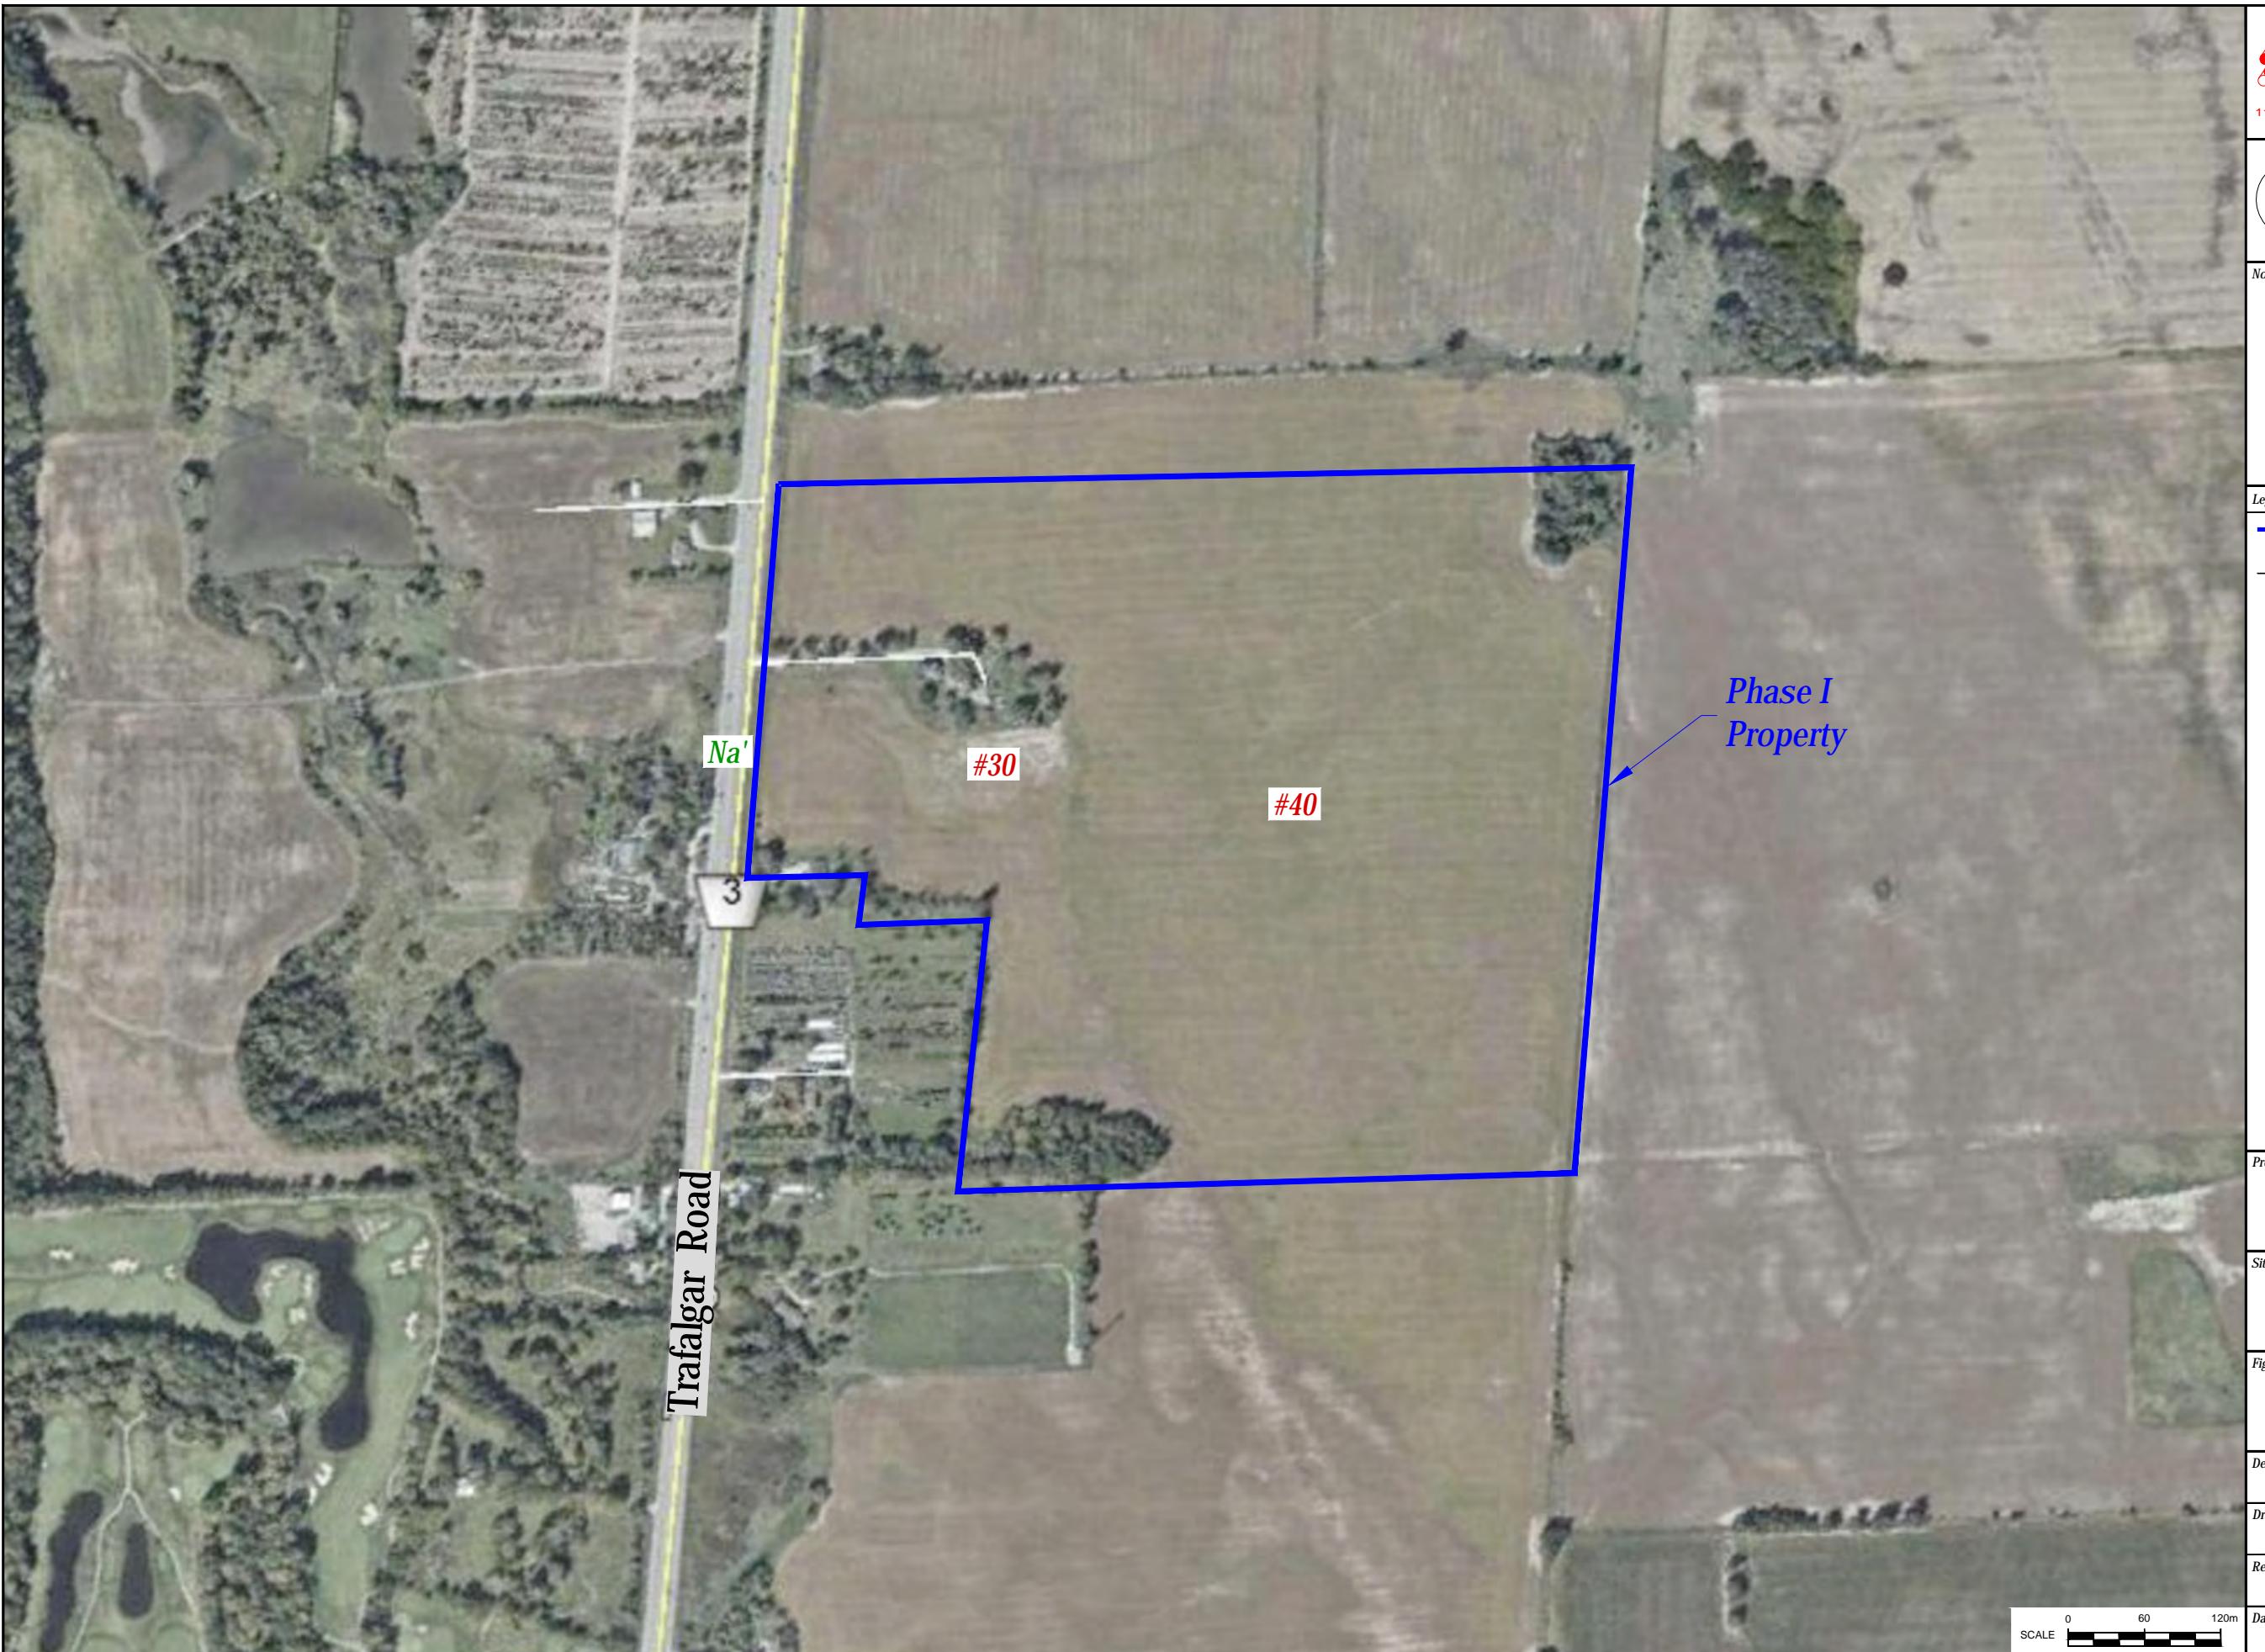
Potentially Contaminating Activity
#30	Importation of Fill Material of Unknown Quality
#40	Pesticides (including Herbicides, Fungicides and Anti-Fouling Agents) Manufacturing, Processing, Bulk Storage and Large-Scale Applications
Na'	Spill
Project Title: Phase I Environmental Site Assessment	
Site Location: 6583 Trafalgar Road, Milton, Ontario	
Figure Title: POTENTIALLY CONTAMINATING ACTIVITIES	
Designed By: AB	File No.: 7-20-0004-41
Drawn By: JB	Scale: As Shown
Reviewed By: MB	Figure No.: 5
DATE: February 2020

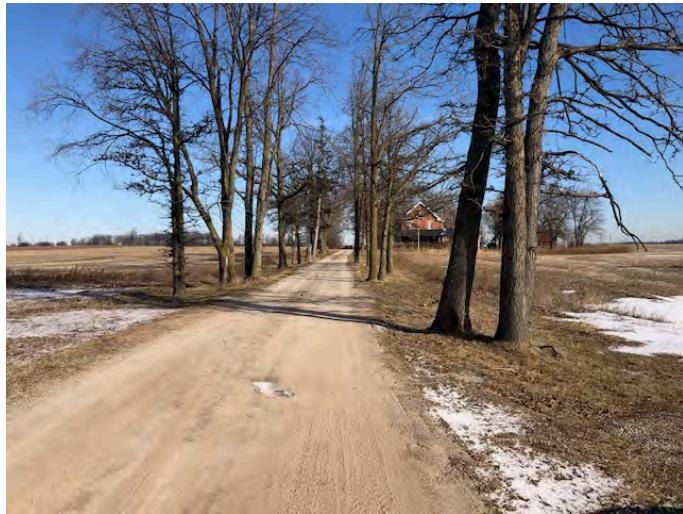
Photograph 1

Location: Phase I Property
Viewing: Northeast
Description: View of the driveway leading to the residence at 6583 Trafalgar Road..

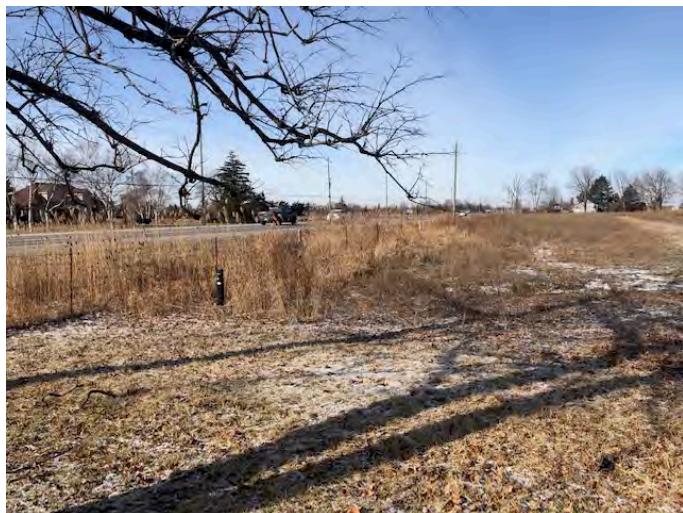
Photograph 2

Location: Phase I Property
Viewing: West
Description: View of the existing monitoring well located on the southwest portion of the Property, west of the driveway.

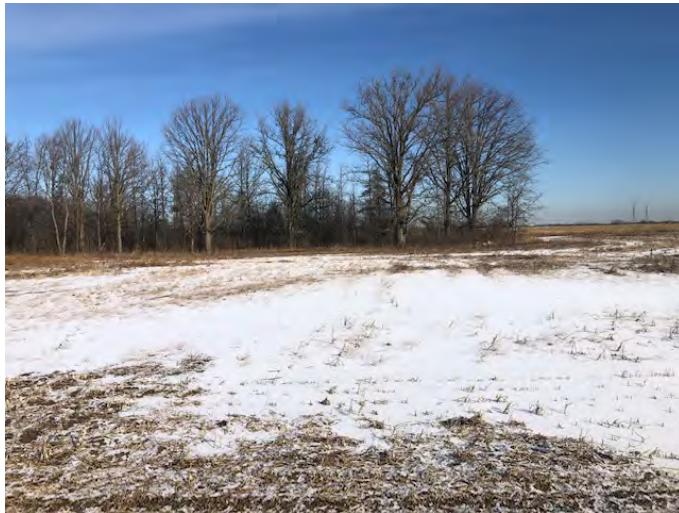
Photograph 4

Location: Phase I Property
Viewing: Northwest
Description: View of the wooded area on the north portion of the Property, in the area of the former structure.

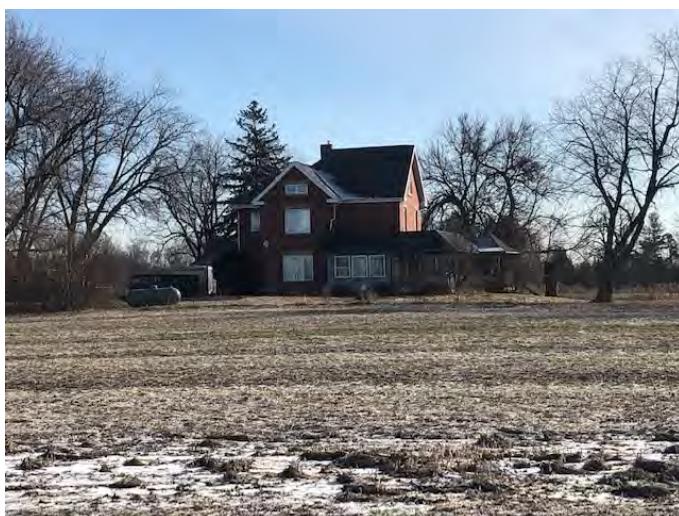
Photograph 6

Location: Phase I Property
Viewing: Northeast
Description: View of the west side of the residence, the propane tank, used as the heating source for the Property, is also pictured.

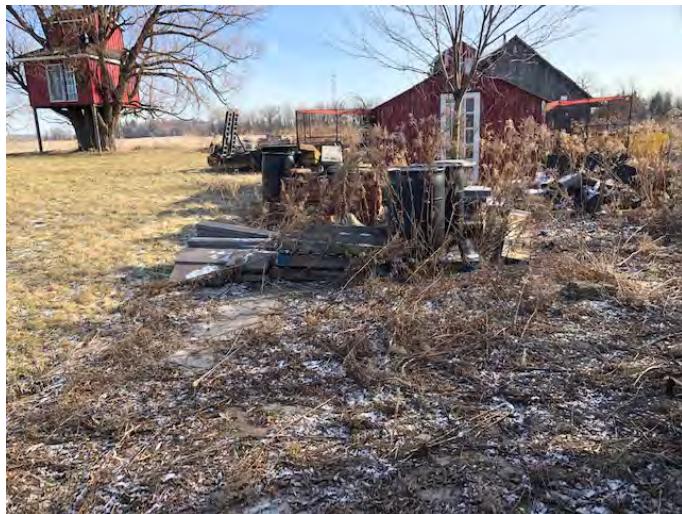
Photograph 7

Location: Phase I Property
Viewing: Southeast
Description: View of the concrete slab located at the rear of the house, in the area of a former structure. The pictured drums were empty at the time of the site assessment.

Fill Materials	No obvious fill materials were observed on the Property.
Watercourses, Ditches or Standing Water	No watercourses, ditches, or areas of standing water were observed on the property during the site inspection.
Air Emissions	No air emission sources were observed on the Property.
Roads, Parking Facilities, and Right-of-Ways	Access to the Property is via a gravel driveway off the east side of Trafalgar Road.
Waste Handling	Waste was primarily domestic in nature. Two twenty yard waste bins, supplied and removed by a private waste handling contractor, were present on the Property. The tenants of the Property indicated they were in the process of vacating the residence and the bins were for disposal purposes. Four plastic drums were also noted on the Property on the concrete slab located at the rear of the residence, the drums were empty at the time of the site inspection.

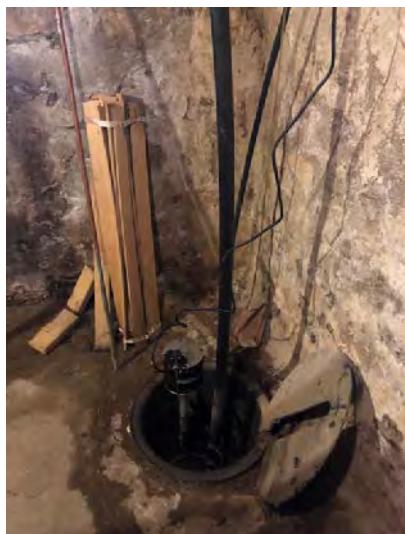
Photograph 8

Location: Phase I Property
Viewing: Interior
Description: View of the sump located in the basement of the residence. Areas of dampness were observed surrounding the sump.

Mould	Some areas of mould and dampness were observed in the basement of the residence, specifically near the sump pit and water treatment system.
Radioactive Materials	No man-made sources of radiation were observed during the site inspection.
Herbicides and Pesticides	An empty plastic tank with a label indicating the contents as pesticides was situated on a small trailer on the concrete slab in the area of the former structure. The tank was empty and no indication of product loss was noted on the ground around the base of the tank. No other materials containing herbicides or pesticides were observed to be stored or used on the site.

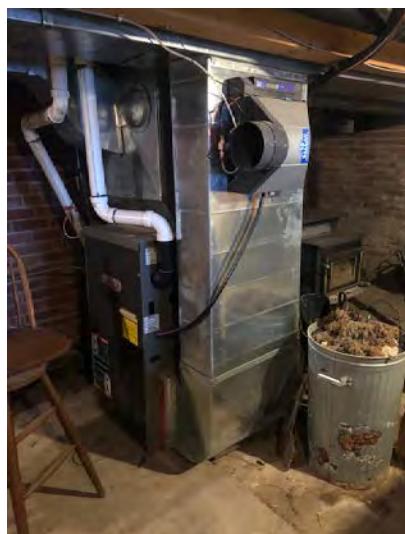
Photograph 9

Location: Phase I Property
Viewing: Interior
Description: View of the propane-fired furnace and wood stove located in the basement of the residence.
