# Terraprobe

**PHASE I ENVIRONMENTAL SITE ASSESSMENT  
6463 TRAFALGAR ROAD  
MILTON, ONTARIO**

File No 7-22-0008-41  
March 9, 2022

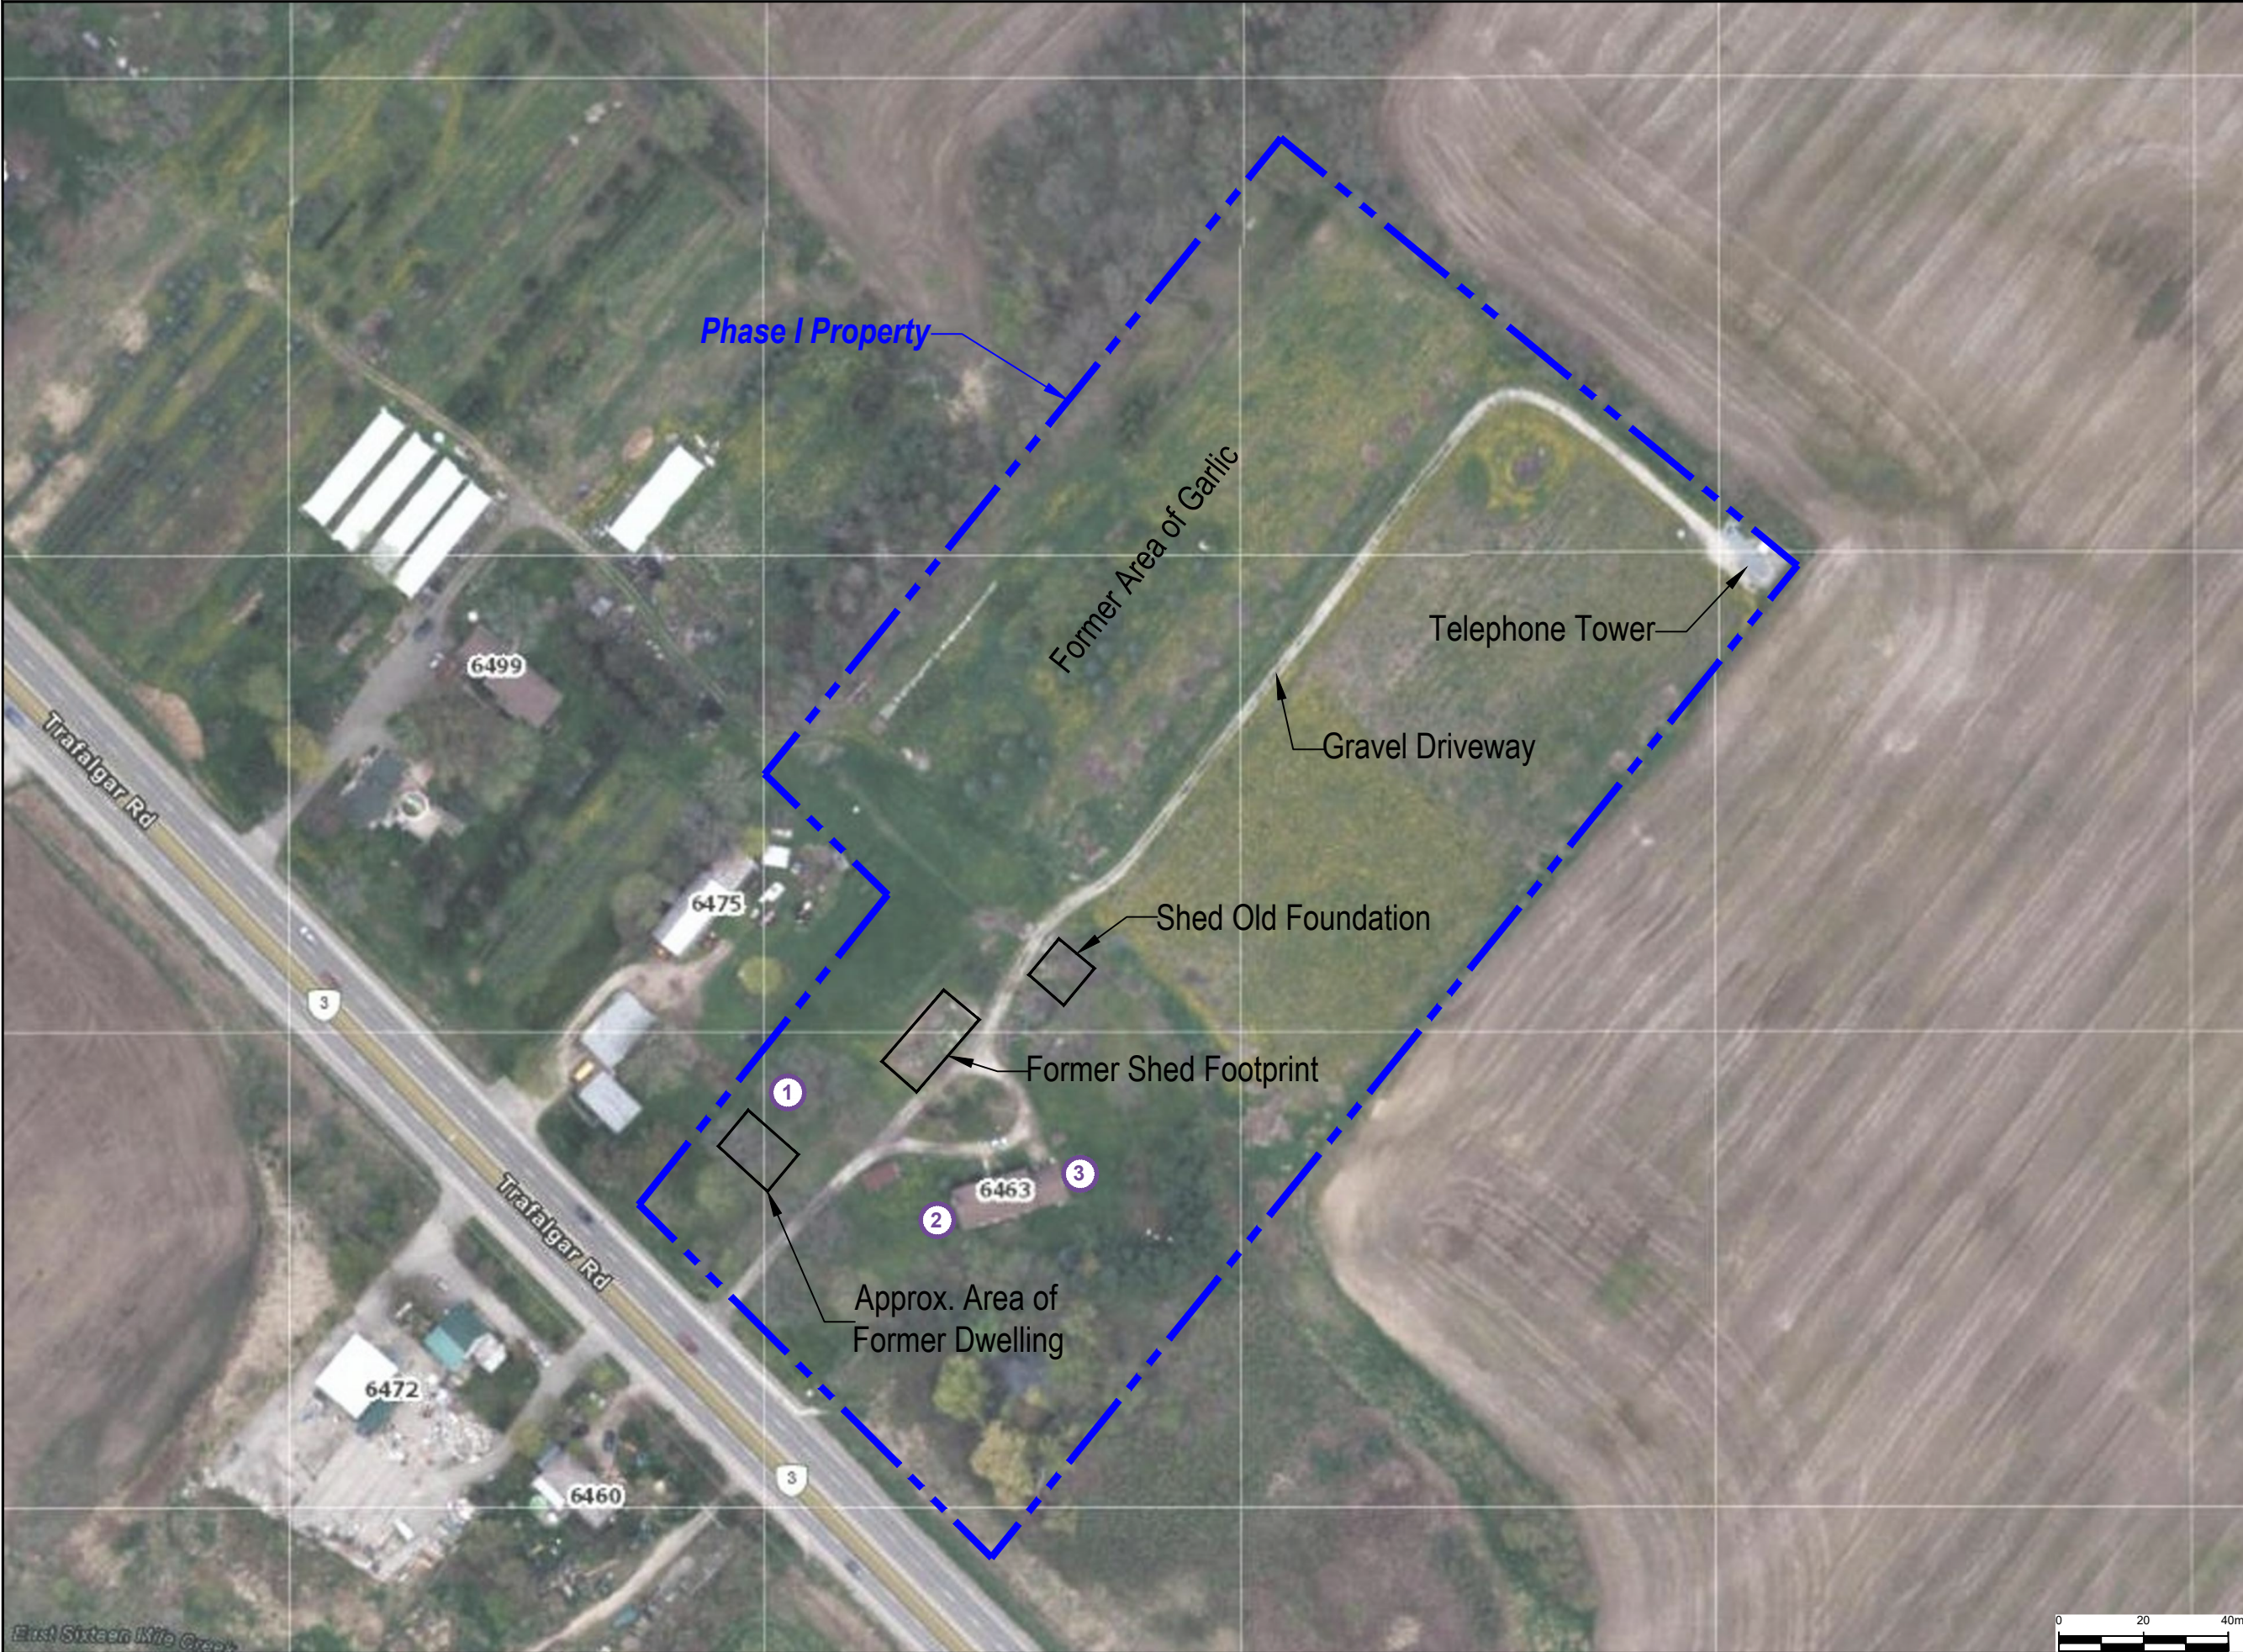
Site features are presented on Figure 2, and site photographs are presented in Appendix G.

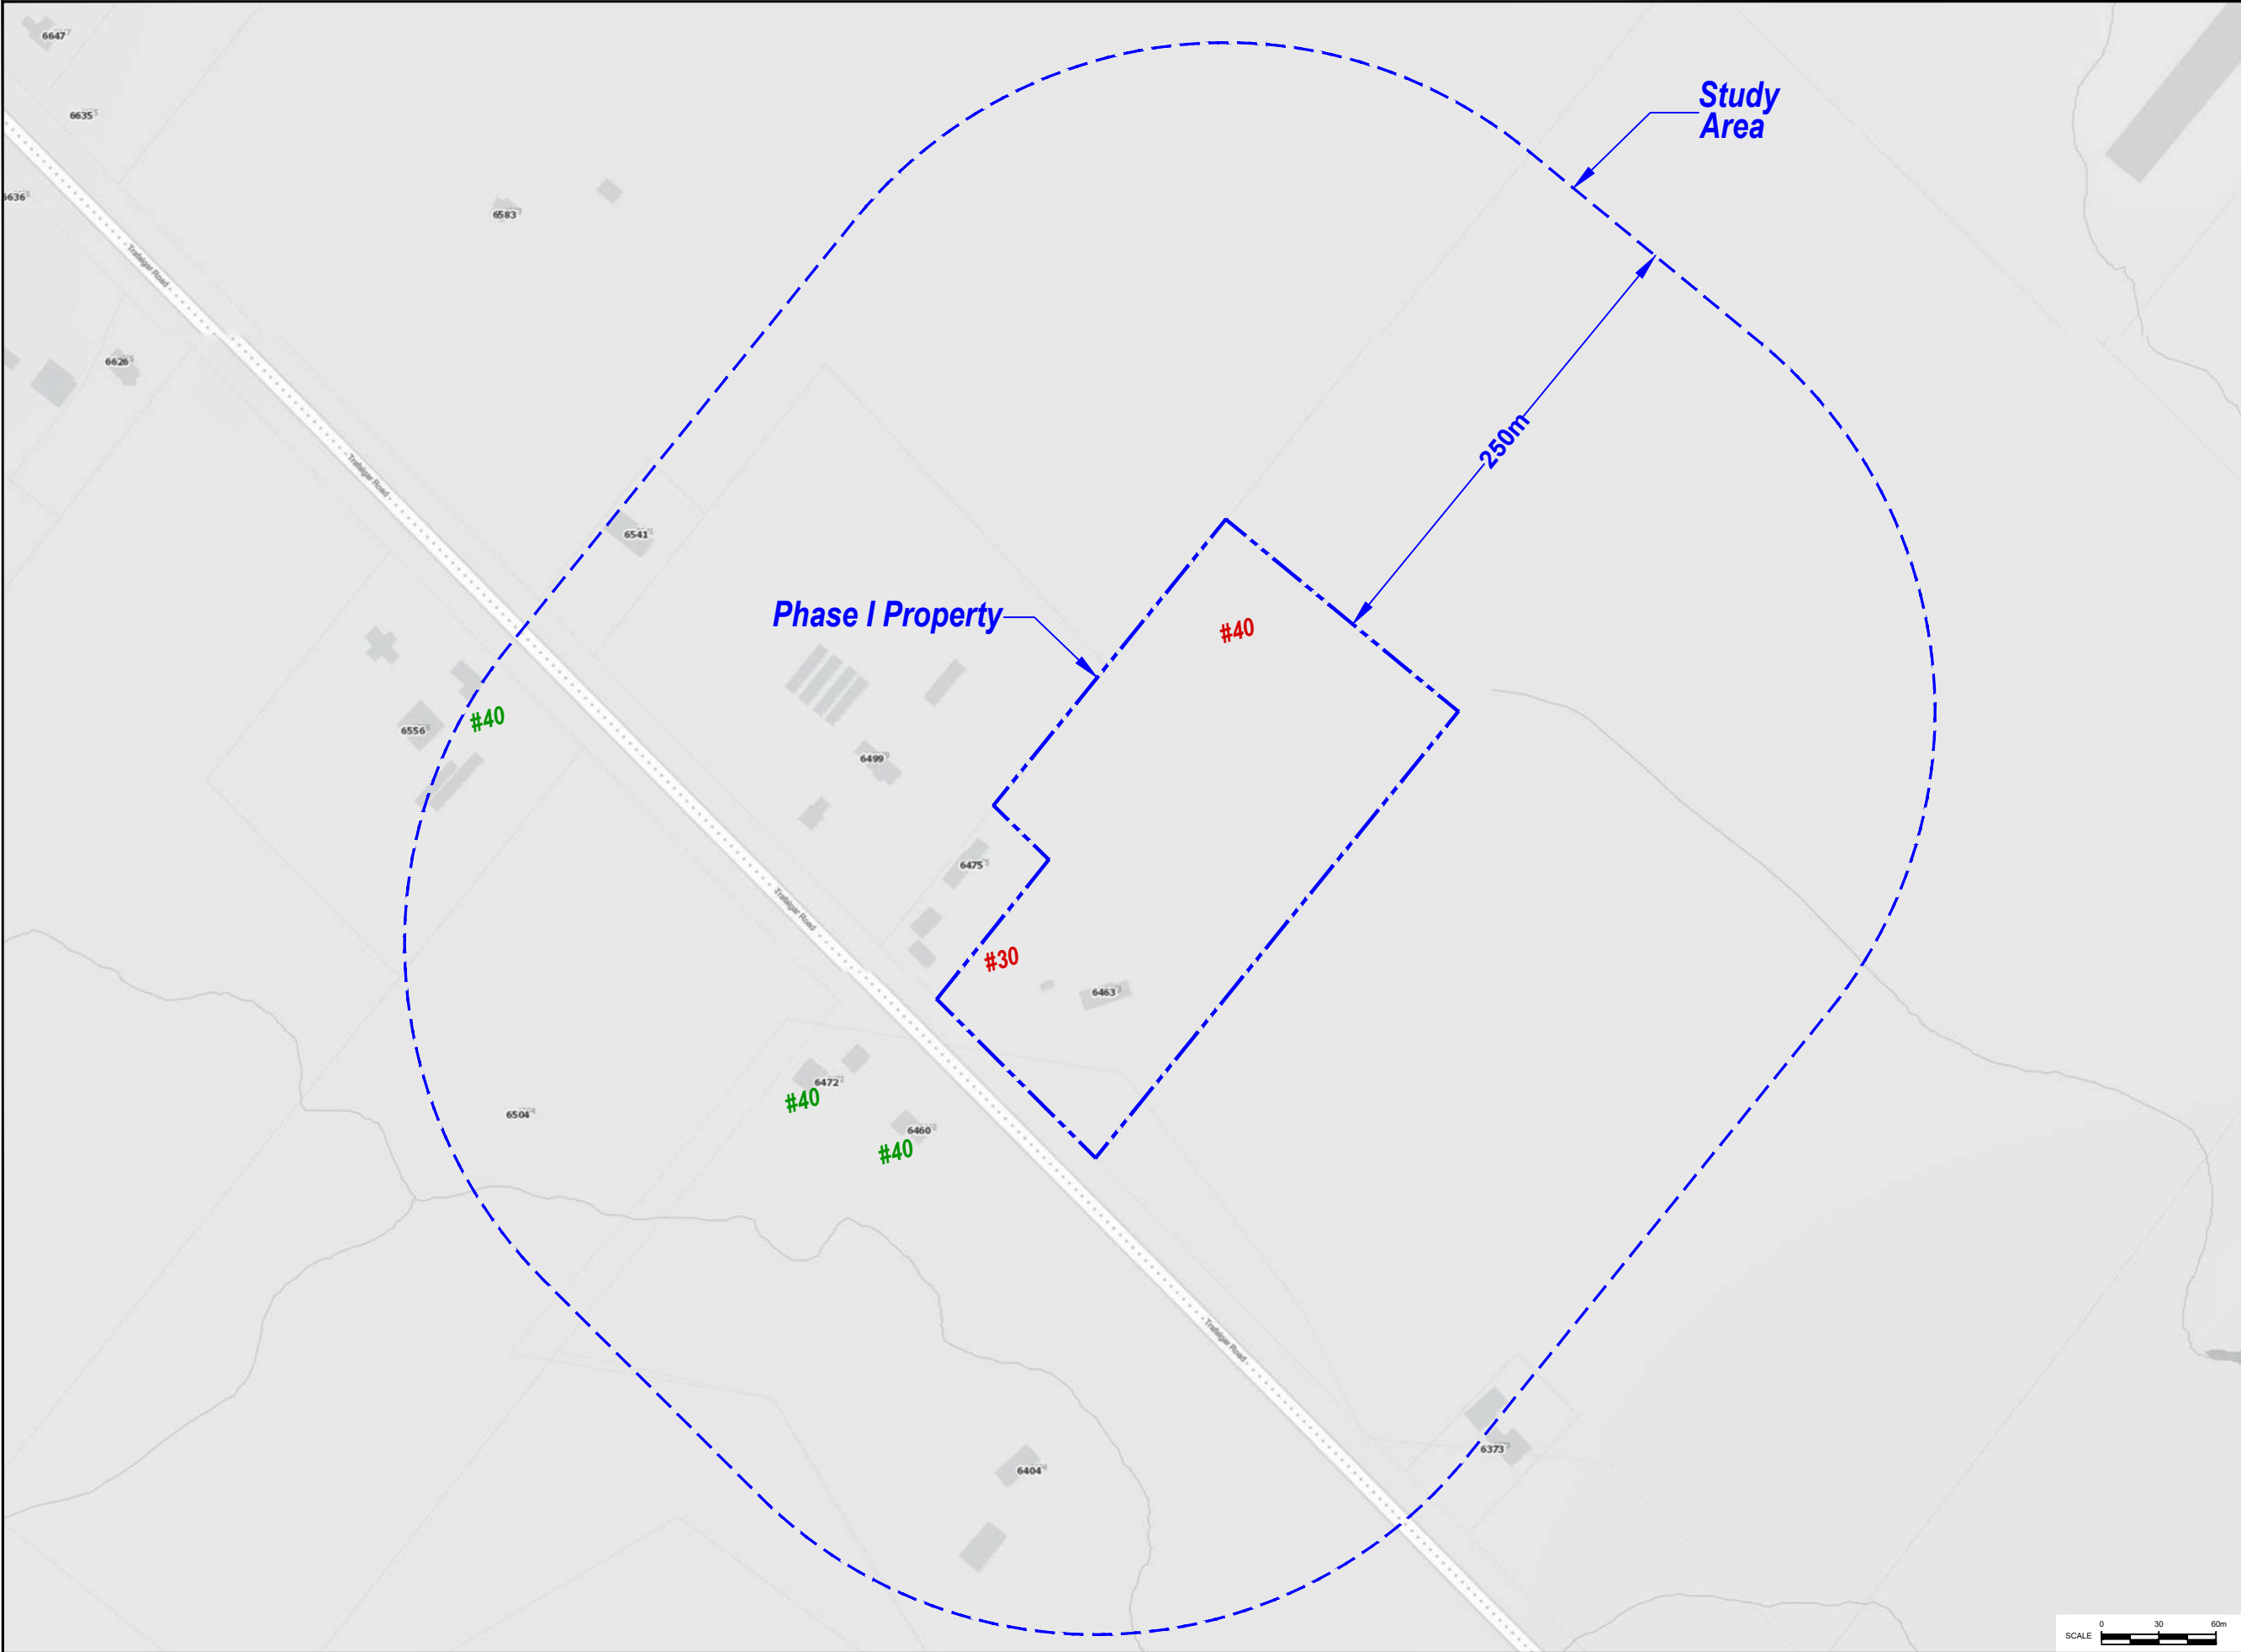
The Phase One ESA identified the following PCAs on the Property and within the Study Area. The locations of the PCAs are illustrated on Figure 5.

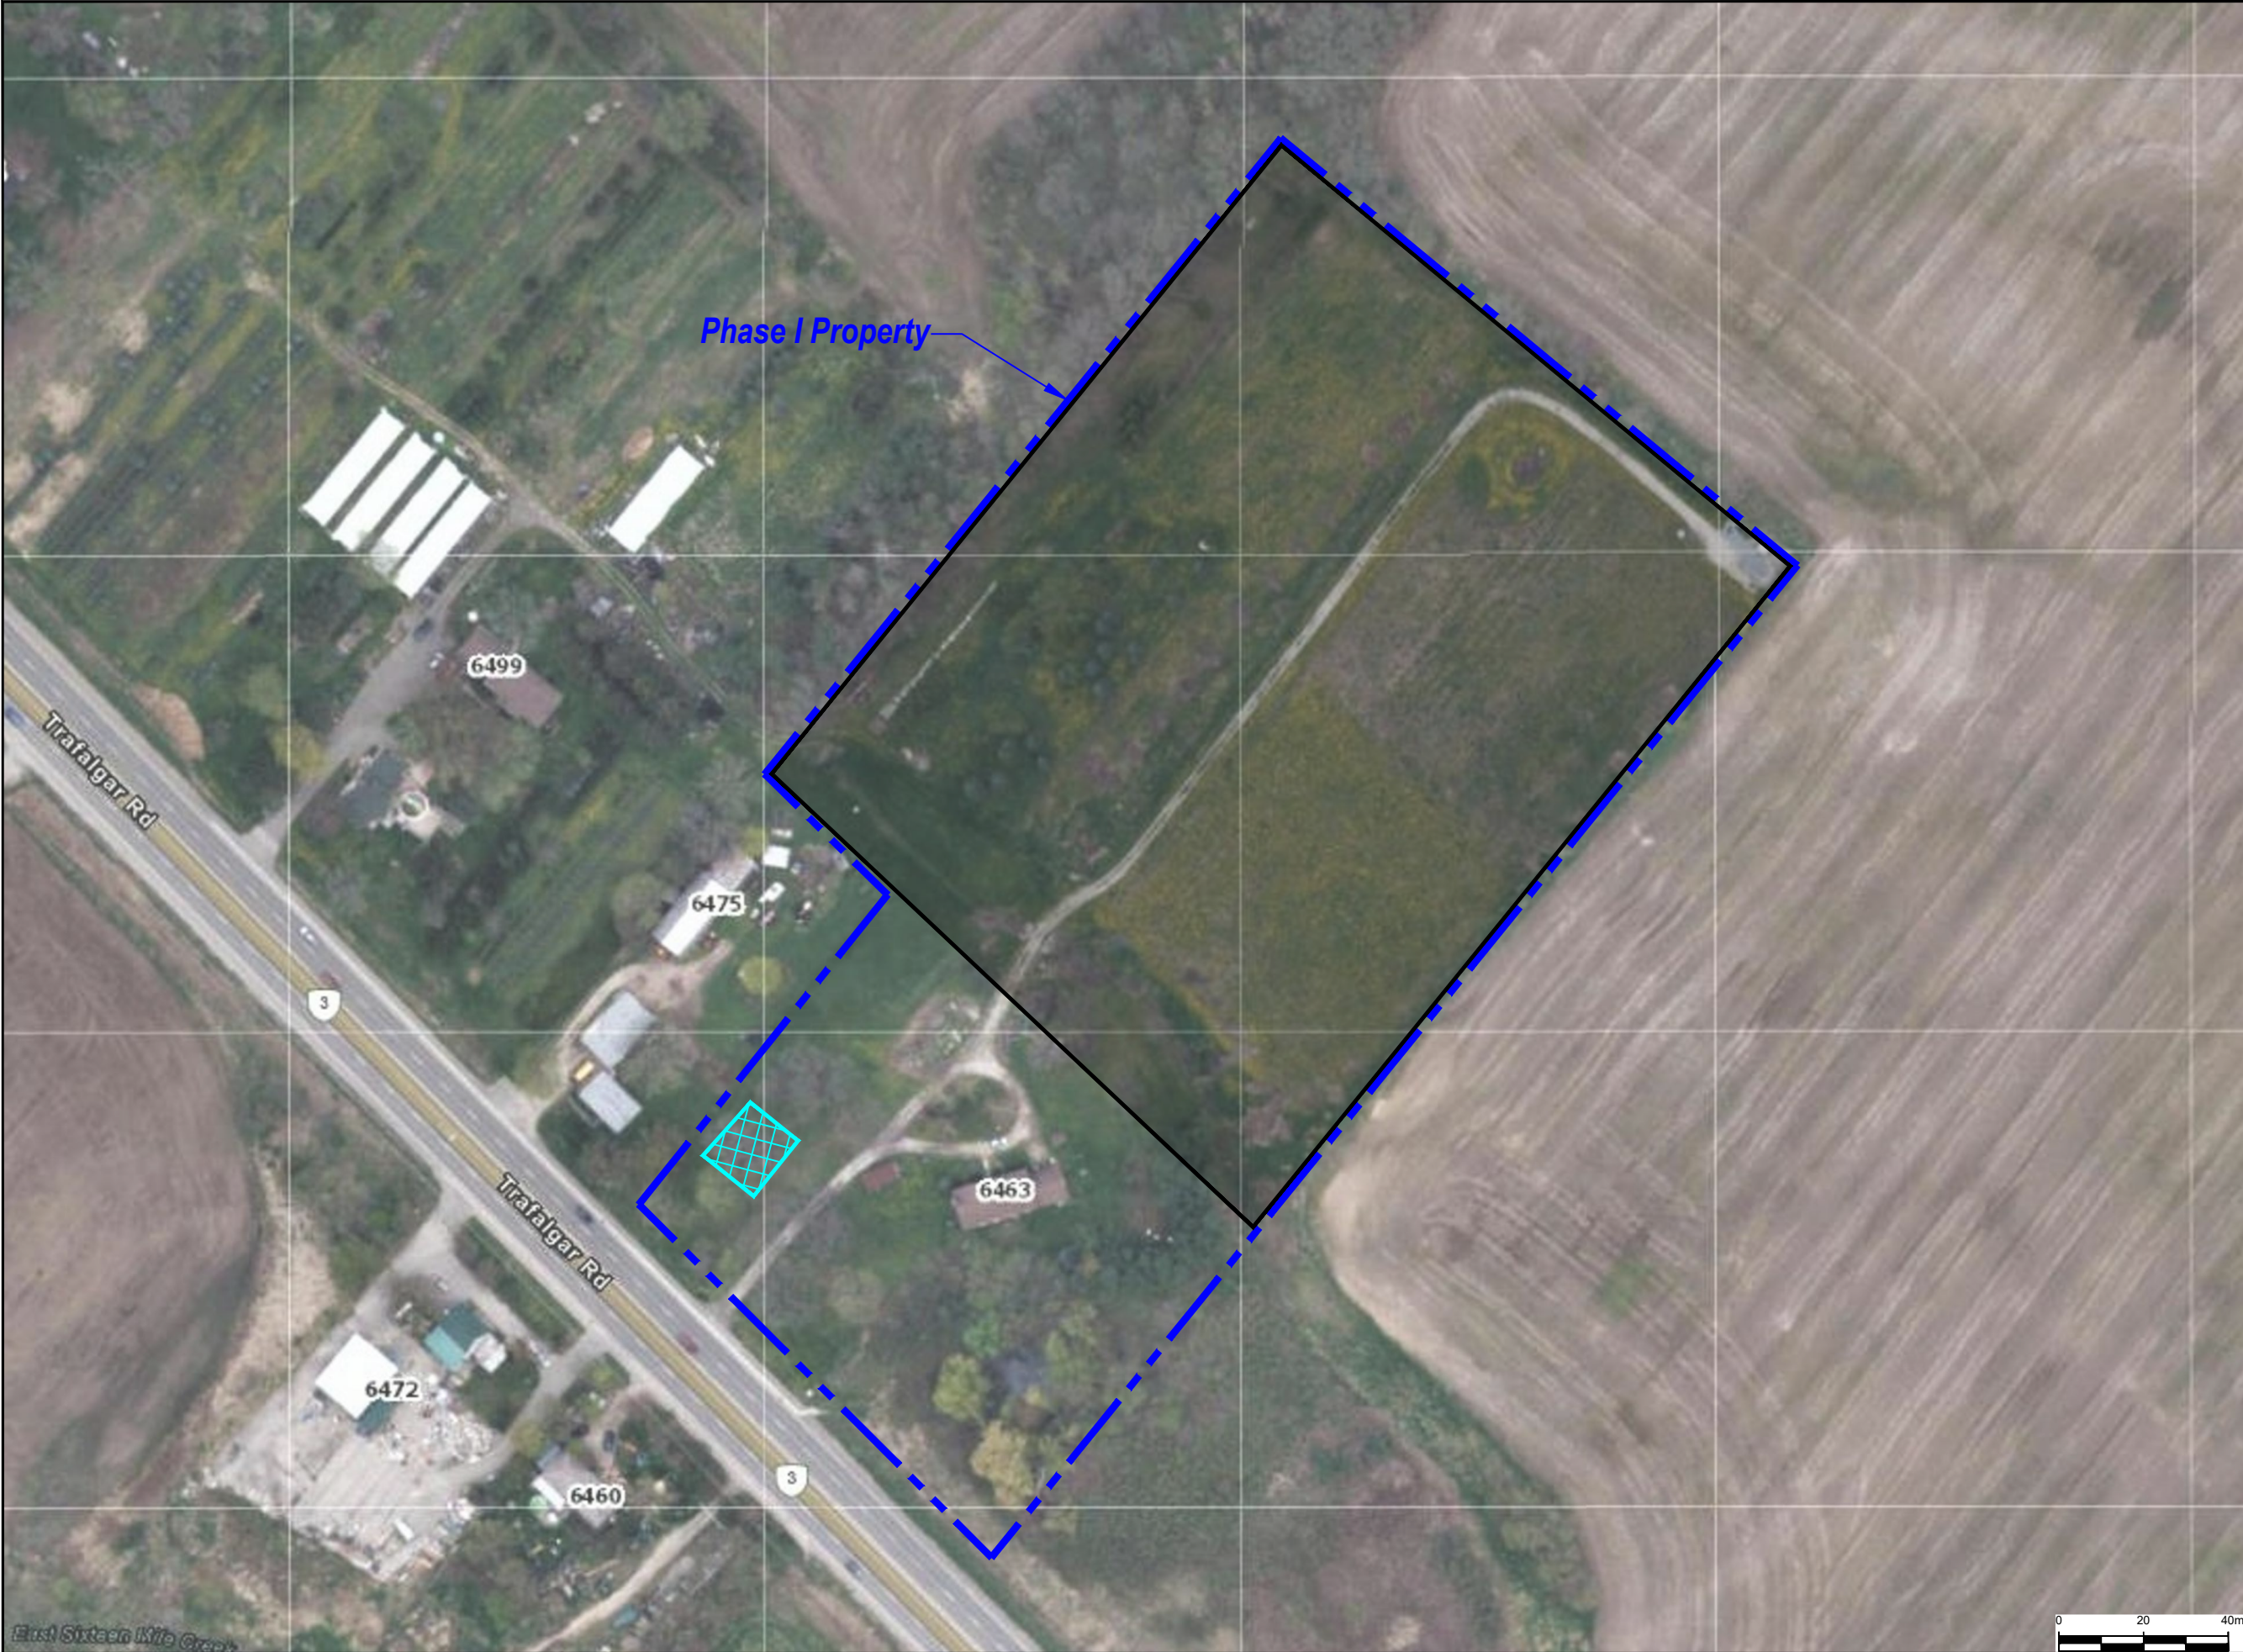
The Phase I ESA identified two (2) APECs on the Property caused by two (2) on-site PCAs. The APECs have been divided into two (2) physical area groups on the Property as illustrated on Figure 6. The APECs will be investigated simultaneously for both soil and ground water.

The Phase I ESA identified two (2) APECs on the Property caused by two (2) on-site PCAs. The APECs have been divided into two (2) area groups on the Property as illustrated on Figure 6. The APECs will be investigated simultaneously for both soil and ground water.

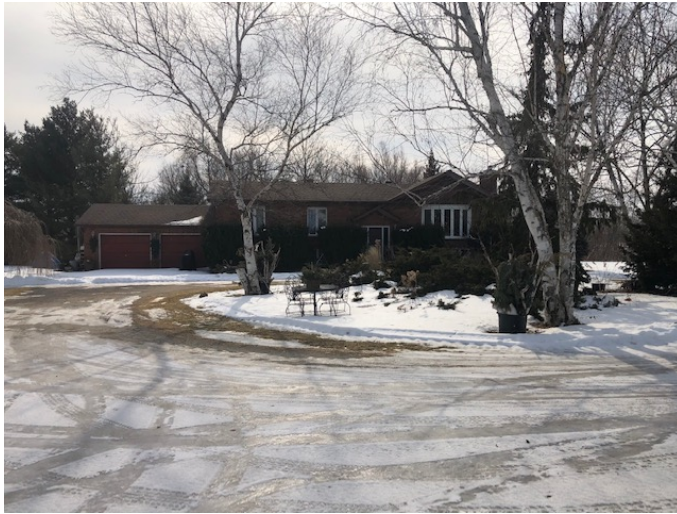
Photograph 1

Location: Phase I Property  
Viewing: South  
Description: View of the dwelling located on the southwestern portion of the Property.

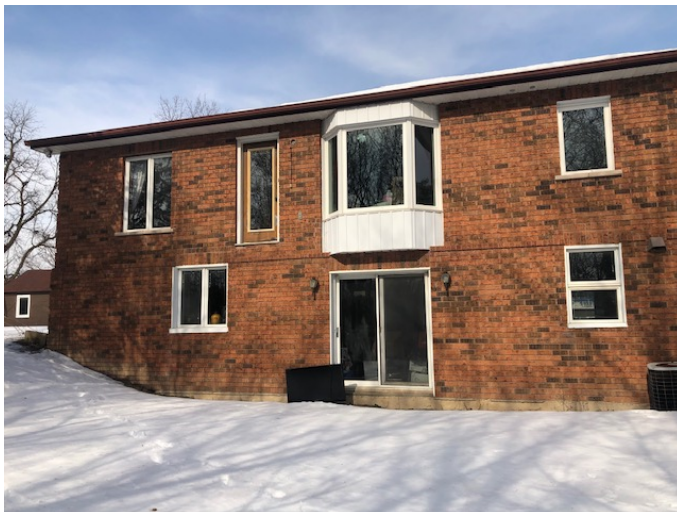
Photograph 2

Location: Phase I Property  
Viewing: North  
Description: View of the rear of the residence located on the Property.

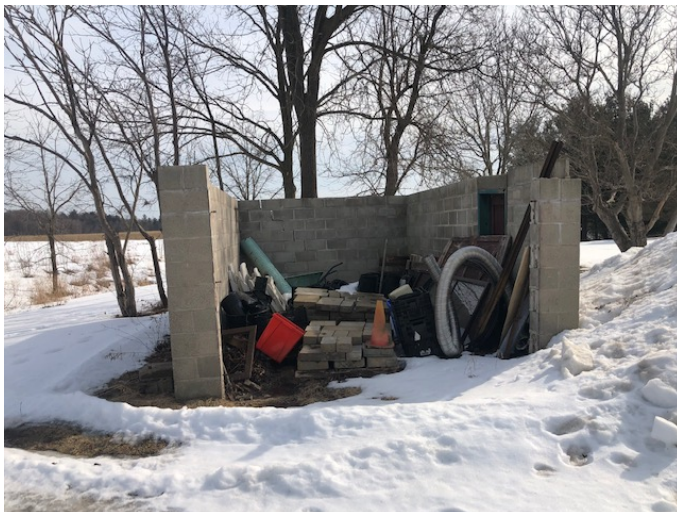
Photograph 3

Location: Phase I Property  
Viewing: South  
Description: View of the remnants of a former shed structure located on the southwest portion of the Property, east of the residence.

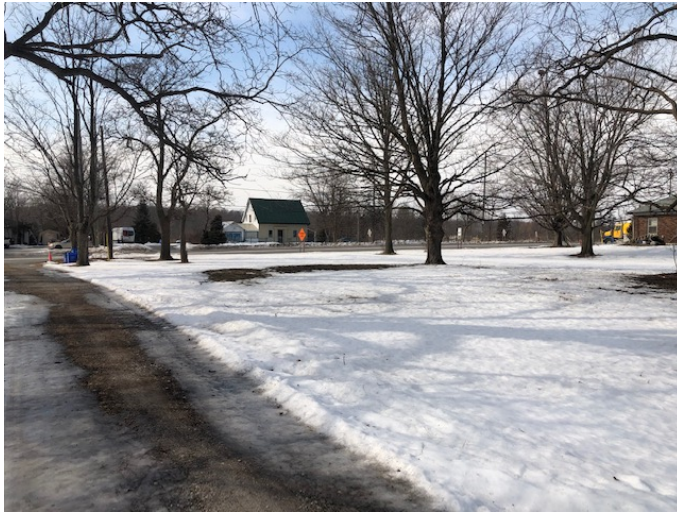
Photograph 4

| <b>Current and Former Wells</b> | One abandoned drinking water well was observed in the area of the former residence, north of the gravel driveway. |

| <b>Fill Materials</b> | No obvious evidence of fill was observed during the site inspection, with the exception of area of slightly mounded soil area in the former residence. |

Location: Phase I Property  
Viewing: West  
Description: View of the area of the former residence located on the Property. The residence was demolished approximately 20 years ago.

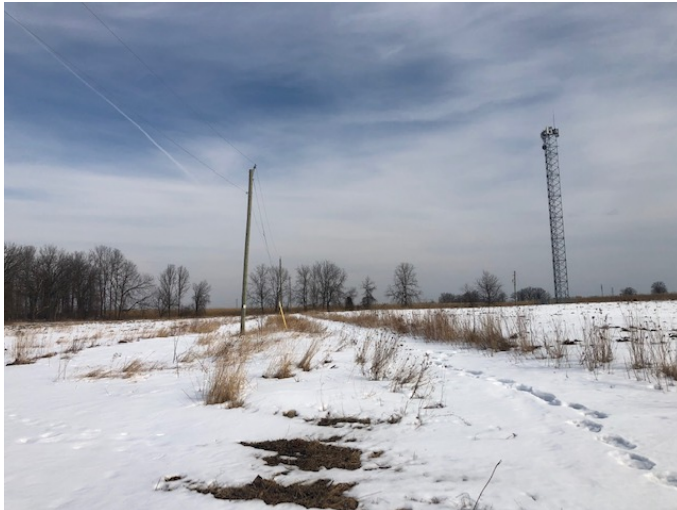
Photograph 5

Location: Phase I Property  
Viewing: East  
Description: View of agricultural area of the Property, formerly used for growing organic garlic. Overhead hydro was observed along the north side of a snow covered gravel driveway leading to a telephone tower on the southeast portion of the Property.

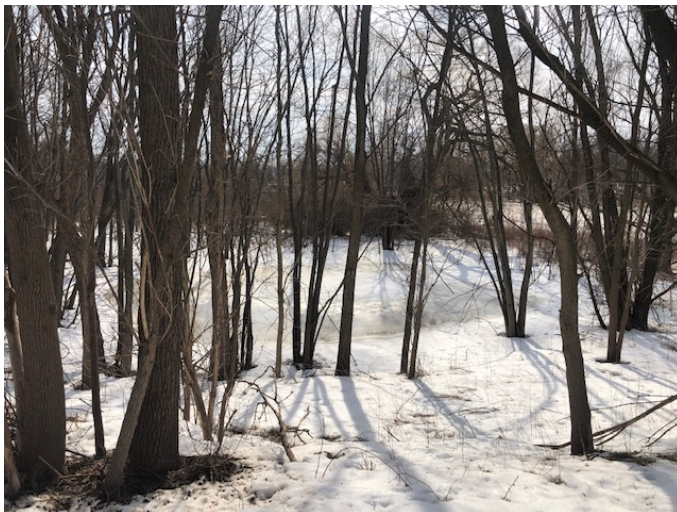
Photograph 6

| <b>Water Bodies (Property)</b> | <ul style="list-style-type: none"> <li>No bodies of water were identified on the Property. It is noted that a pond is located at the southwest portion of the Property along the southern Property boundary. The pond was not present in 1946 and appeared on the Property in the 1965 aerial photo. On this basis, it is interpreted that the pond is man made and not naturally occurring. As per O.Reg. 153/04, the definition of a water body means “<i>a permanent stream, river or similar watercourse or a pond or lake, but does not include a pond constructed on the property for the purpose of controlling surface water drainage</i>”. On this basis, it is the opinion of the QP that the pond present on the Property would not be considered a water body under O.Reg. 153/04.</li> </ul> |

Location: Phase I Property  
Viewing: South  
Description: View of the pond located at the bottom of the slope, south of the residence.

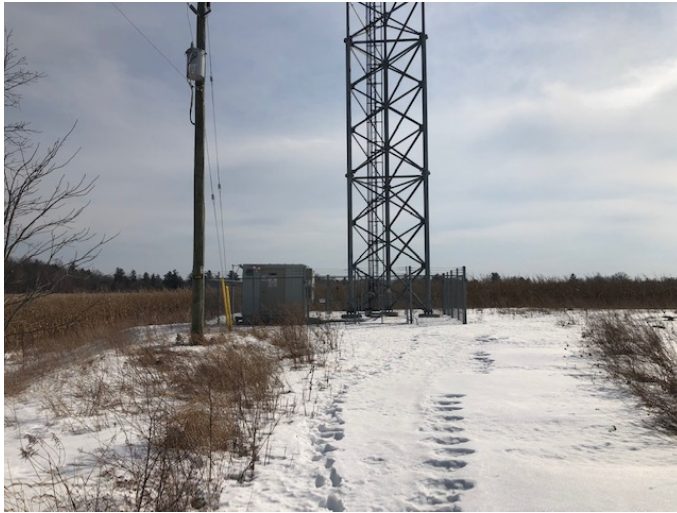
Photograph 7

| <b>PCBs</b> | The use of PCBs in electrical equipment such as transformers, fluorescent lamp ballasts and capacitors was banned in electrical equipment installed after 1977. A pole mounted transformer was noted on the hydro pole located near the telephone tower on the southeast portion of the Property. Based on the age of the telephone tower, it is not anticipated that the transformer contains PCBs. |

Location: Phase I Property  
Viewing: South  
Description: View of the telephone tower located on the southeast portion of the Property.
