**PROJECT NO.: SM 220141-E**

**MAY 26, 2023**

**PHASE ONE ENVIRONMENTAL SITE ASSESSMENT  
388 MAIN STREET EAST, 395-409 PEARL STREET & 17 PRINCE STREET  
MILTON, ONTARIO**

**SOIL-MAT ENGINEERS & CONSULTANTS LTD.  
401 GRAYS ROAD  
HAMILTON, ONTARIO  
L8E 2Z3**

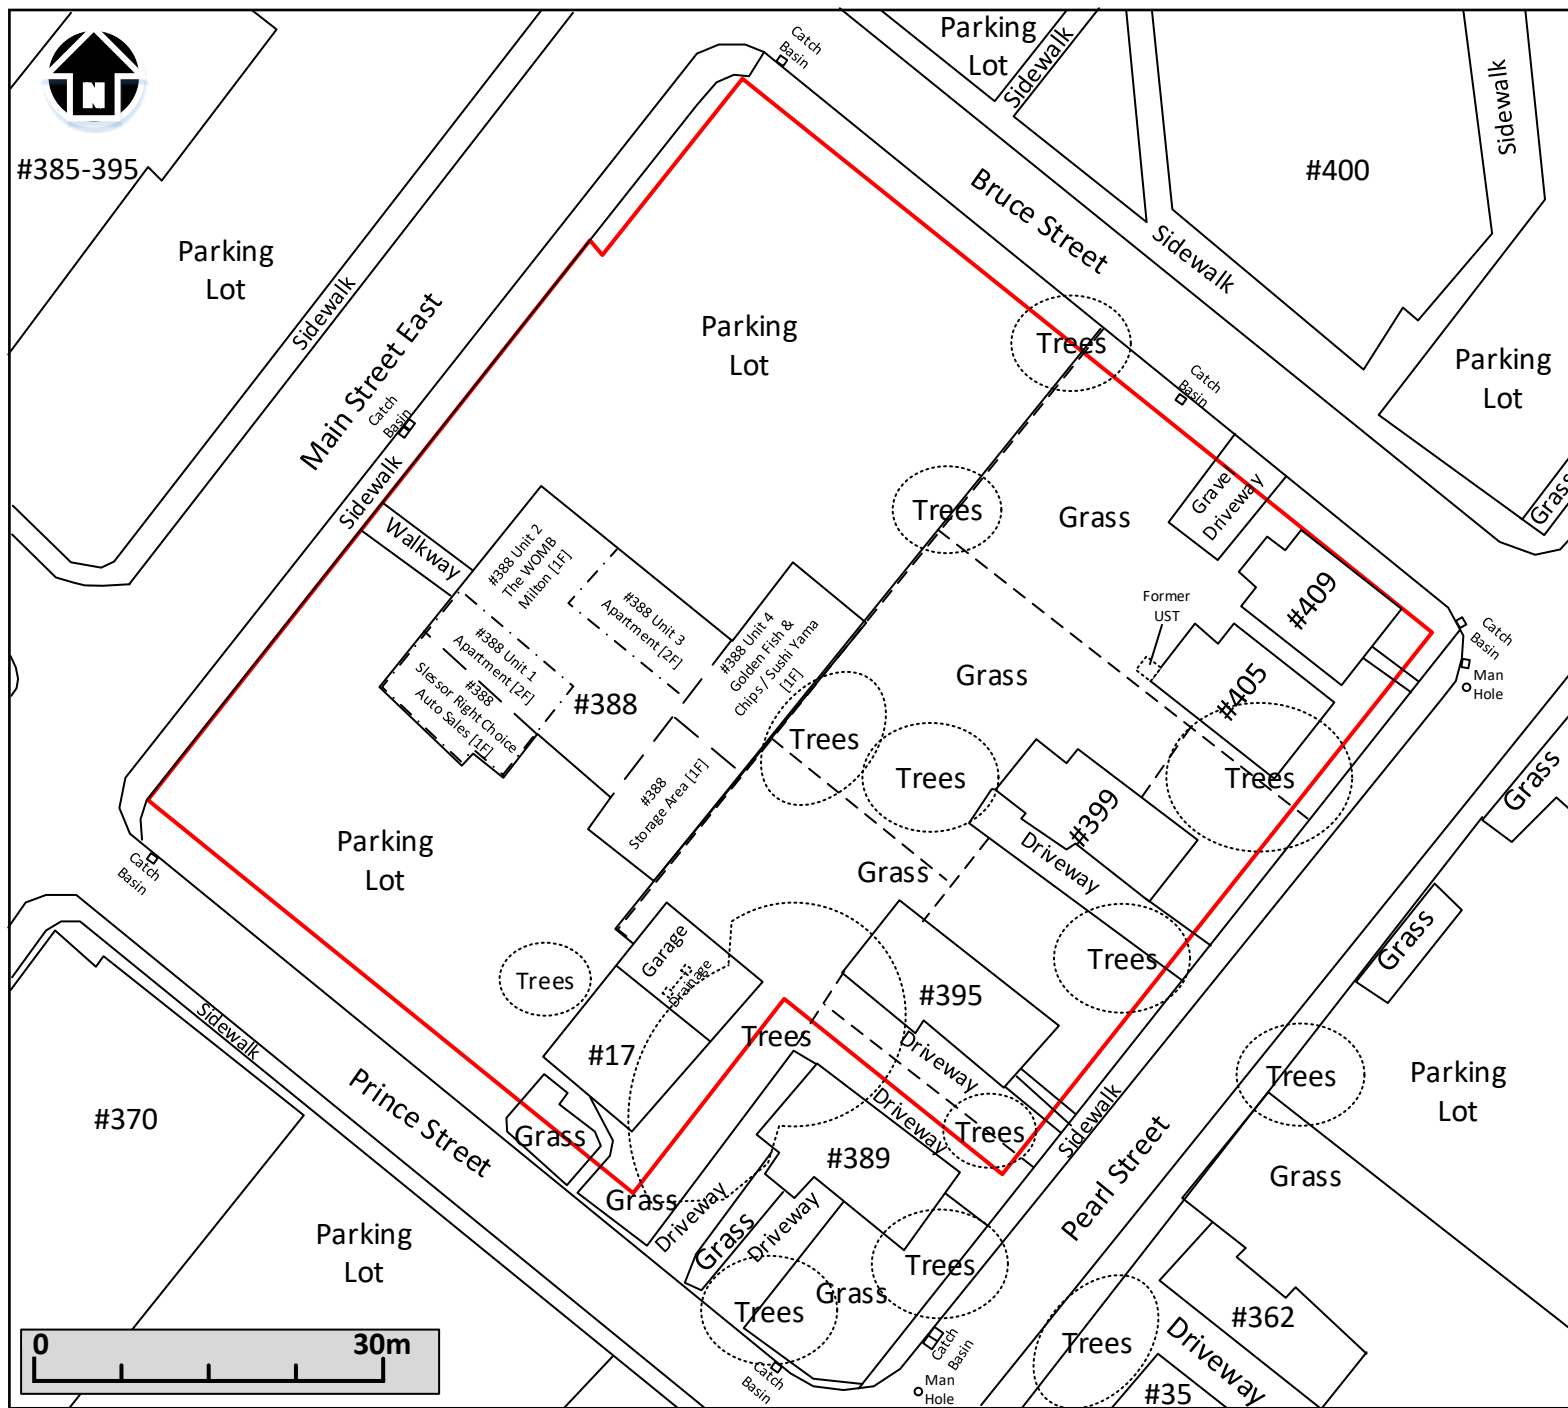
1. Drawing No.: 1.: Site Plan;
2. Drawing No.: 1A.: APECs;
3. Drawing No.: 2: Study Area View, and;
4. Drawing No.: 3: Site Location

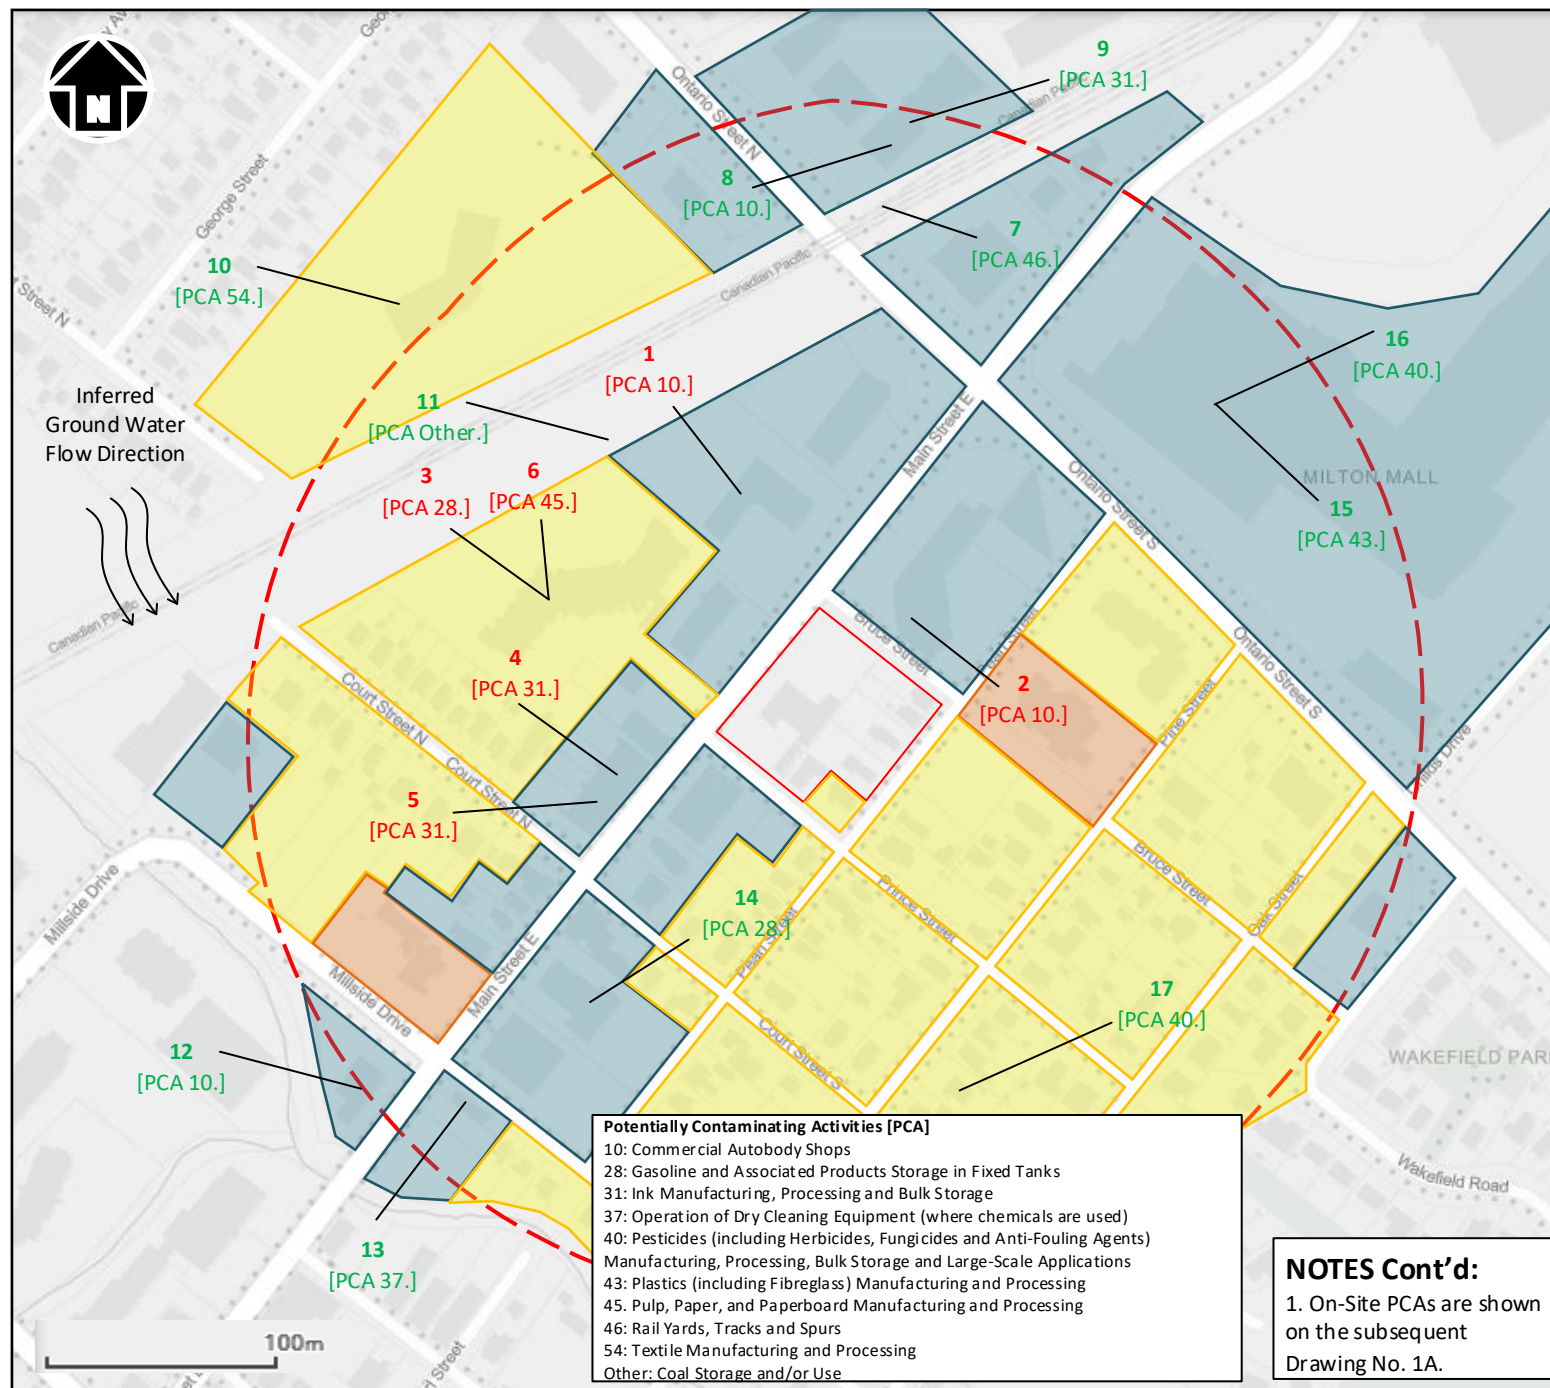
### **1. Phase One Conceptual Site Model**

- = Site Boundary
- = Phase One ESA Study Area
- = Institutional Lands
- = Residential Lands
- = Commercial Lands
- PCA # = Off-Site PCA causing an APEC on the RSC Property
- PCA # = Off-Site PCA not causing an APEC on the RSC Property

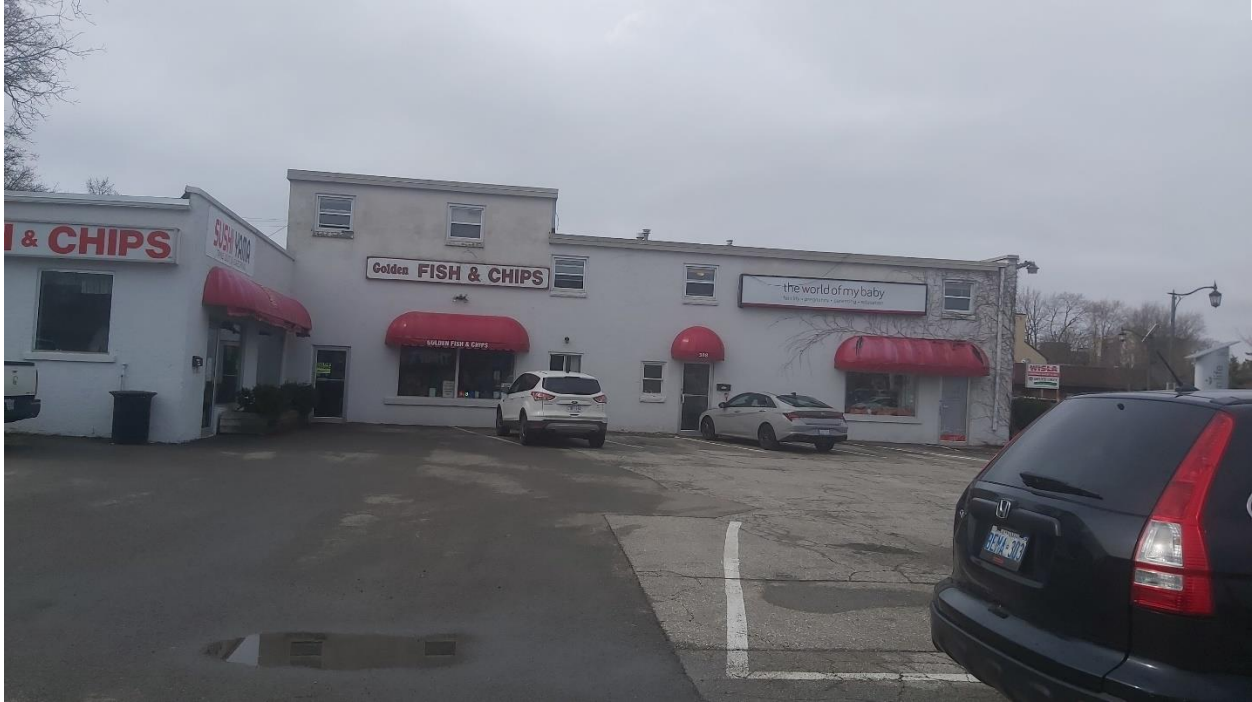
Photo of the east side of the commercial/residential building at 388 Main Street East. Taken from the eastern portion of the Site, facing west.

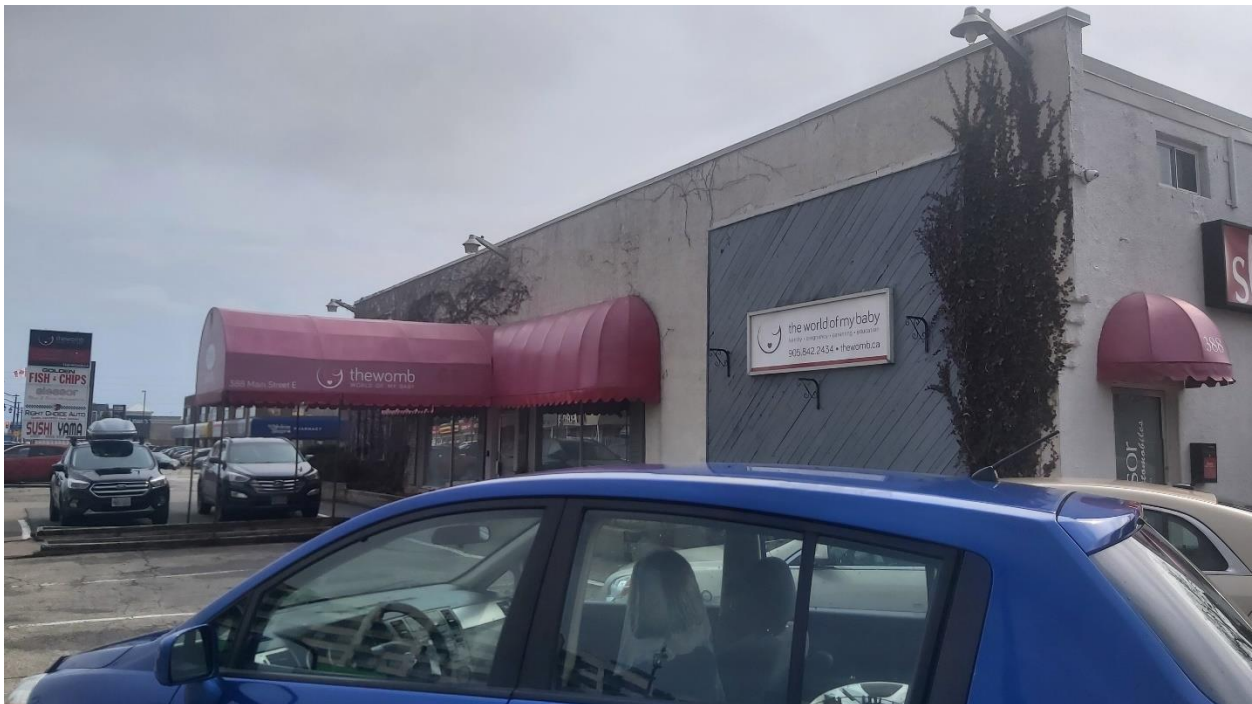
Photo of the north side of the commercial/residential building at 388 Main Street East. Taken from the northern portion of the Site, facing southeast.

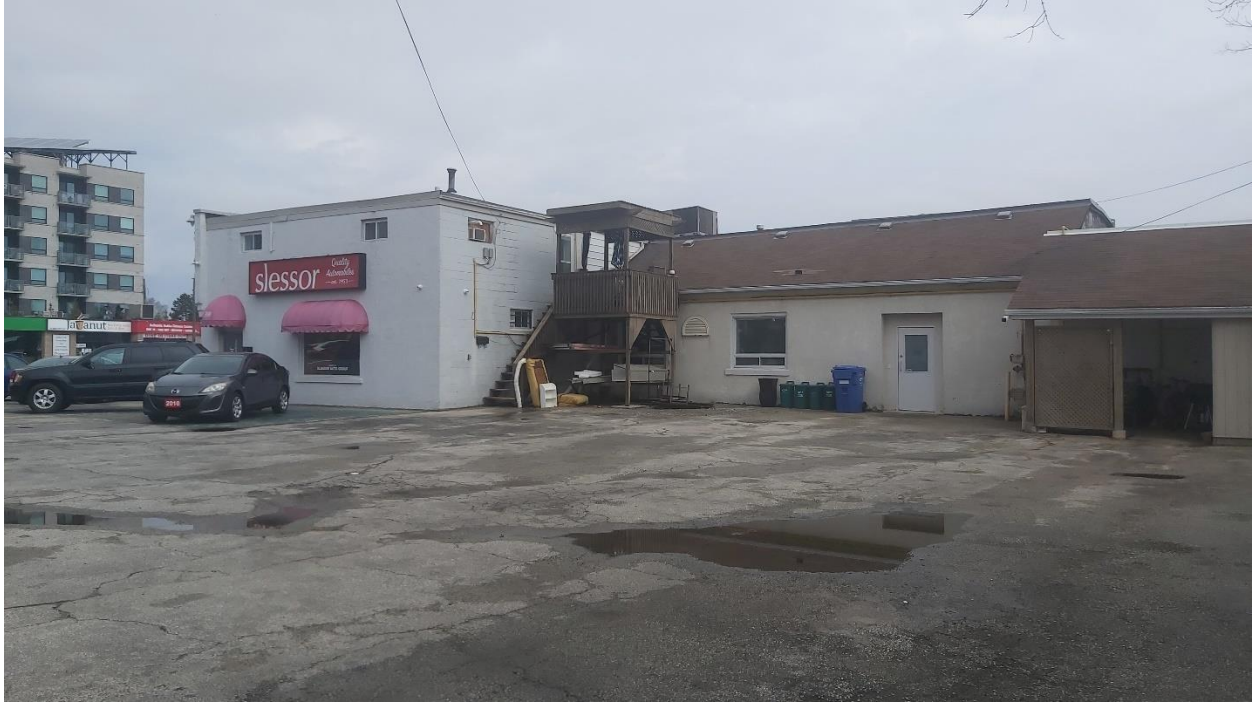
Photo of the west side of the commercial/residential building at 388 Main Street East. Taken from the western portion of the Site, facing northeast.

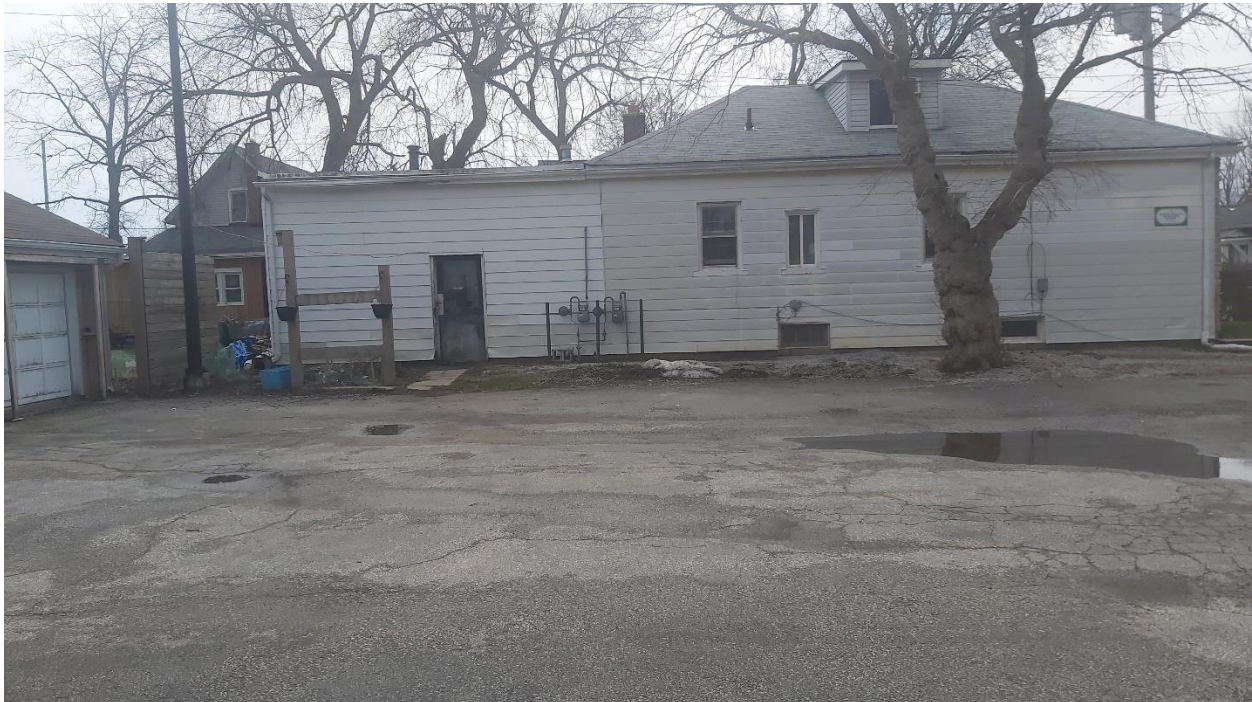
Photo of the north side of the garage and residential building at 17 Prince Street. Taken from the western portion of the Site, facing south.

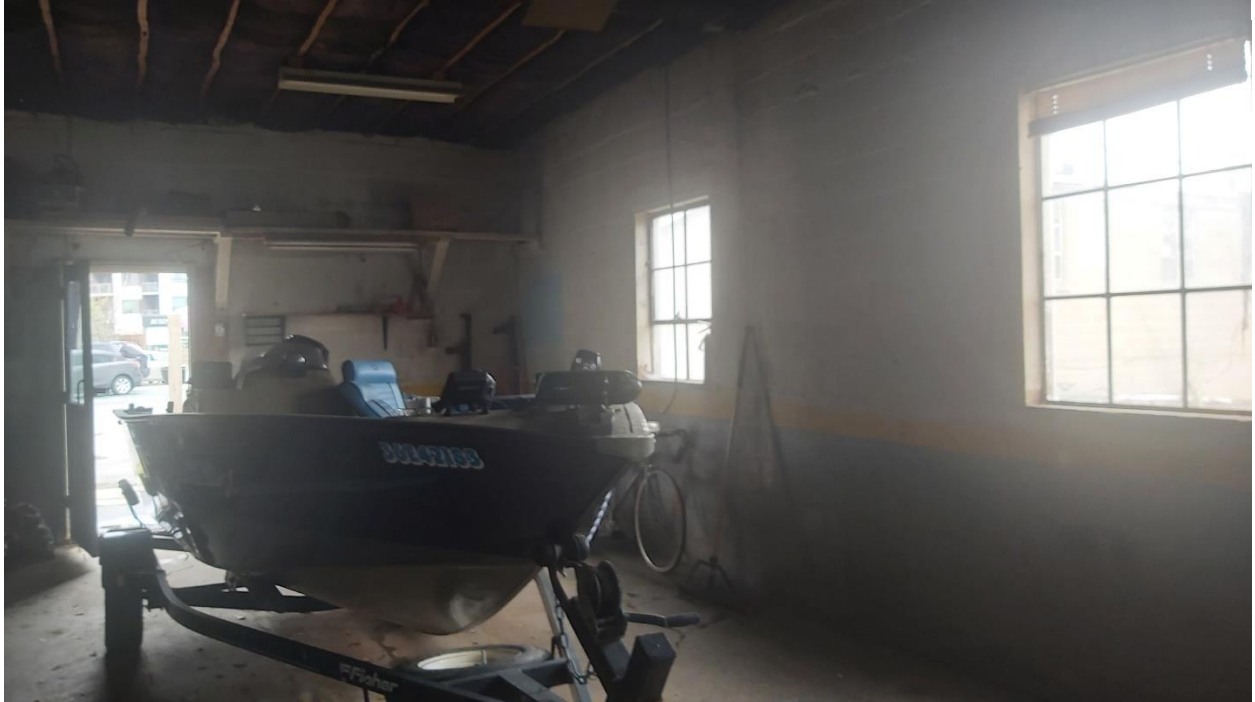
Photo of the garage interior at 17 Prince Street. Taken from the south side of the garage, facing north.

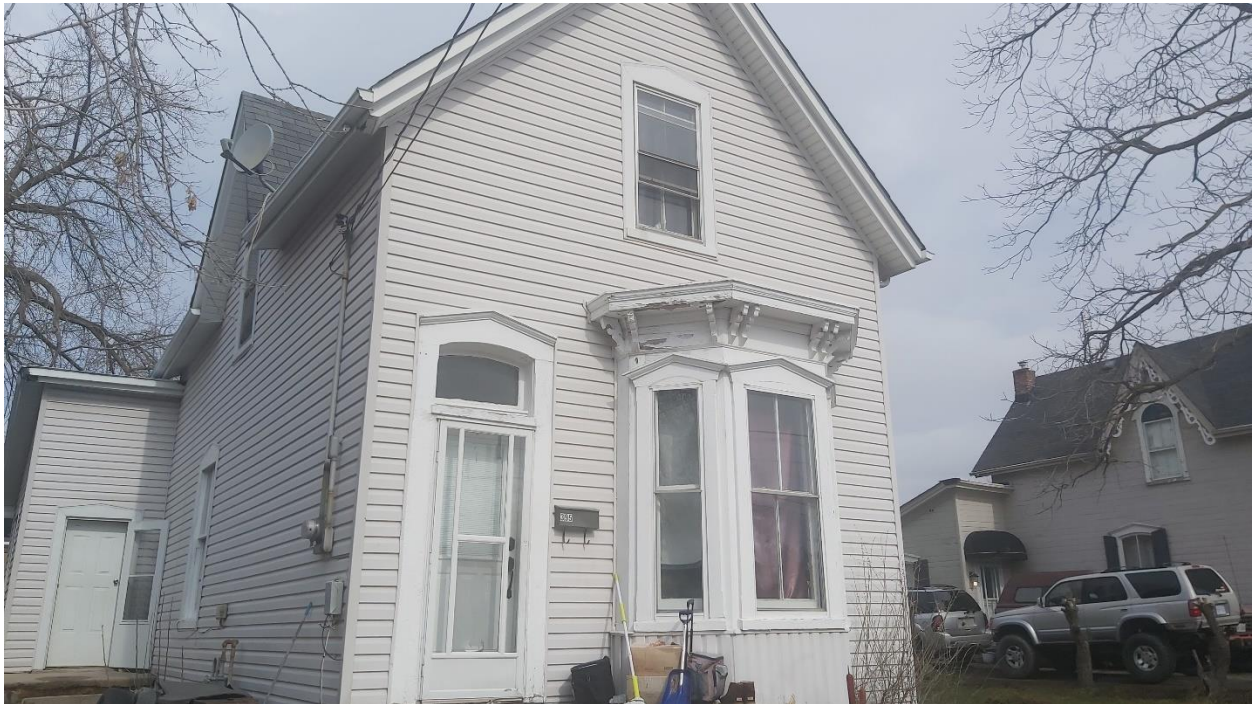
Photo of the south side of the dwelling at 395 Pearl Street. Taken from the southern portion of the Site, facing north.

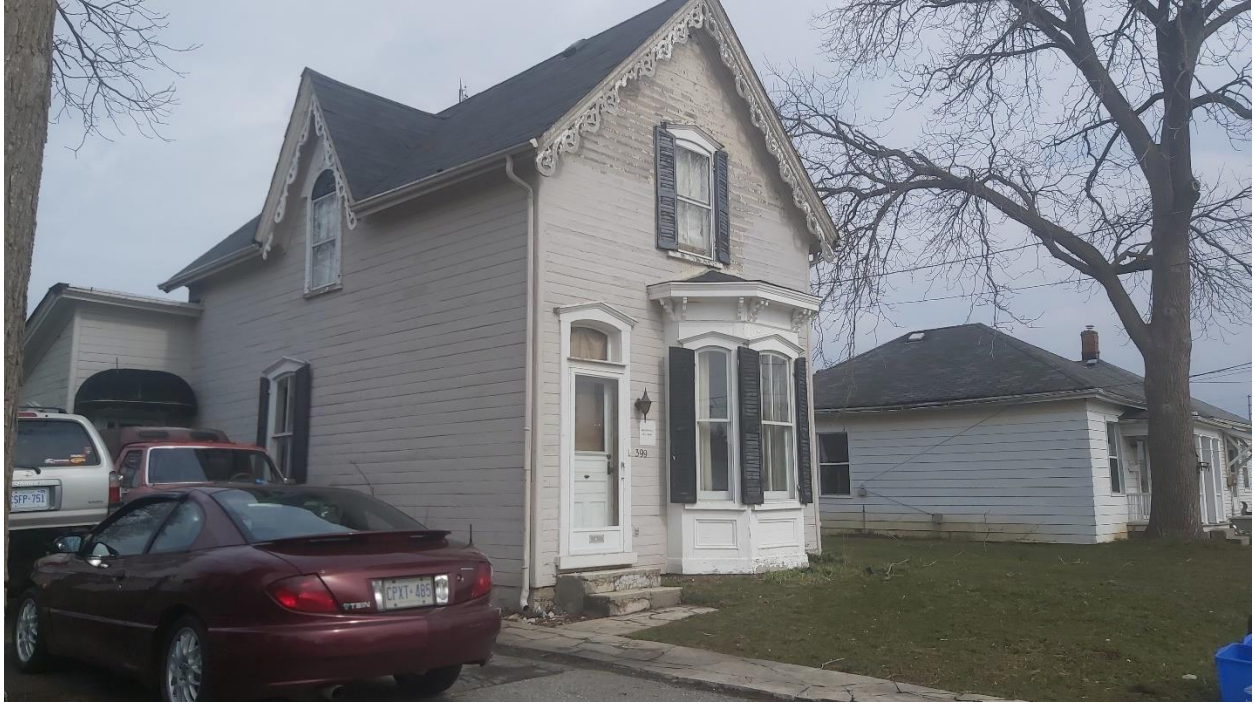
Photo of the south side of the dwelling at 399 Pearl Street. Taken from the southern portion of the Site, facing northeast.

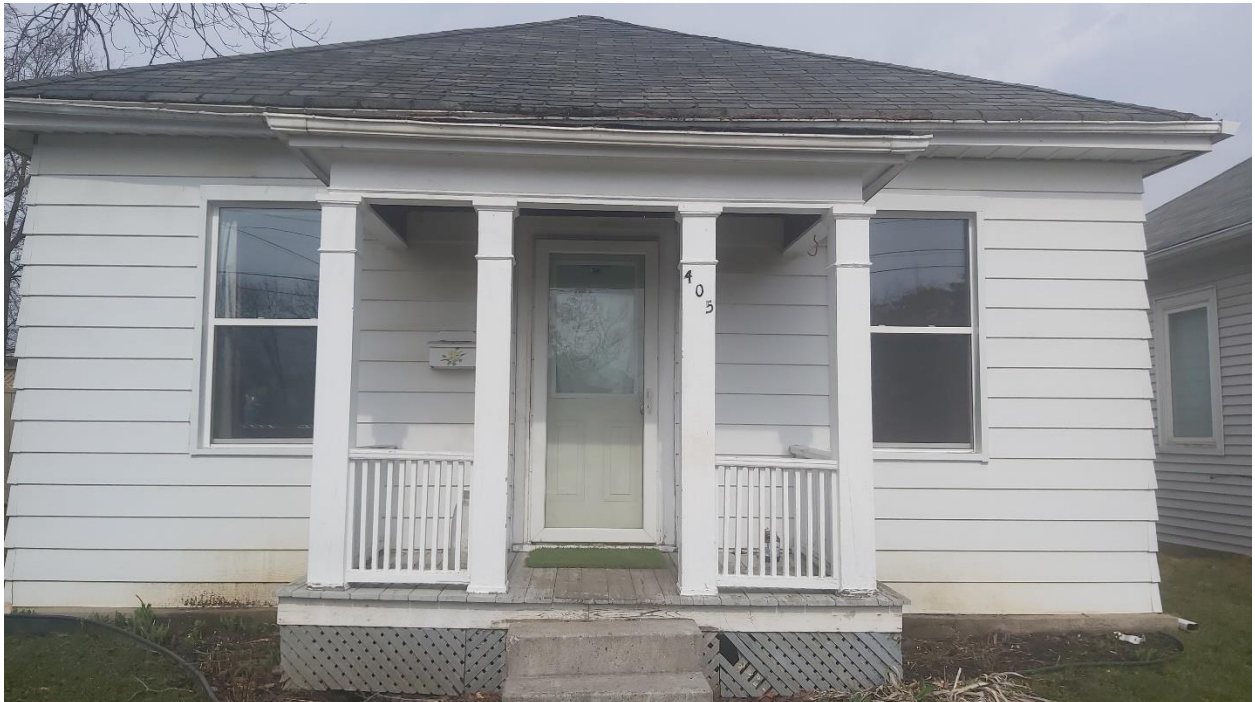
Photo of the south side of the dwelling at 405 Pearl Street. Taken from the southeastern portion of the Site, facing north.

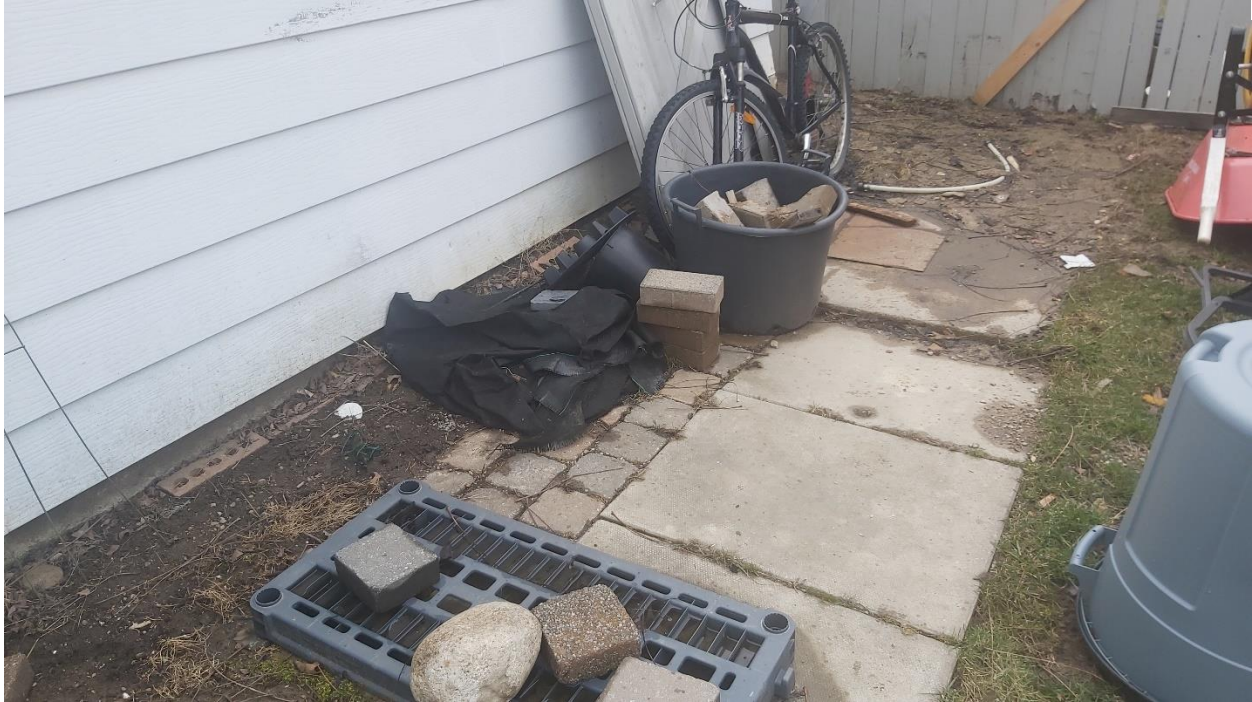
Photo of the former underground storage tank area, located north of the dwelling at 405 Pearl Street.  
Taken from the southeastern portion of the Site, facing west.

6. Waste Management Records: No records were found for the Site but records of waste generation were found for the adjacent properties. Refer to the EcoLog ERIS Database Search in Section 4(b), Part 12 for more details.
7. Reports Submitted to the MOE: No records were found for the Site or adjacent properties.
8. Retail Fuel Storage Tanks: SOIL-MAT ENGINEERS contacted the T.S.S.A. to undertake a search of the Site and neighbouring properties for the registered presence of any underground storage tanks. The T.S.S.A. does not have records on file of any underground storage tanks located on the Site or in the Study Area.

It is however noted that the T.S.S.A. does not have records of USTs installed prior to 1987. In addition, "private use" USTs were not registered with the agency until 1990, and even then many owners of "private use" USTs do not register the tanks with T.S.S.A.

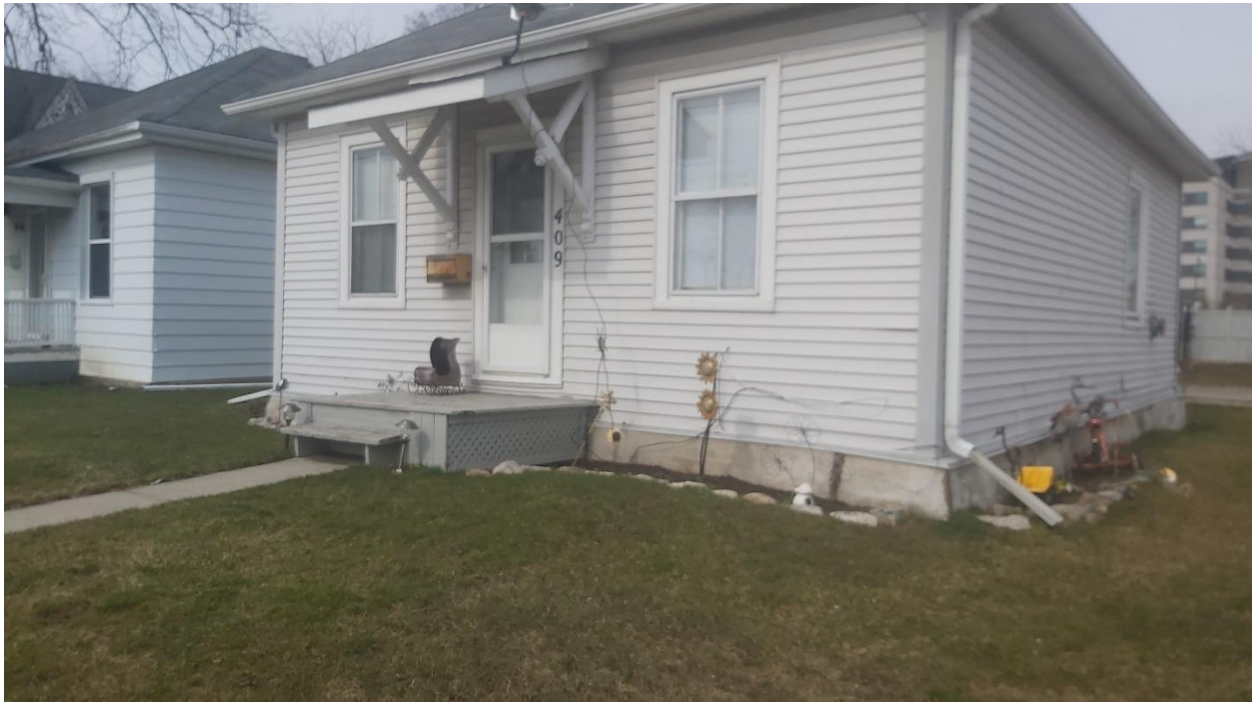
Photo of the south side of the dwelling at 409 Pearl Street. Taken from the southeastern portion of the  
Site, facing northwest.
