Phase One Environmental Site Assessment

Development Lands (Phase 1 to 5) at Britannia Road and First Line, Milton, Ontario

Project Number:
GTR-23015375-A0

Date Submitted: May 20, 2025

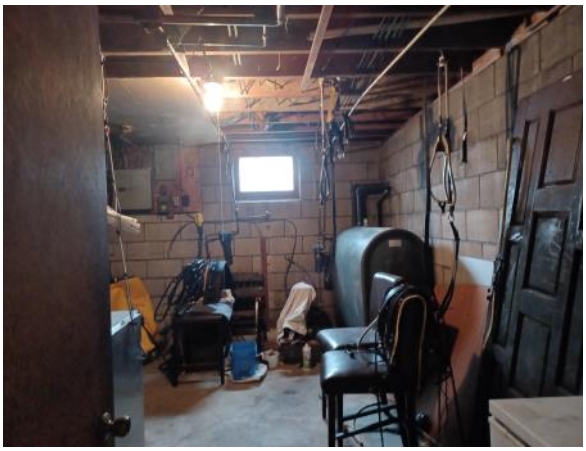
Photo 12: View of the AST for heating oil storage in the basement of 4519 Tremaine Road.
