**Geotechnical Investigation-Top of Bank Stability  
For the property at Part Lot 48  
(6451 Sixth Line, Milton, ON) – Rev01  
Project No. 30291.233**

Neamsby Investment Inc.  
7501 Keele Street, Suite 100,  
Vaughan, ON L4K 1Y2

**AME** Materials Engineering  
10 Perdue Court, Units 2 & 3  
Caledon, ON L7C 3M6

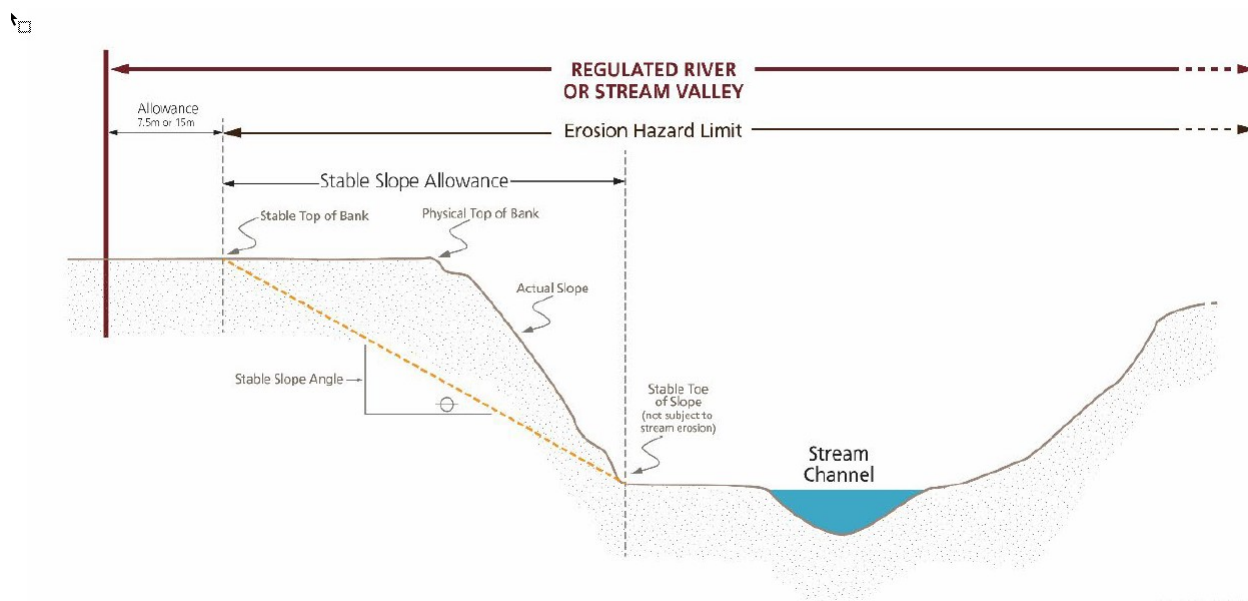
**Figure 1 – Valley Erosion Hazards – Stable Toe of Slope**  
**Riverine Erosion Hazard – Apparent (Confined) Valleys with Stable Toe of Slope**

The minimum 8 meters toe erosion allowance was considered and the projected slope to the existing top of bank was analyzed, approximately 1.5H:1.0V and 1.0H:1.0V slope for section A-A and B-B, respectively. The calculated factor of safety (FS) of the existing slope at cross section A-A and B-B is 3.563 and 2.370, respectively, for the most critical slipping plane will be passing through the fill layer (See Figure D-6 and D-7 of Appendix D). The calculated FS is significantly more than the generally acceptable value of 1.5 for long-term stability of slopes. Accordingly, no adjustment will be required for the defined allowances in section 6.1 and 6.2.
