Preliminary Hydrogeological Investigation

Proposed Residential Buildings 150 Steeles Avenue East Milton, ON

Project #: 21-122-106 Date: April 7, 2025

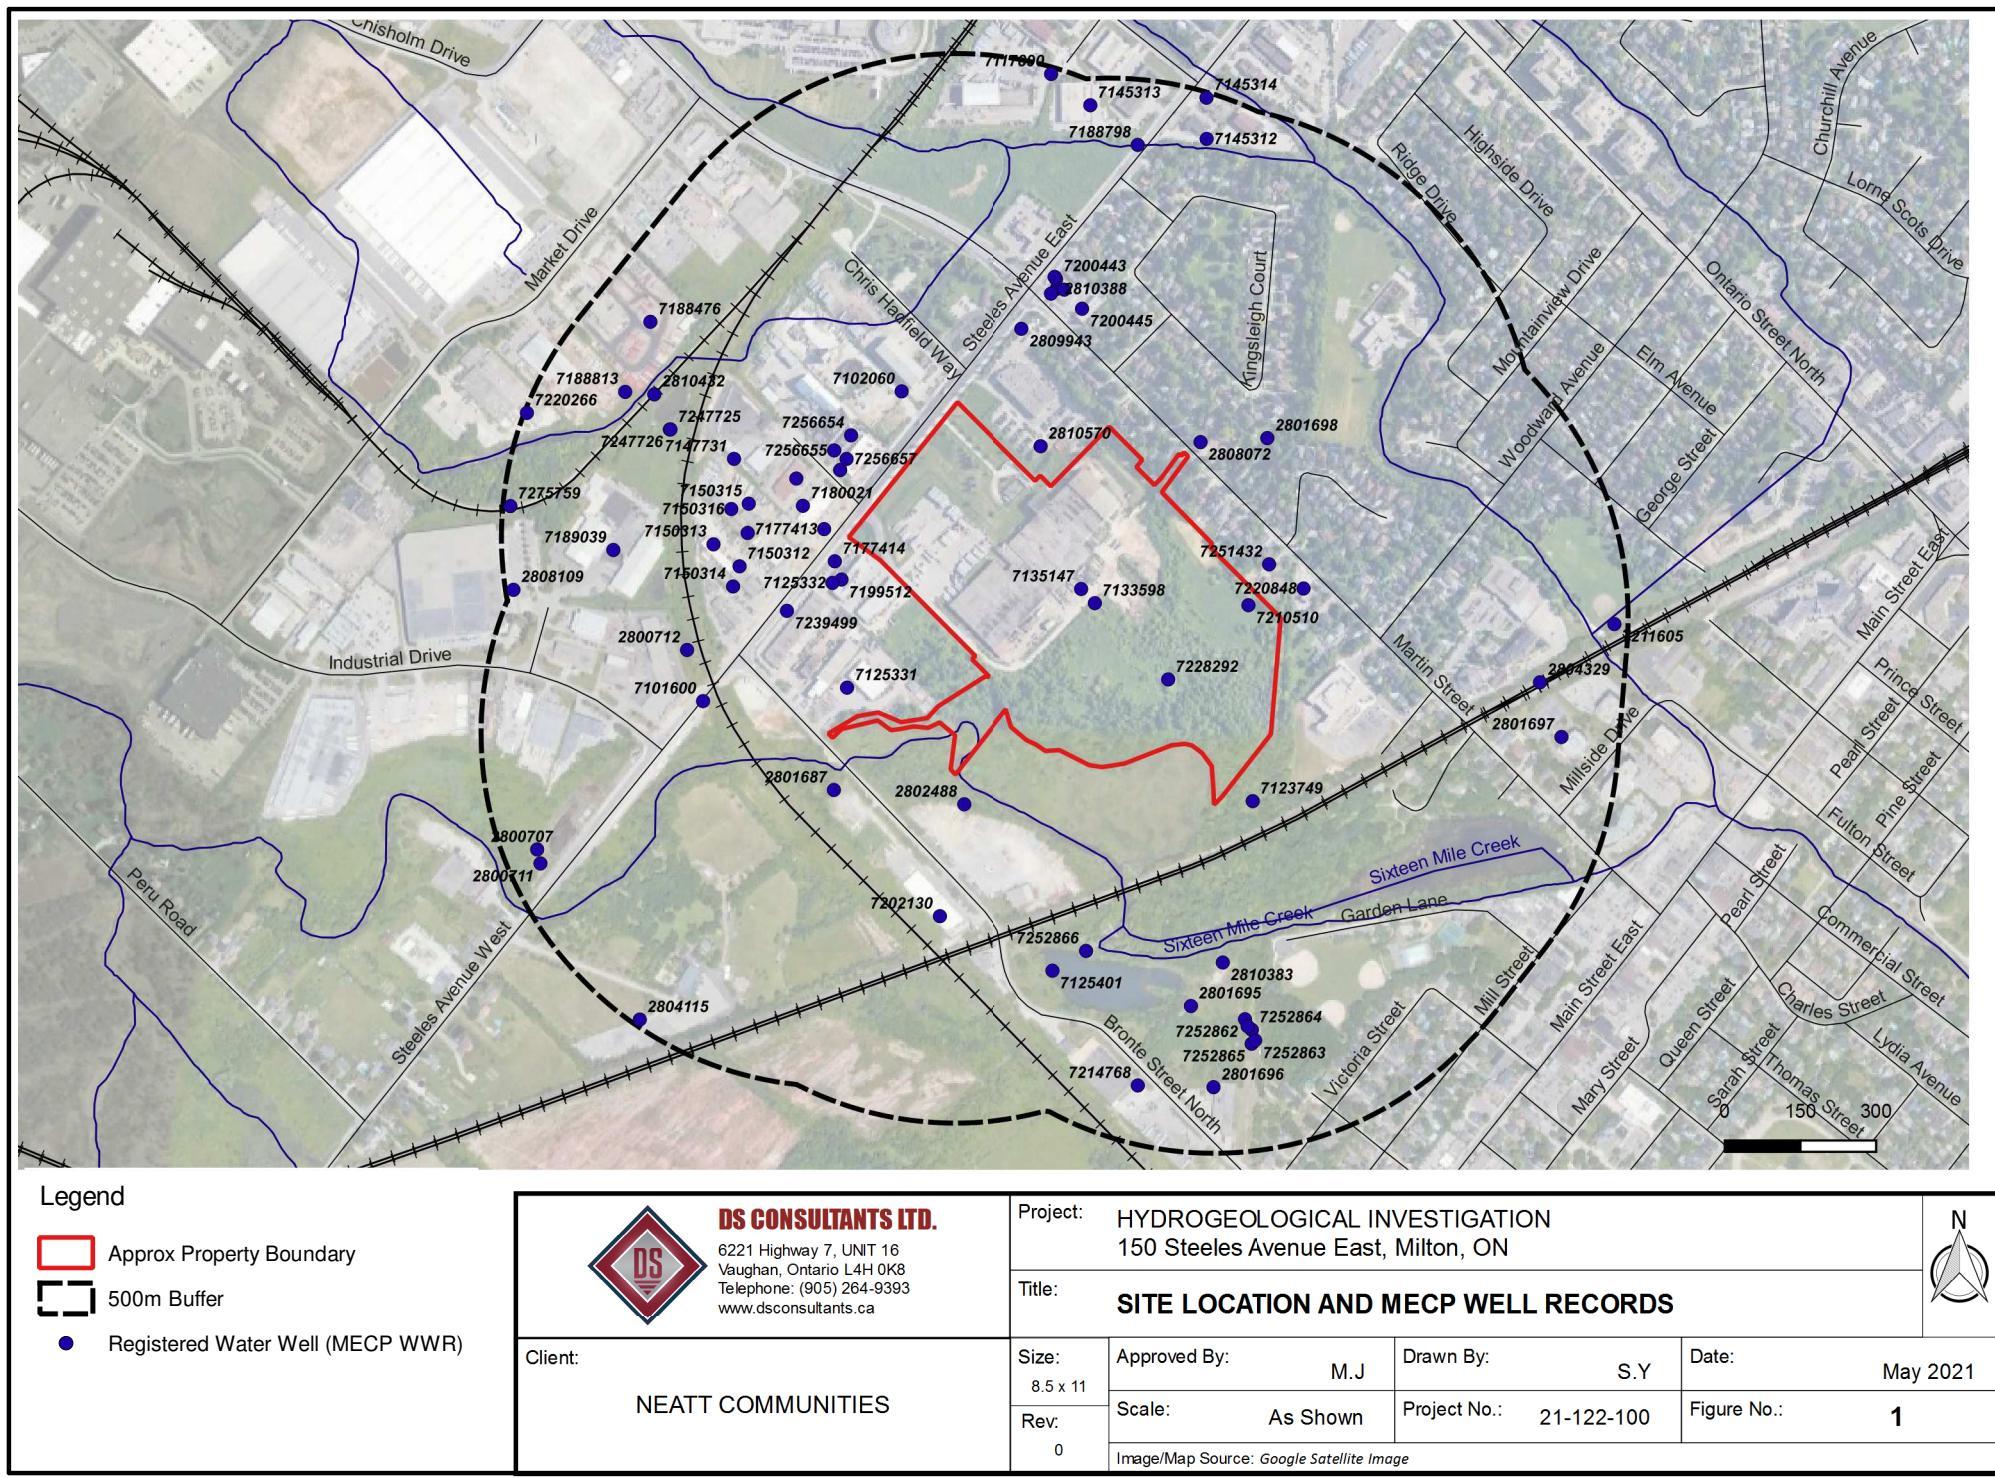
C:\0Sharon\21-122-100 Enviro Geo Investigations 150 Steeles Ave E\1-QGIS\HydroG\Figure 1 - Site Location and MECP Well Records.qgs May-20 16:03

As part of the hydrogeological study, DS completed a search of the Ministry of the Environment, Conservation and Parks (MECP) Water Well Record (WWR) database. Based on the MECP water well records search, there were seventy-four (74) water wells within a 500 m radius of the Site. all wells were noted as monitoring/test holes or not in use except for five (5) records for domestic, three (3) records for industrial and three (3) records for commercial purposes. **Figure 1** shows the MECP water well location plan. The study area is fully serviced with municipal water.

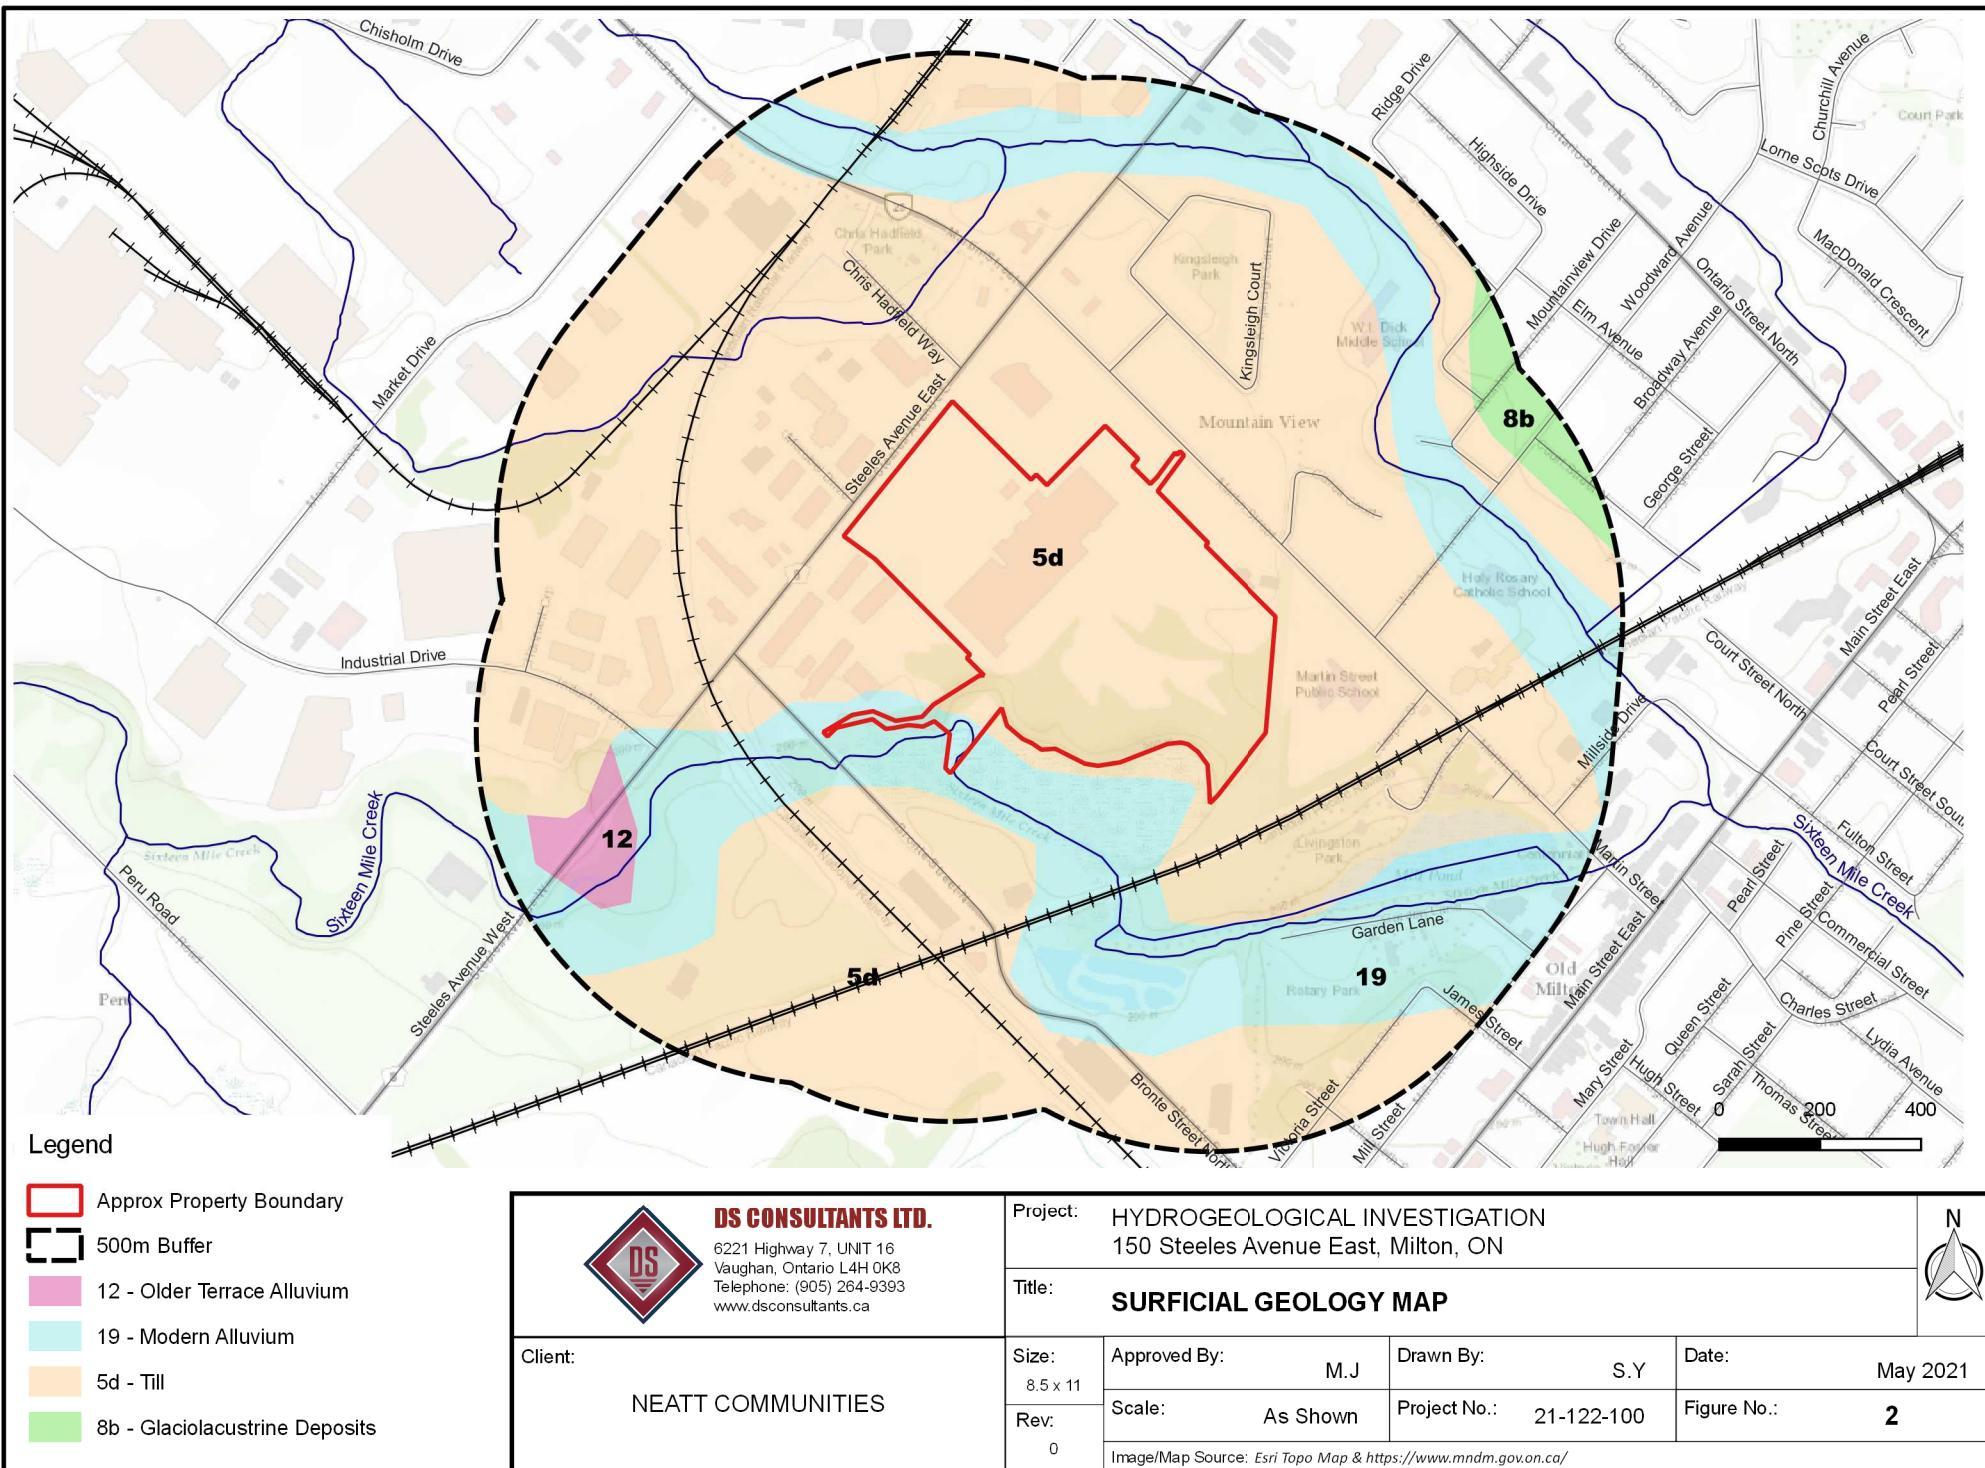
C:\0Sharon\21-122-100 Enviro Geo Investigations 150 Steeles Ave E\1-QGIS\HydroG\Figure 2 - Surficial Geology Map.qgs May-20 16:27

- 4. The surficial geology of the Site and study area has been mapped as "clay to silt-textured till, derived from glaciolacustrine deposits or shale. The overburden geology at the Site generally consists of glacial deposits of clayey silt till, sandy silt till, cohesionless deposits of sandy silt, silty sand, silt and sand and Gravel. Bedrock was found in all boreholes except BH21-2 at approximate depths varying from 15.3 to 18.3m below the existing ground, corresponding to elevations varying from 188 to 190.2 masl.

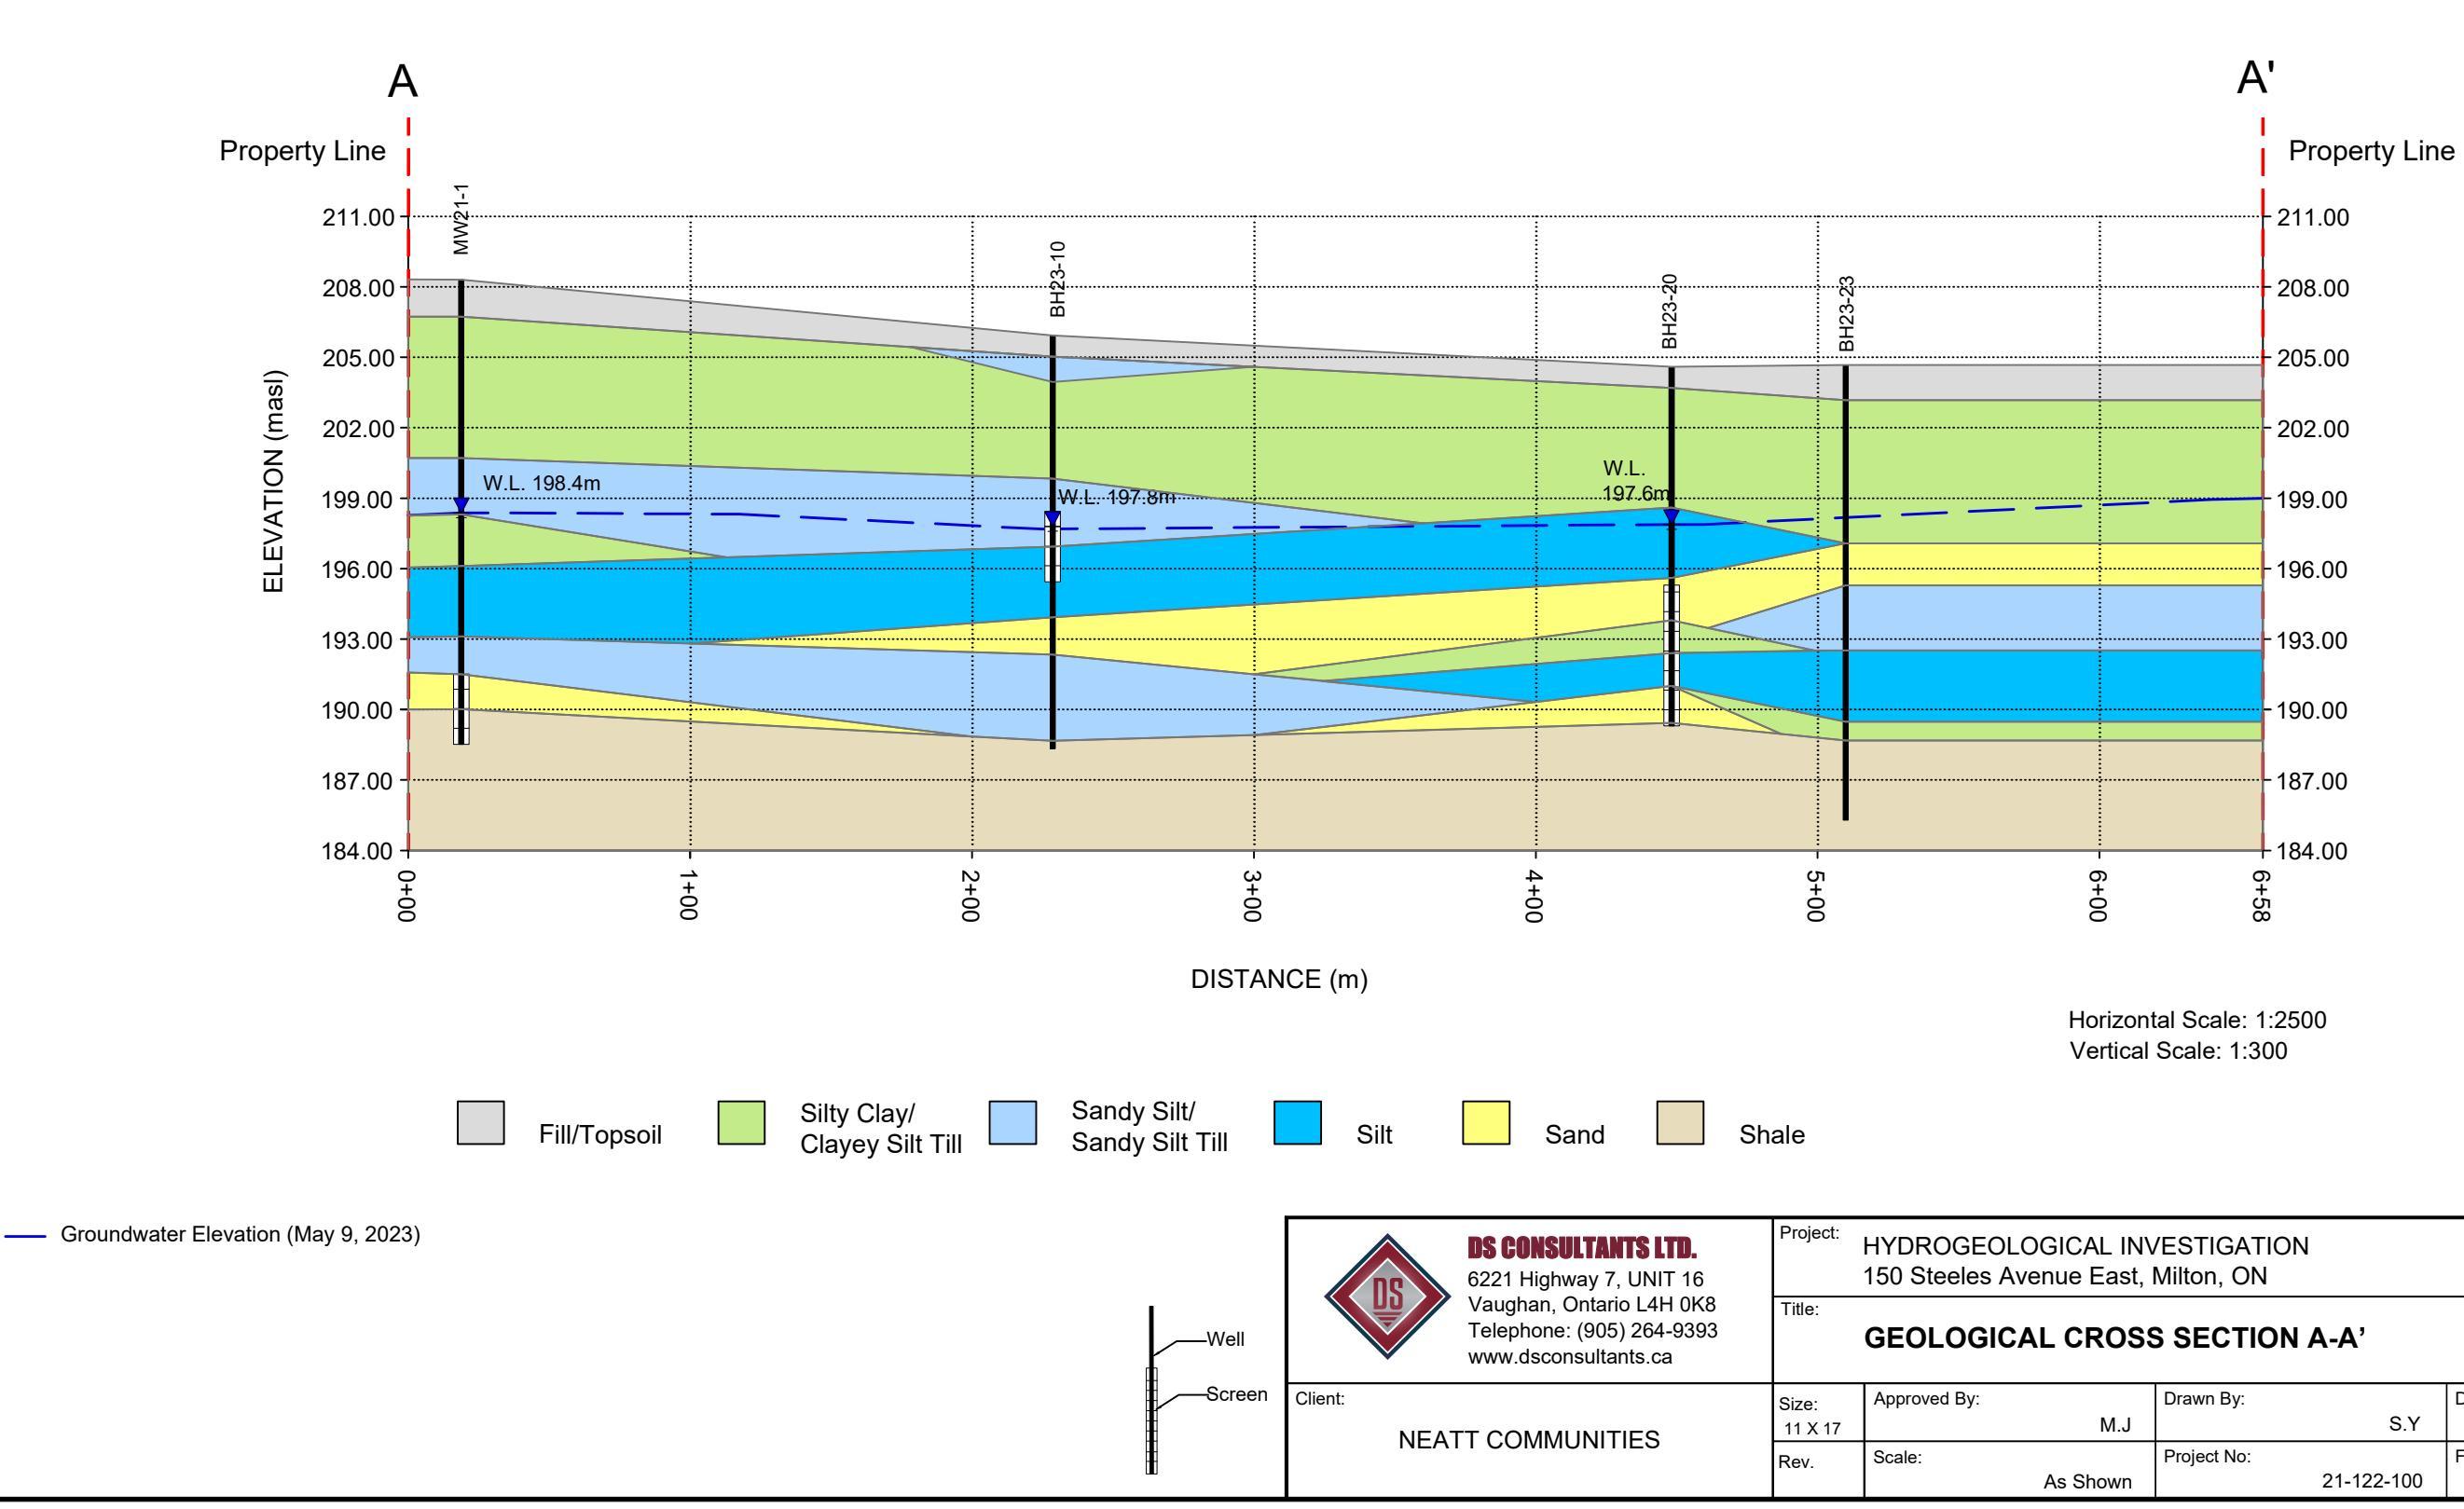
Drawn By:		Date:	
M.J		S.Y		July 2023
	Project No:		Figure No.	
As Shown		21-122-100		5A

On-site subsurface soils were interpreted according to a preliminary geotechnical investigation report performed by DS (July 2021 and 2023) based on the boreholes/monitoring wells (BHs/MWs) drilled by DS. The locations of the BHs/MWs are shown in **Figure 3** and detailed subsurface conditions are presented on the borehole Logs in **Appendix A**. The subsurface conditions in the boreholes are summarized in the following paragraphs, and the geologic cross-sections (A-A', B-B' and C-C') are presented in **Figure 5**.

In May 2023, the hydrogeological test drilling was carried out by a licensed water well contractor utilizing the mud rotary drilling method. As the test hole was being advanced, samples of soil were collected and logged. A representative from DS was onsite for all drilling activity. The location of the pumping and monitoring wells are shown on the attached **Figure 3**. The subsurface conditions have been interpreted and displayed as cross-sections' A-A', B-B' and C-C' as shown in the attached **Figure 5A to 5C**, respectively.
