Preliminary Hydrogeological Investigation

Proposed Residential Buildings 150 Steeles Avenue East Milton, ON

Project #: 21-122-106 Date: April 7, 2025

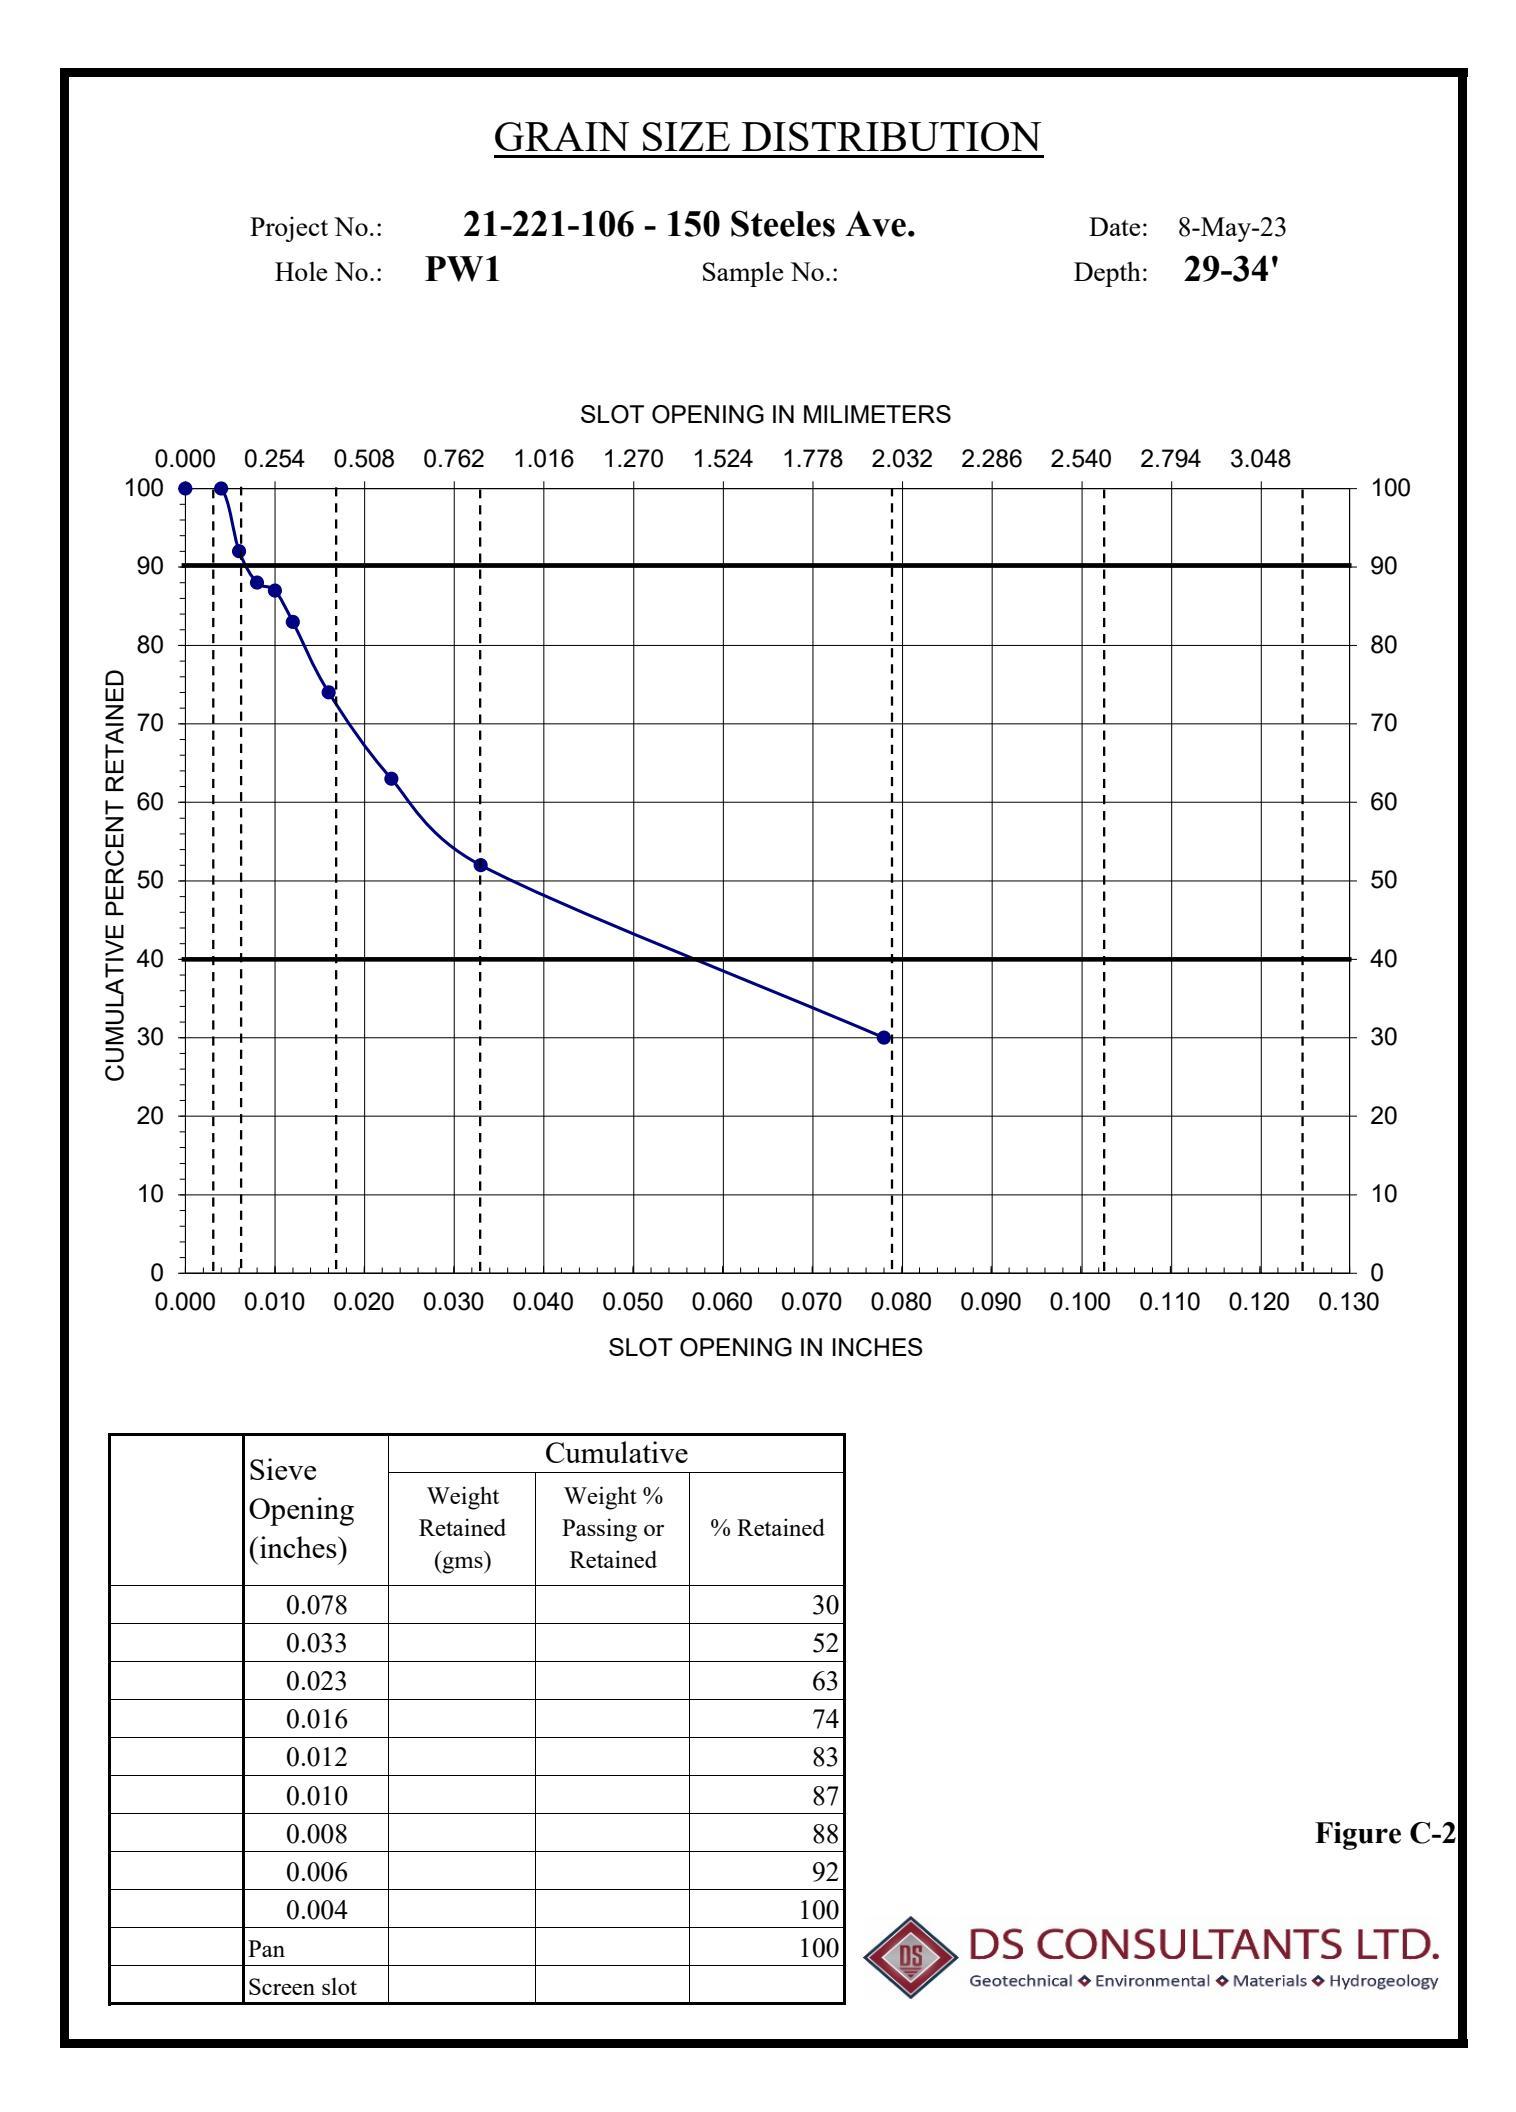
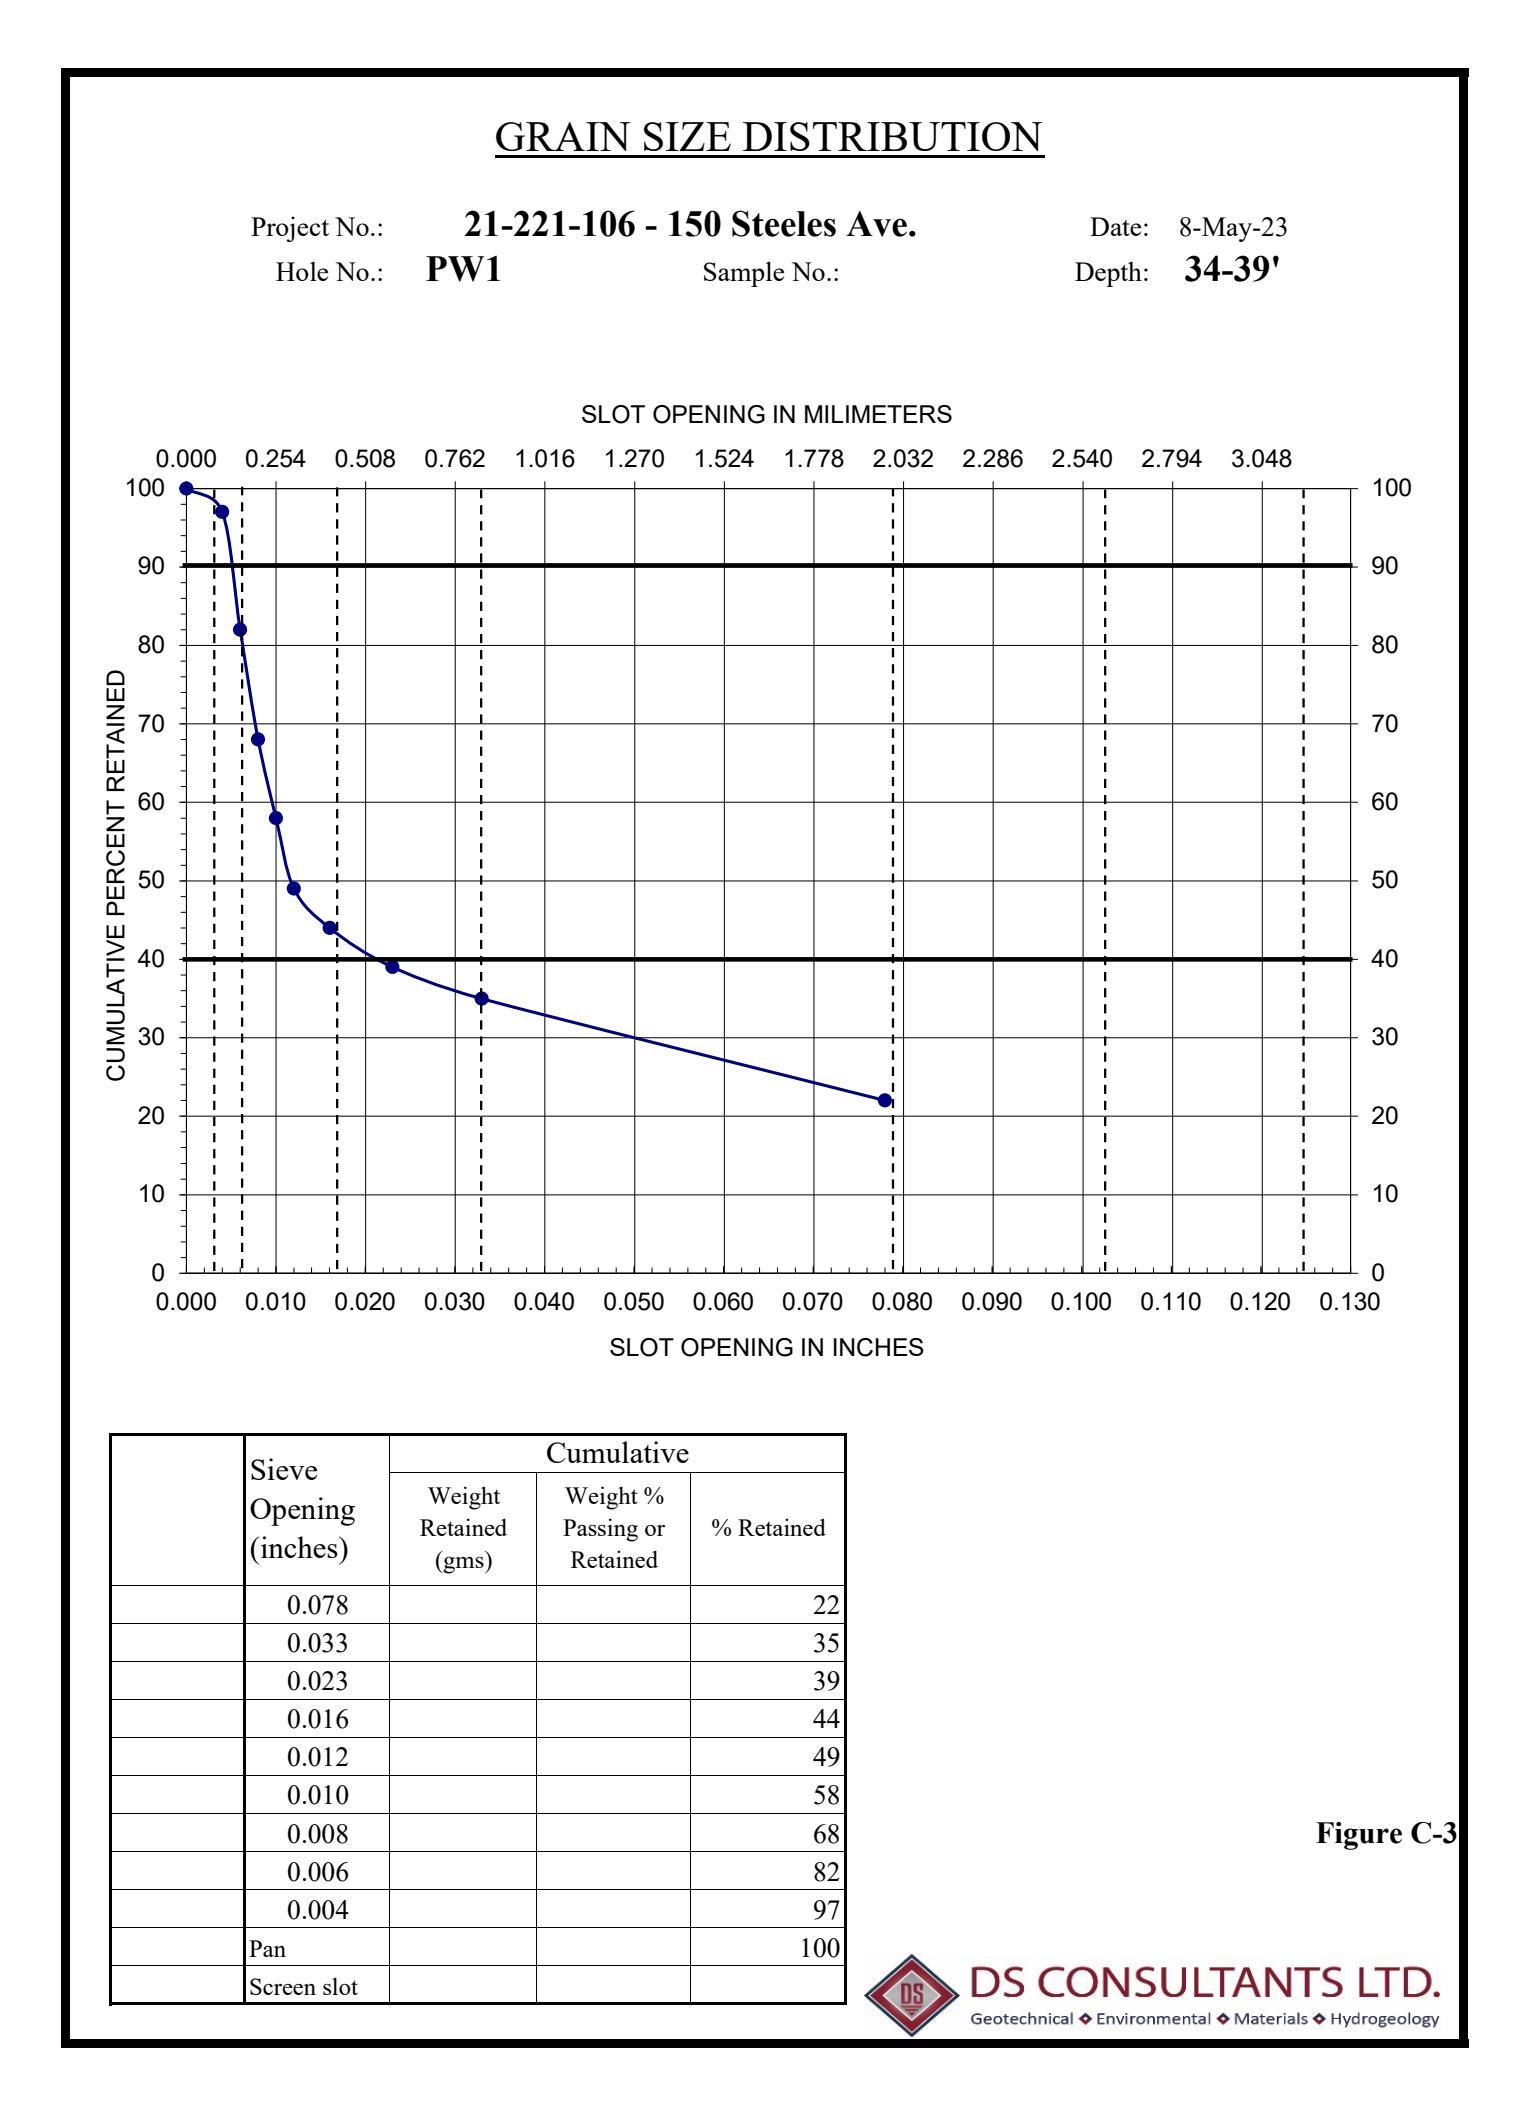
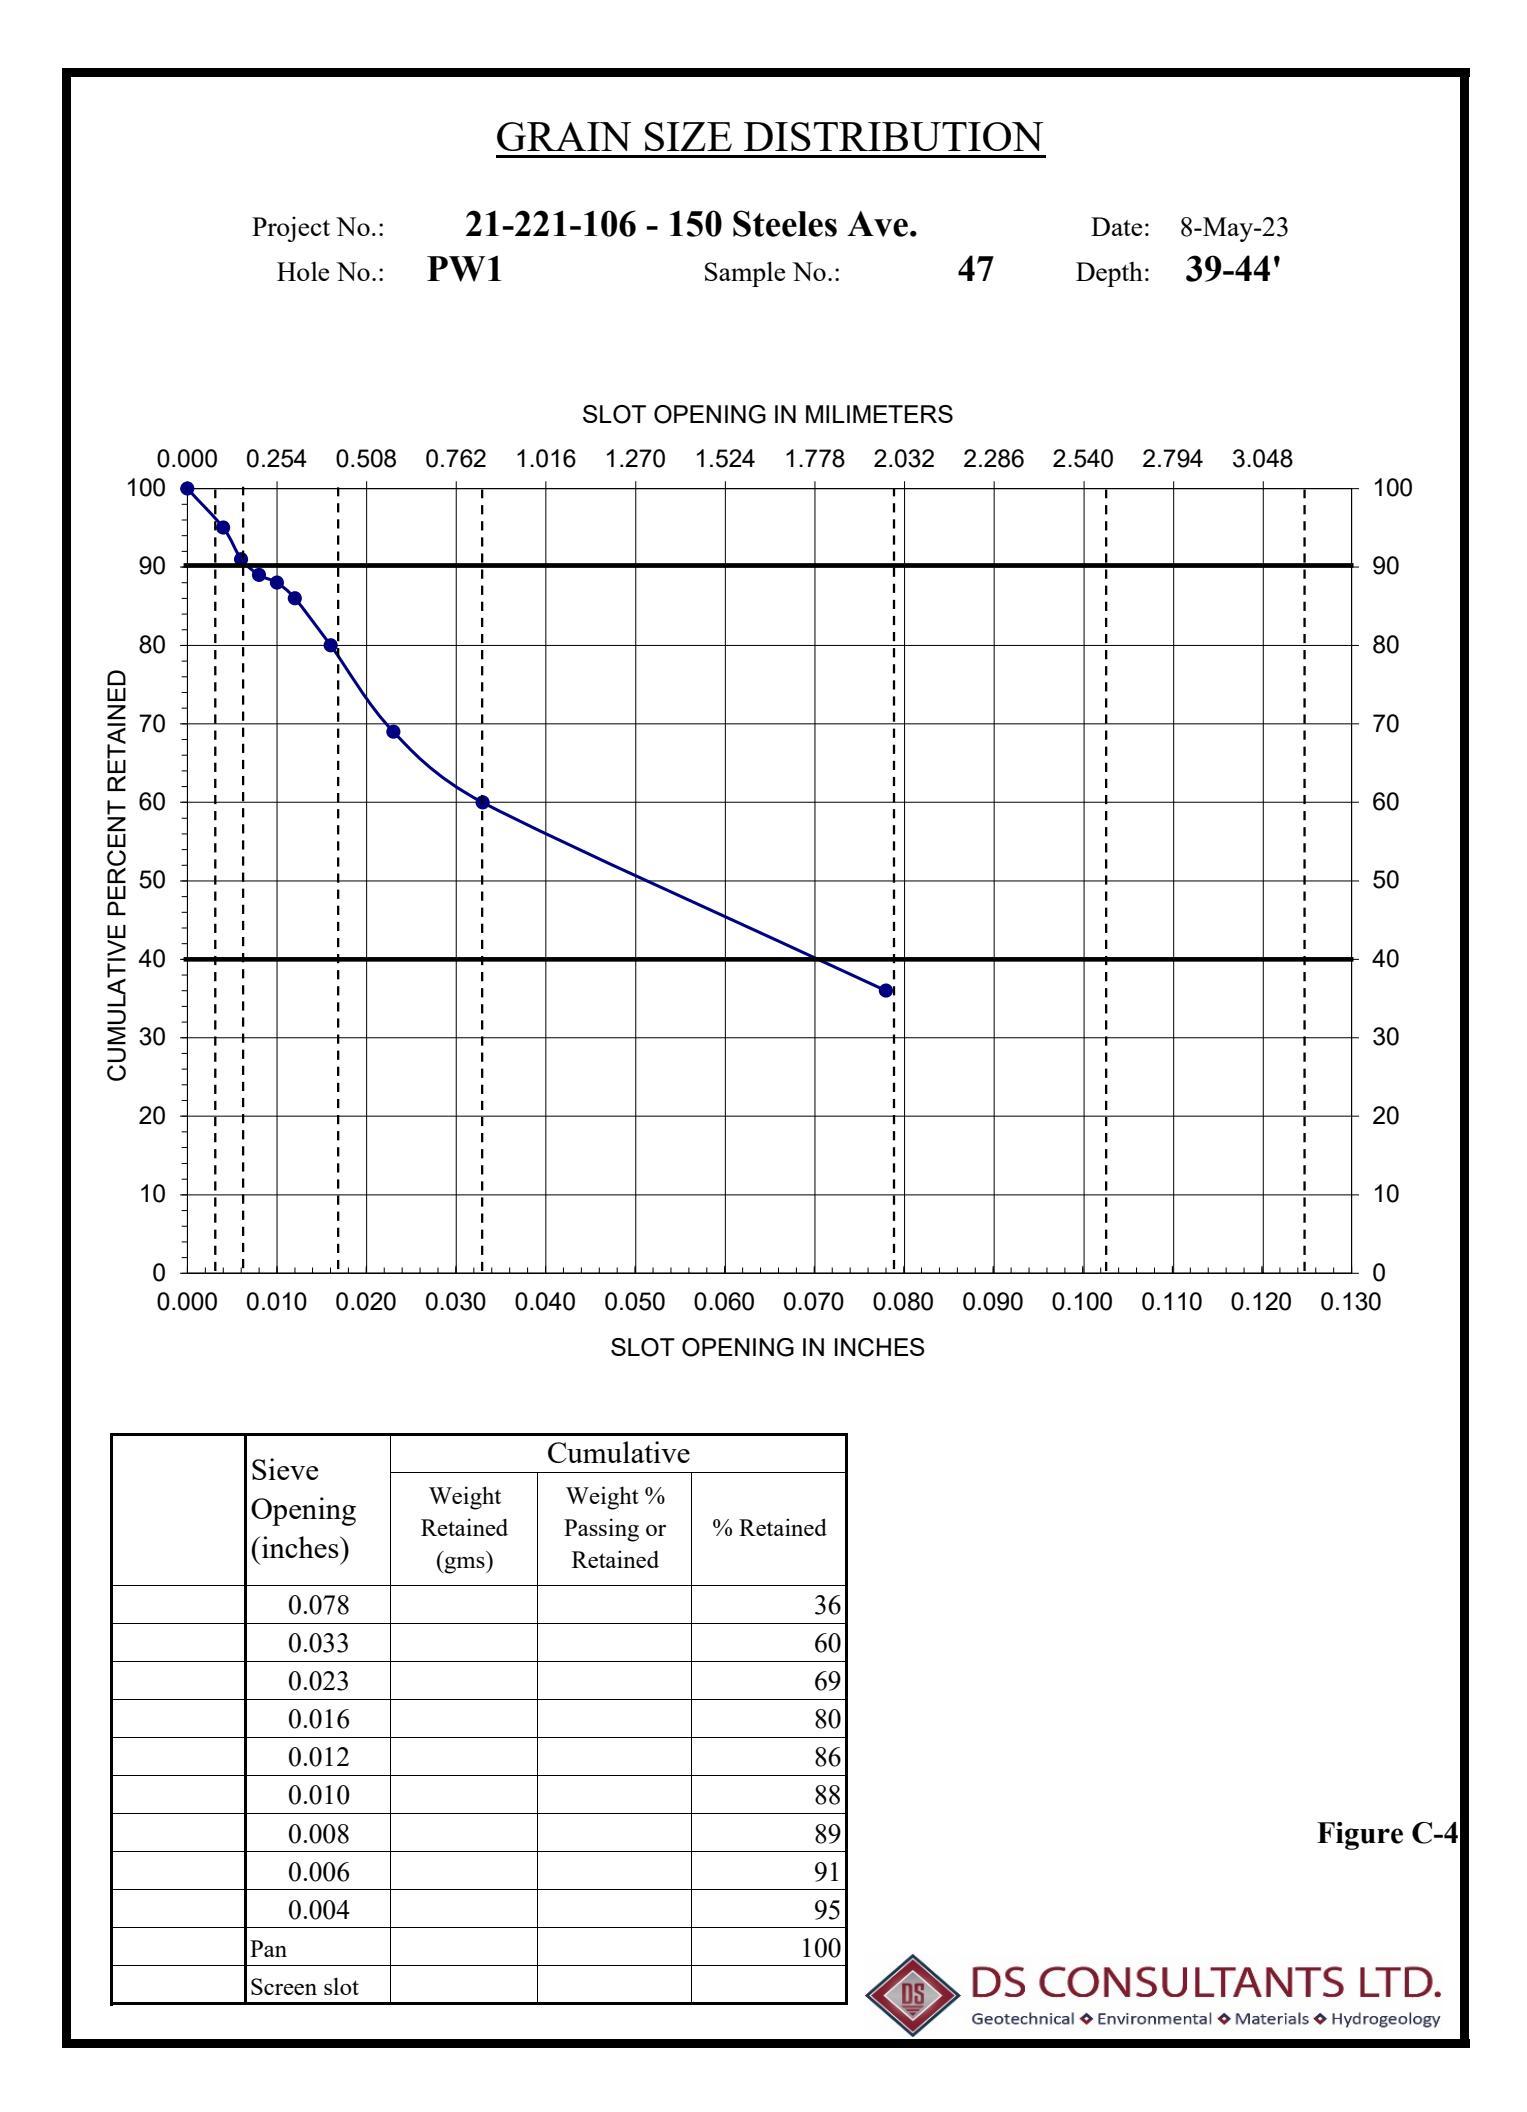
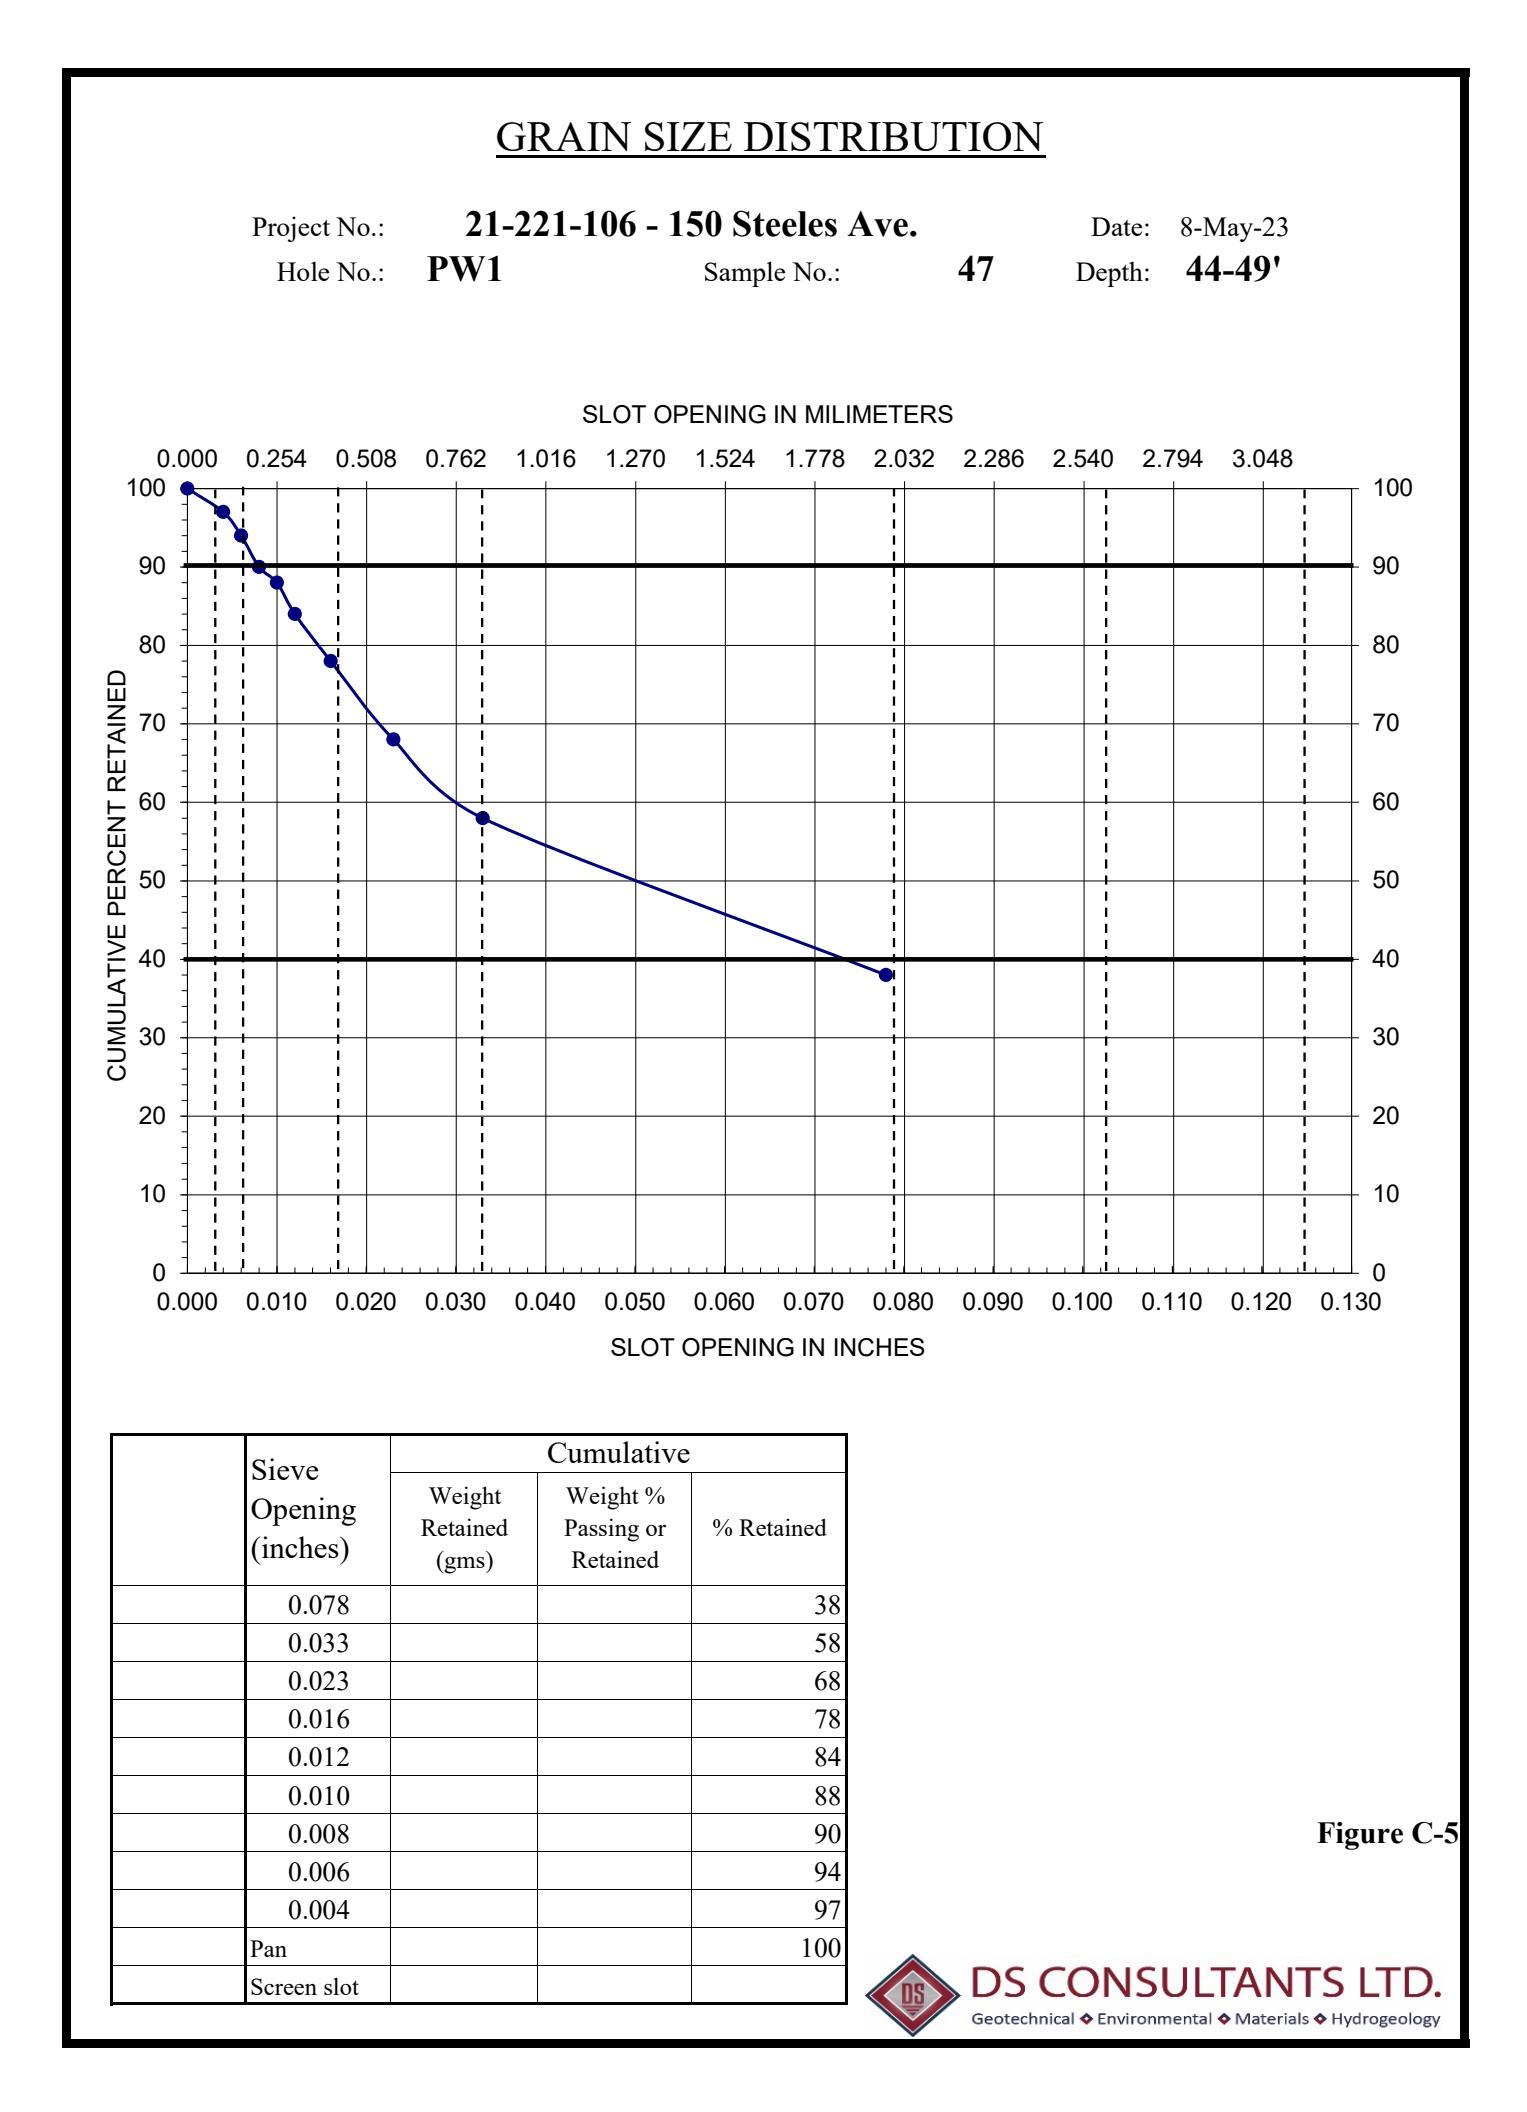
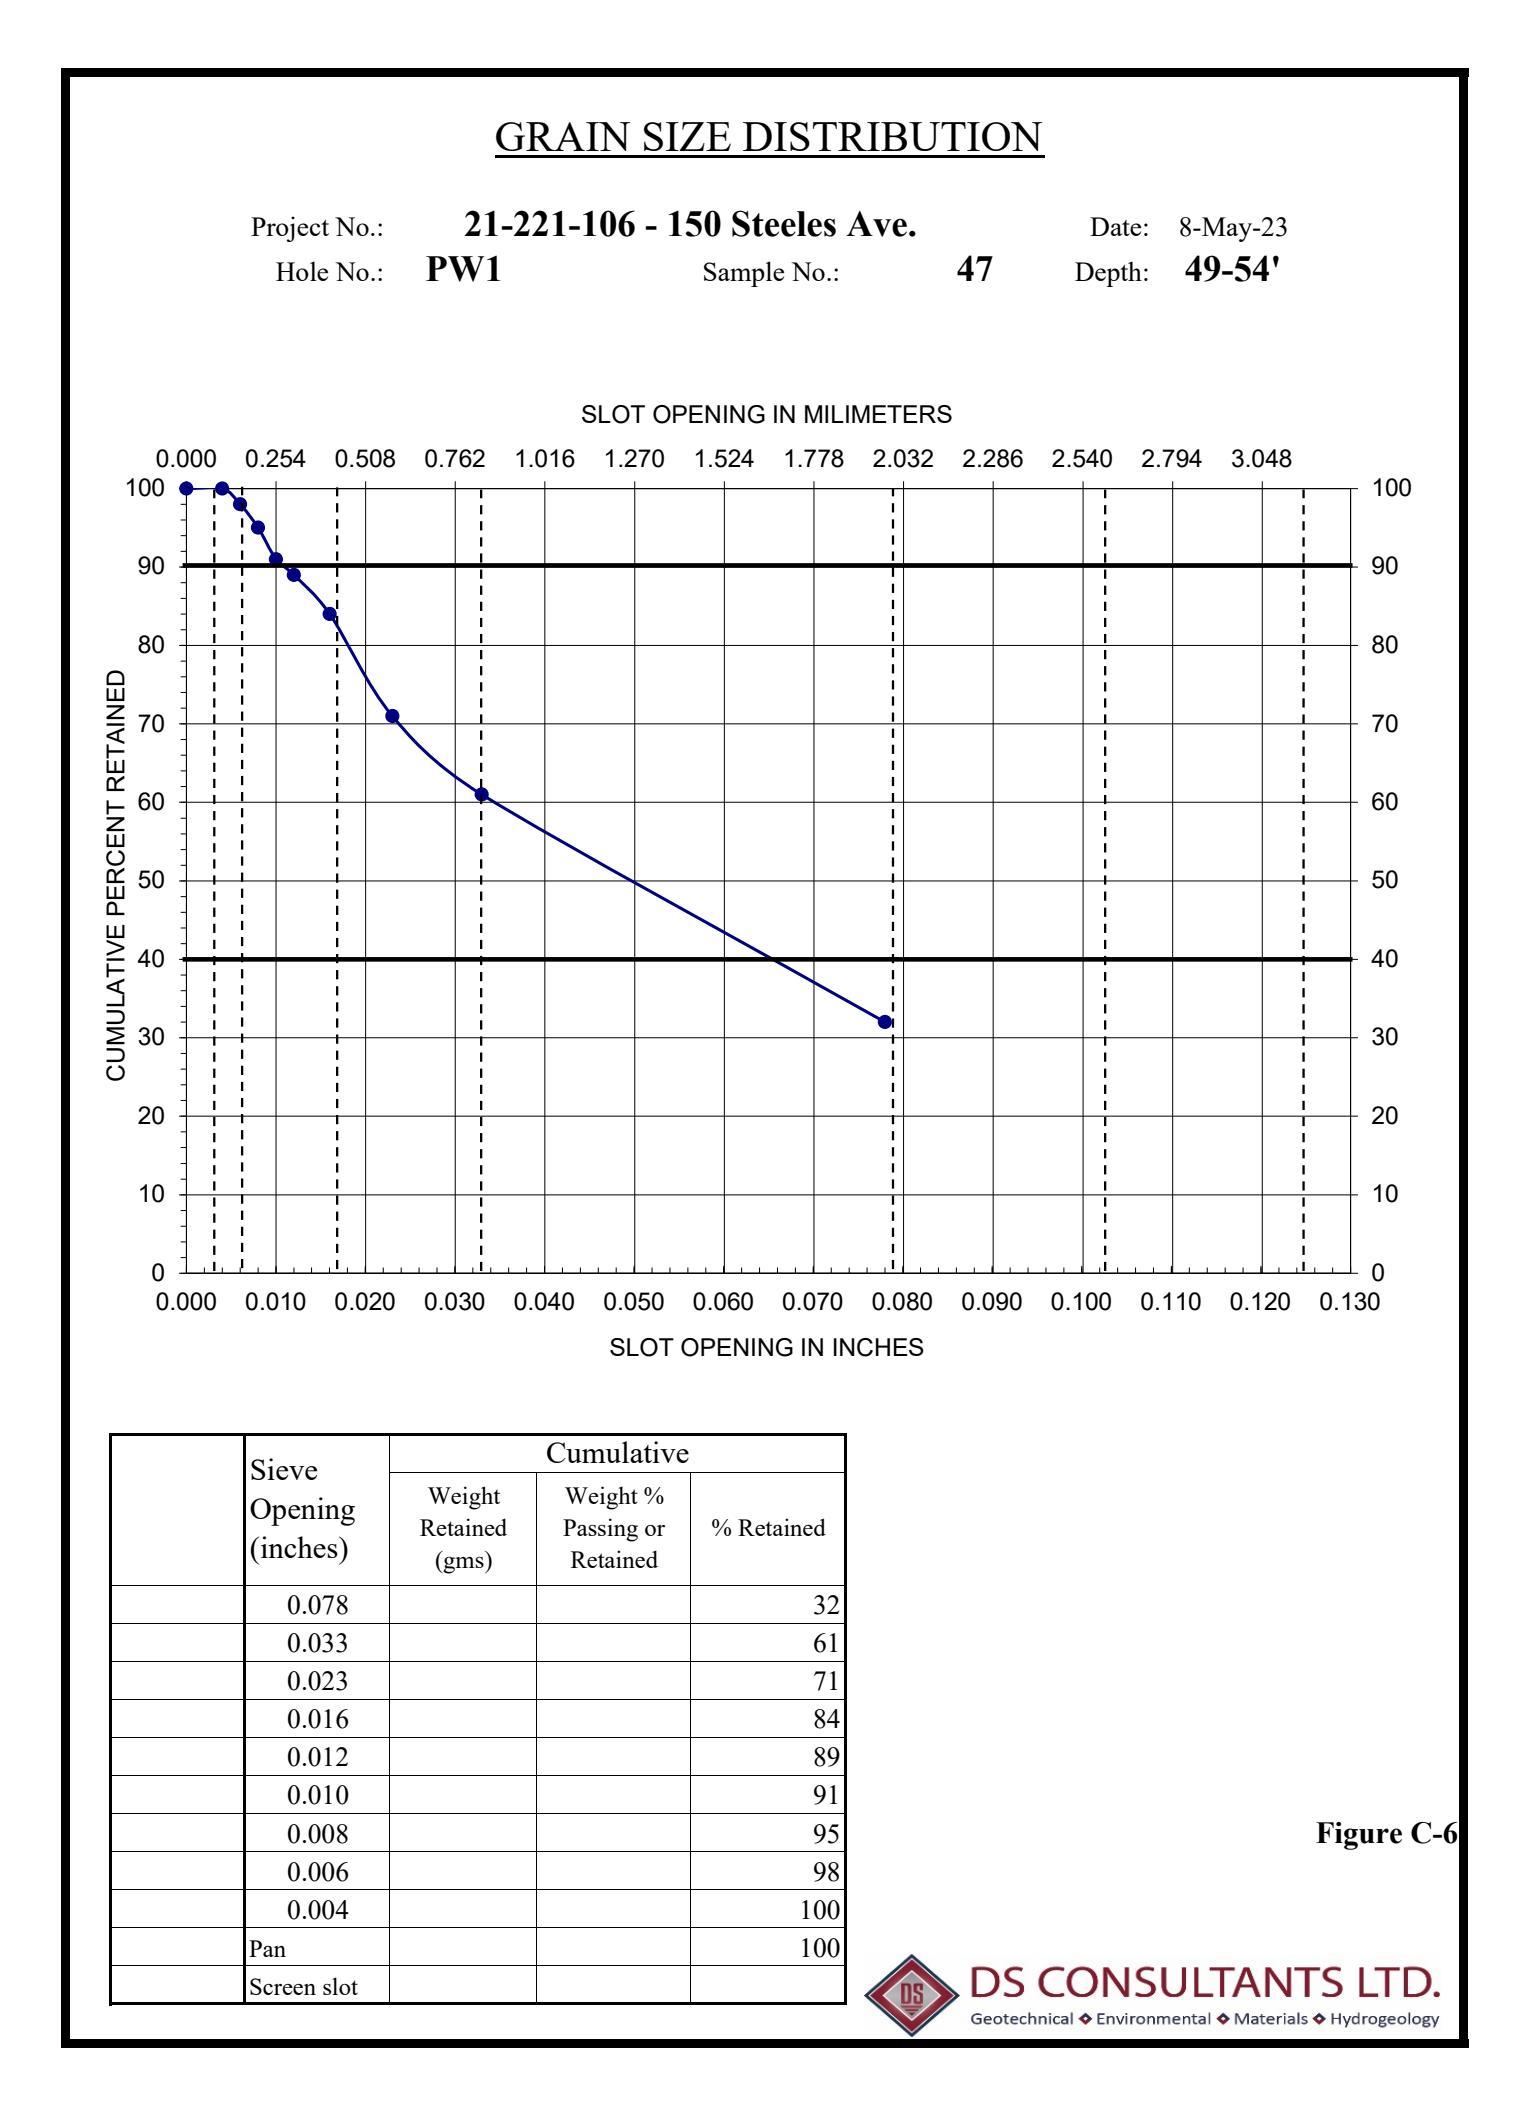
Test hole PW1 was advanced on May 8, 2023, to a total depth of 18.2 mbgs (60 ft.). **Appendix C** shows the Driller's description of the test hole and the well construction features of PW1. The overburden material consisted of mainly of a sandy clay unit overlying a permeable sand and gravel layer above the shale/bedrock. The Drillers' log and field observations were used in the design for a 150 mm (6 inch) diameter well. The well screen assembly consisted of 20 slot stainless steel well screen installed from 12.2 to 15.2 mbgs (40 to 50 ft.). The static water level measured on May 13, 2023, was 8.3 mbgs at an approximate elevation of 197.9 masl. **Appendix C** features the test hole log and well design of the Pumping Well (**Fig. C-1**) and grain size curves (**Fig. C2-C6**).

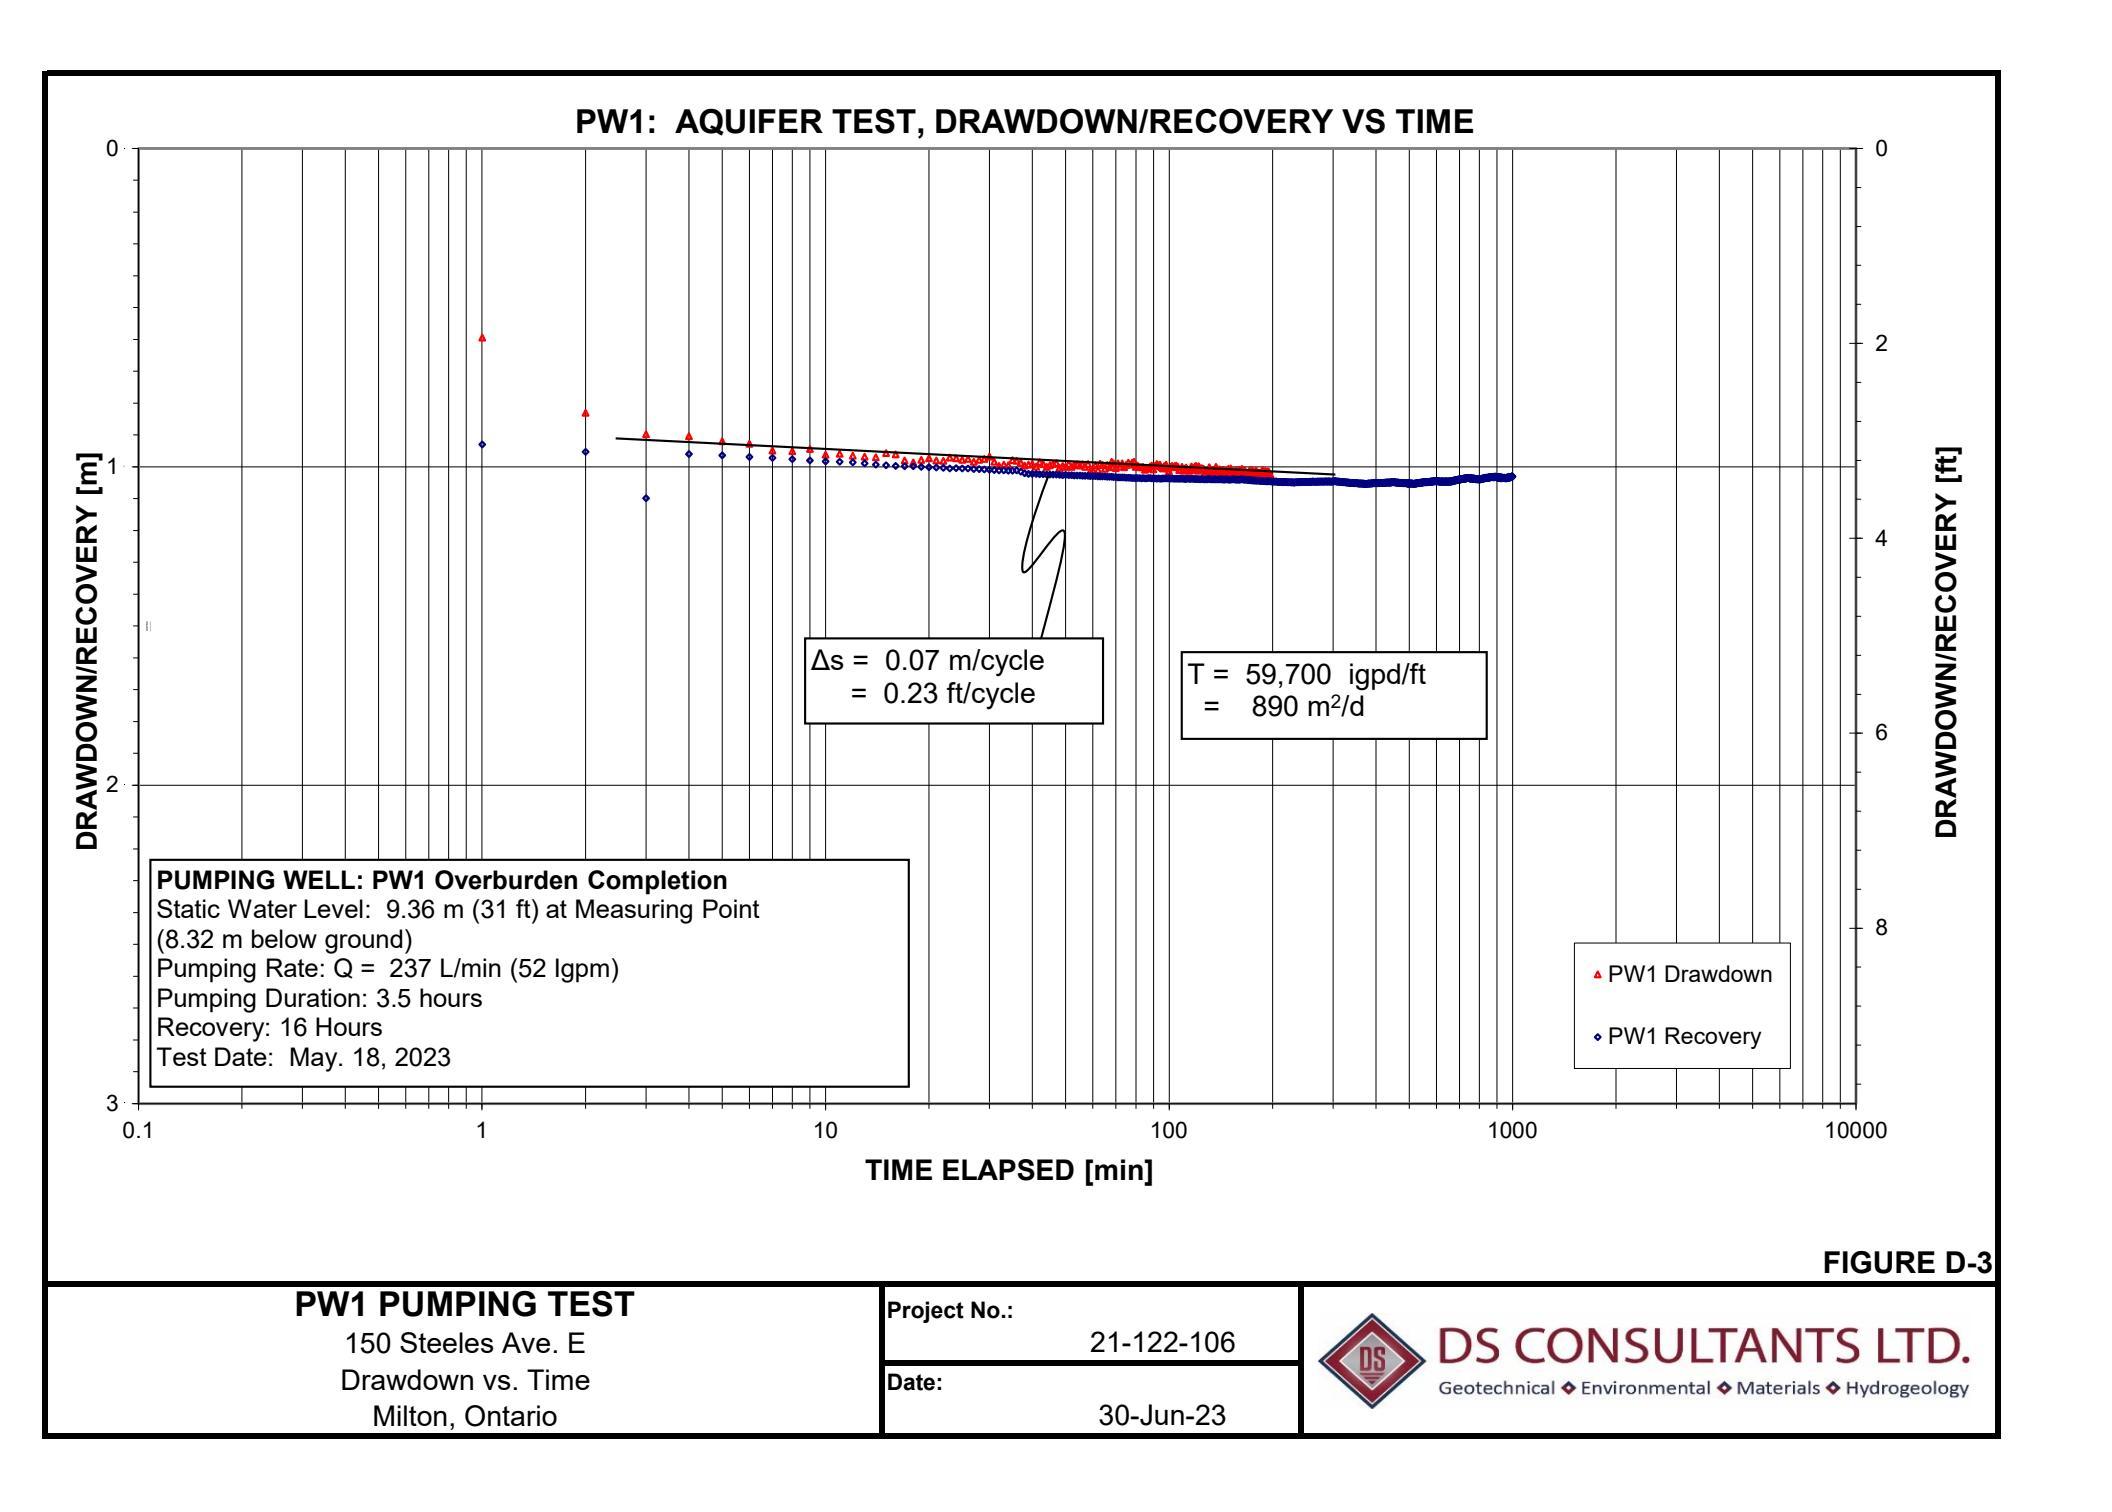
The attached **Figure D-3** is a semi-logarithmic plot of the drawdown vs. time response to pumping inside the well, PW1. **Figure D-4 to D-5** shows the response in the monitoring wells BH23-9, and BH23-15, respectively, during the pumping at PW1. At BH23-9, and BH23-15 the drawdown due to the interference/pumping of PW1 at 3.5 hours was measured to be 0.37 and 0.23, respectively. The drawdown response observed at the observation wells after 3.5 hours of drawdown is also displayed graphically in **Figure D-6** as a function of radial distance from the center of the pumped well.

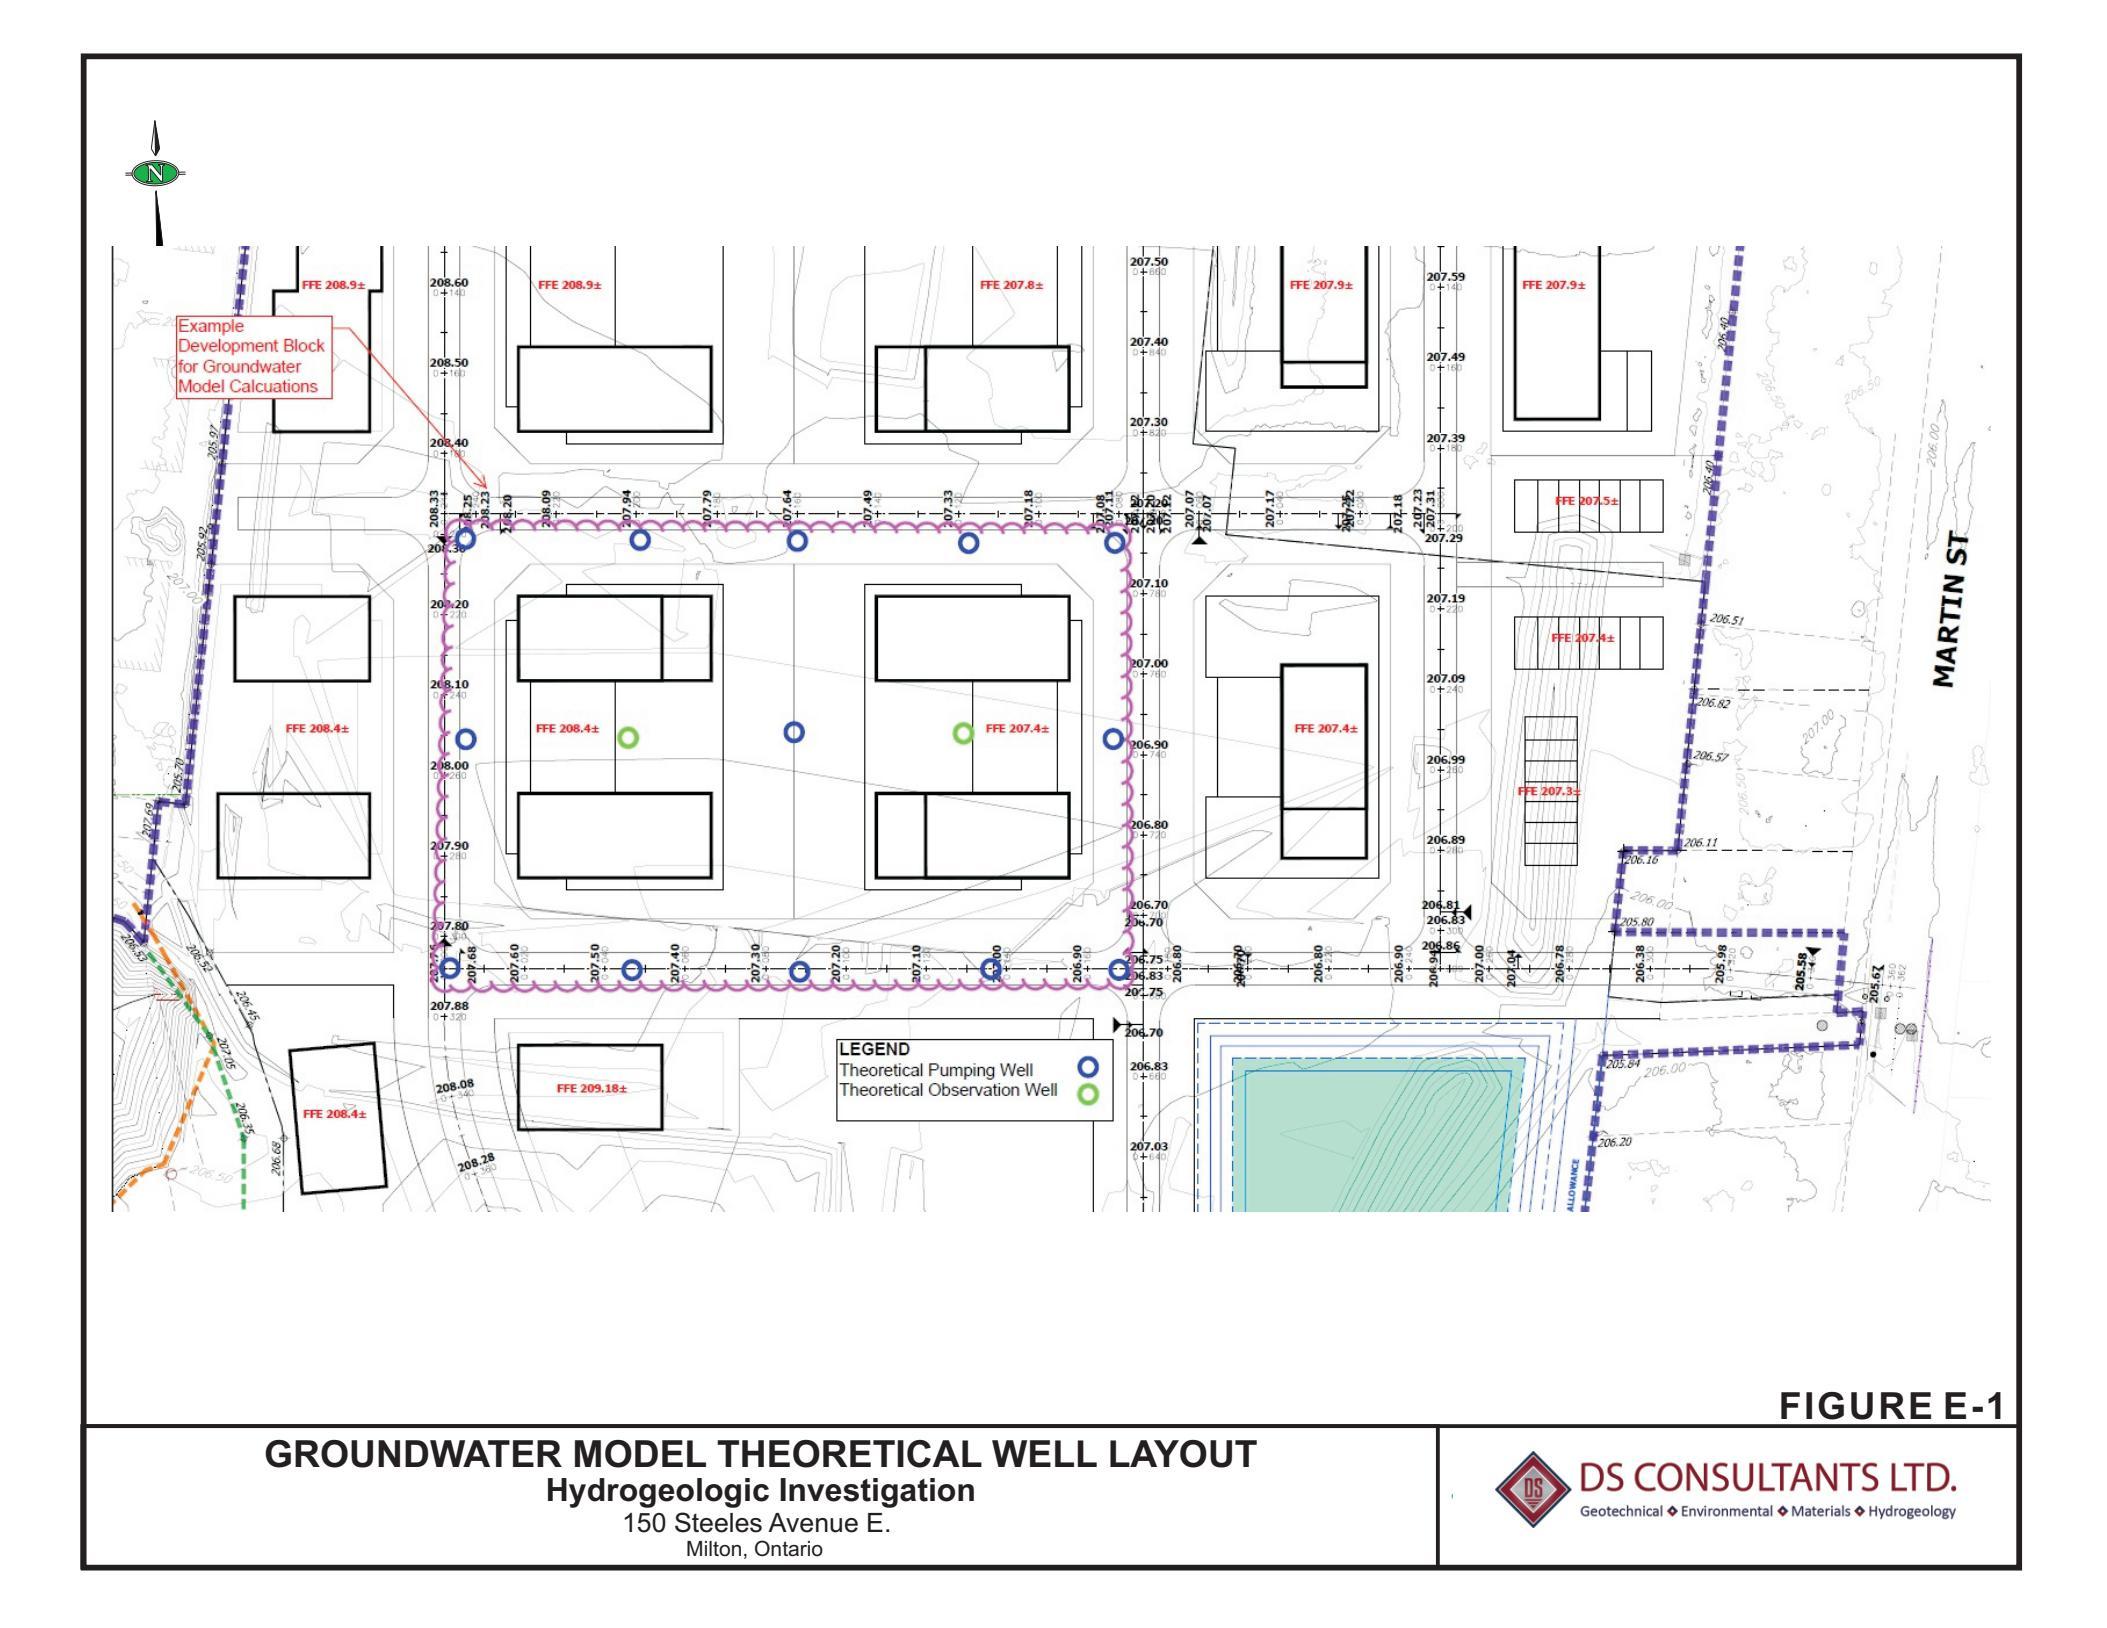
Appendix E: Groundwater Control Model for Construction Dewatering

The radius of influence (Ro) for the construction dewatering was calculated based on the Sichardt equation. Ro is the distance at which the drawdown resulting from pumping is negligible. The equation is empirical and was developed to provide representative flow rates using the steady-state flow dewatering equations as indicated above. Under steady-state conditions, Ro of pumping will extend until boundary flow conditions are reached, and sufficient water inputs are equal to the discharge rate due to pumping. Therefore, the Sichardt equation is used to provide a representative flow rate but is not precise in determining the actual radius of influence by pumping. Based on Sichardt equation and the hydraulic conductivity (derived from the transmissivity obtained from the pumping test at PW1) the zone of influence for the proposed development at the site (from the centre of excavation) is approximately 187 m (P2 Level Design) and 936 m (P4 Level Design).
