Scoped Environmental Impact Assessment 150 Steeles Avenue East, 248, 250 & 314 Martin Street, Town of Milton

Date: 2025-04-14 Project: 221265

Scoped EIA: 150 Steeles Ave. E., 248, 250 & 314 Martin St., Milton

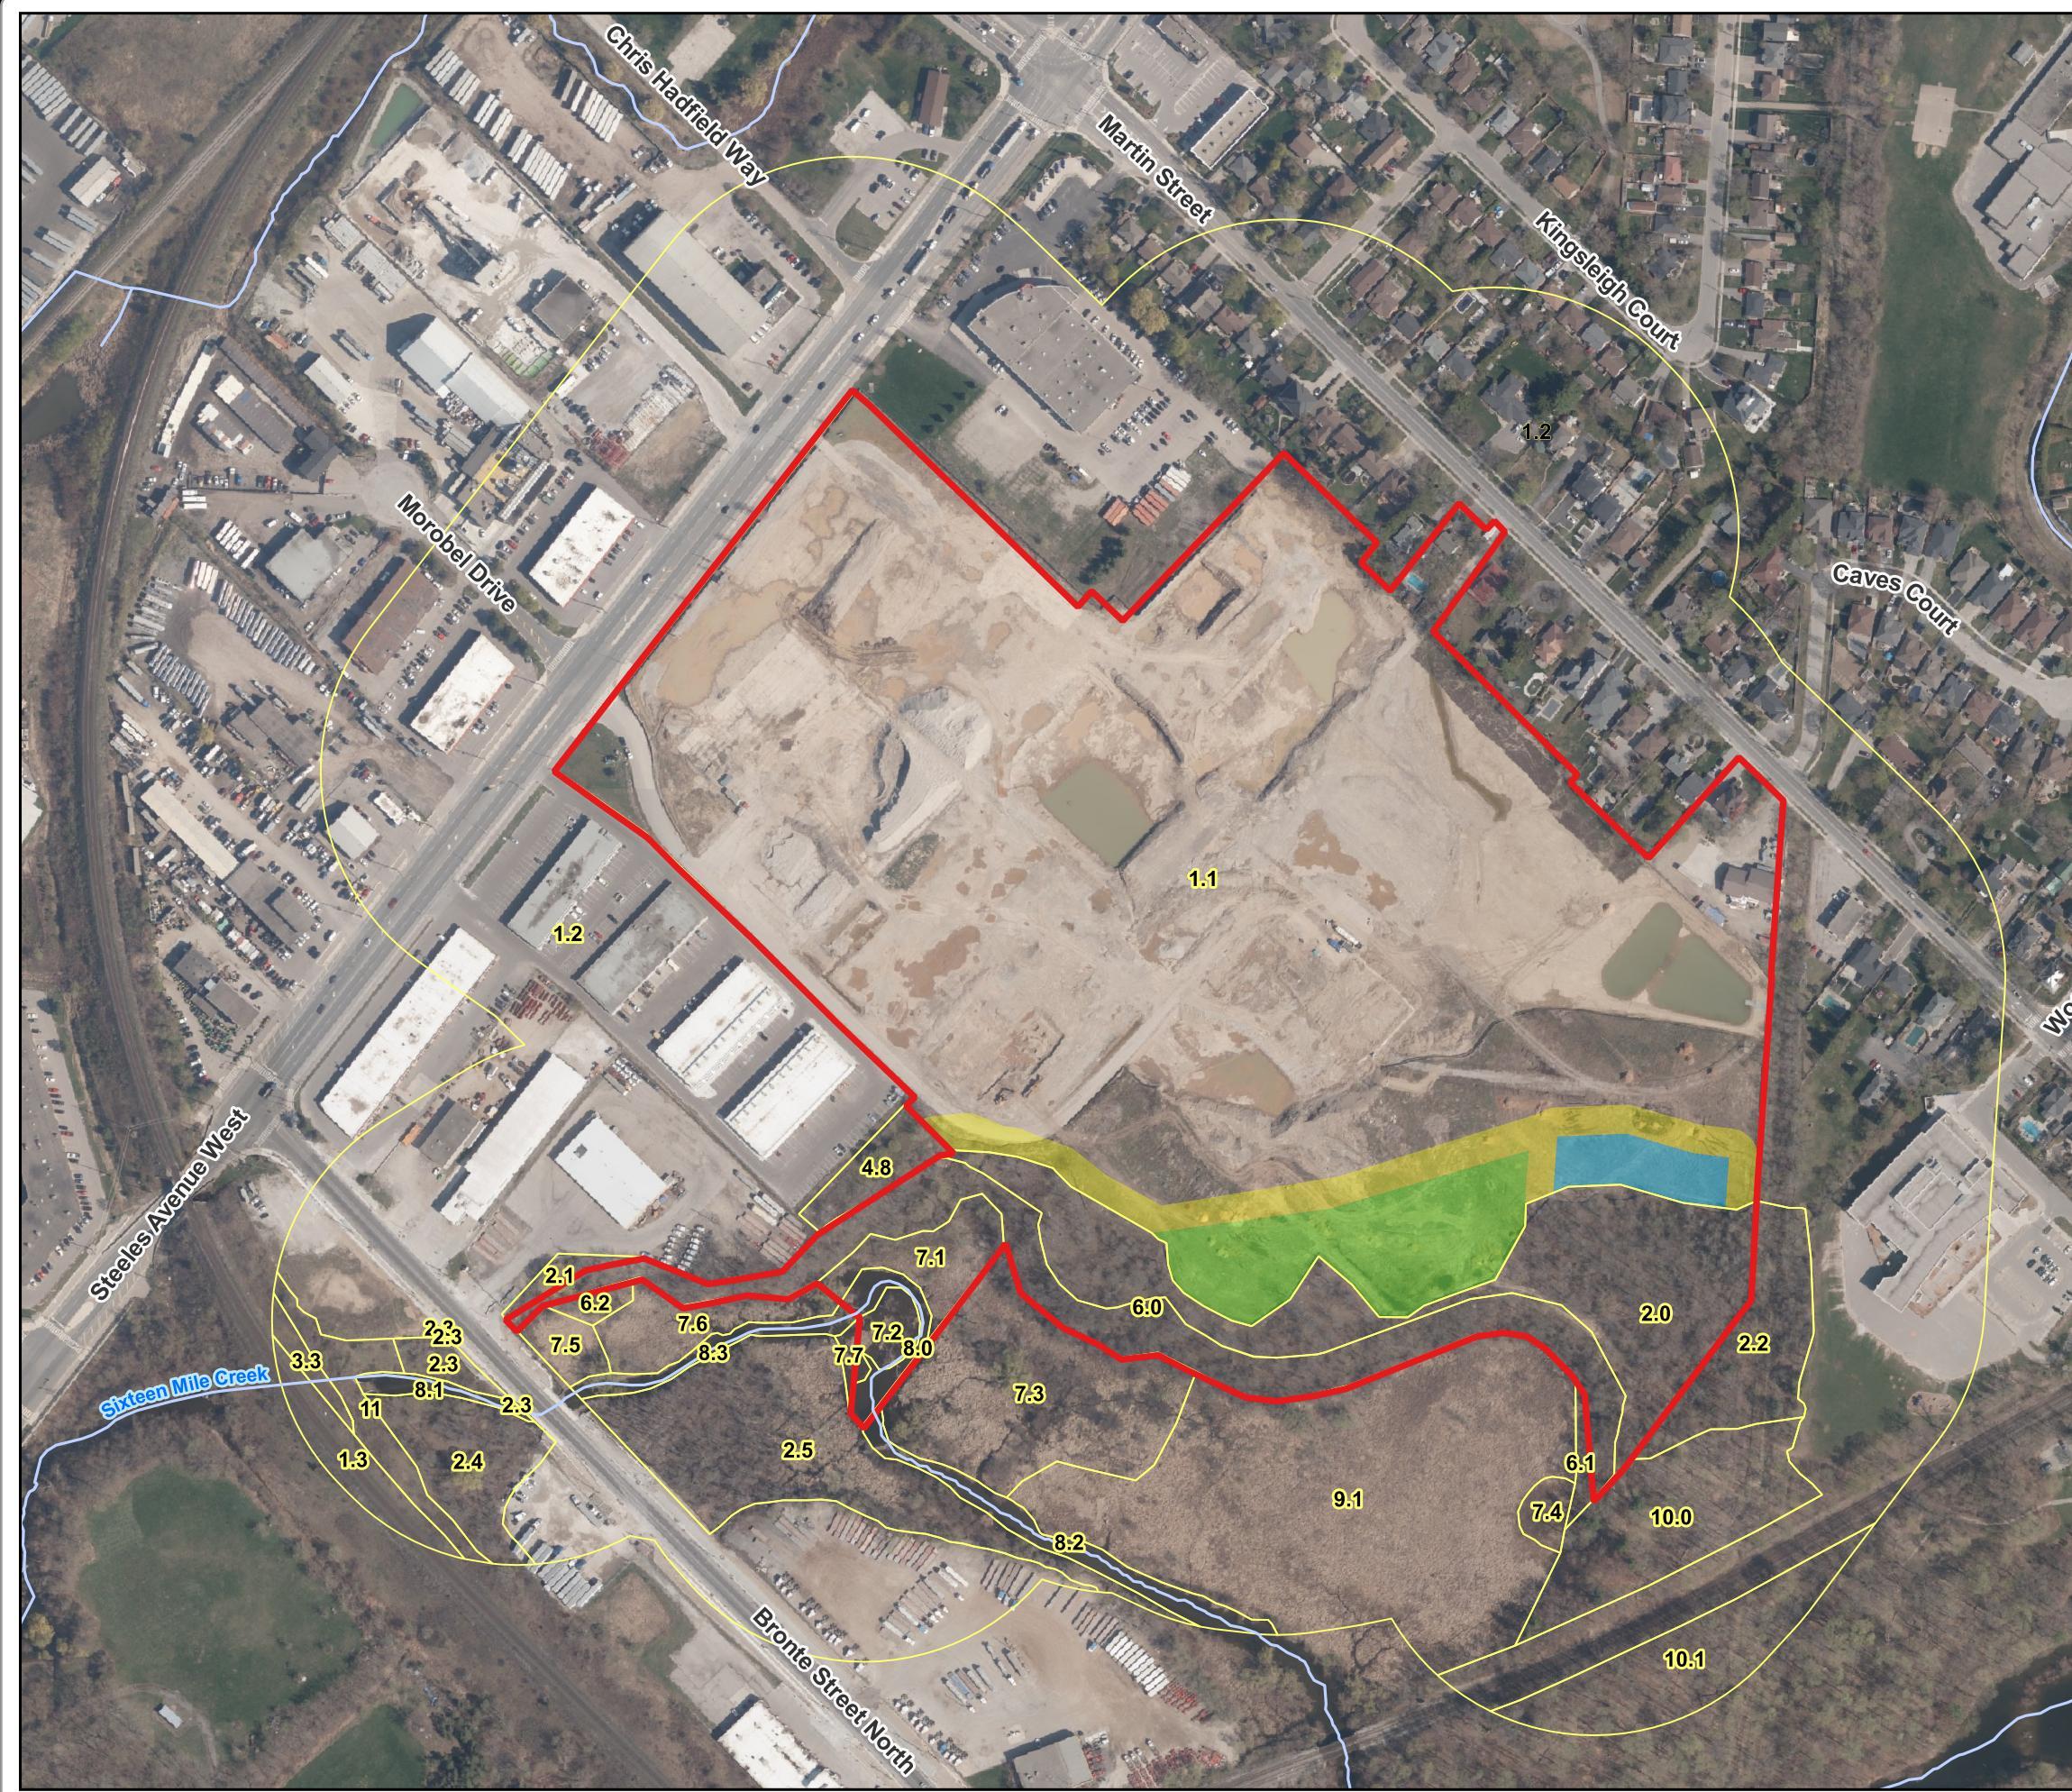
Ecological Land Classification Figure 3

Unit Number	ELC Code	Ecological Communities
1	ANT	Anthropogenic (units 1.1 - 1.25)
2	CUW1	Mineral Cultural Woodland (units 2.0 - 2.5)
3	CUM1	Mineral Cultural Meadow (units 3.1 - 3.3)
4	CUS1	Mineral Cultural Savanah (units 4.1 - 4.8)
6	FOD4	Dry - Fresh Deciduous Forest (unit 6.0 - 6.2)
7	MAM2	Mineral Meadow Marsh (units 7.1 - 7.7)
8	SA	Shallow Water (unit 8.0 - 8.3)
9	MAS2-1	Cattail Mineral Shallow Marsh (units 9.0 - 9.1)
10	FOD5	Dry - Fresh Sugar Maple Deciduous Forests (units 10.0 - 10.1)
11	CUT	Cultural Thicket (unit 11)

Note: Prior to remediation ELC Unit 5 (SWT2-5) was associated with a contaminated tailings pond, and the equivalent wetland area has been reproduced in the wetland restoration area.

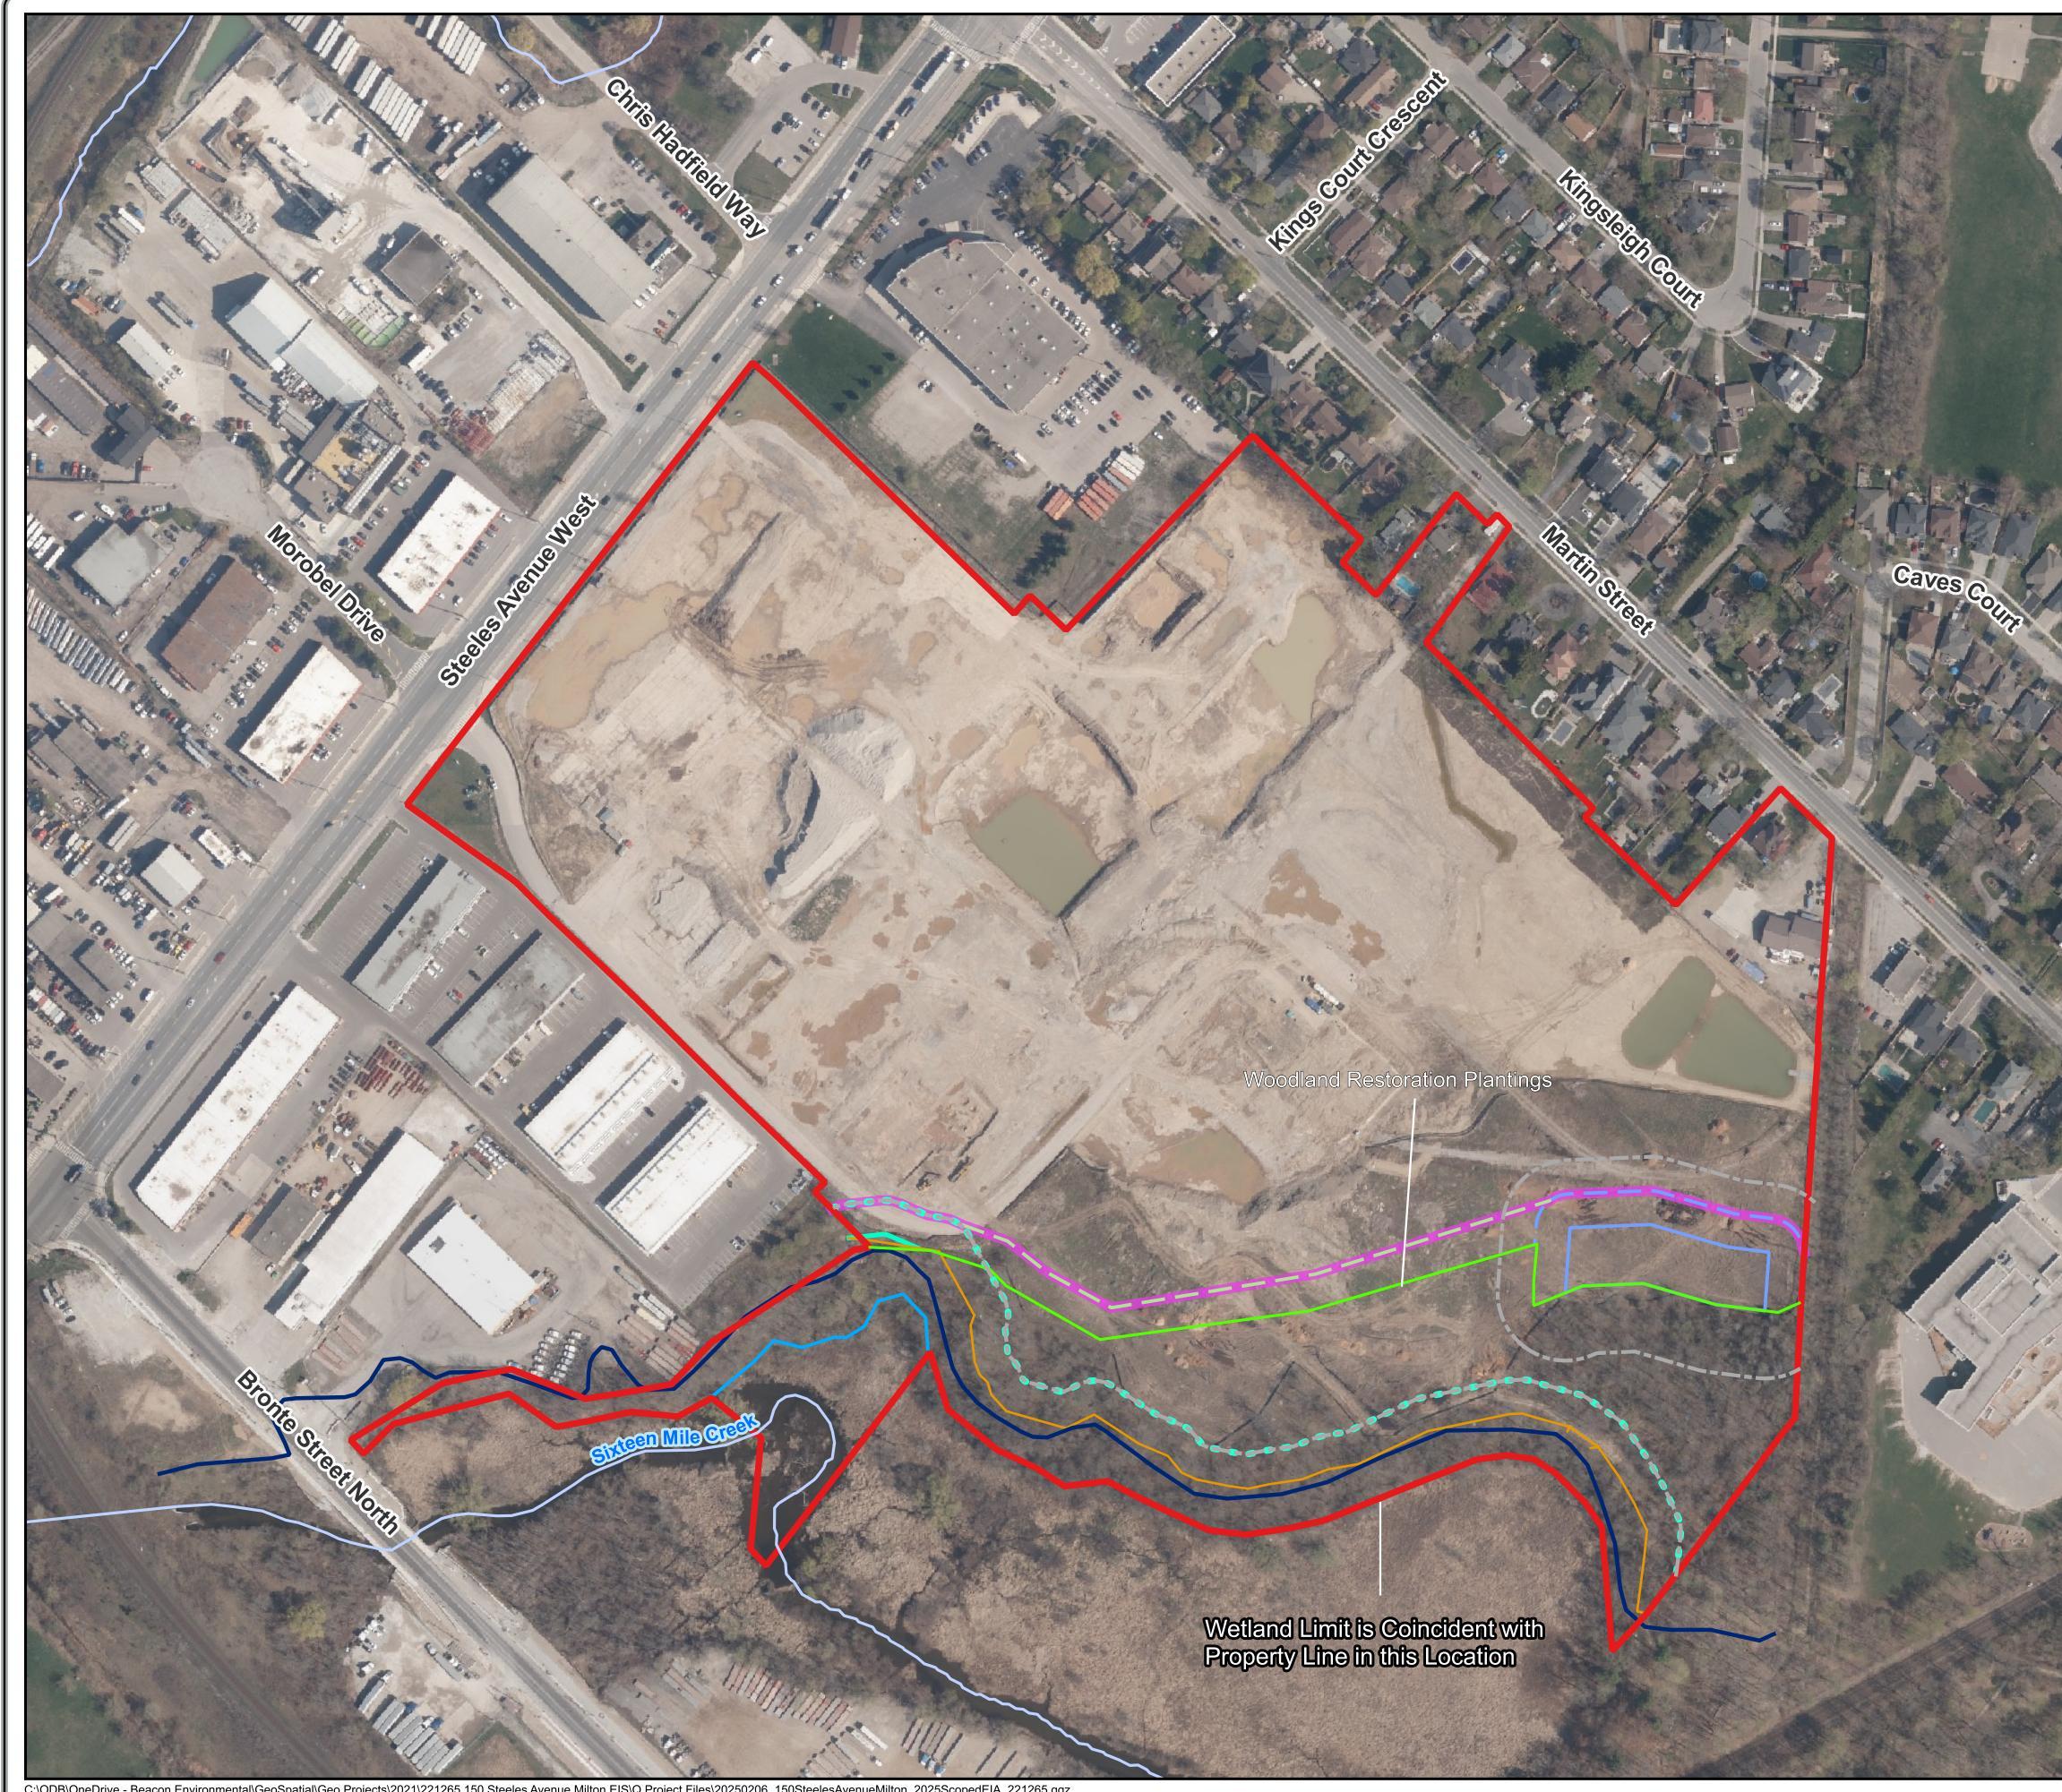
Environmental Constraints

The RNHS contains the following components: - Key Features, such as: - Habitat for Endangered and Threatened Species - Significant Wetlands - Significant Woollands (Restored) - Significant Valleylands - Significant Valleylands - Significant Wildlife Habitat (Restored) - Fish Habitat - Inkages - Regulated Watercourse - Non-Significant Wetlands (Restored) - Buffers - Regulated Floodplains Project: 221265 Last Revised: April 2025 Client: Neatt Communities Prepared by: BD Checked by: JS 1:3,000 <u>60</u> 120 m	CH Regulate	ed Allowar	nce				
Project: 221265 Last Revised: April 2025 Client: Neatt Communities Prepared by: BD Checked by: JS 1:3,000 0 60 120 m Contains information licensed under the Open Government License–	The RNHS contains f - Key Features, such - Habitat for Endar - Significant Wetla - Significant Wood - Significant Valley - Significant Wildlif - Fish Habitat - Linkages - Regulated Watercco - Non-Significant We - Buffers - Regulated Floodpla	the followin as: Igered and Ids lands (Res lands e Habitat (Purse ttlands (Re	g components: Threatened Spe tored) Restored) stored)	cies

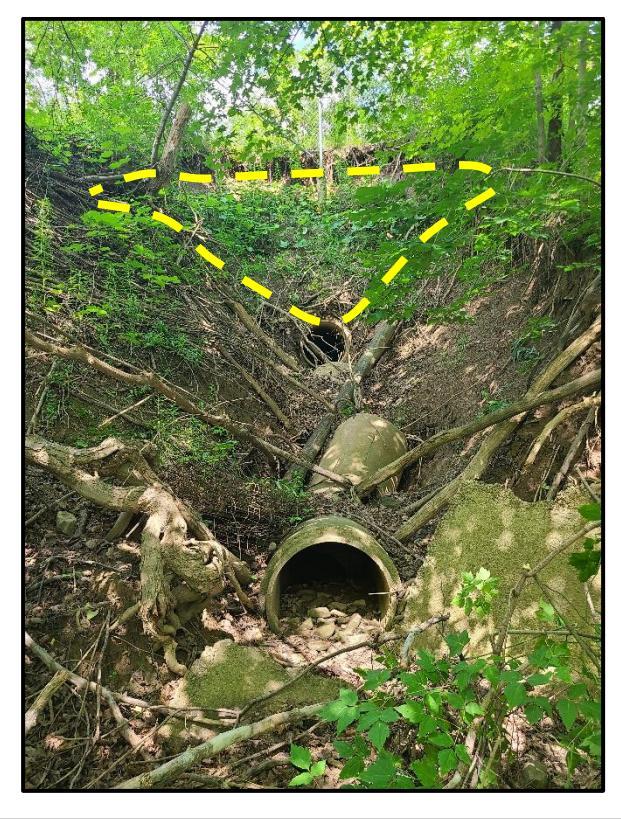
Photograph 1. Mid- and Upper-Slope of Eroded Slope. Upper eroded slope is indicated with yellow dashed line. Note the side slopes of this area are approximately ³/₄ h:1 v. Photo facing north, taken July 18, 2023.

Opportunities to address the erosion as identified above were explored in the CEMS. It was determined that vegetating the area, to mitigate the erosion of soils was the best option that minimized impacts to the valleyland. This recommendation continues to be applicable, and a CH permit will be required for this work pursuant to O. Reg. 41/24.

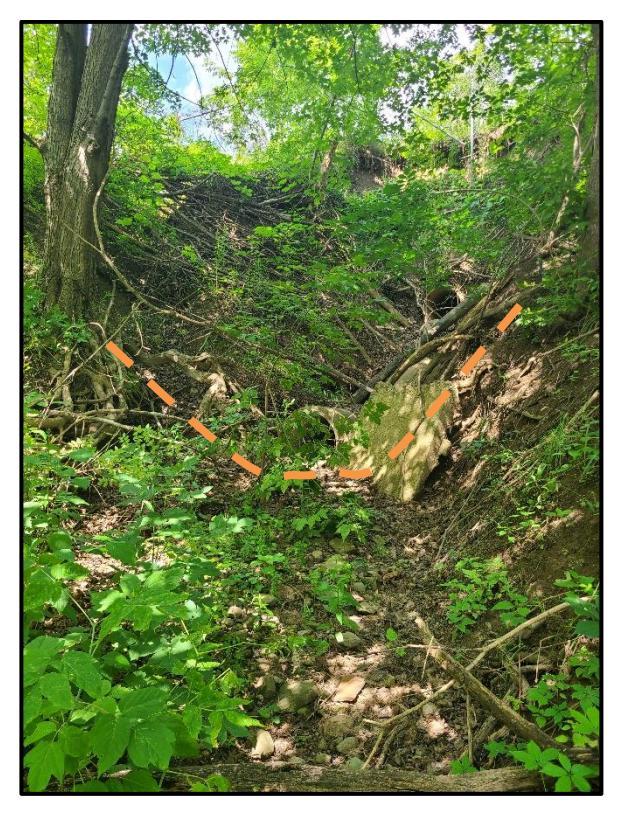
Photograph 2. Lower Slope of Eroded Slope. Boundary between mid- and lower-slope indicated with orange dashed line. Note the side slopes of this area are approximately ³/₄ h:1 v. Photo facing north, taken July 18, 2023.

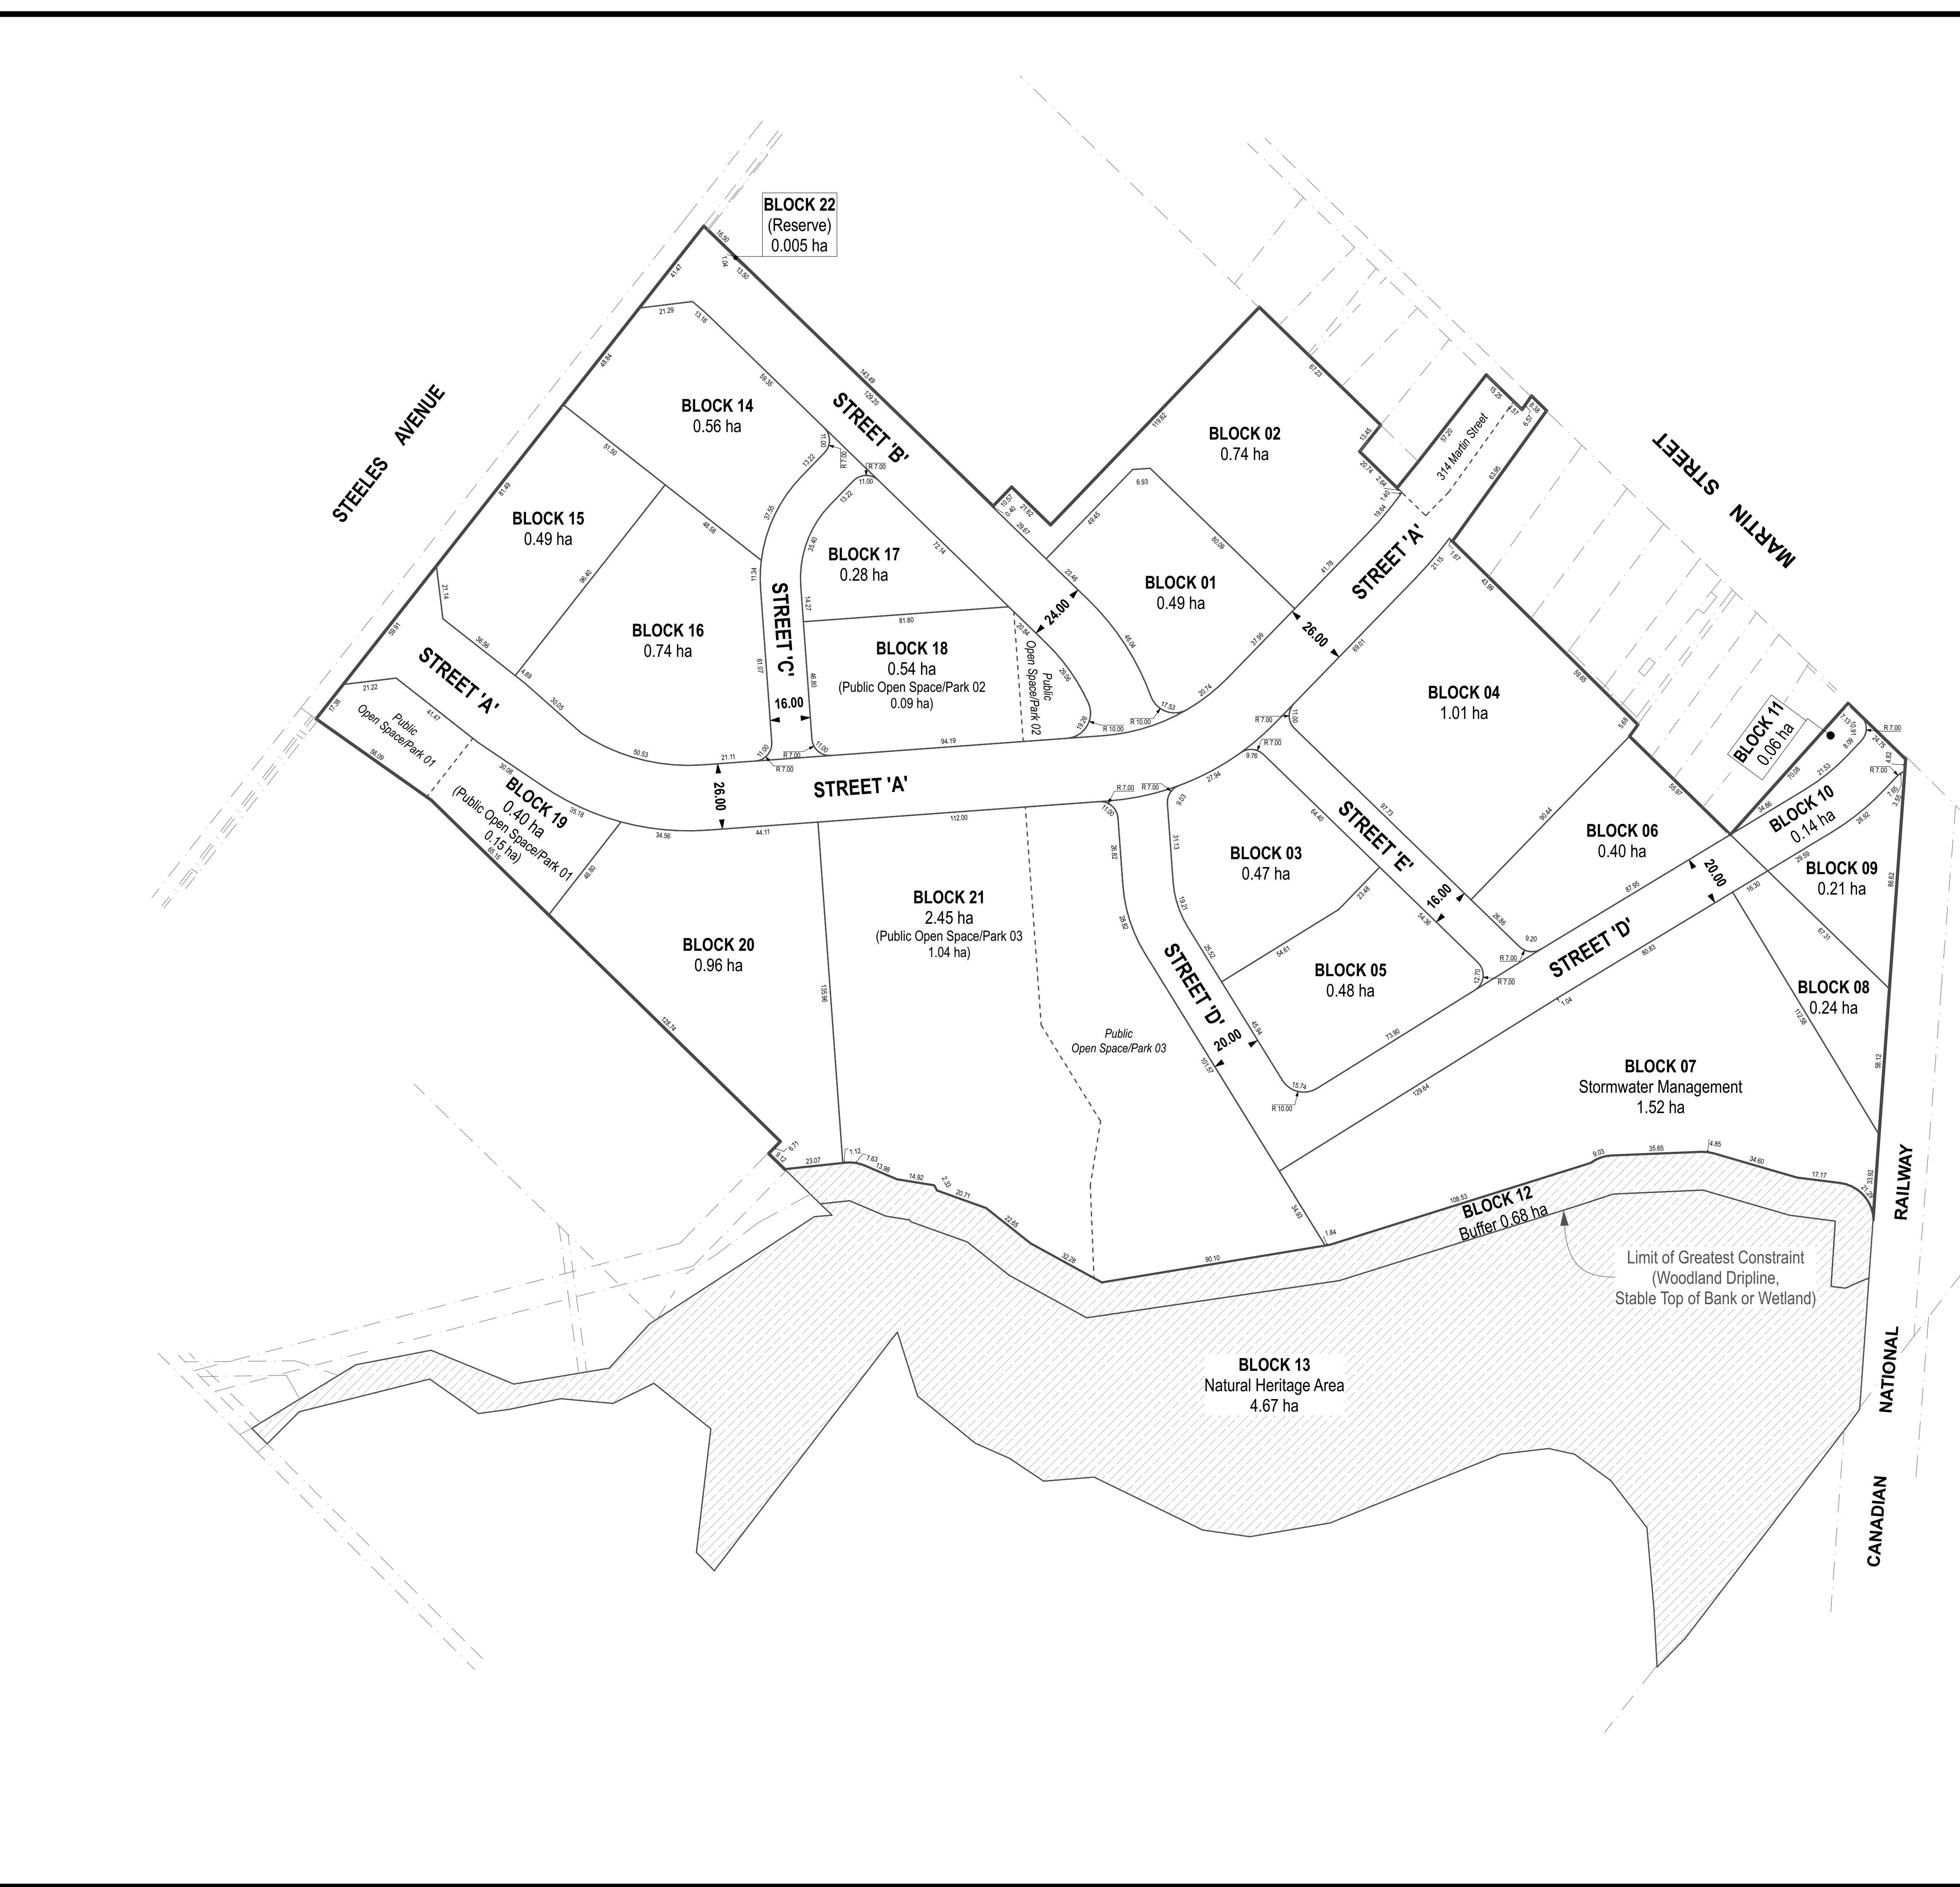
DRAFT PLAN OF SUBDIVISION

Name	Area (ha)
	<u>.</u>
BLOCK 01	0.49
BLOCK 02	0.74
BLOCK 03	0.47
BLOCK 04	1.01
BLOCK 05	0.48
BLOCK 06	0.40
BLOCK 07	1.52
BLOCK 08	0.24
BLOCK 14	0.56
BLOCK 15	0.49
BLOCK 16	0.74
BLOCK 17	0.28
BLOCK 18	0.54
BLOCK 19	0.40
BLOCK 20	0.96
BLOCK 21	2.45
BLOCK 22 (Reserve)	0.005
STREET 'A'	1.45
STREET 'B'	0.65
STREET 'C'	0.21
STREET 'D'	0.74
STREET 'E'	0.22
	15.04
Natural Heritage	<u> </u>
BLOCK 12 (Buffer)	0.68
BLOCK 13	4.67
	5.35
248 Martin	
BLOCK 09	0.21
BLOCK 10	0.14
BLOCK 11	0.06
	0.41
TOTAL	20.80

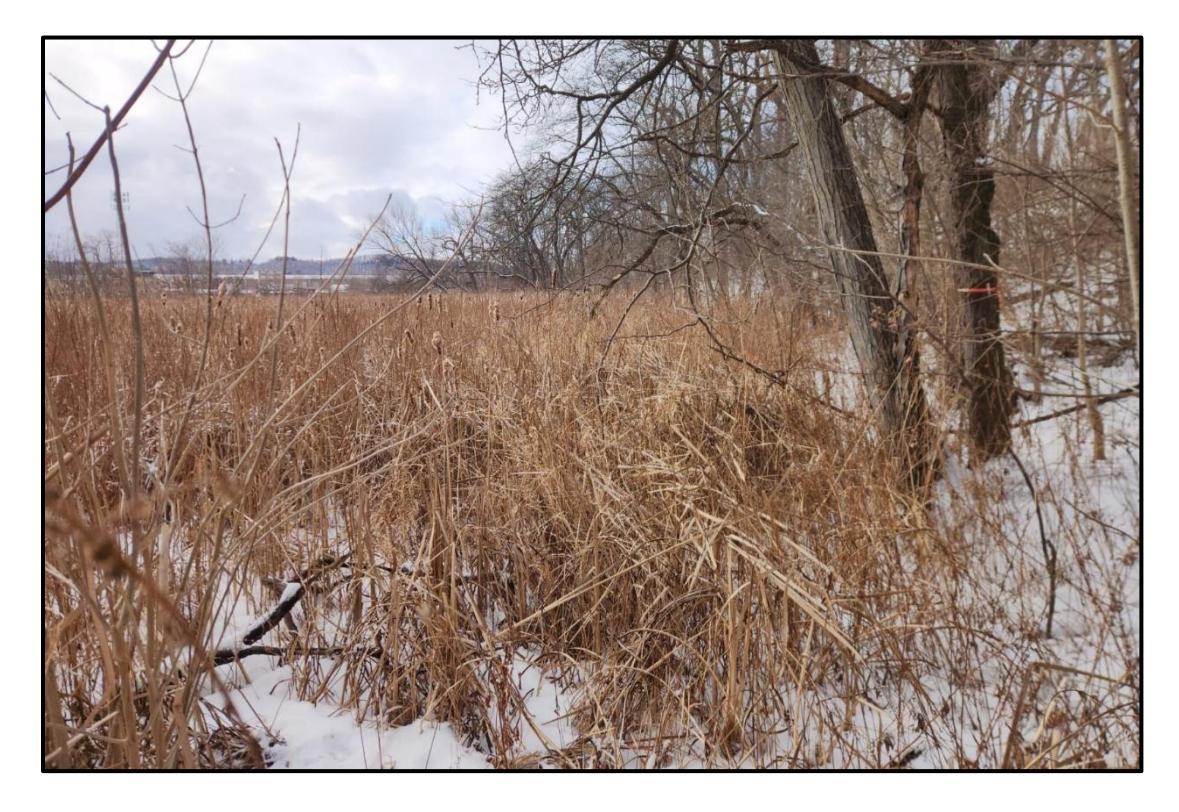
Photograph 3. General area of proposed stormwater outlet (Alternative 2b) January 29, 2025 (west-facing view)

Based on this assessment, Alternative 2b meets the test of an "essential infrastructure" (in the public interest after all alternatives have been considered) in accordance with ROP Policies 117.1(9) and 233 and should be considered as a permitted use in the RNHS.

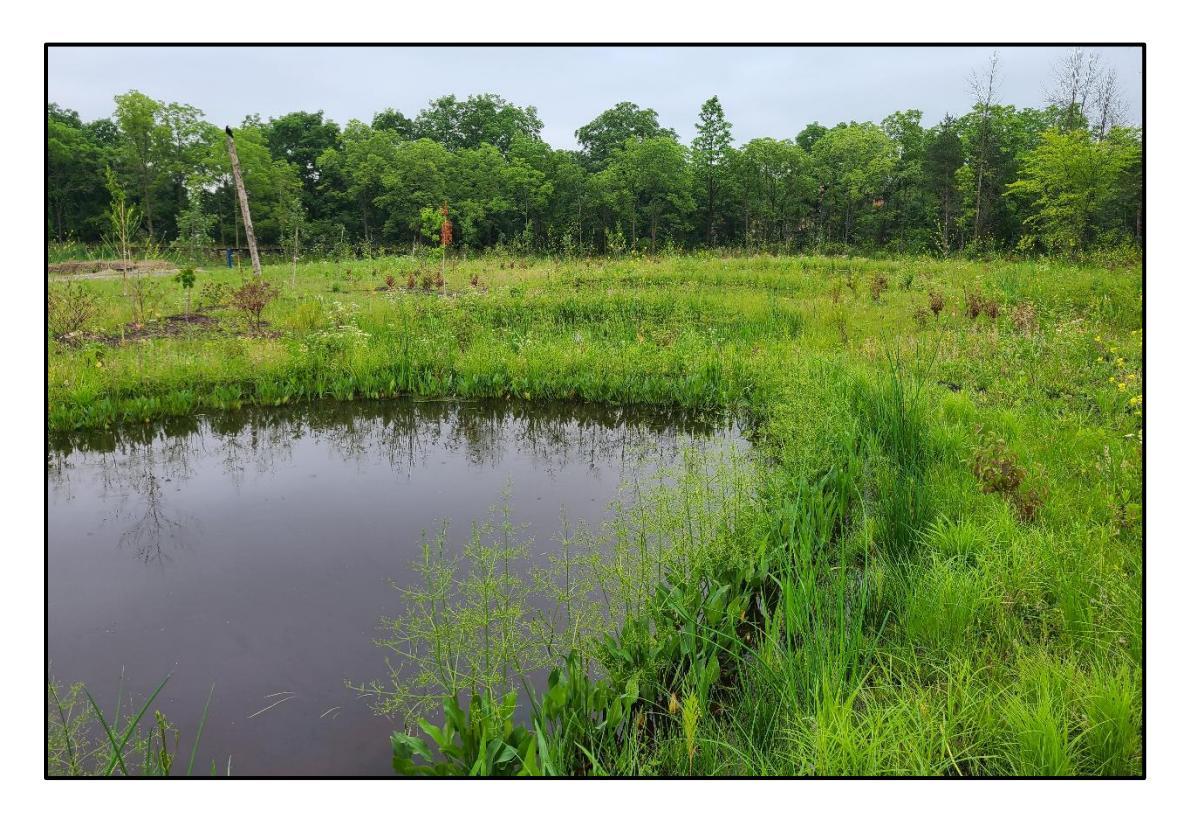
Photograph 4. Wetland Restoration Area, July 15, 2024 (east-facing view)

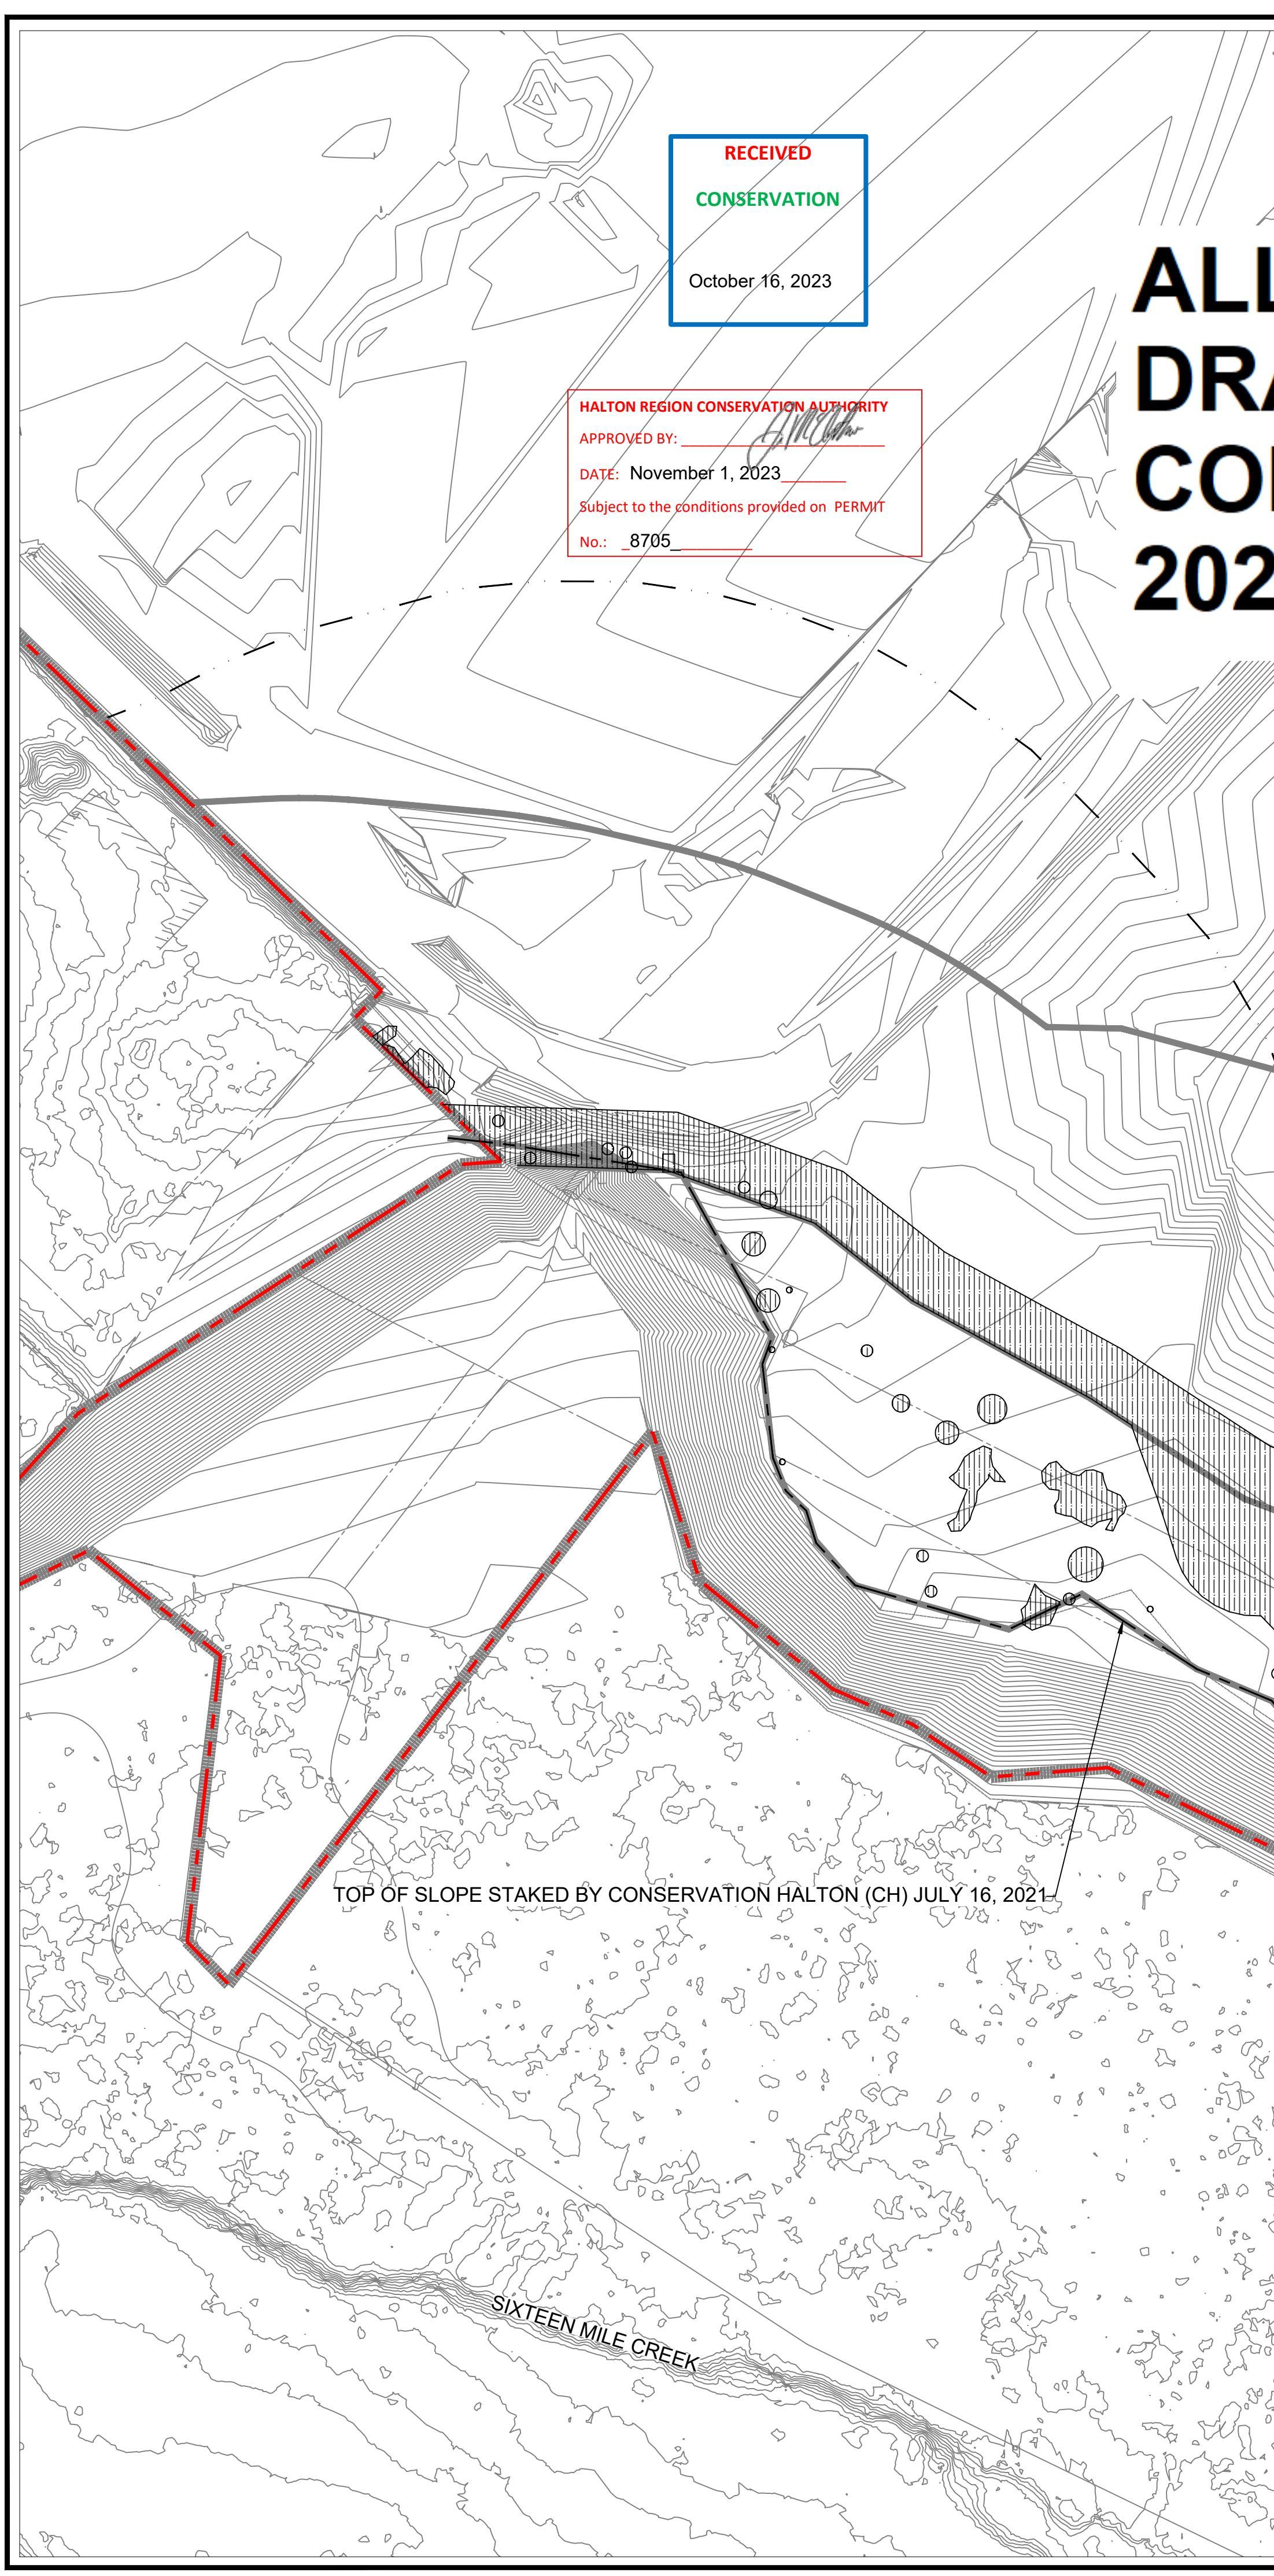
C1. CH Approved Wetland Restoration Drawings

ALL WORKS IN THESE DRAWINGS WERE COMPLETED IN 2023/2024

WOODLAND REMEDIATION PART OF SEPARATE APPLICATION

INVASIVE REMOVAL REMEDIATION AREAS (SHEET L-5)

BUFFER PLANTING AREA (SHEET L-3) WETLAND REMEDIATION PLANTING AREA (SHEET L-4)

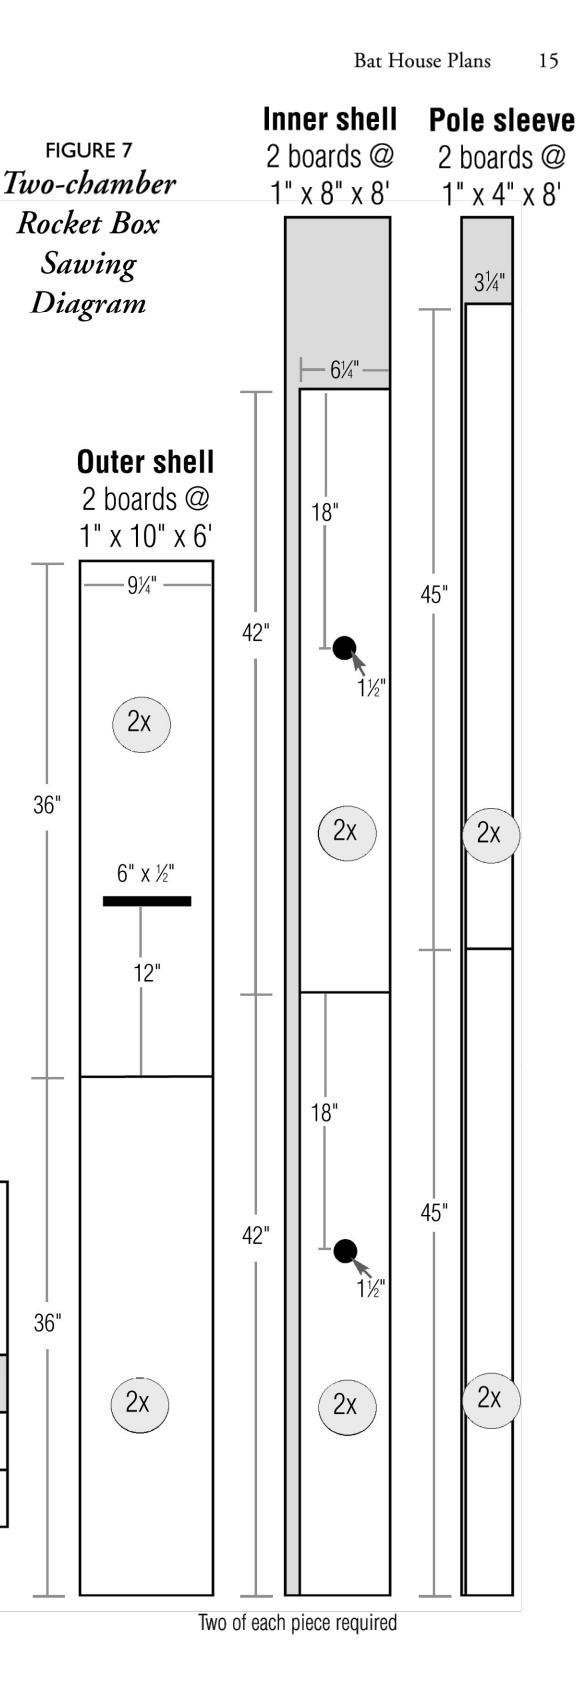
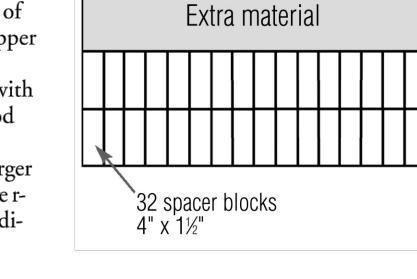
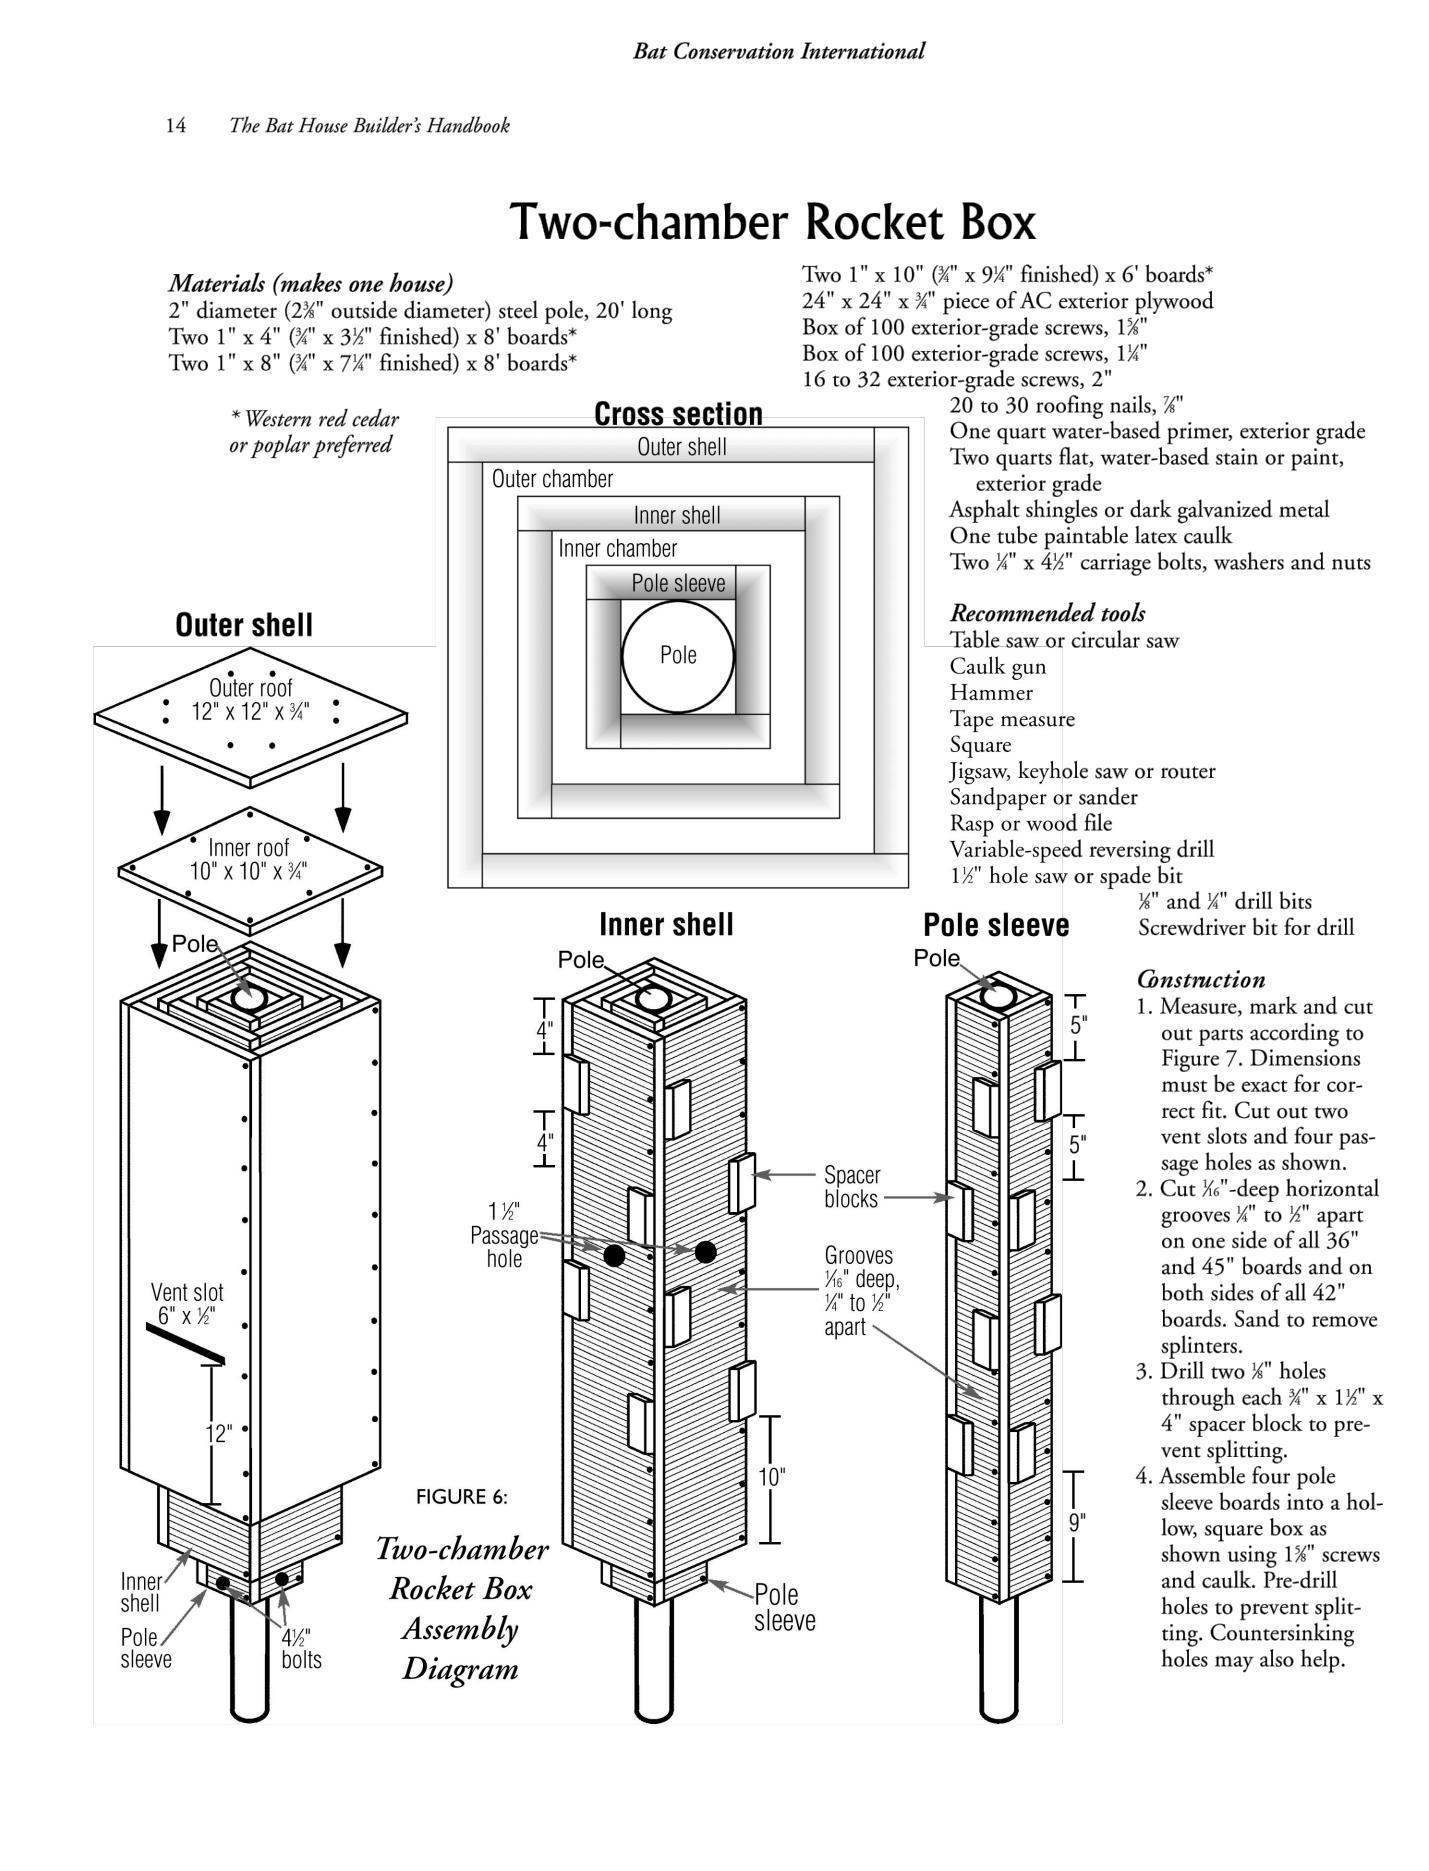
TWO CHAMBER ROCKET BOX BAT HOUSE DETAIL

- 5. Attach spacer blocks to pole sleeve as shown (four per side) using two 1¹/4" screws per block. Bottom spacer blocks are 9" up from bottom of pole sleeve. Top spacer blocks are 5" from top. Alternate spacer blocks on left and right sides, 5" apart. 6. Assemble four inner shell boards into a hollow, square box as in

2' x 2' x ¾" AC plywood

Outer roof 12" x 12"

Inner roof

10" x 10
