Scoped Environmental Impact Assessment 150 Steeles Avenue East, 248, 250 & 314 Martin Street, Town of Milton

Date: 2025-04-14 Project: 221265

Scoped EIA: 150 Steeles Ave. E., 248, 250 & 314 Martin St., Milton

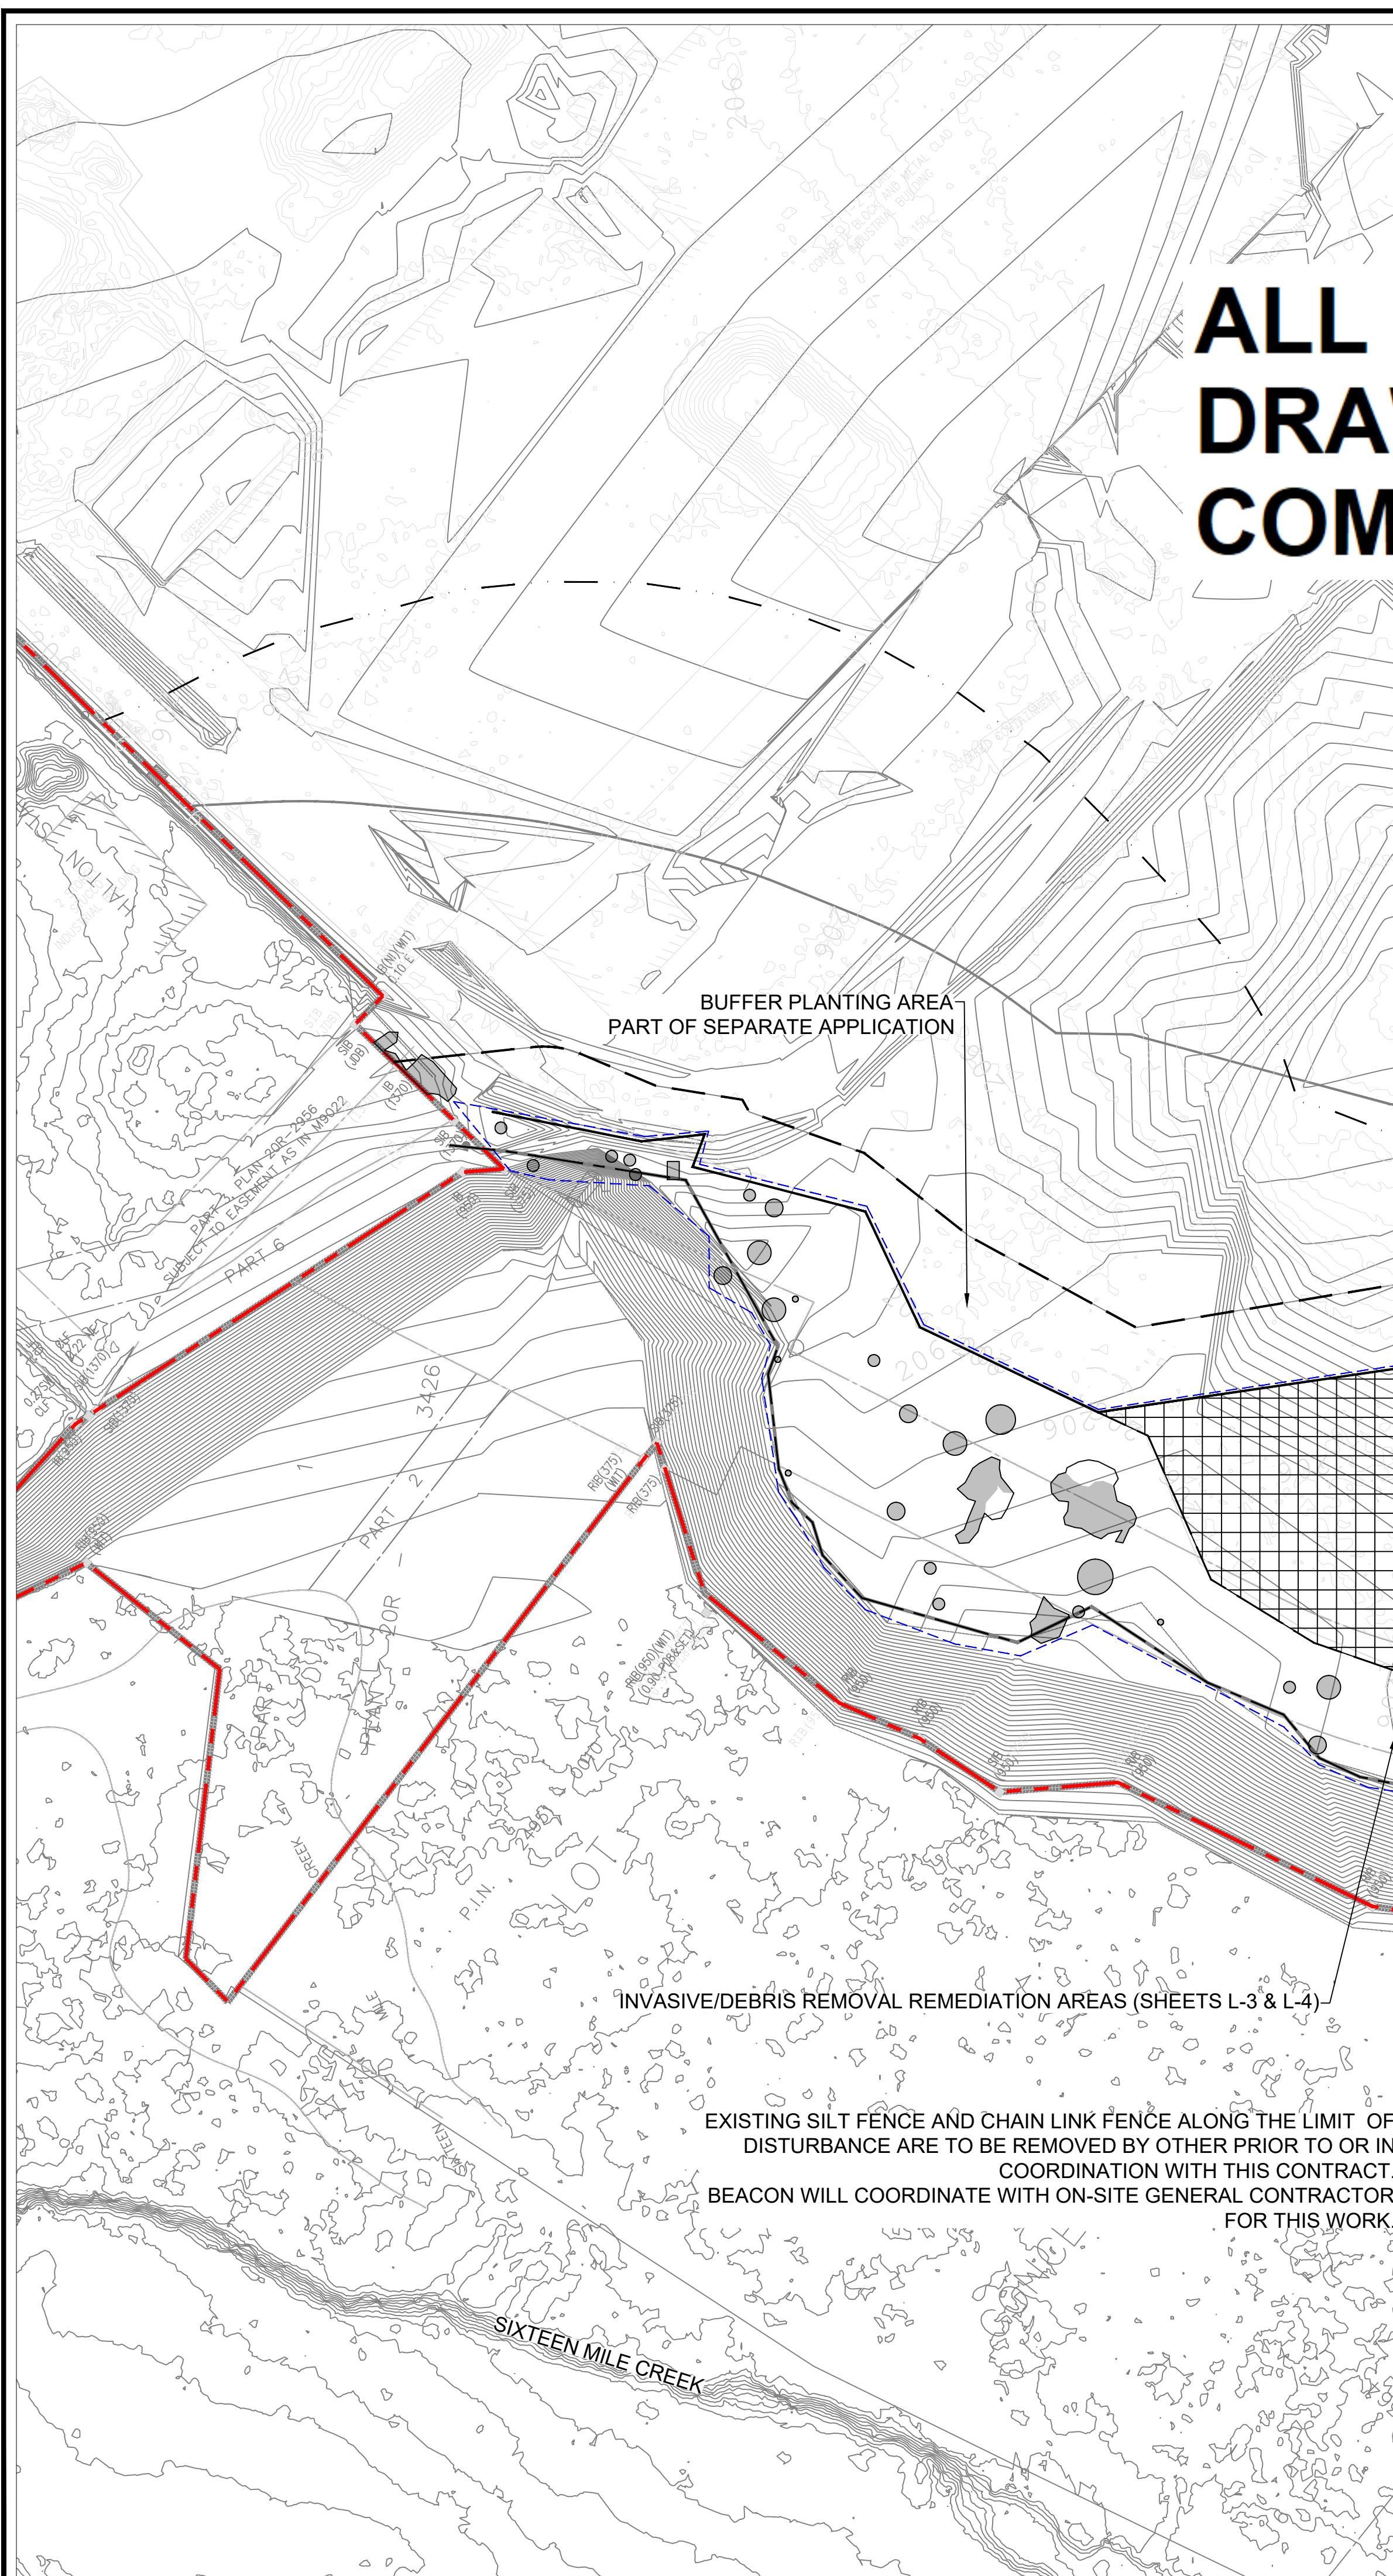
ALL WORKS IN THESE DRAWINGS WERE COMPLETED IN 2024

WOODLAND REMEDIATION AREA (SHEET L-

WETLAND AND RESTORATION PART OF SEPARATE

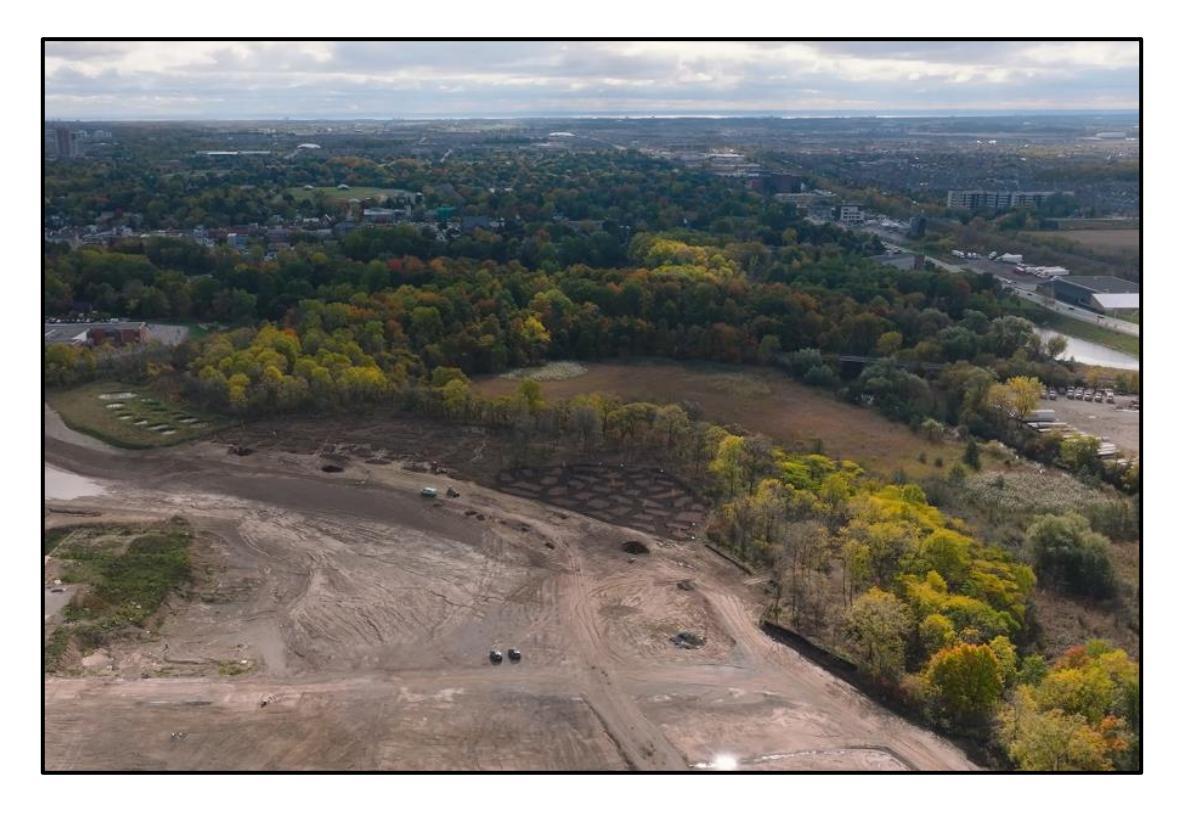
Photograph 1. NHS Restoration and Adjacent NHS, South-Facing View (Oct 16, 2024).

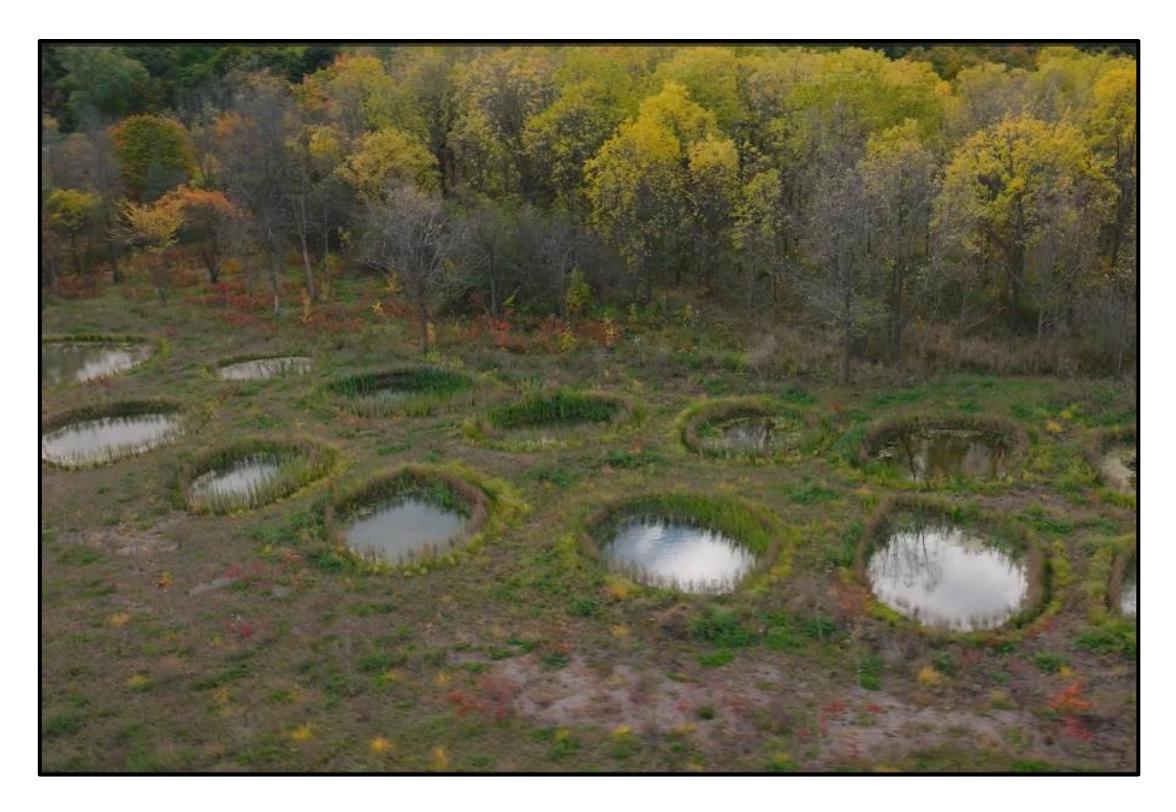
Photograph 2. Wetland (foreground) and Enhancement Area (background), South-Facing.

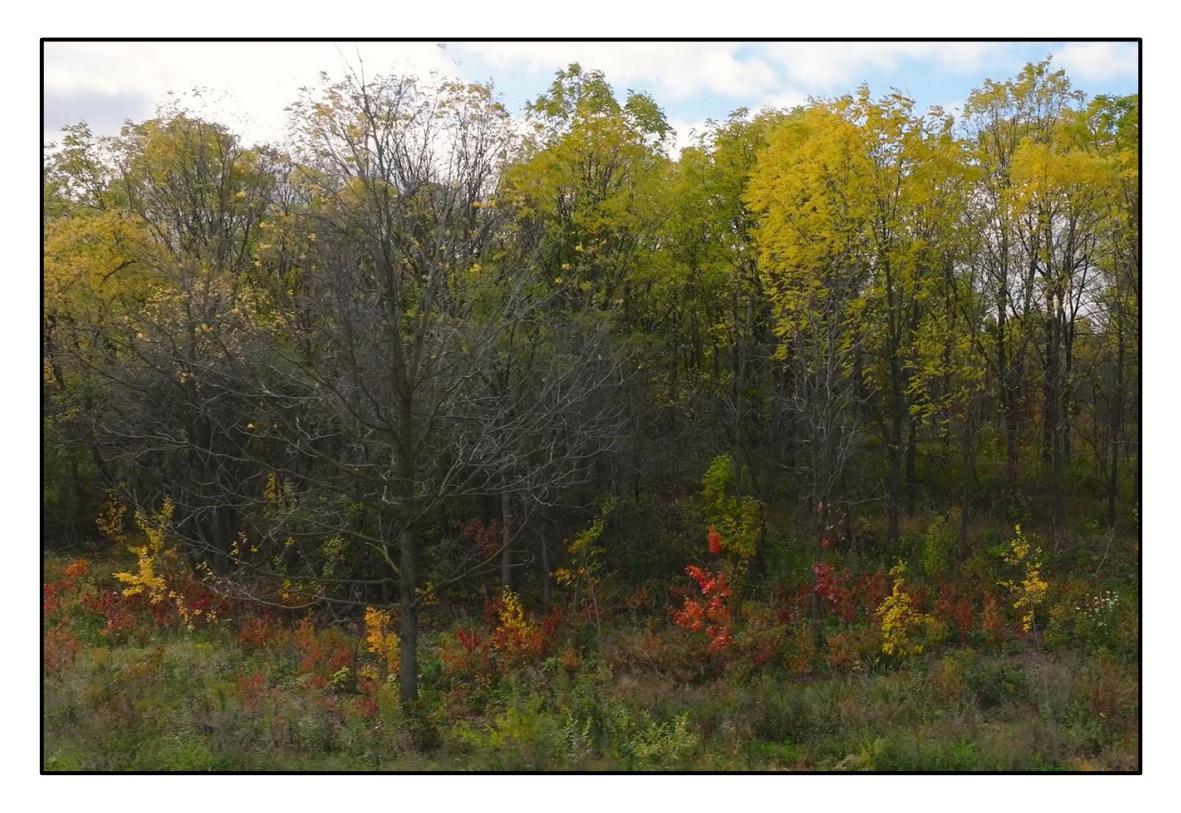
Photograph 3. Enhancement Area: Former Buckthorn Thicket with Native Trees and Shrubs.

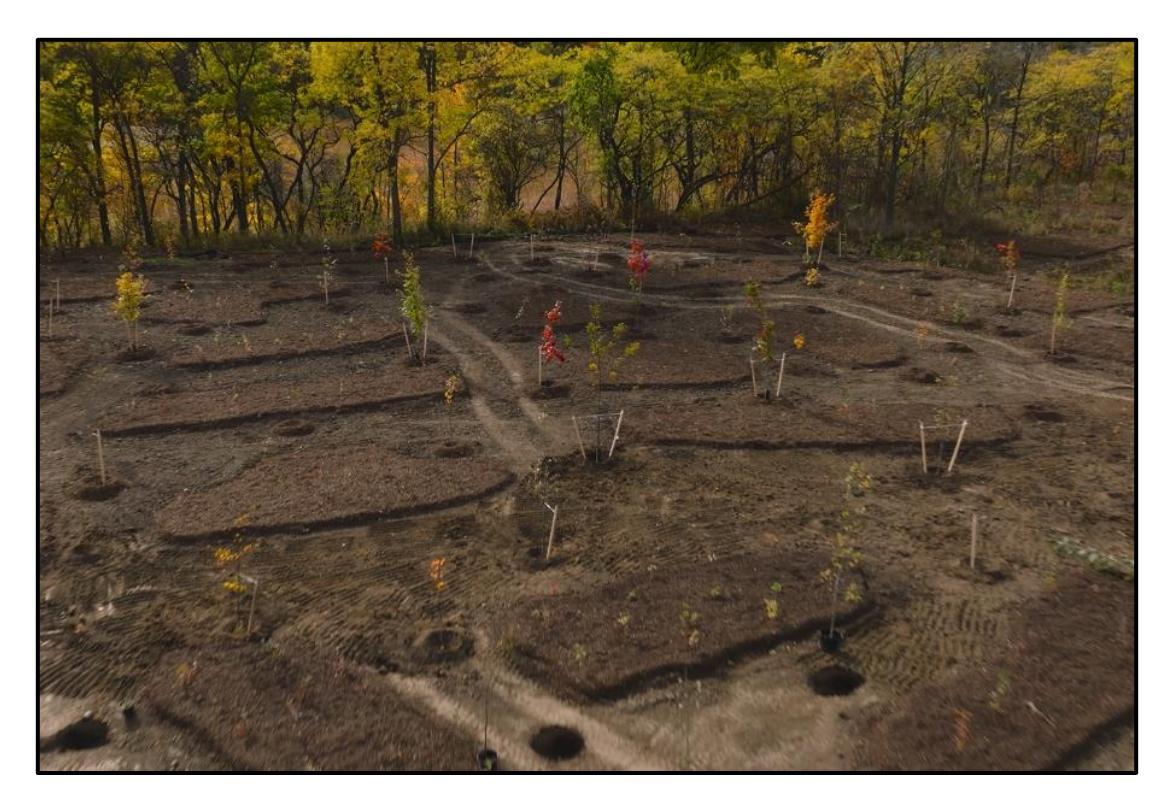
Photograph 4. Eastern Portion of Woodland Restoration. Note photo predates topsoiling.

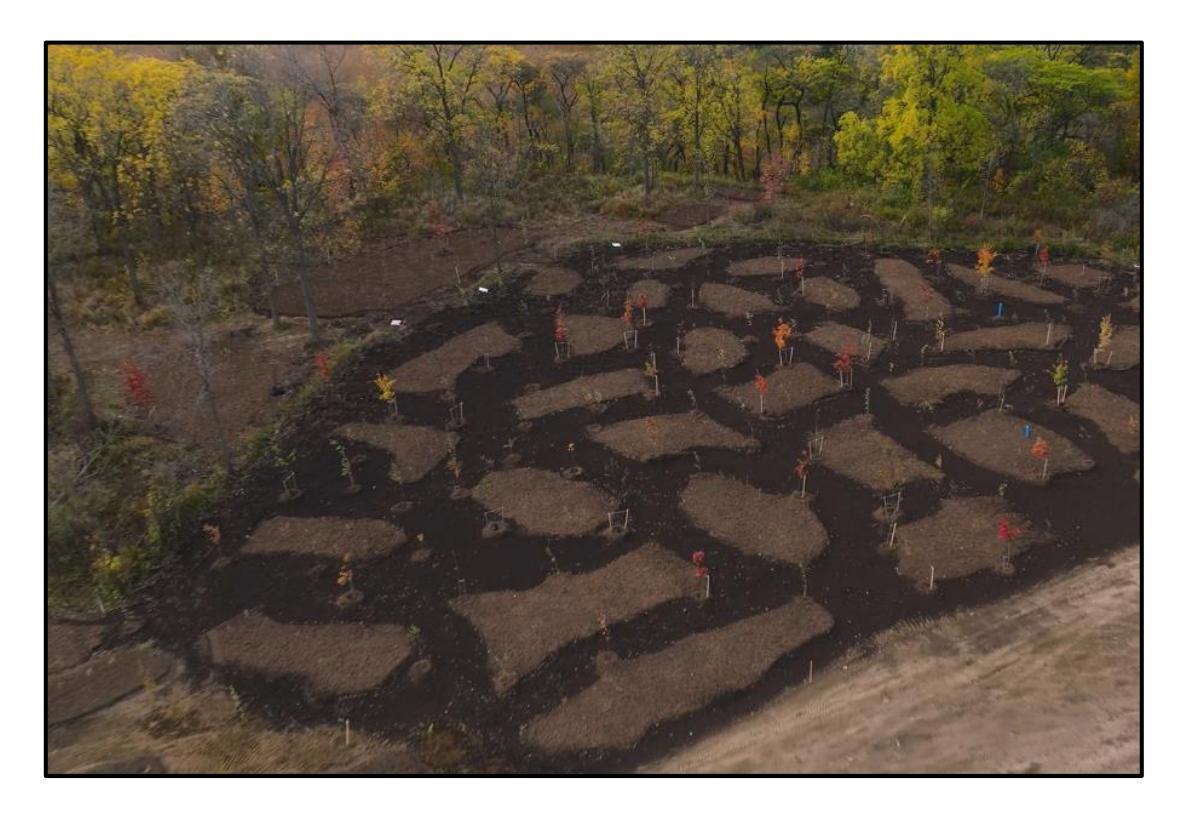
Photograph 5. Western Portion of Woodland Restoration and NHS Enhancement Area.
