PHASE ONE ENVIRONMENTAL SITE ASSESSMENT

**1190 Bronte Street South
Milton, Ontario**

Grounded Engineering Inc.

File No. 25-116

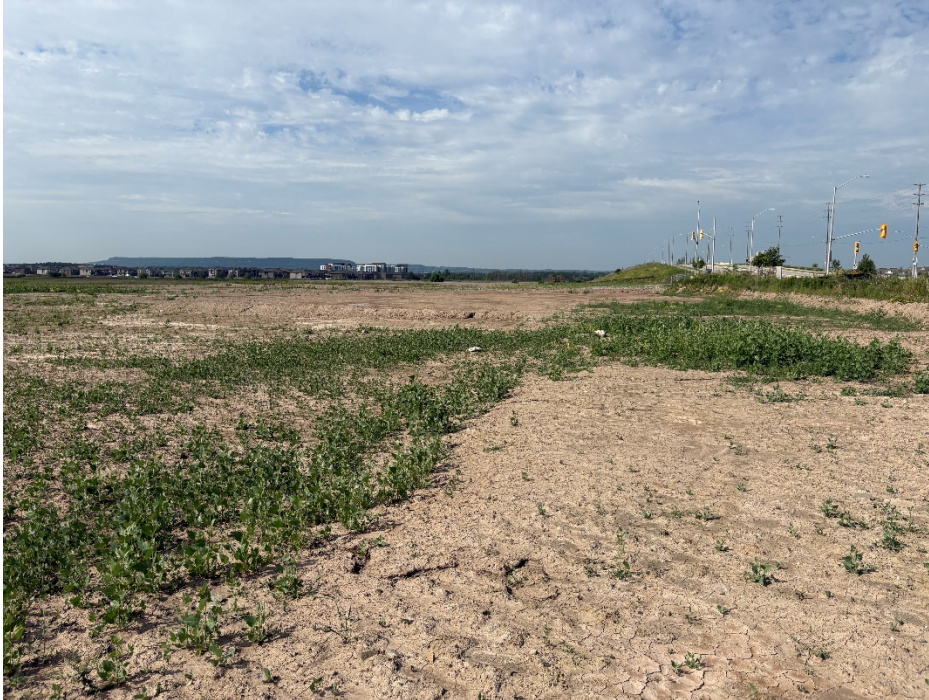
Photograph 1

Location: Phase One Property

Direction: Northern Property Boundary, facing west.

Description: vacant land, topsoil removed

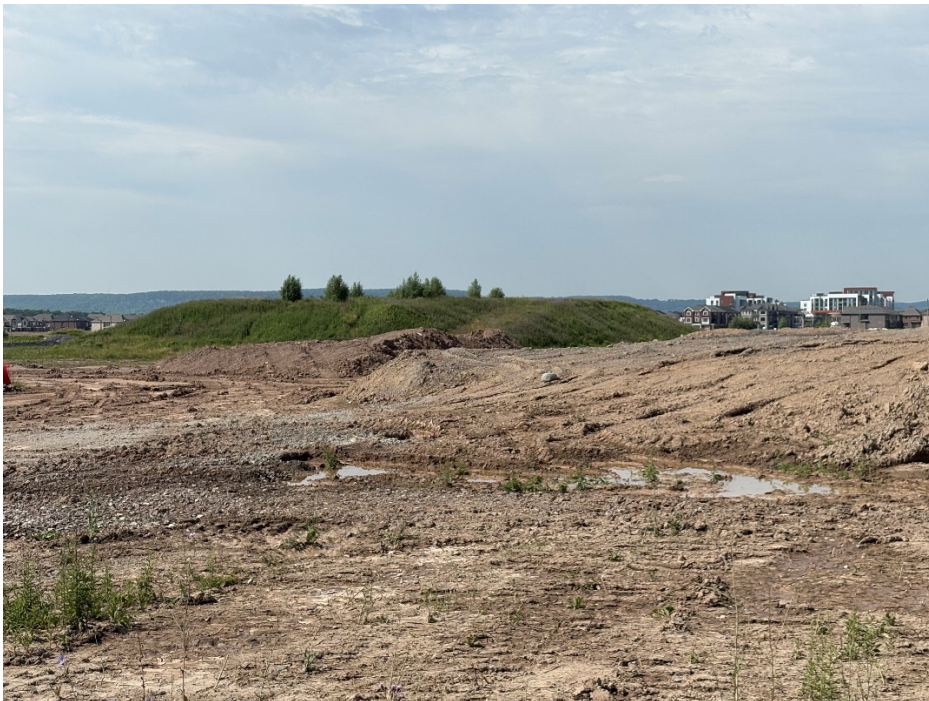
Photograph 2

Location: Phase One Property

Direction: Central Portion, facing west

Description: stockpiles and grading work on site.

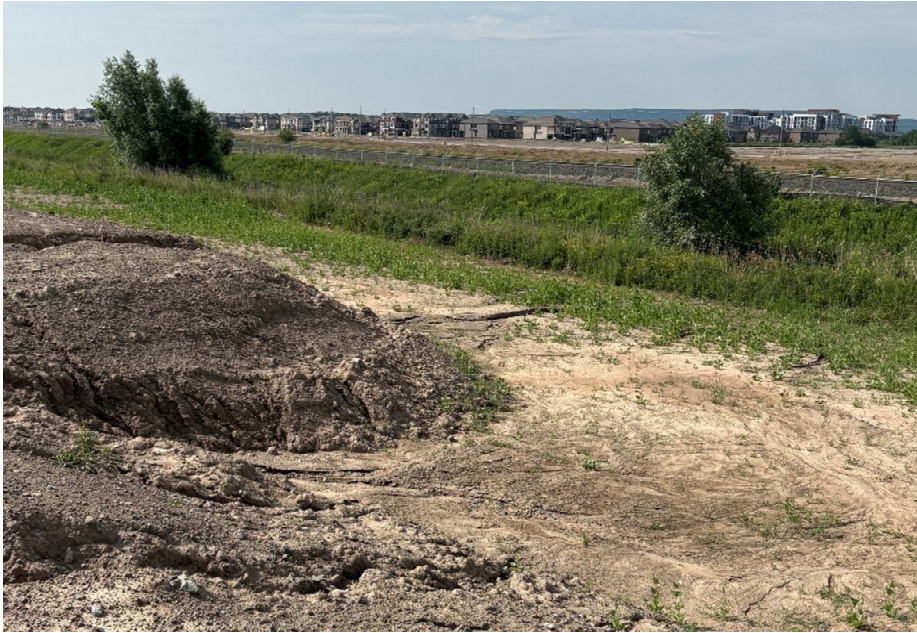
Photograph 3

Location: Phase One Property and adjacent CN railway

Direction: Facing west

Description: on-site grading, drainage ditch, berm, CN railway

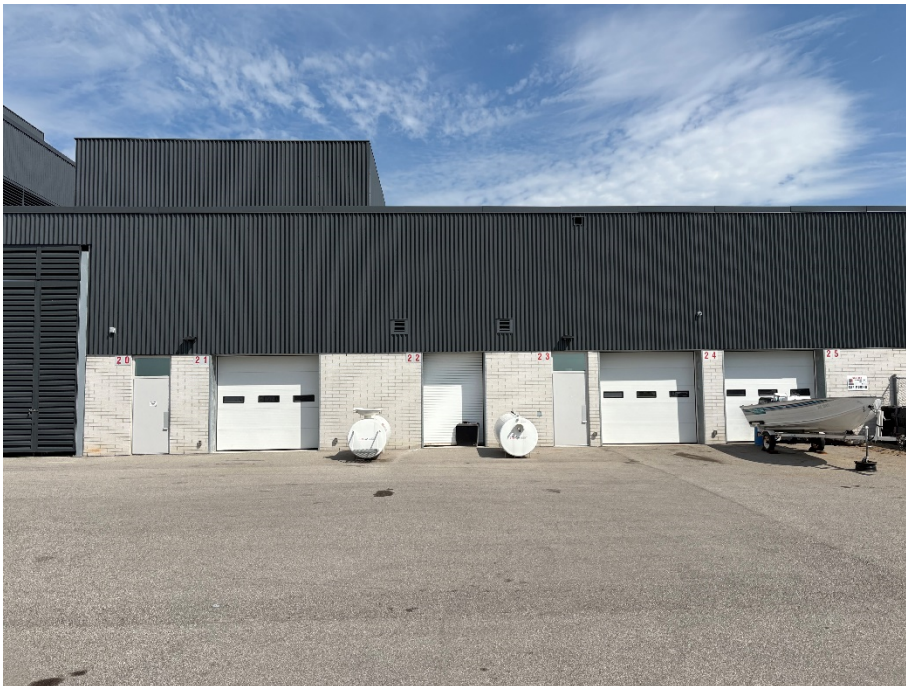
Photograph 4

Location: 1410 Bronte St. S.

Description: Two (2) ASTs, four (4) bay doors.

1410 Bronte St. S. 104 m Southeast	28 A	28 - Gasoline and Associated Products Storage in Fixed Tanks	No	ERIS Site Visit	A generator of waste classes 251 (oil skimmings & sludges), 212 (aliphatic solvents), 252 (waste oils & lubricants) is registered to Halton District School Board as of 2022. Two (2) ASTs were observed during the site visit at the south facing end of the building along with four (4) bay doors to a potential shop class.	Based on the downgradient distance from the Property and the clayey silt till overburden in the area it is the opinion of the QP that this PCA will not lead to an APEC.
95 Locker Pl. 179 m Northeast	40 A	40 - Pesticides (including Herbicides, Fungicides and Anti-Fouling Agents) Manufacturing, Processing, Bulk Storage and Large-Scale Applications	No	ERIS	AR Pest Control Inc. was registered on the Pesticide Registry from 2019 to 2020.	Due to the cross-gradient distance from the Property, and the hydrophobic nature of pesticides, it is the opinion of the QP that this PCA will not lead to an APEC.
